# Lyle Creek Restoration

## 2003 Annual Monitoring Report

March, 2004

## 2003 Lyle Creek Monitoring Abstract

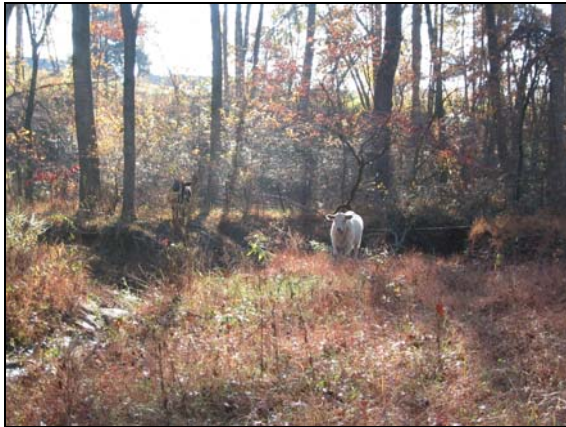
**Issue Photo 1  
Cattle within the Lyle Creek Easement.**

- **Easement Limits**
  - NCWRP should work with landowners to ensure easement limits are maintained and that cattle stay out of the riparian area.
- **Areas of major head cuts**

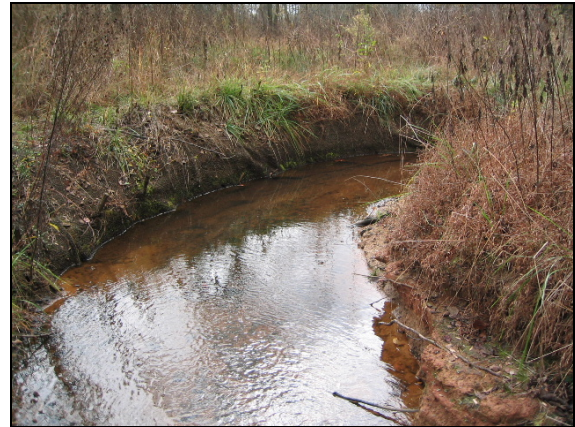
**Issue Photo 2 – Station 11+00  
Bank undercutting due to lack of vegetation.**

- **Areas with bank slumping**
  - These areas should be planted heavily with live stakes to help establish root mass along the channel bank.
  - These areas should be monitored closely during upcoming site visits to determine if the problem is localized to more regional in scale.

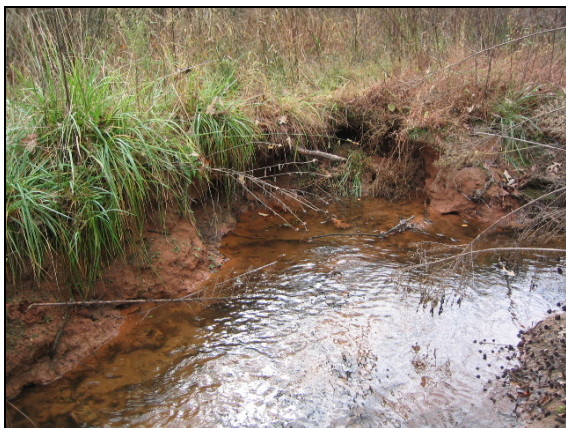
**Issue Photo 3 and 4 – Station 16+90  
Bank failure due to overland flow.**

- Overland flow may need to be routed away from areas that show signs of severe bank erosion
- **Areas lacking stream features**
  - There are seven riffles that were constructed that do not exist in the longitudinal profile measured during the 2003 monitoring

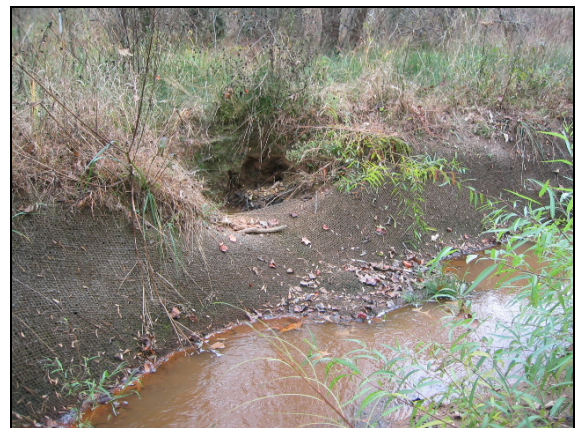
**Issue Photo 5 – Station 10+40  
Bank failure under matting.**

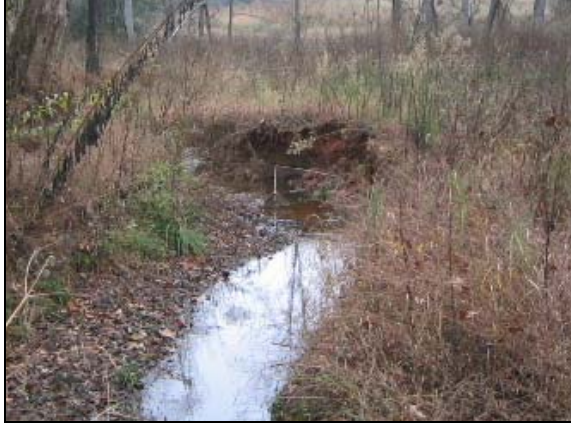
**Issue Photo 6 – Station 15+80  
Bank erosion due to lack of vegetation.**

- It is recommended to stake in areas where erosion is problematic in a few areas, particularly on outside meander bends
  - The invasive vegetation requires no treatment at this time.

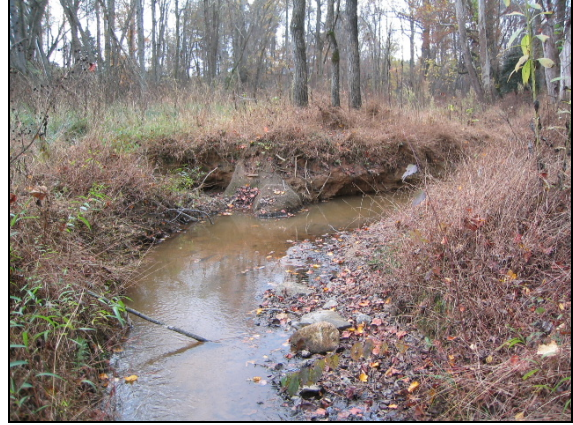
**Issue Photo 7 – Station 15+00  
Bank Failure under matting.**

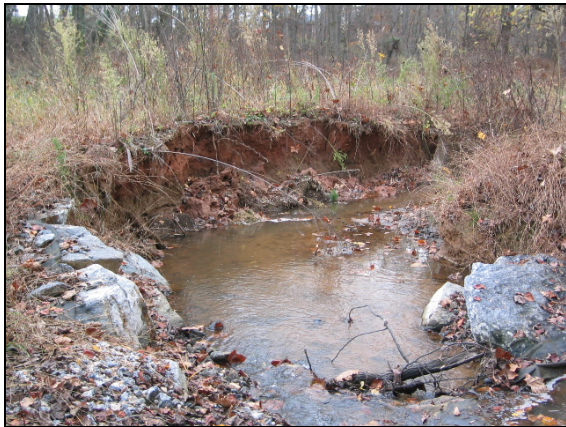
**Issue Photo 8 – Station 13+70  
Severe bank erosion.**

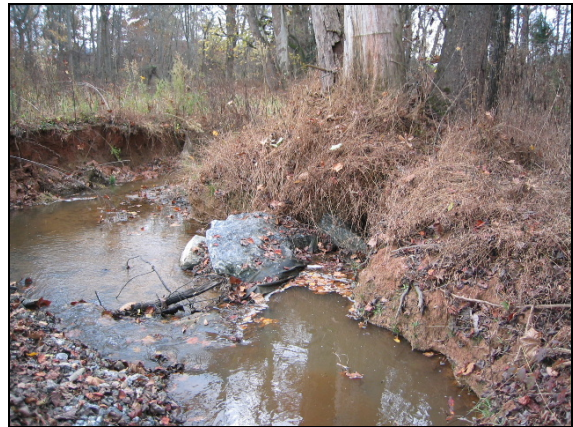
**Issue Photo 9 – Station 13+40  
Scour around upstream side of cross vane wing.**

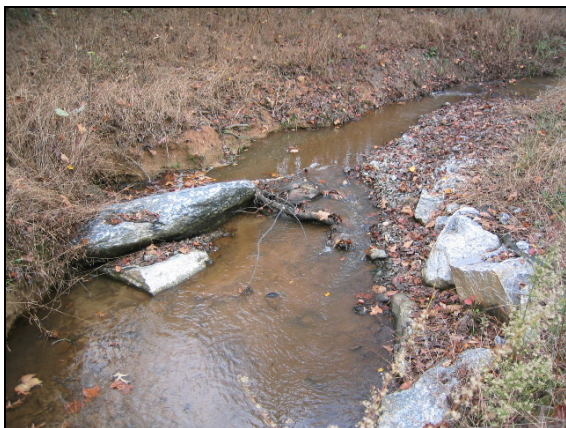
**Issue Photo 9A – Station 18+50  
Scour around upstream side of cross vane wing.**

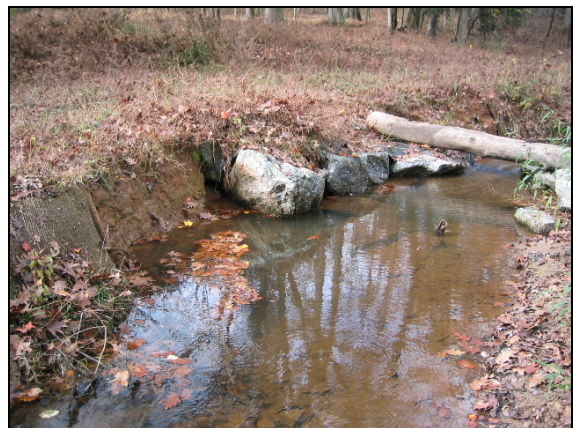
**Issue Photo 9B – Station 19+70  
Scour below cross vane.**

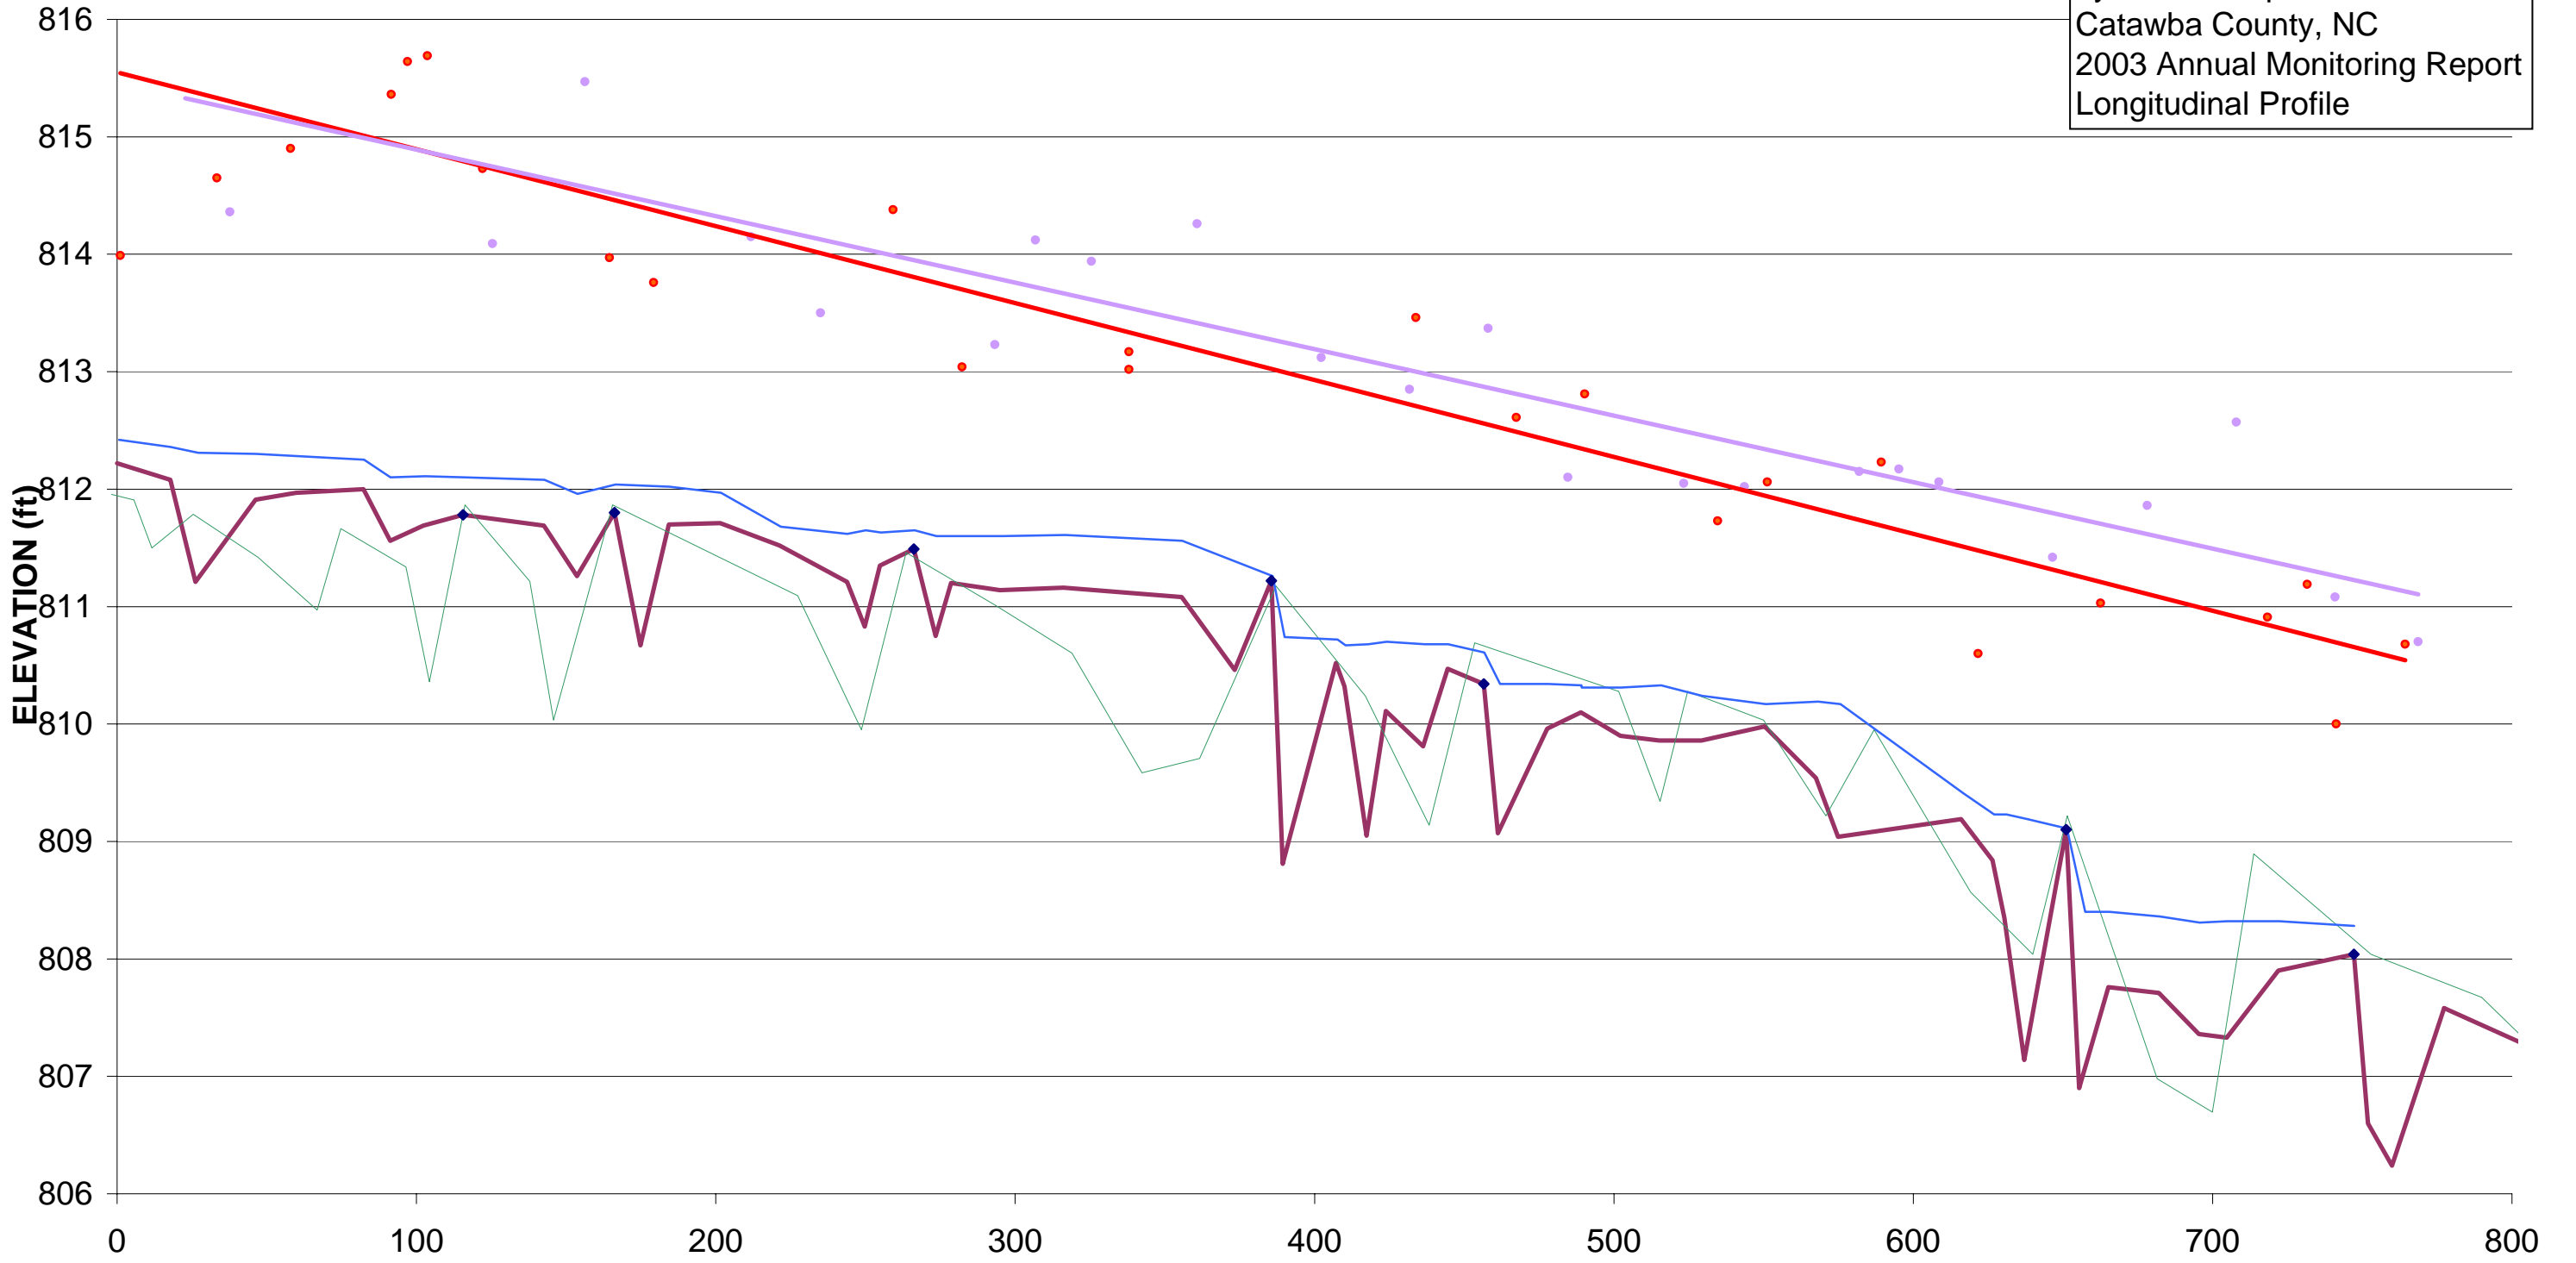
Figure 5  
Lyle Creek Inplace Channel  
Catawba County, NC  
2003 Annual Monitoring Report  
Longitudinal Profile

Channel profile along the in place section of has remained similar to as-built conditions. Two cross vane structures near the tie-in with the relocated reach have one-foot drops. These areas should be watched closely in future monitoring periods to ensure the structures do not fail. The remaining area appears to be functioning well. The previous survey of this area did not match up very well with the 2003 survey due to file conversion difficulties. Pools and riffles identified in the field matched up with 2003 survey data and profile or planform appeared to be located correctly so 2003 data will be used as base data for future monitoring periods.

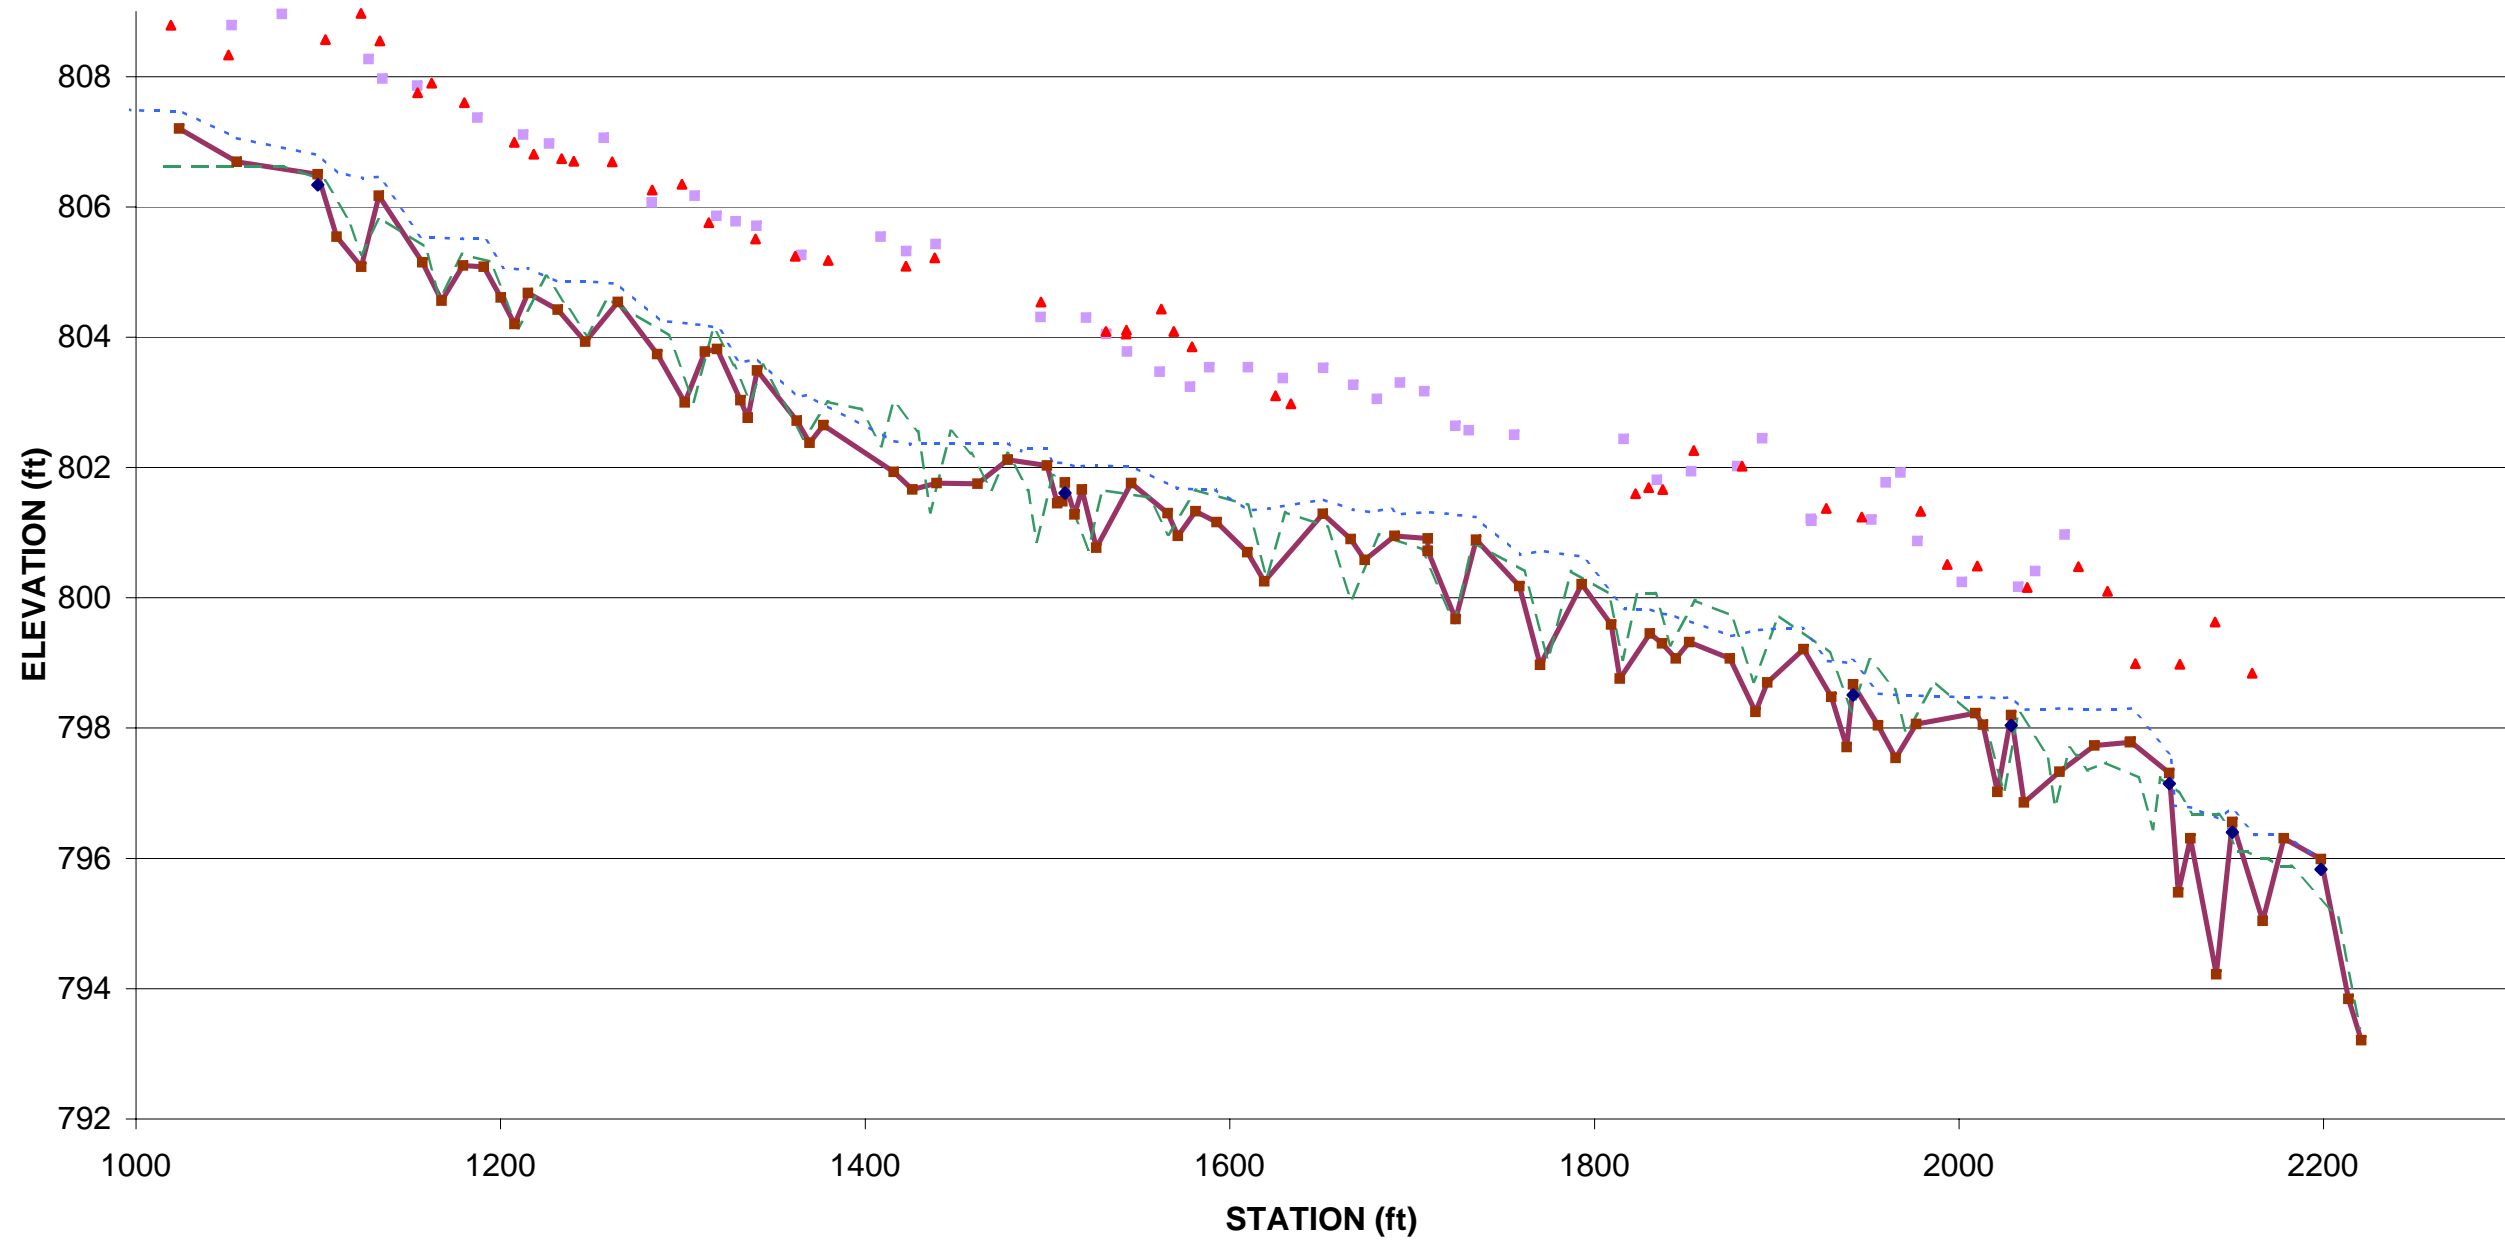
Figure 5  
Lyle Creek New Channel  
Catawba County, NC  
2003 Annual Monitoring Report  
Longitudinal Profile

Channel profile along the relocation section of Lyle Creek has shown two areas of significant down-cutting. The first area is held by a structure at station 15+09 and works upstream 190 feet but has the potential to migrate another 200 foot until it reaches the next structure. The maximum head cut in this section is one foot. This head cut is possibly caused by a designed decrease in riffle slope from the structure at station 15+09. Another compounding factor may have been that the riffle features in this section were built with the highest bankfull area and the channel cross-sectional area is increasing due to significant bank erosion. The second area of down cutting is held by a structure at station 20+30 and works upstream 235 feet but has the potential to migrate another 300 foot until it reaches the next structure. The maximum head cut in this section is six inches. During the monitoring, the cause of this head cut was not identified. The number of defined riffles in the bedform has decreased from 20 in 2002, to 13 in 2003. The average riffle length has also decreased to 17 feet. This is also consistent with pebble count results which show a significant increase in fine particles since construction in the cross sections located within the head cut regions, and no significant change in the pebble count results from the other cross sections. Hardened riffle areas are not maintaining elevation throughout the relocated entire reach. The structures are maintaining the grade and in general look good. Eco-Science results were recalculated using NCSU techniques for consistency purposes. Data was examined but field identified features were retained.
