Lyle Creek Stream Restoration 2004 Annual Monitoring Report

February, 2005

2004 Lyle Creek Monitoring Abstract

This is the 2nd year of the 5-year monitoring plan for Lyle Creek.

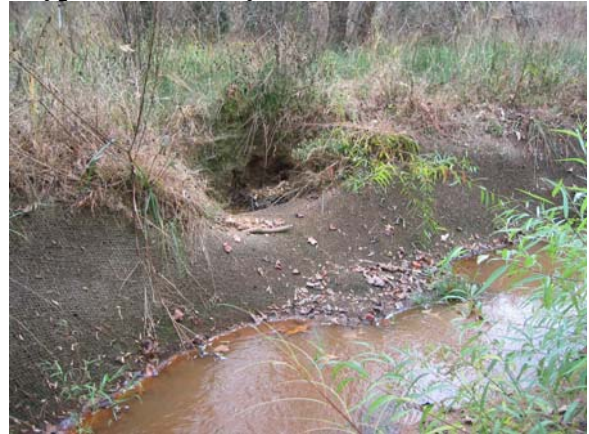
- Areas with bank erosion and slumping
 - The following meander bends have a high near NBS and very high BEHI rating for at least a 10 ft section on the outside of the meander bend.

- @ STATIONS 9+50; 11+10; 11+50; 11+75; 12+90; 13+80; 16+20; 16+60; 16+80; 18+00; 18+50
 - All of these problem areas were located in the reach that was restored. The stabilized reach had some bank erosion but nothing that classified as high near NBS and very high BEHI.

**Issue Photo 1
Lyle Creek Pool near station 9+40.
Typical Bank Slump on Left Bank**

- These areas should be regarded and planted heavily with live stakes to help establish root mass along the channel bank. Root wads should also be considered for bank protection.

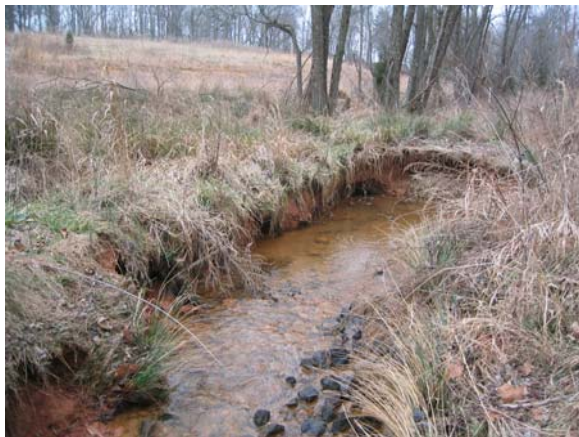
**Issue Photo 2
Lyle Creek Pool near station 11+90.
Typical Bank Failure on Left Bank**

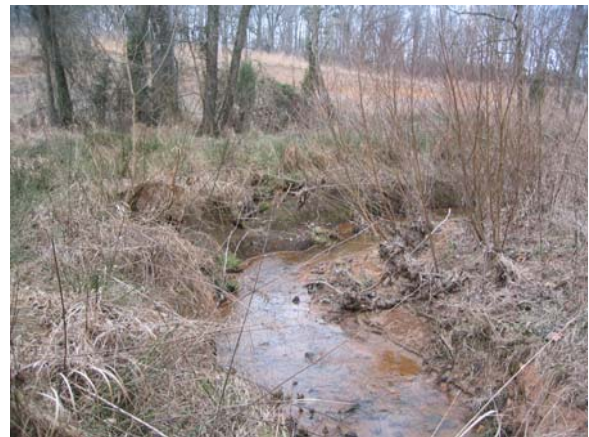
**Lyle Creek Pool near station 9+40.
Typical Bank Slump on Left Bank**

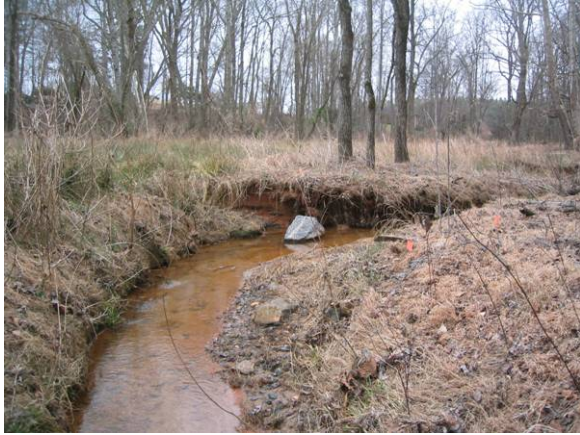
**Lyle Creek Pool near station 11+90.
Typical Bank Failure on Left Bank**
