Year 4 Monitoring Report

Lyle Creek Stream Restoration

February 2006

S&EC Project No. 9442.D1
EEP Project No. 00102

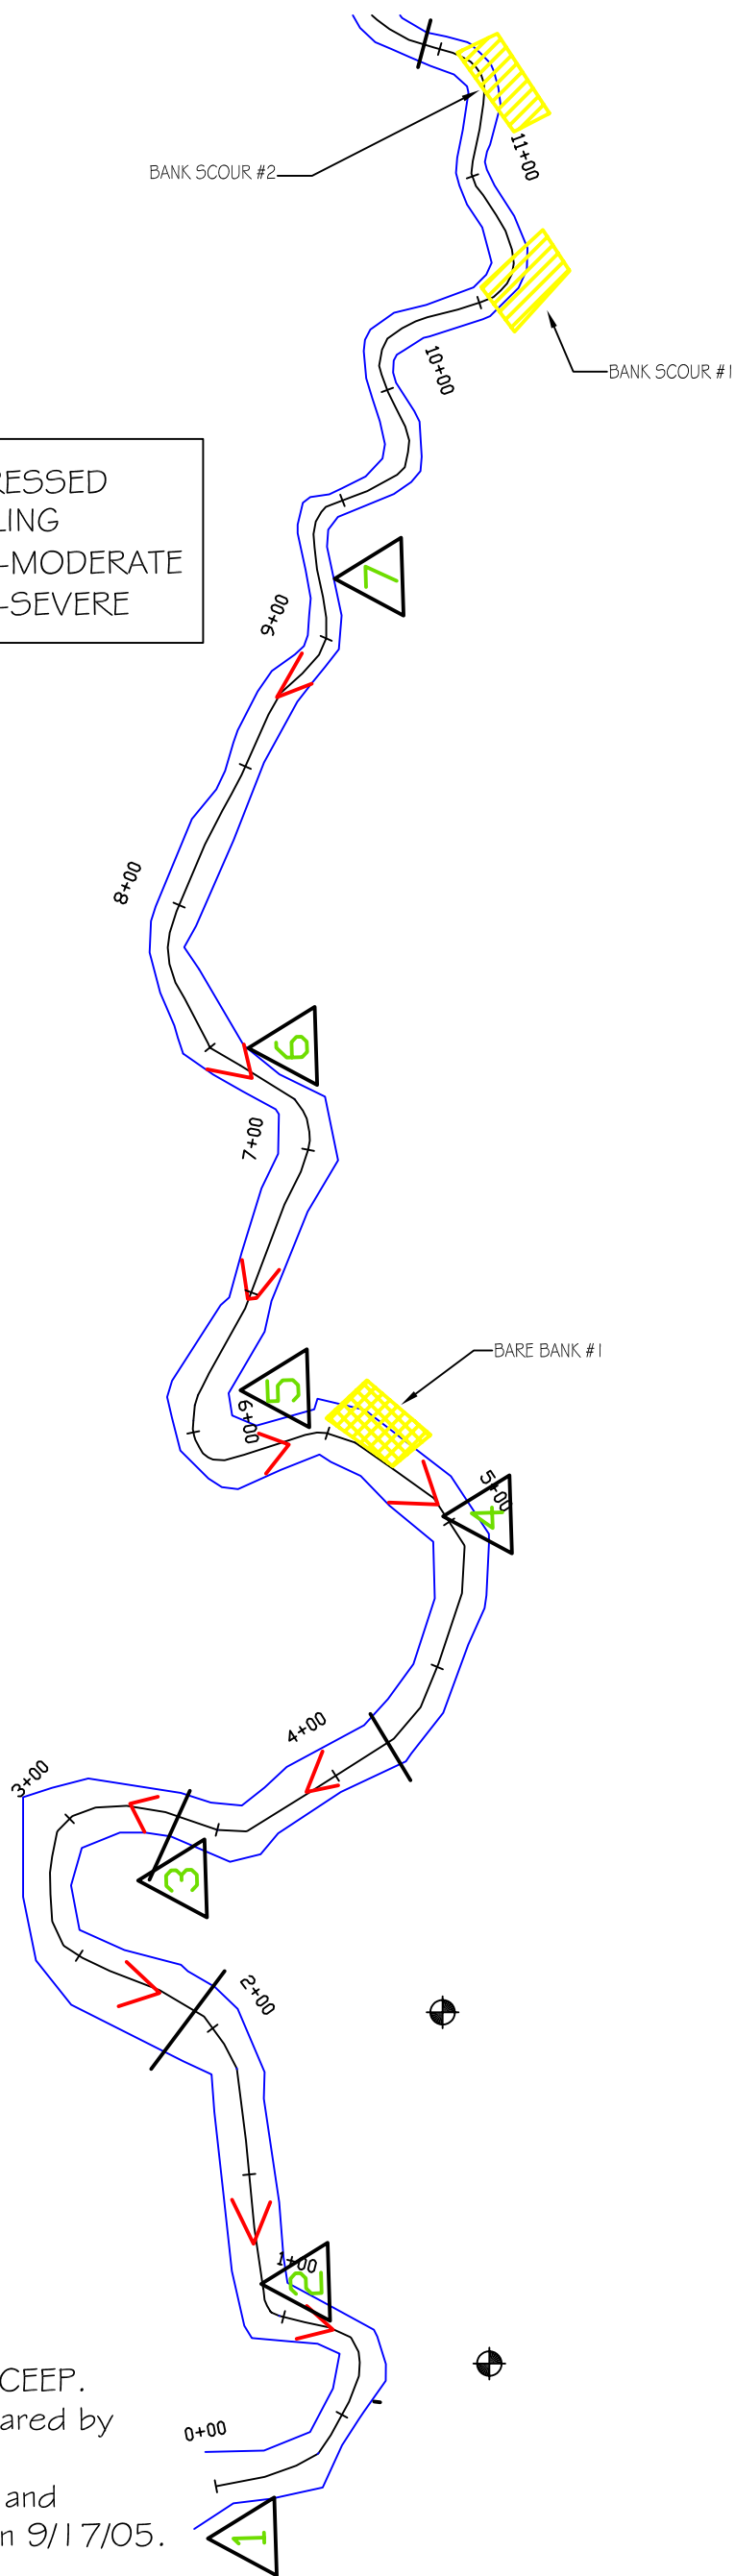
Project: LYLE CREEK STREAM RESTORATION		Project No.: 9442.D1	
Location: CATAWBA CO., NC	Client: NCEEP	Proj. Mgr.: FKS	Drawn: JER
Sheet Title: PAPV - SEGMENT 1		Scale: 1" = 60'	
		Sheet No.: 3 OF 4

During a field inspection on September 12, 2005, it was noted that several areas along the banks of Lyle Creek and its floodplain have suffered localized loss of vegetation. It is suspected that large overbank flows occurred before the newly planted vegetation had sufficient time to establish a root system capable of withstanding flood flows. There is an area with exposed soil as indicated on the Problem Area Plan View as “Bare Bank.”

An assessment of channel stability was performed on September 12, 2005, by S&EC. Areas of concern that were observed and documented included localized bank scour, and stressed or failing structures. These problem areas are shown on Sheets 3 and 4 – Problem Area Plan View.

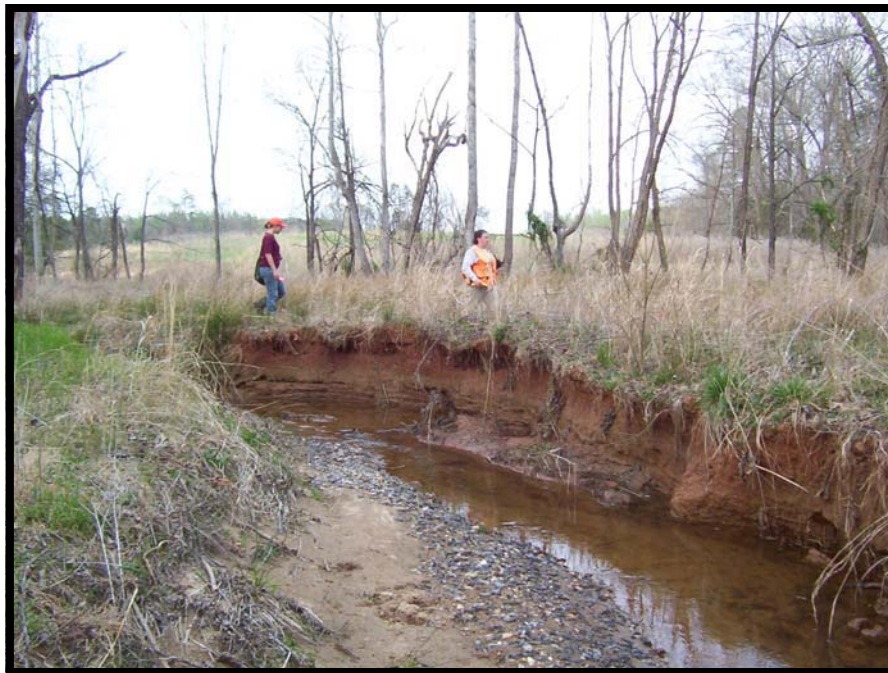
Table IXa: Stream Problem Areas Lyle Creek Stream Restoration Site (EEP Project #00102)			
Feature Issues	Station numbers	Suspected Cause	Photo number
Bank Scour	10+50 to 10+75	Excessive shear stress on banks	Photos 1-3
	11+05 to 11+40	Excessive shear stress on banks	
	12+50 to 12+75	Excessive shear stress on banks	
	14+05 to 14+50	Excessive shear stress on banks	
	16+00 to 16+25	Excessive shear stress on banks	
	16+50 to 17+25	Excessive shear stress on banks	
	18+00 to 18+25	Excessive shear stress on banks	
	18+70 to 19+00	Excessive shear stress on banks	
	19+20 to 19+40	Excessive shear stress on banks	
Stressed or Failing Structures	16+65	Excessive shear stress on banks	Photo 4
	19+25	Excessive shear stress on banks

Figure 3—Typical Bank Scour

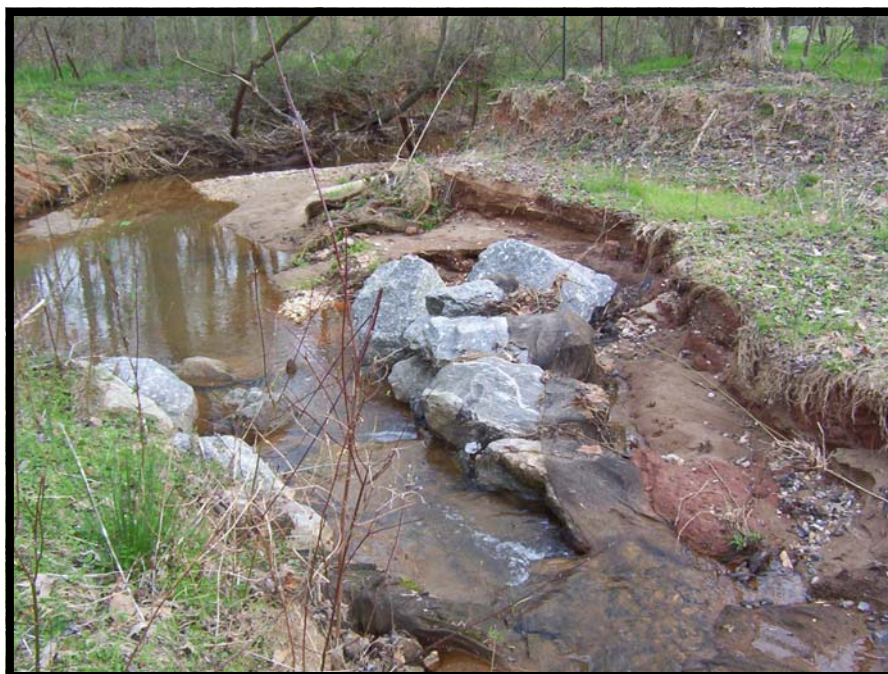
While most structures on this restoration are functional and stable, the two (2) most downstream rock cross vanes are currently failing. A comparison of the surveyed thalwegs for 2004 and 2005 shows some lateral migration of meanders, as well as some downvalley migration. The profile shows that a headcut may have already moved though a portion of the reach, and another headcut may be caused in the near future by the complete failure of either of the stressed rock cross vanes. For these reasons, it is recommended that a repair plan be prepared immediately for the Lyle Creek restoration project.

Figure 4—Typical Failing Structure
