Lyle Creek Stream Restoration

Project No. 423

2006 Monitoring Report: Year 4 of 5

March 2007

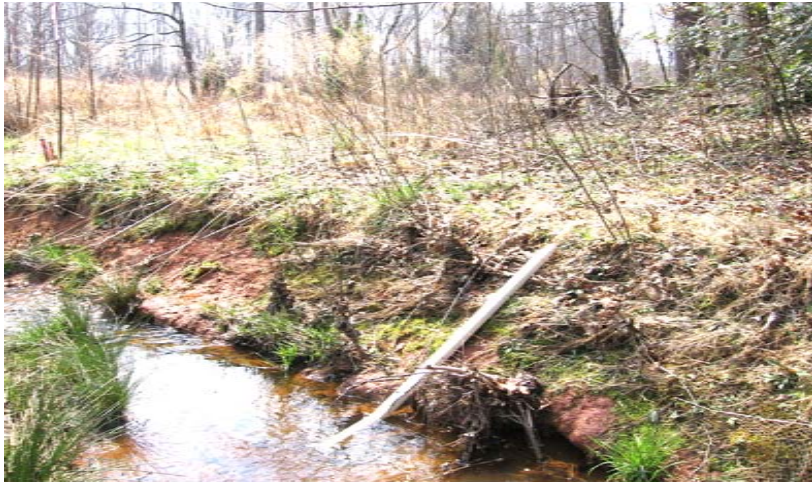
1. Bank Erosion: Moderate-3/30/06

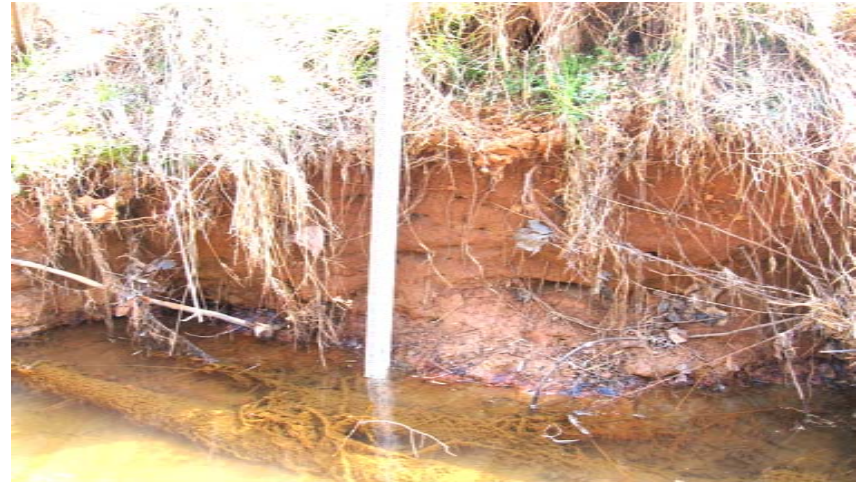
2. Bank Erosion: Severe-3/30/06

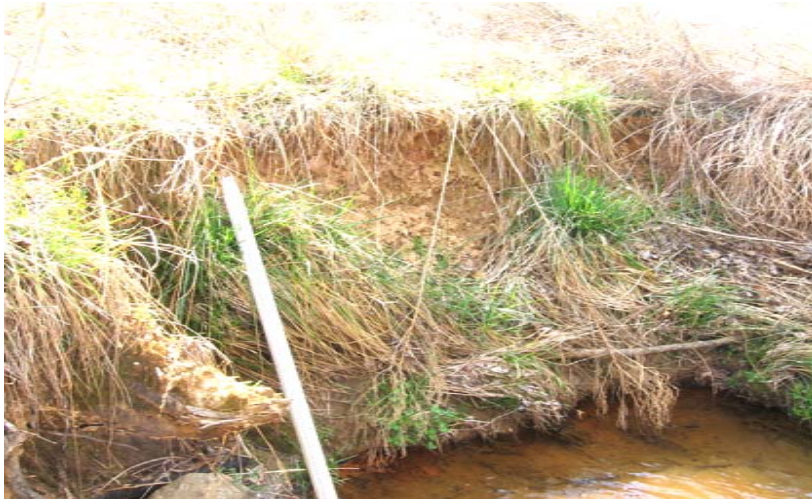
3. Bank Erosion: Moderate-3/30/06

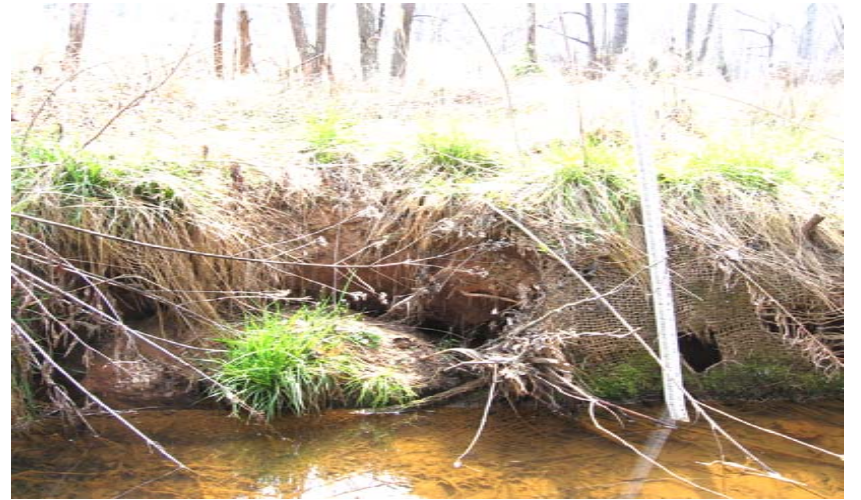
4. Bank Erosion: Severe-3/30/06

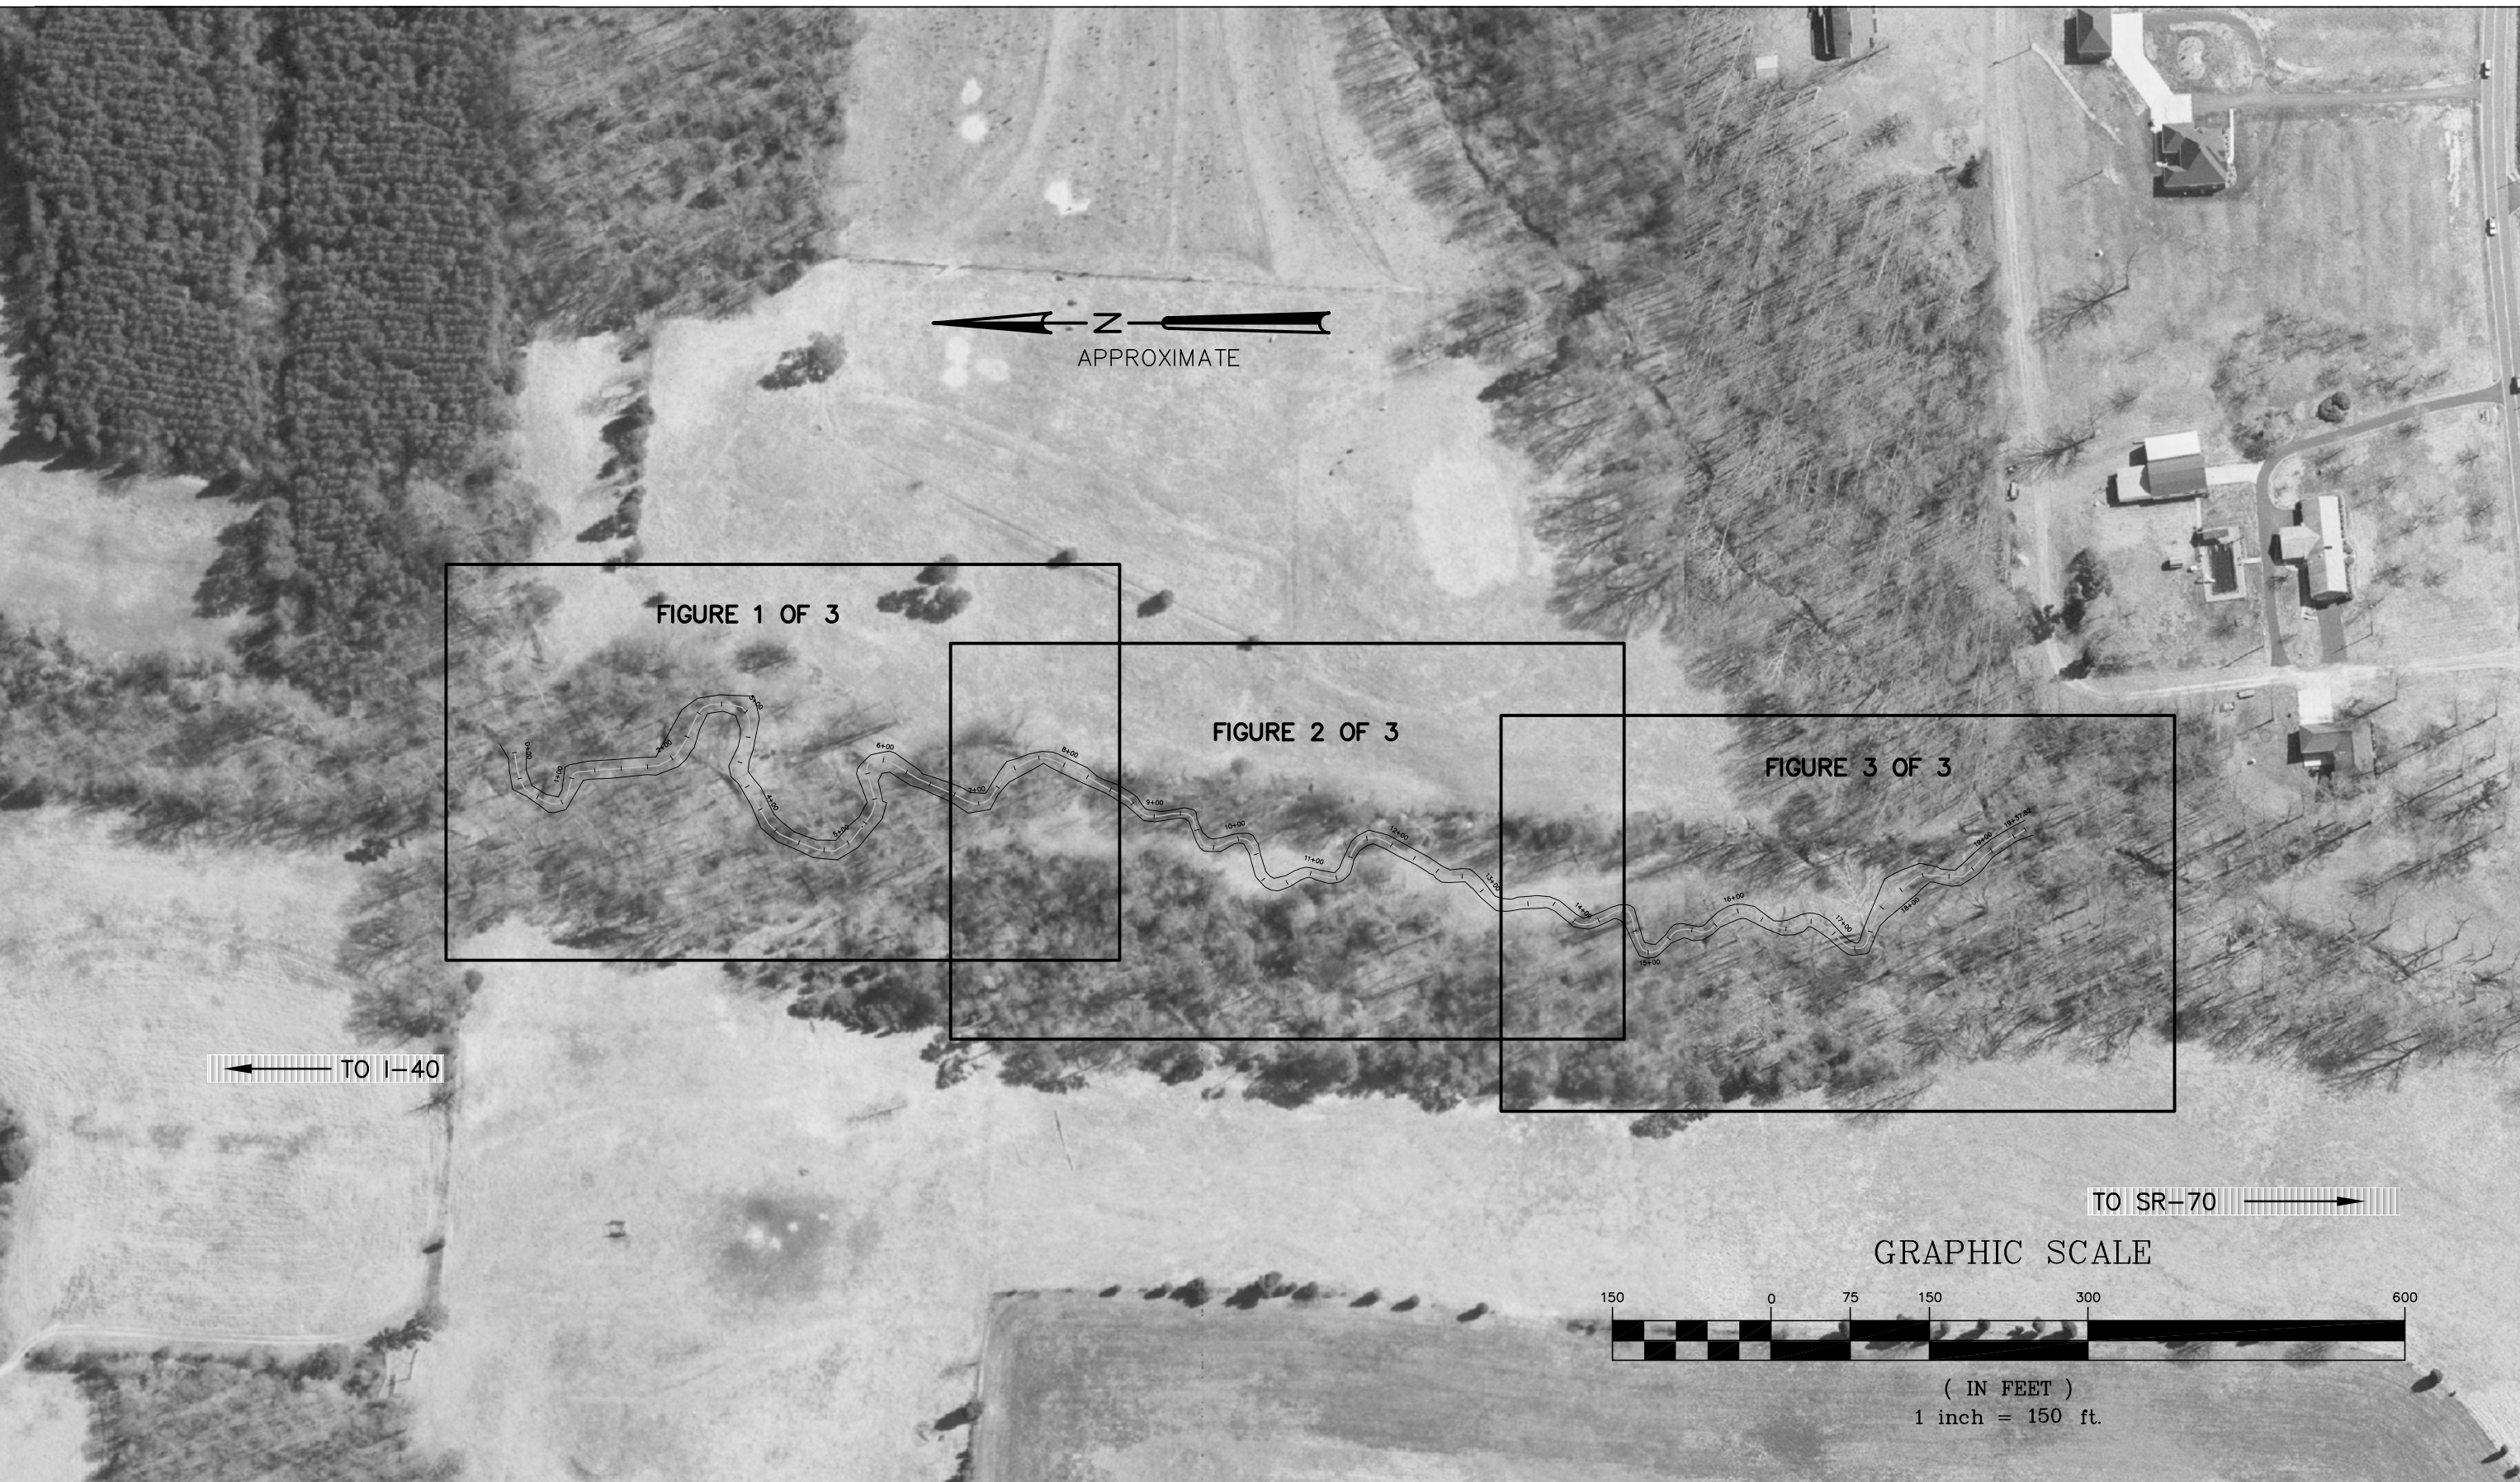
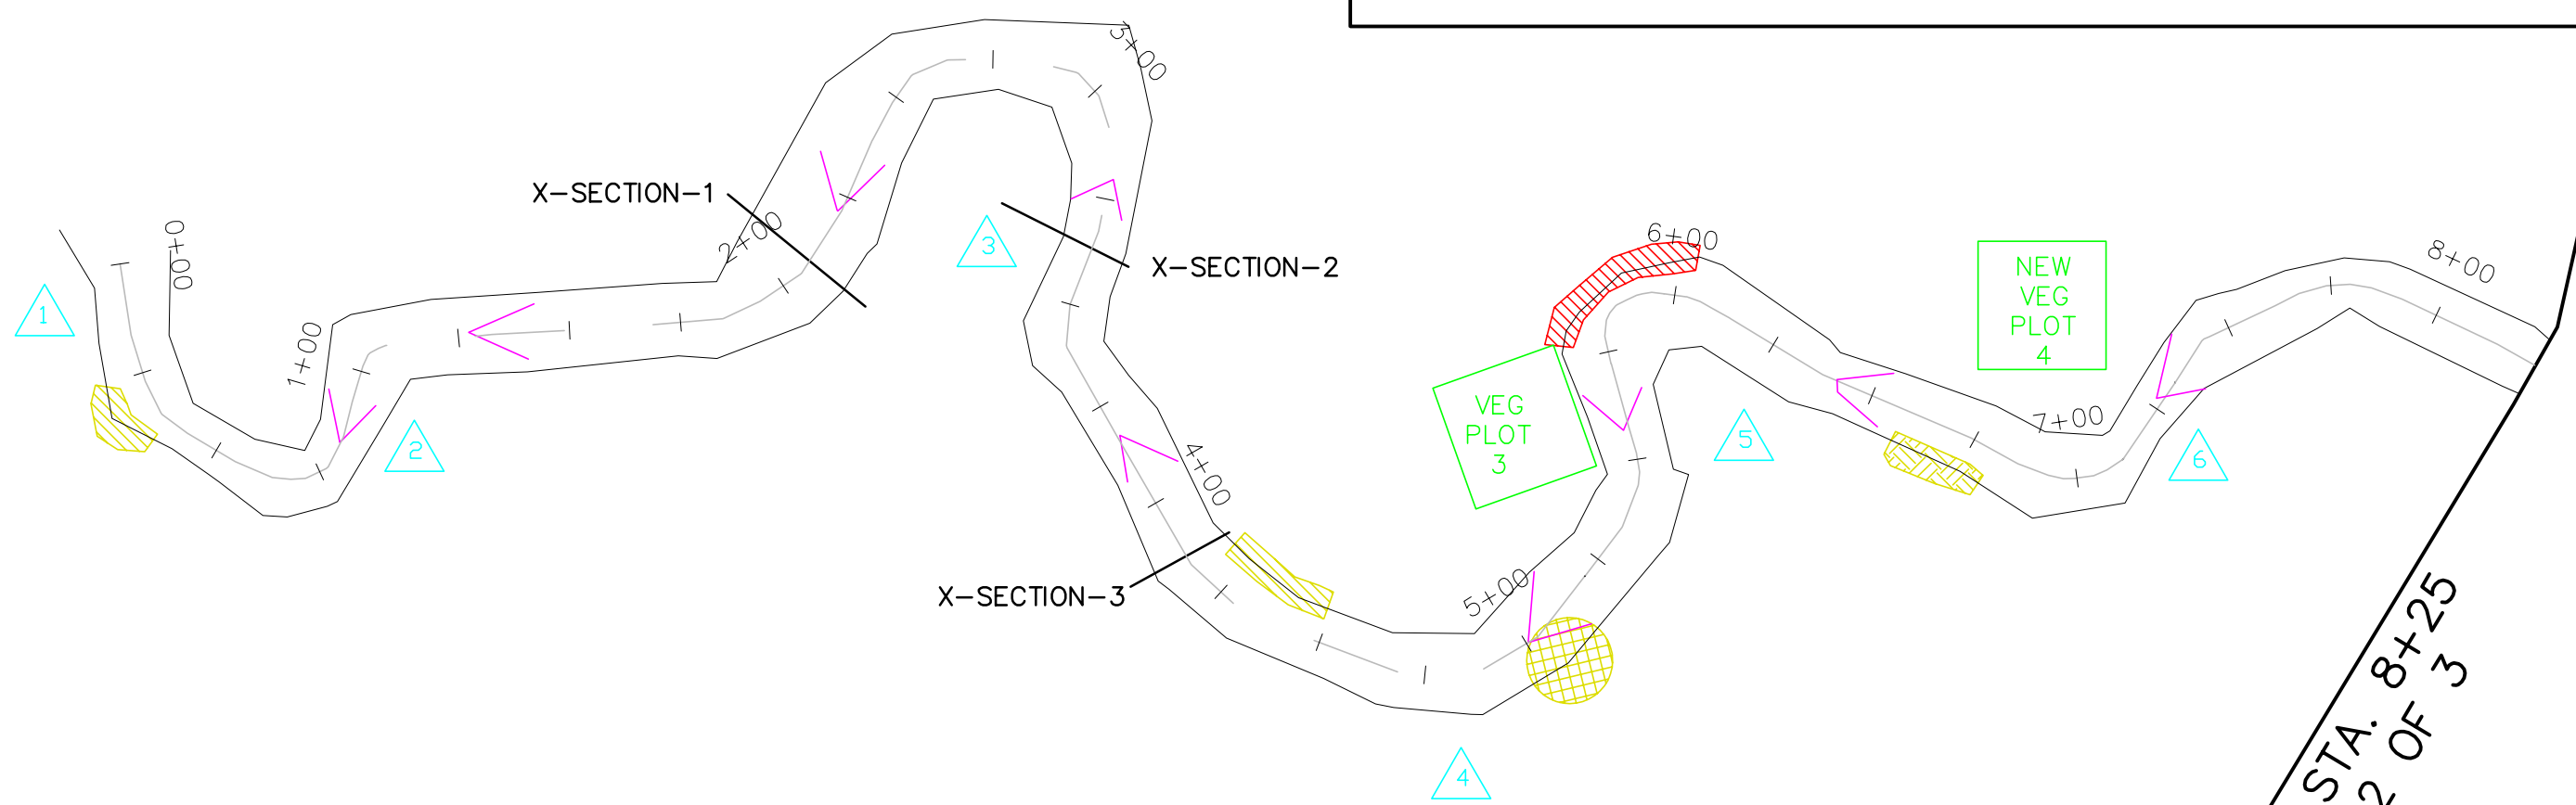
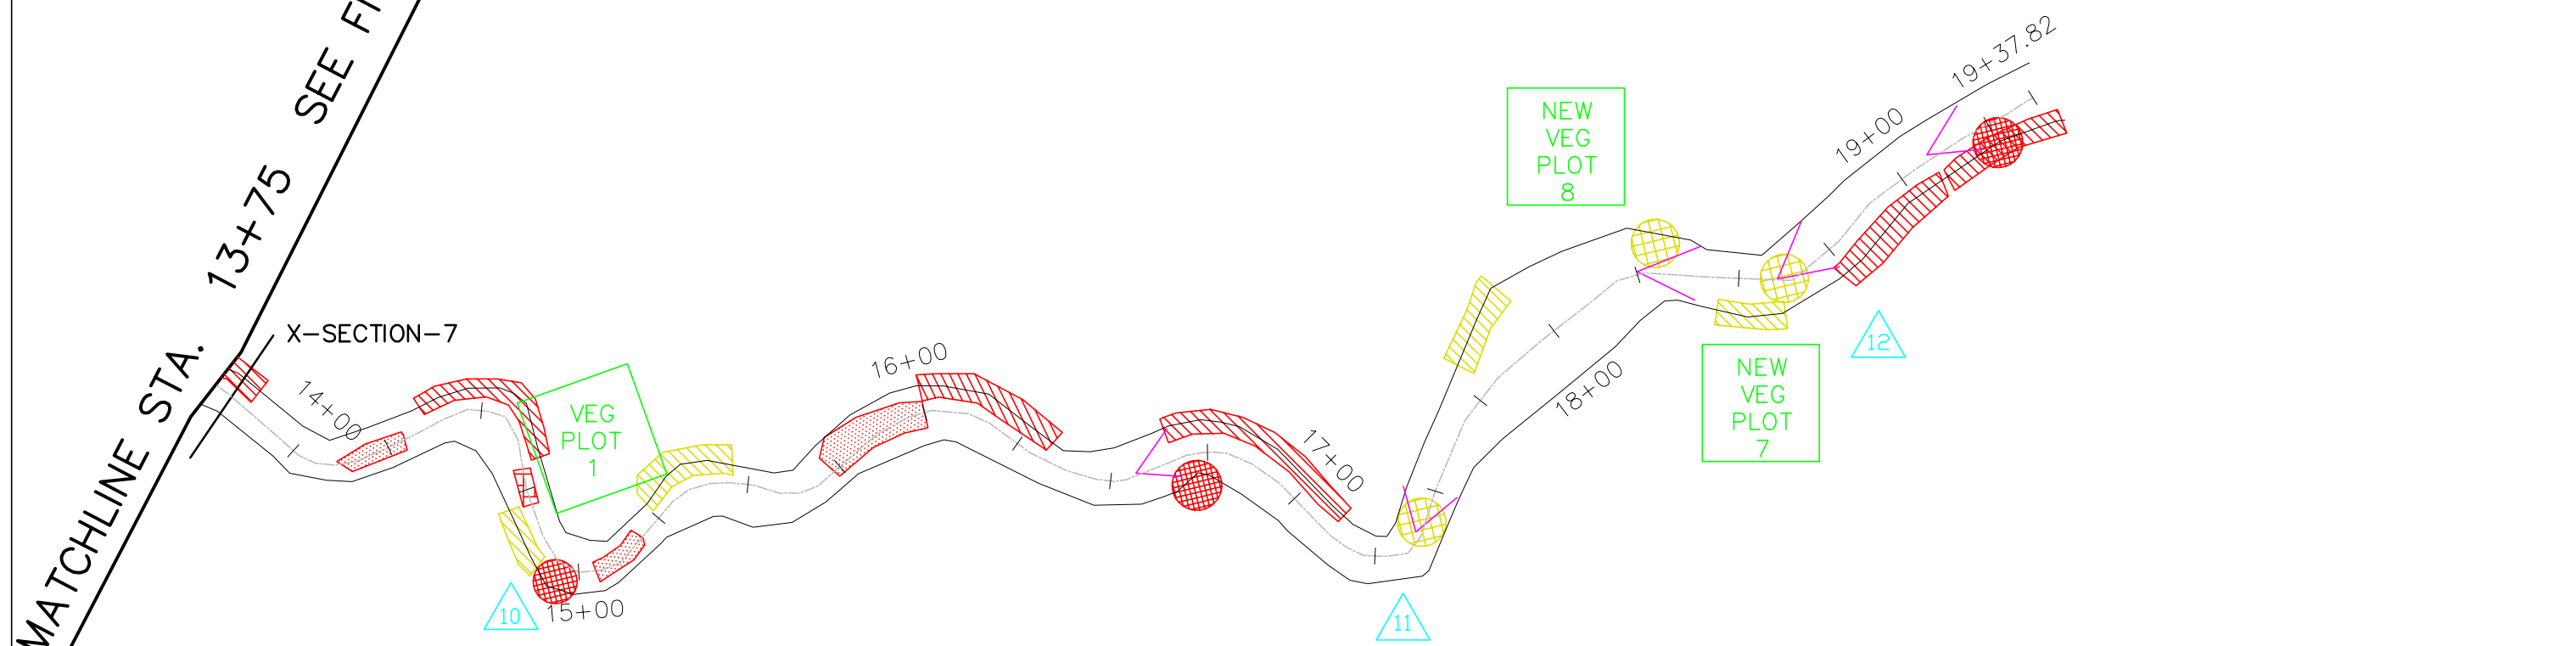
Lyle Creek/Project No.423				
Feature Issue		Station Numbers	Suspected Cause	Photo ID
Bank erosion - moderate	Reach 1	00+25 - 00+45	Erosion under tree root due to excess shear stress	B2.1
		04+20 - 04+50	Moderate bank slumping due to excess shear stress - LB	
	Reach 2	14+75 - 14+90	Bank undercutting due to excess shear stress - RB	
		18+45 - 18+65	Moderate erosion due to shifting of upstream pool to RB	
Bank erosion - severe	Reach 1	05+75 - 06+05	No bank protection on downstream end of bend resulting in severe erosion - LB	B2.2
		09+20 - 09+40	Severe bank erosion and failure due to insufficient channel capacity and excess shear stress - LB	
		10+00 - 10+25	Severe bank erosion and failure due to insufficient channel capacity and excess shear stress - LB	
		11+60 - 11+95	Severe bank erosion and failure due to channel migration and excess shear stress - LB	
	Reach 2	13+55 - 13+85	Bank undercut and failed due to excess shear stress - LB

14+35 - 14+70	Bank undercut and failed due to channel migration, downcutting, and excess shear stress - LB	
		15+25 - 15+45	Bank undercutting due to excess shear stress - LB	
		17+80 - 18+00	Severe erosion due to excess shear stress - LB	
		16+00 - 16+30	Stream downcut and channel shifted resulting in severe erosion and tree fall - LB	
		16+70 - 17+10	Severe bank erosion and failure due to upstream structure failure - LB	
		18+75 - 19+05	Severe bank erosion and failure due to upstream structure failure - RB	
		19+10 - 19+40	Severe bank erosion and bank failure below right arm of failed cross vane - RB

Lyle Creek/Project No.423				
Feature Issue		Station Numbers	Suspected Cause	Photo ID
Downcut/lost riffle	Reach 2	08+85 - 09+00	Insufficient channel capacity shifting riffle downstream	B2.3
		10+90 - 11+15	Insufficient channel capacity shifting riffle downstream	
		11+95 - 12+20	Insufficient channel capacity shifting riffle downstream	
		14+10 - 14+30	Insufficient channel capacity shifting riffle downstream into pool	
		15+10 - 15+20	Insufficient channel capacity shifting riffle downstream into pool	
		15+75 - 16+00	Insufficient channel capacity shifting riffle downstream into pool	
Lateral bar	Reach 1	06+60 - 06+80	Stream over widened	B2.4
Mid-channel bar	Reach 2	14+70 - 14+75	Mid-channel bar formed from upstream erosion	B2.5
Structure - failed	Reach 2	14+95	Log vane structure detached from bank and blocking channel due channel erosion under log.	B2.6
		16+70	Right vane arm collapsed due to shifting channel and excess shear stress

19+25	Right vane arm eroded and dislodged due total failure of structure and bank	
Structure - stressed	Reach 1	05+00	Erosion at top right vane arm due to insufficient channel capacity	B2.7
	Reach 2	17+50	Erosion under invert & footer rock and stressing right arm	
		18+30	Erosion behind left vane arm due to insufficient channel capacity	
		18+60	Erosion under invert and footer rock

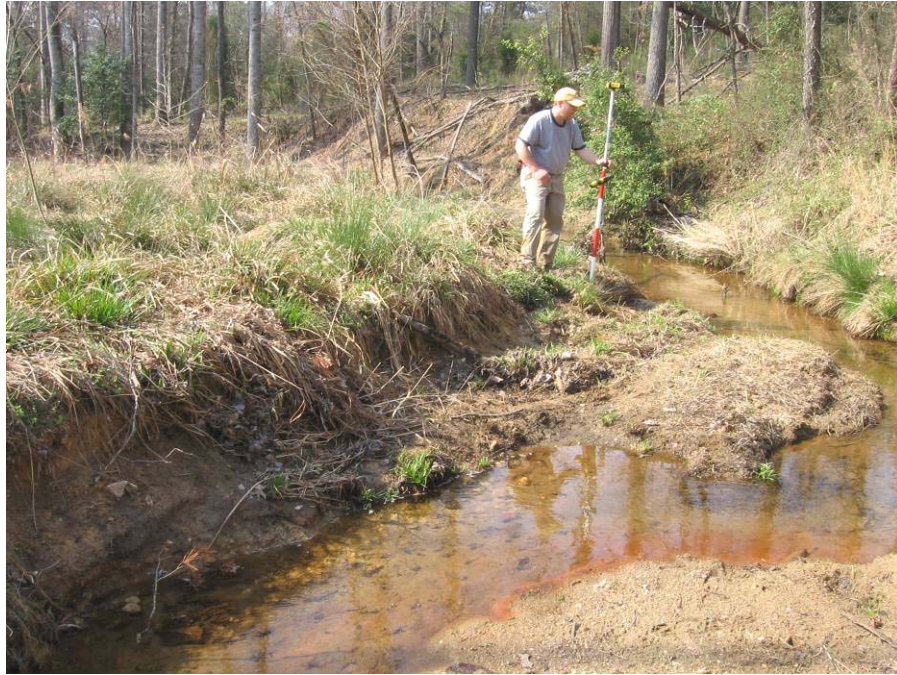
1. Bank Erosion: Moderate-3/30/06

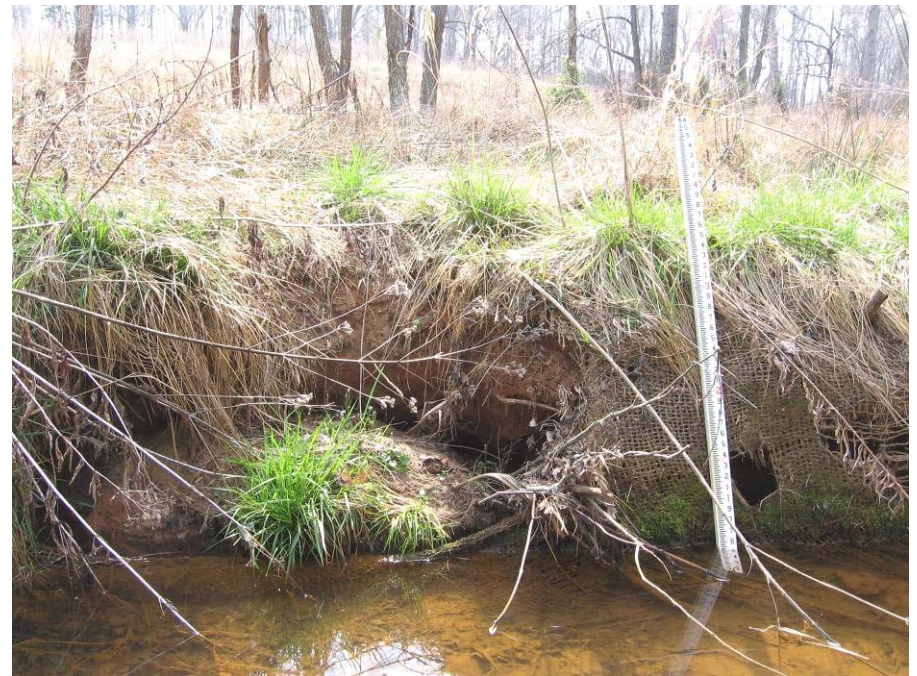
2. Bank Erosion: Severe-3/30/06

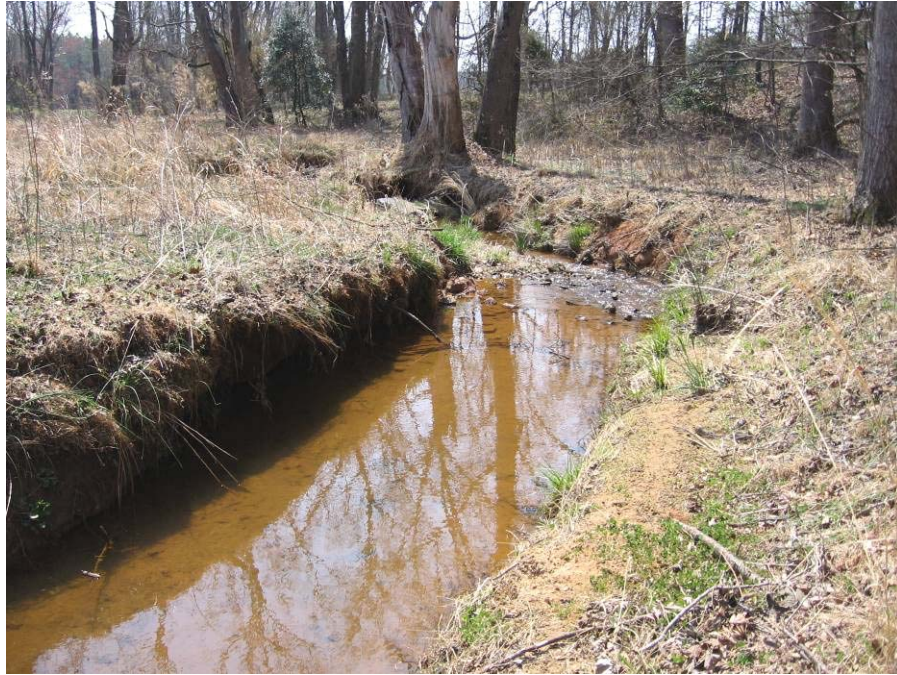
3. Downcut/Lost Riffle-3/30/06

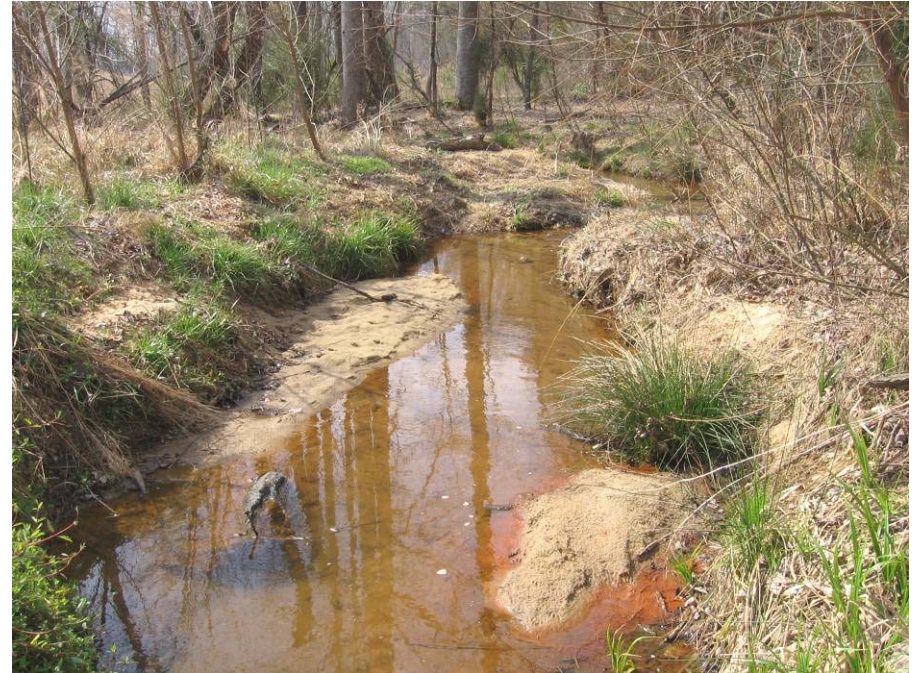
4. Lateral Bar-3/30/06

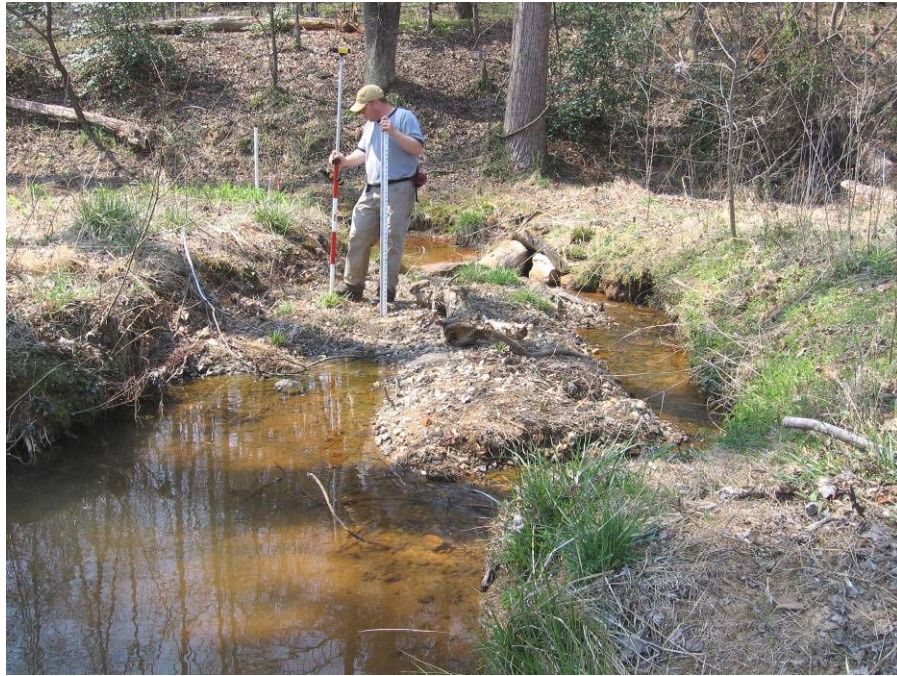
5. Mid-Channel Bar-3/30/06

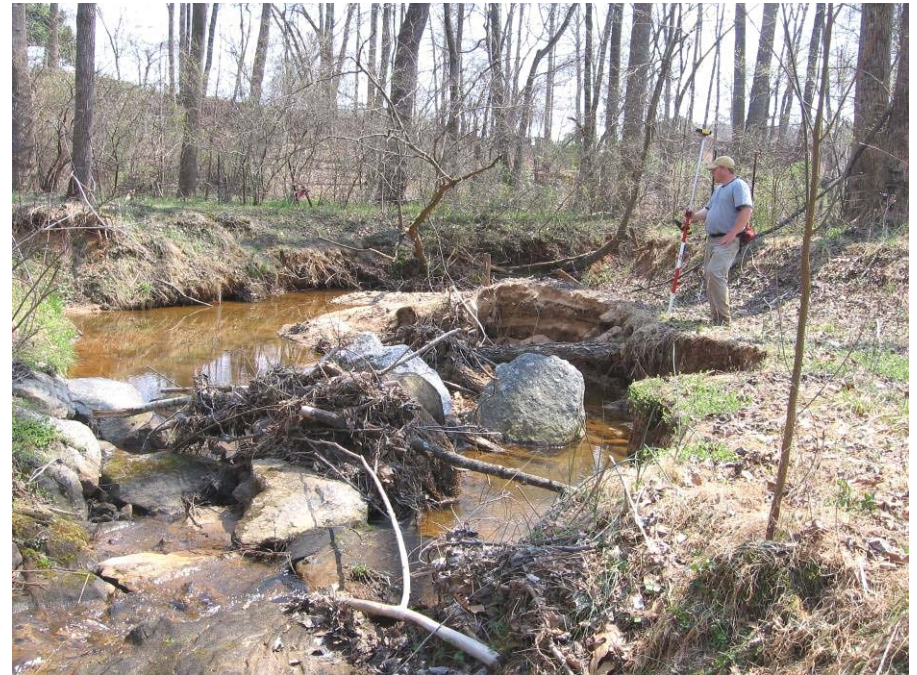
6. Structure failed-3/30/06

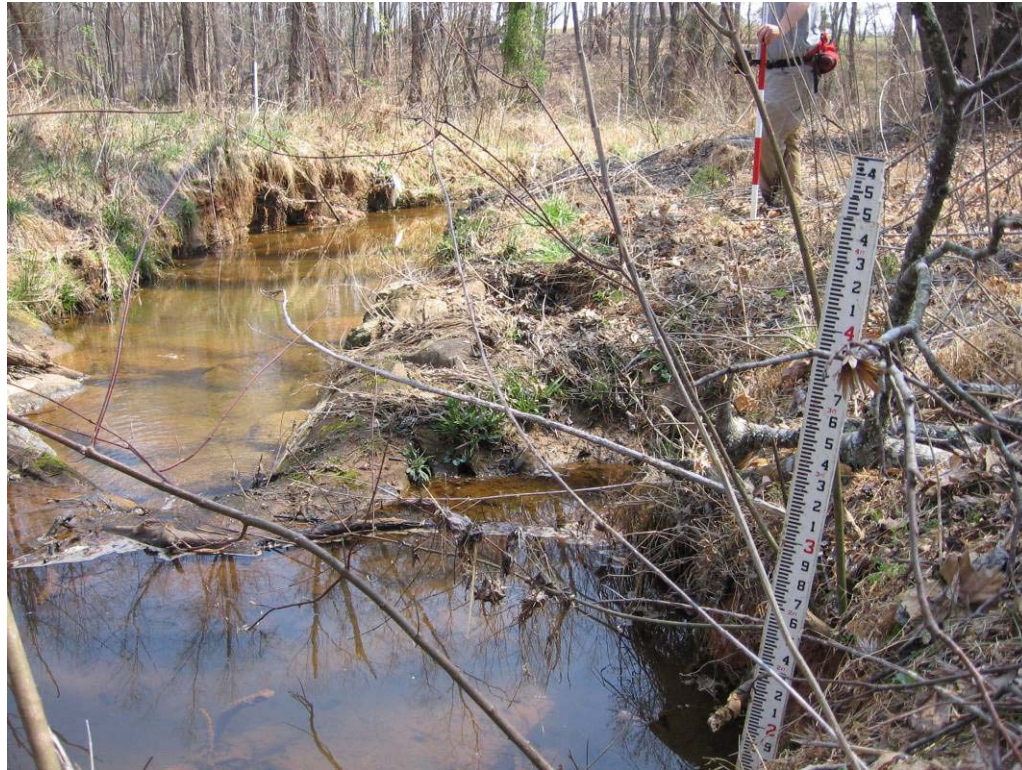
7. Structure stressed-3/30/06
