**Lyle Creek Stream Restoration**  
**Project No. 423**  
**2007 Monitoring Report (Final): Year 5 of 5**

**March 2008**

Prepared by: Jordan, Jones, and Goulding, Inc.  
9101 Southern Pine Blvd., Suite 160  
Charlotte, NC 28273

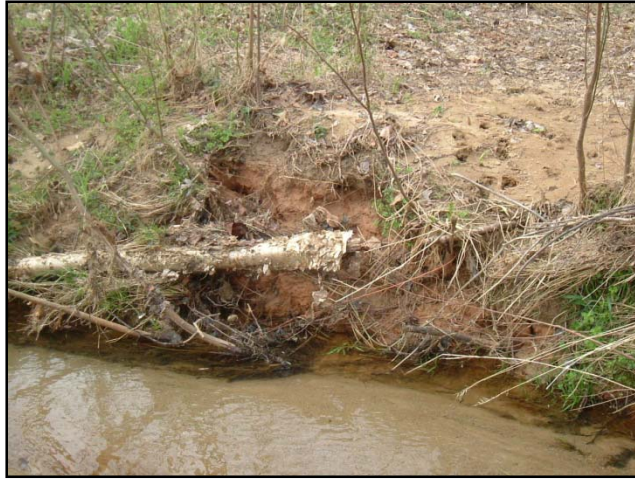
Feature Issue		Station Numbers	Suspected Cause	Photo ID
Bank erosion - moderate	Reach 1	1+98 - 2+00	Scour under matting, loose matting -RB	1
		4+00 - 4+50	Moderate bank slumping due to excess shear stress - LB	
		5+40 - 5+50	Scour under vegetation - RB	
		6+95 - 7+00	Point bar scouring	
	Reach 2	8+65 - 8+75	Moderate scour: lack of vegetation -RB	
		9+62 - 9+68	Moderate scour: lack of vegetation -RB	
		11+15 - 11+40	Moderate bank erosion due to insufficient channel capacity - clay bank - RB	
		12+70 - 12+90	Bank undercutting due to excess shear stress - LB	
		17+80 - 18+00	Moderate erosion due to excess shear stress - LB	
		18+45 - 18+65	Moderate erosion due to shifting of upstream pool to RB	
Bank erosion - severe	Reach 1	0+25 - 0+45	Erosion under tree root due to excess shear stress -RB	2
		5+75 - 6+05	No bank protection on downstream end of bend resulting in severe erosion - LB	
	Reach 2	9+20 - 9+40	Severe bank erosion and failure due to insufficient channel capacity and high shear stress - LB

1. Moderate Bank Erosion-3/22/2007

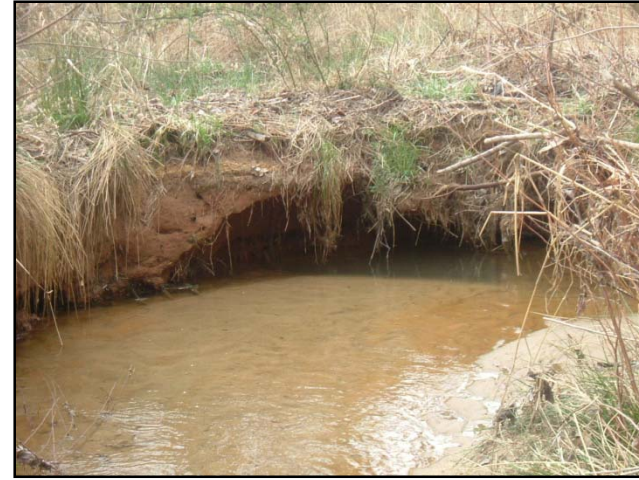
10+00 - 10+25	Severe bank erosion and failure due to insufficient channel capacity and excess shear stress - LB	
		11+60 - 11+95	Severe bank erosion and failure due to channel migration and excess shear stress LB	
		12+50 - 12+62	Severe bank erosion and failure due to high shear stress - LB	
		13+55 - 13+85	Bank undercut and failed due to excess shear stress - LB	
		14+35 - 14+70	Bank undercut and failed due to channel migration, downcutting, and excess shear stress - LB	
		14+75 - 14+90	Bank undercutting due to excess shear stress - RB	
		15+25 - 15+45	Bank undercutting due to excess shear stress - LB	
		16+00 - 16+30	Stream downcut and channel shifted resulting in severe erosion and tree fall - LB	
		16+70 - 17+10	Severe bank erosion and failure due to upstream structure failure - LB	
		18+75 - 19+05	Severe bank erosion and failure due to upstream structure failure - RB	
19+10 - 19+40	Severe bank erosion and bank failure below right arm of failed cross vane - BB

2. Severe Bank Erosion-3/22/2007

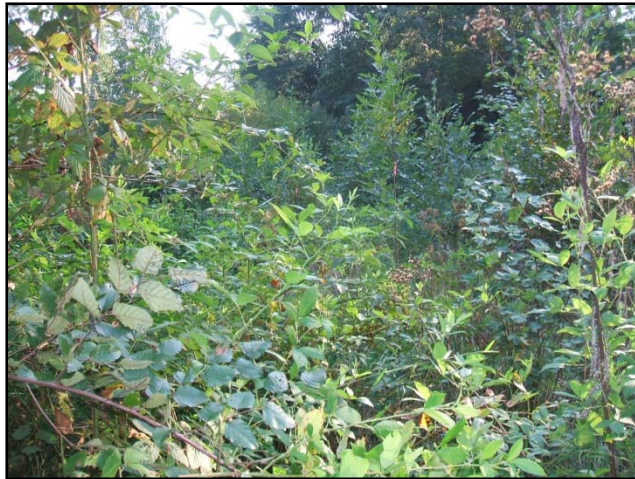
Invasive Population	N/A	Plot 2	existing seed source, storm flows, and land disturbance	3
		Plot 3	existing seed source, storm flows, and land disturbance	
		Plot 5	existing seed source, storm flows, and land disturbance	
		Plot 6	existing seed source, storm flows, and land disturbance	
		Plot 7	existing seed source, storm flows, and land disturbance	
Vegetation Cover - Poor	Reach 2	11+40 - 11+48	Bare bank	4

3. Invasive Population-9/24/2007

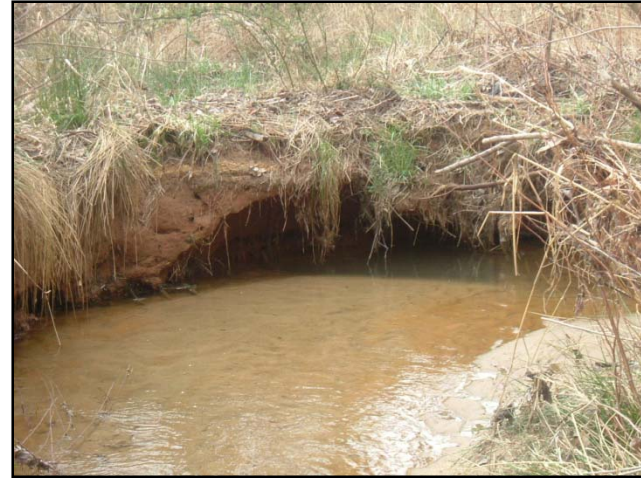
10+00 - 10+25	Severe bank erosion and failure due to insufficient channel capacity and excess shear stress - LB	
		11+60 - 11+95	Severe bank erosion and failure due to channel migration and excess shear stress - LB	
		12+50 - 12+62	Severe bank erosion and failure due to high shear stress - LB	
		13+55 - 13+85	Bank undercut and failed due to excess shear stress - LI	
		14+35 - 14+70	Bank undercut and failed due to channel migration, downcutting, and excess shear stress - LB	
		14+75 - 14+90	Bank undercutting due to excess shear stress - RE	
		15+25 - 15+45	Bank undercutting due to excess shear stress - LE	
		16+00 - 16+30	Stream downcut and channel shifted resulting in severe erosion and tree fall - LB	
		16+70 - 17+10	Severe bank erosion and failure due to upstream structure failure - LB	
		18+75 - 19+05	Severe bank erosion and failure due to upstream structure failure - RB	
		19+10 - 19+40	Severe bank erosion and bank failure below right arm of failed cross vane - BB

2. Severe Bank Erosion-3/22/2007

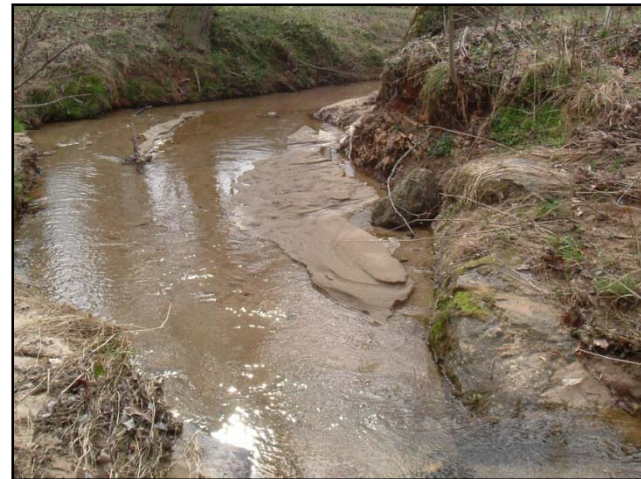
4. Aggradation-3/22/2007

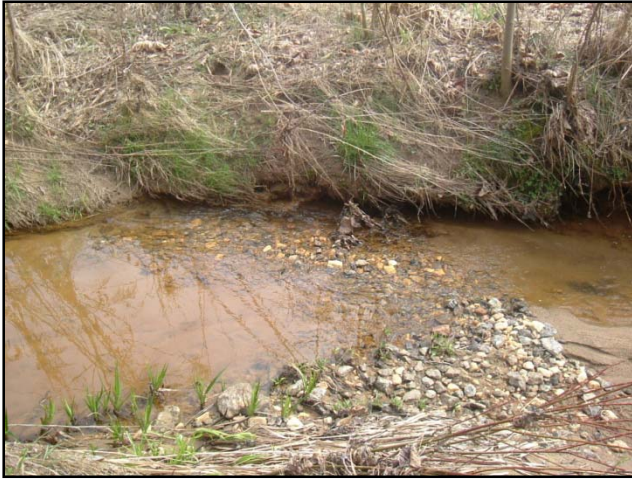
5. Lost/Downcut Riffle-3/22/2007

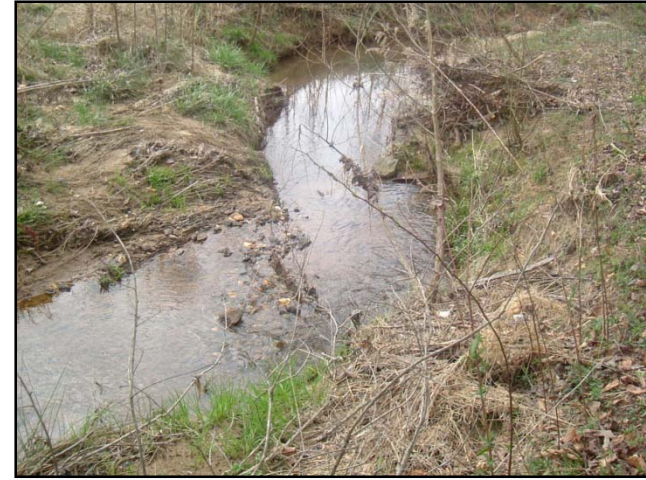
6. Transverse Bar-3/22/2007

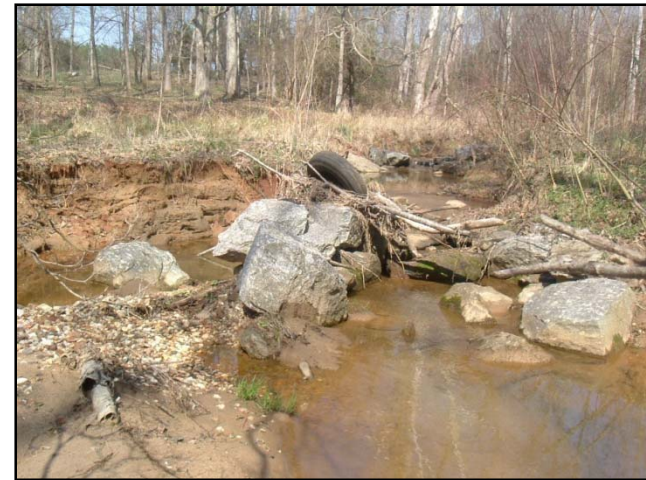
Severe shifts in bed features and structural failure are occurring primarily within the lower 200-300 linear feet of the reach. For most cross-vanes, the stress or failure is associated with only one vane arm. The riffle sill located approximately 150 feet above the downstream end of the project is stable. There are three cross-vanes upstream of the confluence with an unnamed tributary of Lyle Creek at the end of the project (approximate stationing 18+30, 18+60, and 19+25). The stress and failure level of these structures increase as the stream elevation decreases to meet the elevation of the confluence point. The most downstream structure has completely failed; the stream flows around the right arm as well as through the invert.

8. Structure Failed-3/22/2007

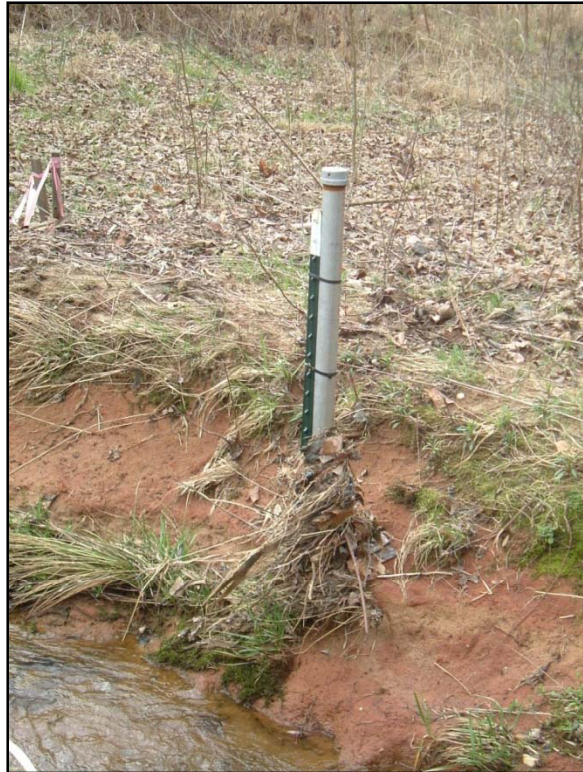
9. Vegetation Cover Poor-3/22/2007

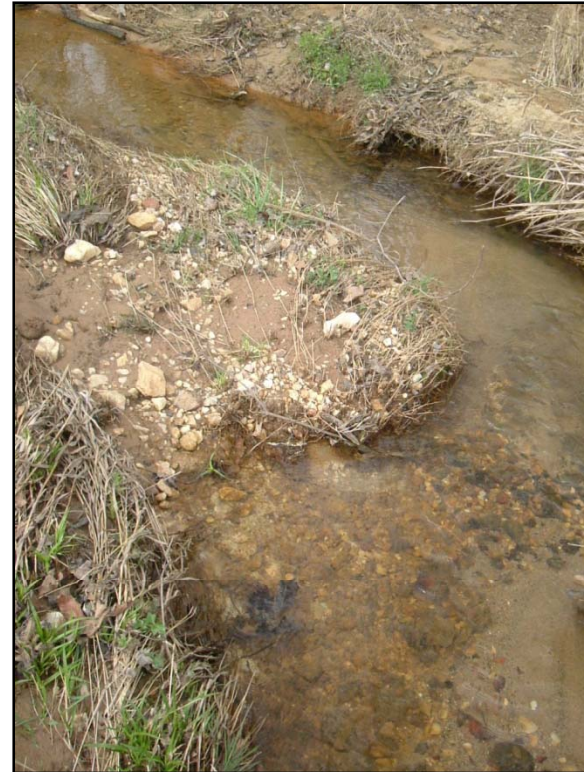
10. Point Bar Erosion-3/22/2007

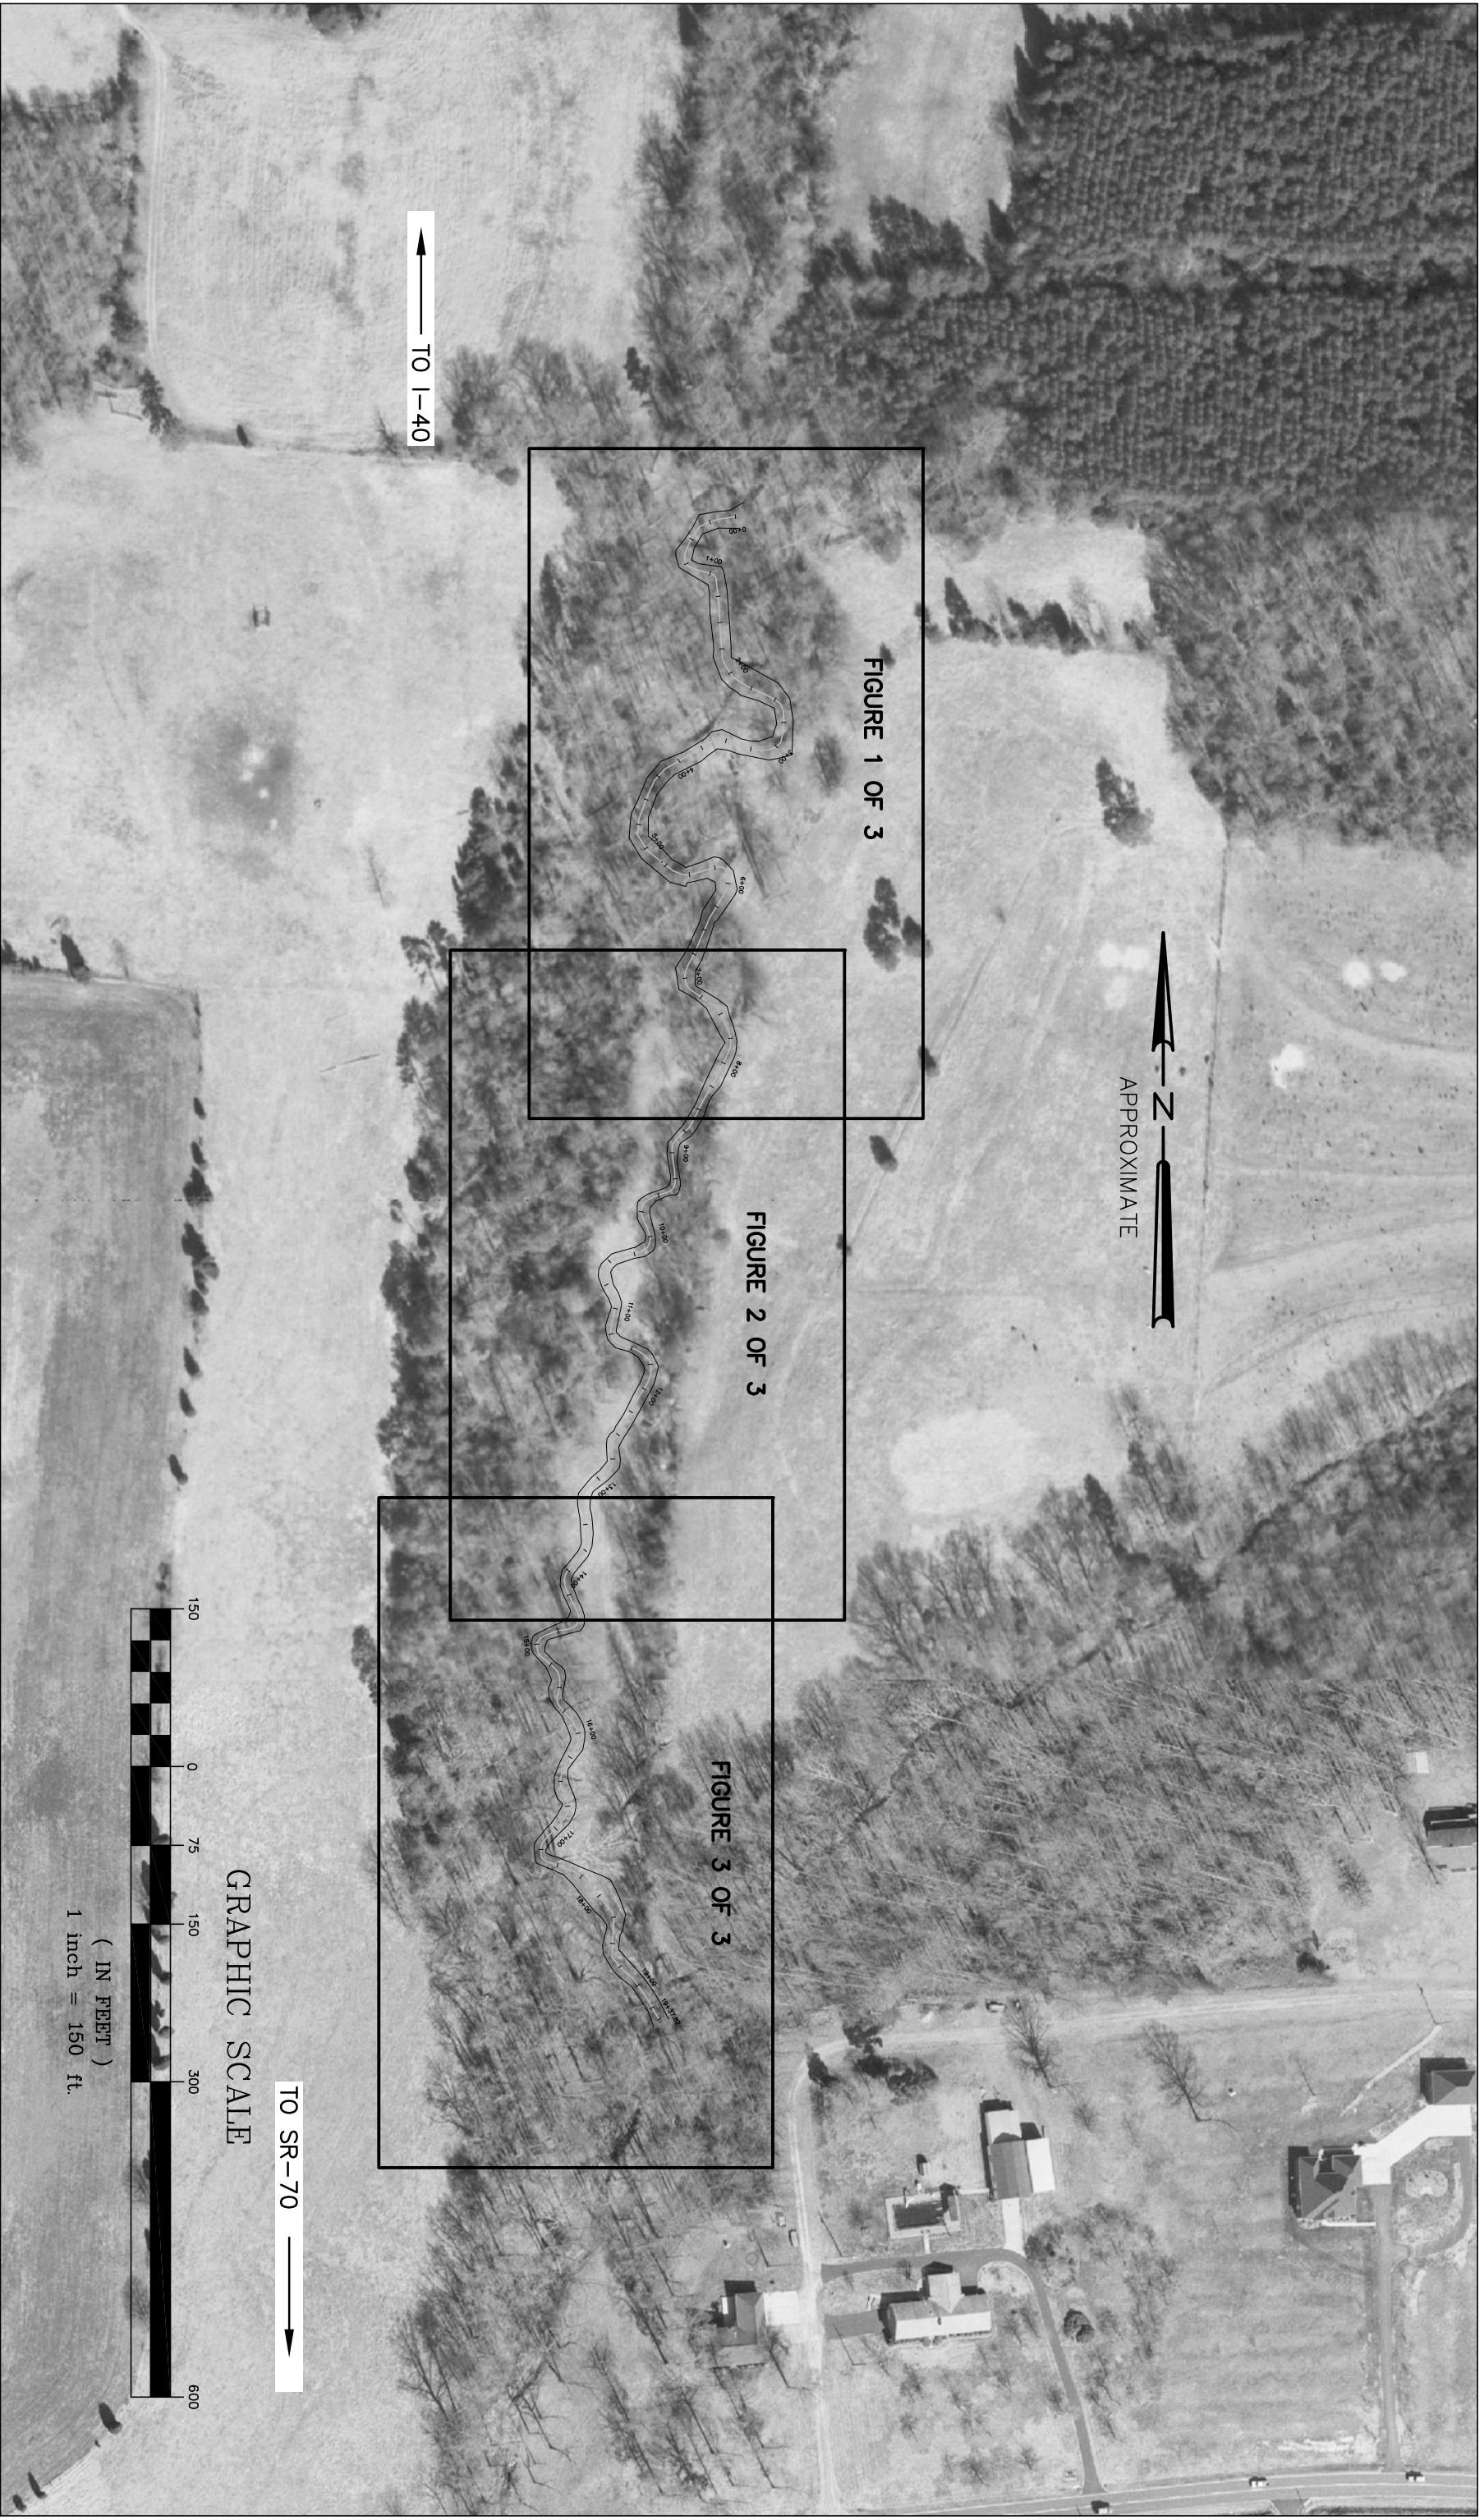
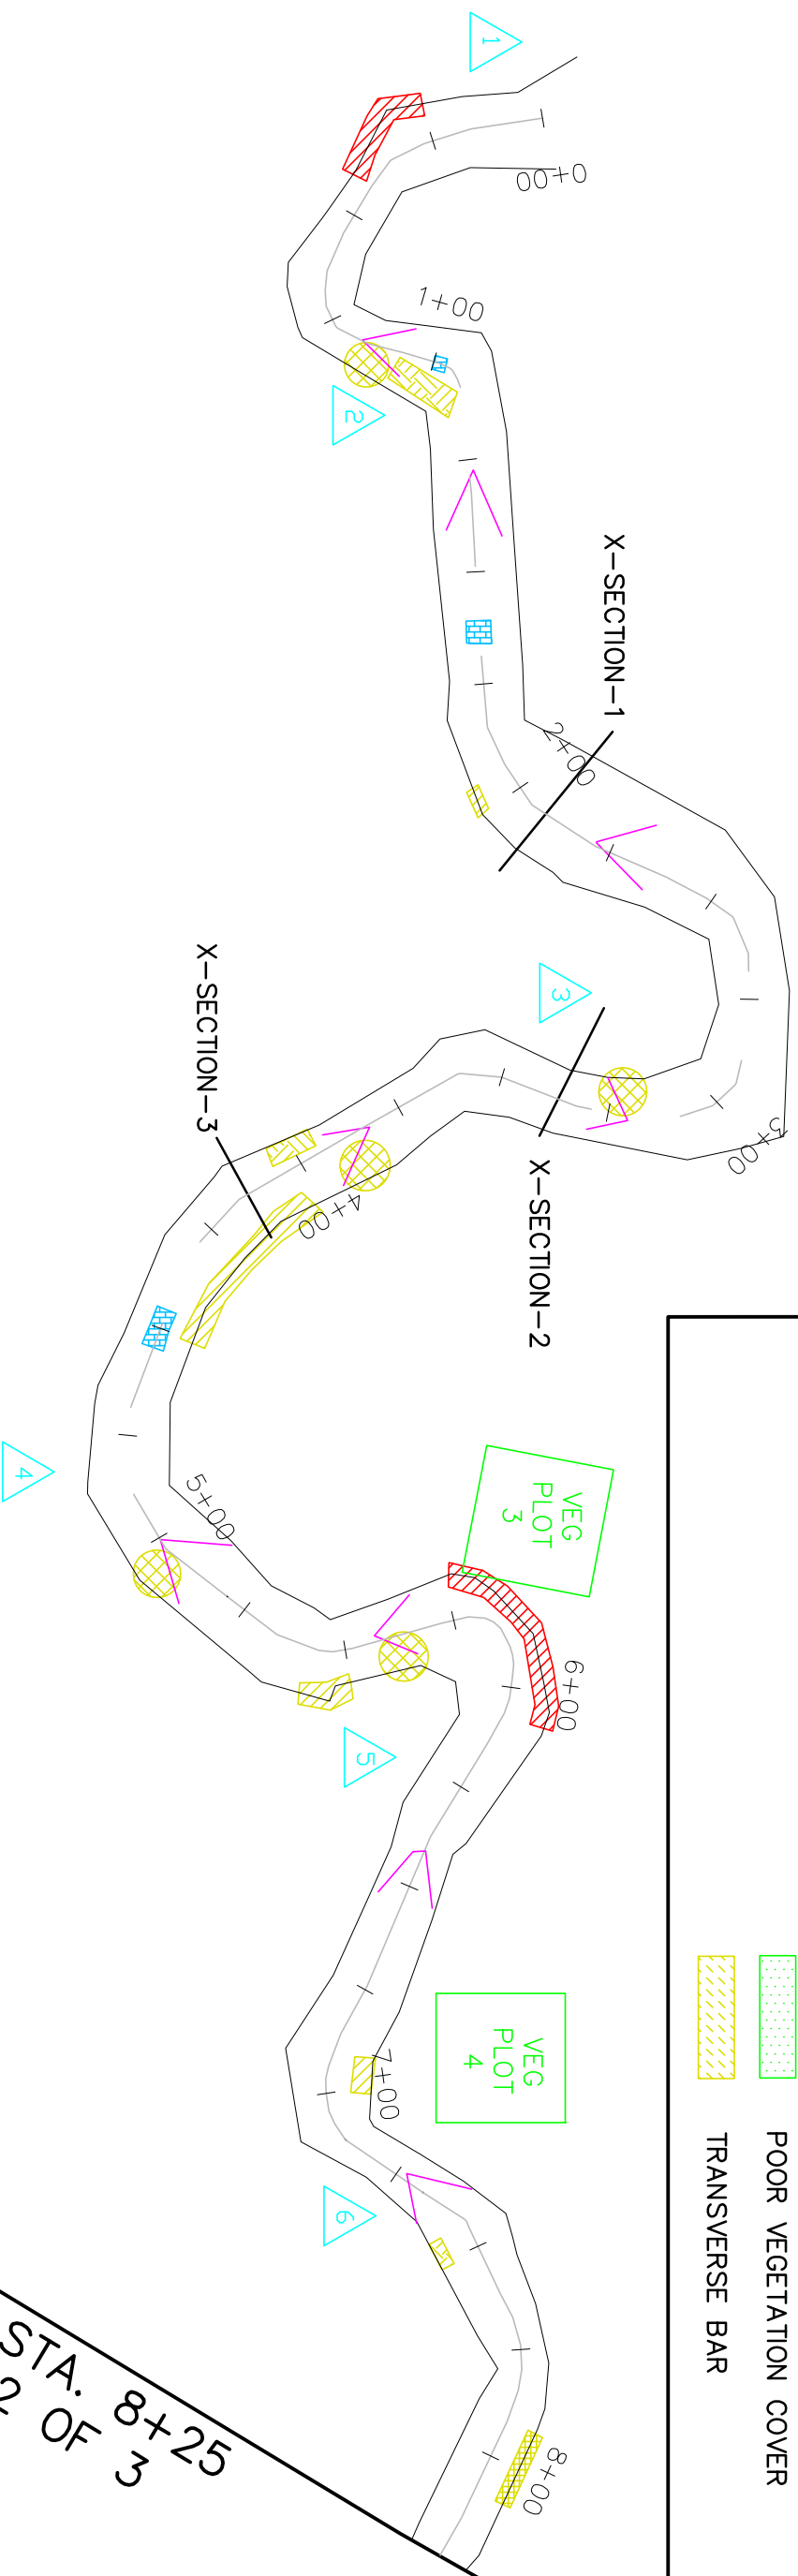
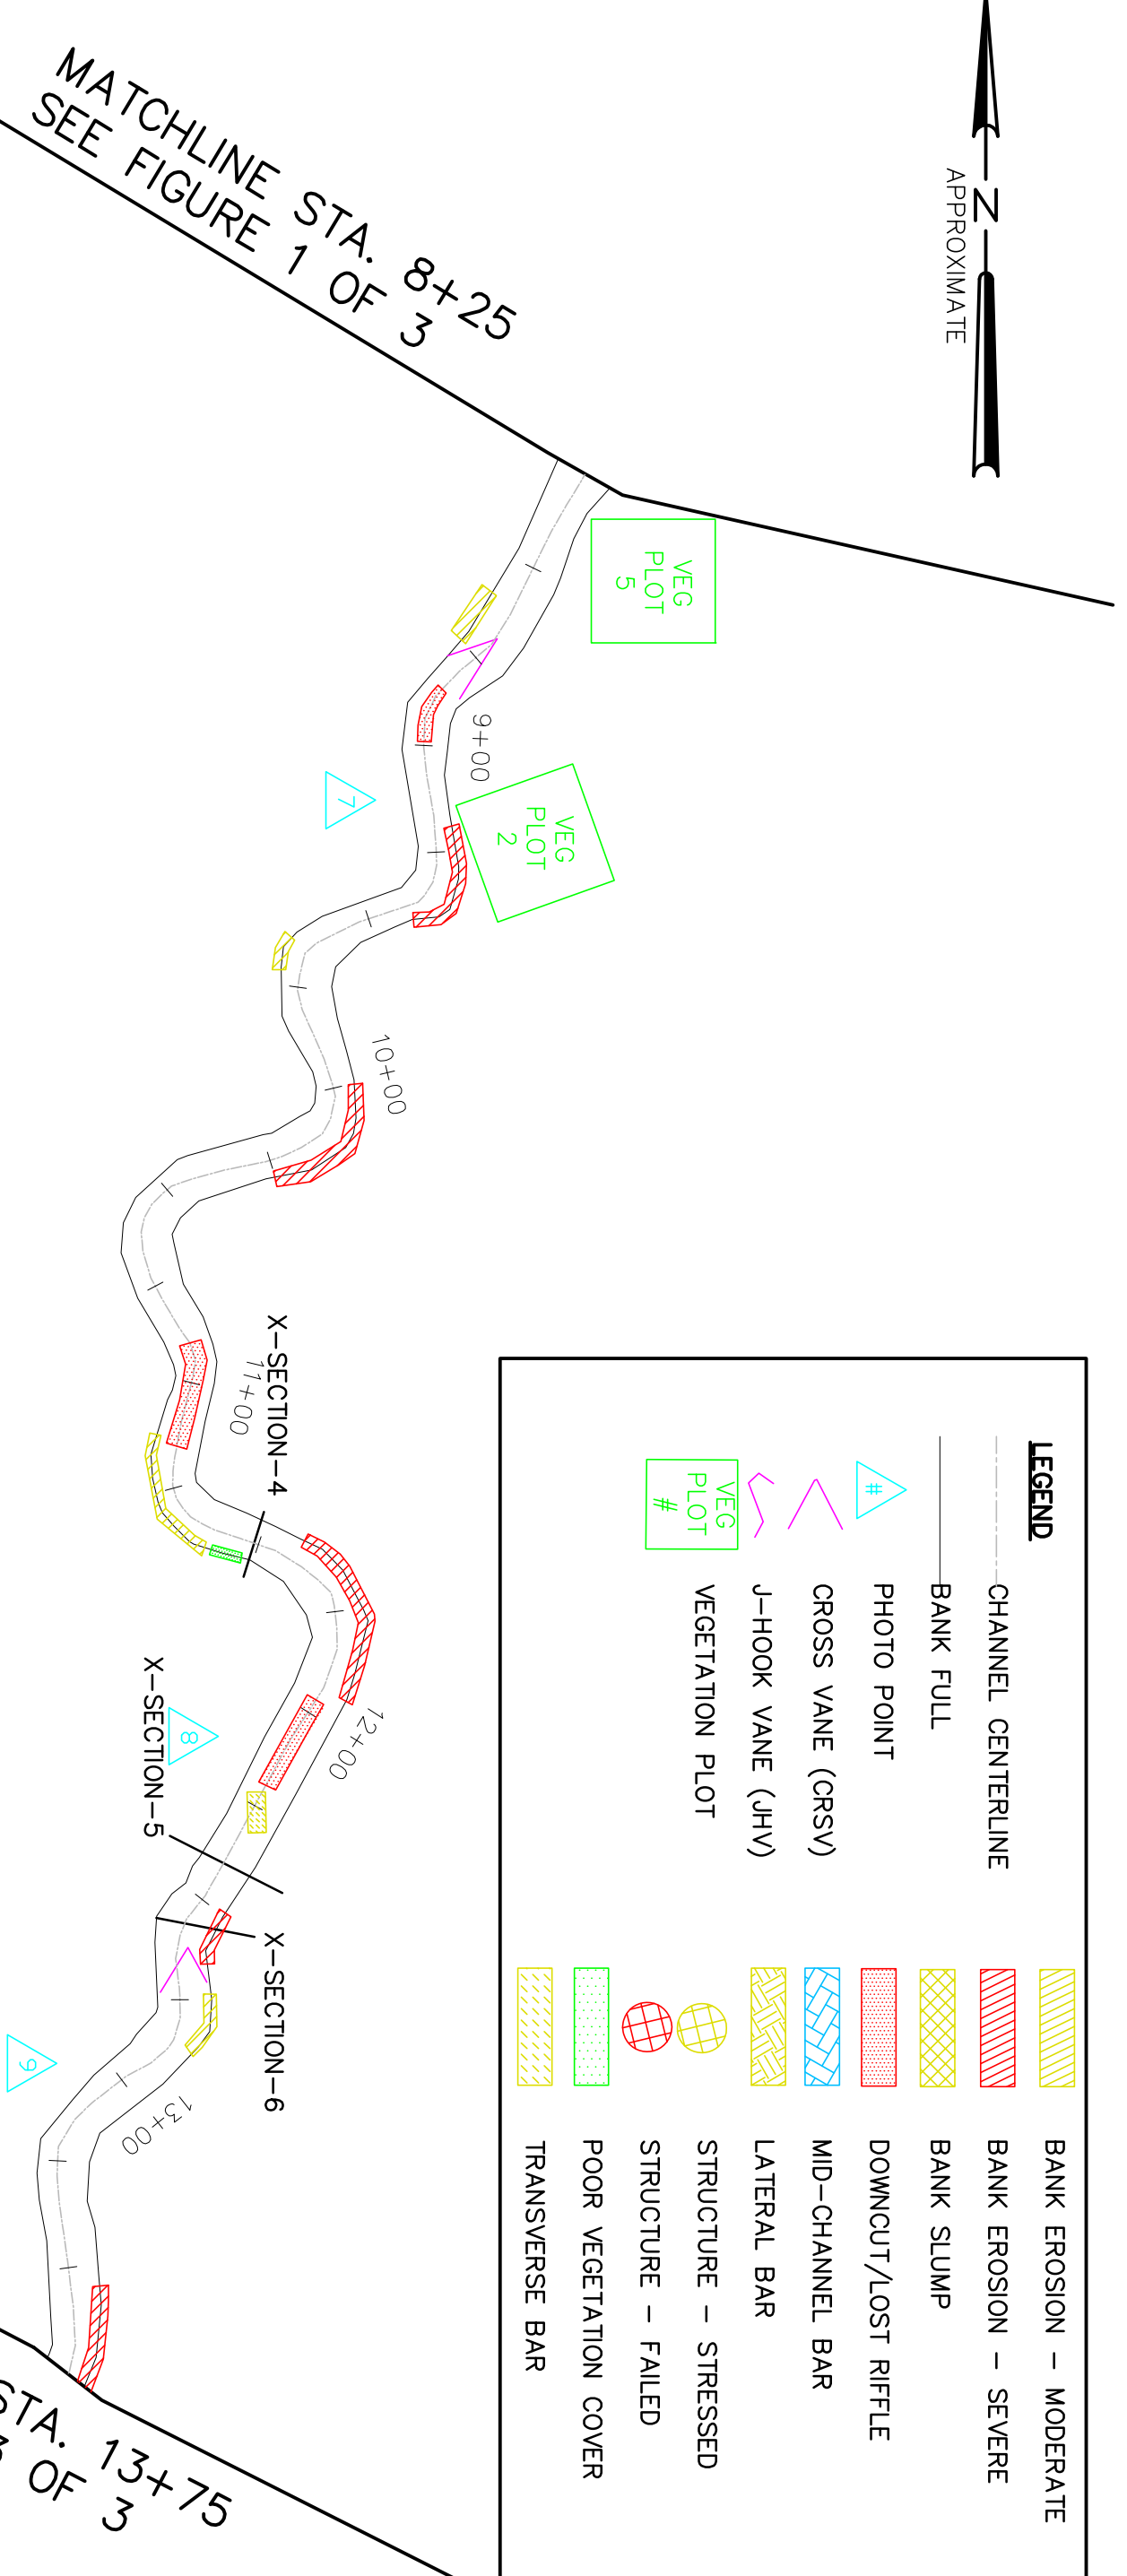
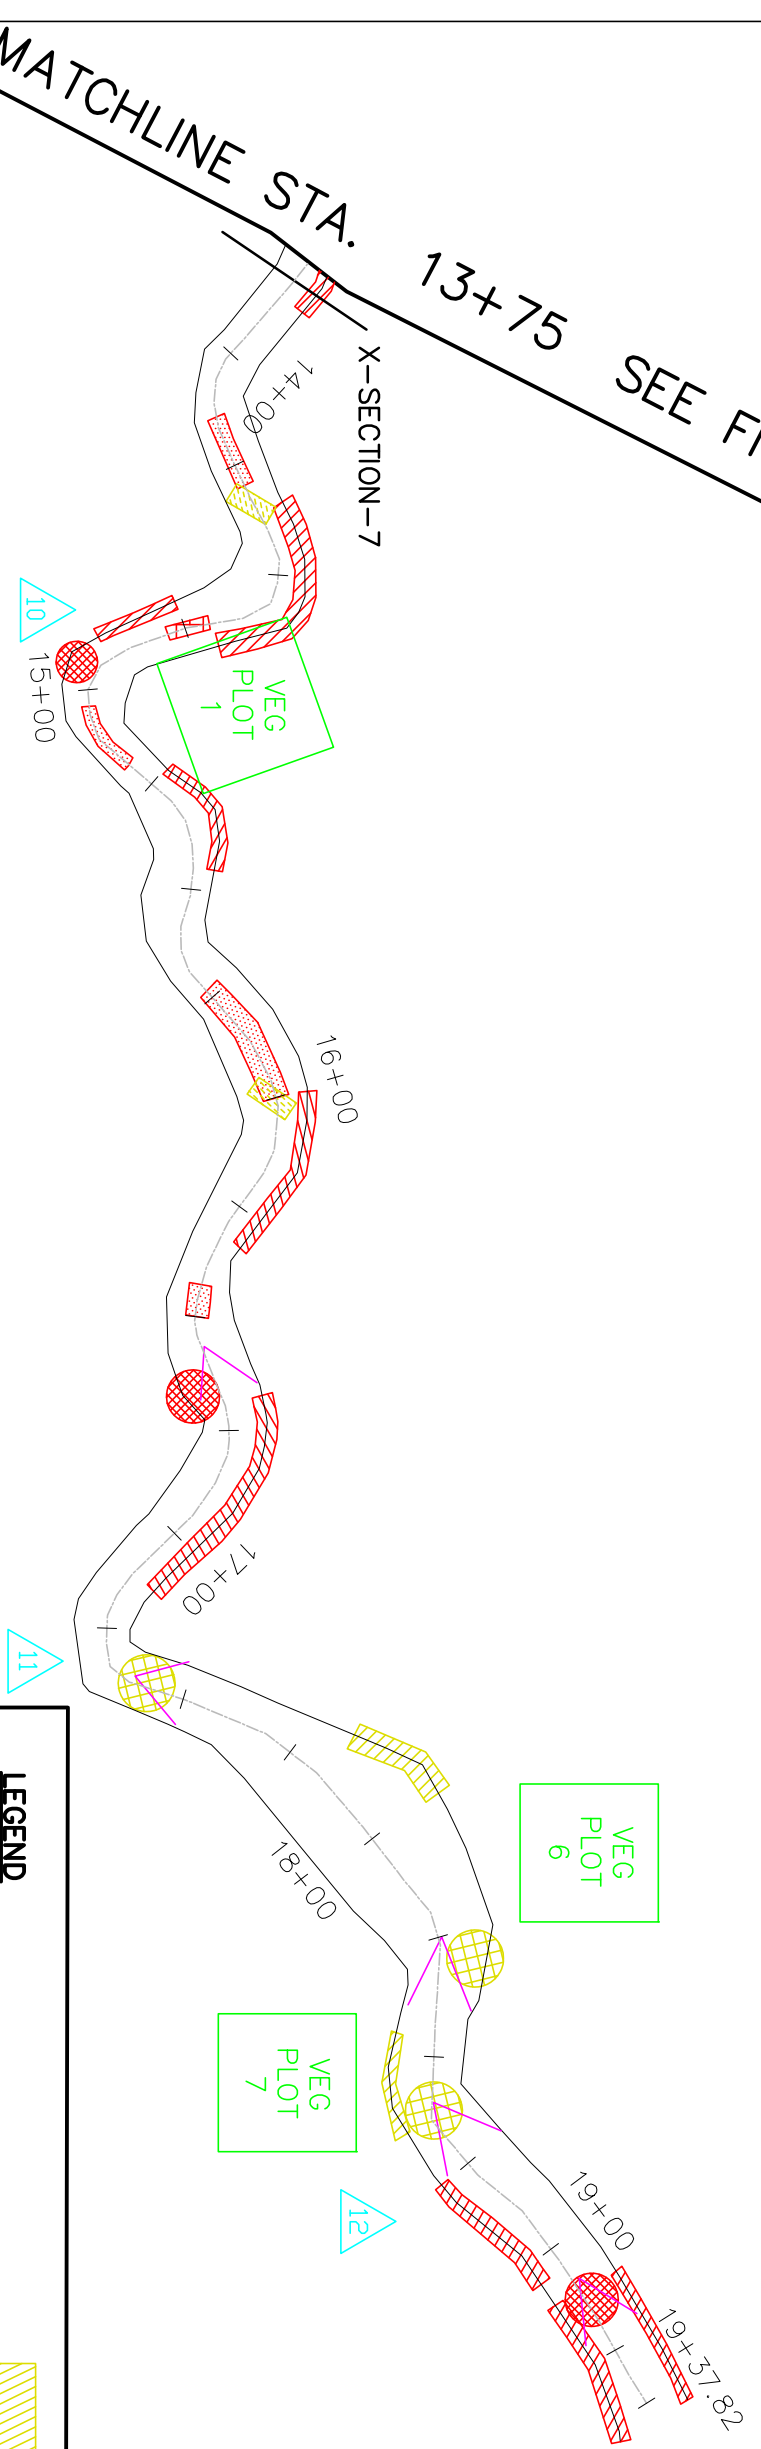
APPENDIX 3  
CURRENT CONDITION PLAN VIEW MAP

Feature Issue		Station Numbers	Suspected Cause	Photo ID
Bank erosion - moderate	Reach 1	1+98 - 2+00	Scour under matting, loose matting -RE	1
		4+00 - 4+50	Moderate bank slumping due to excess shear stress - LB	
		5+40 - 5+50	Scour under vegetation - RE	10
		6+95 - 7+00	Point bar scouring	
	Reach 2	8+65 - 8+75	Moderate scour; lack of vegetation -RE	1
		9+62 - 9+68	Moderate scour; lack of vegetation -RE	
		11+15 - 11+40	Moderate bank erosion due to insufficient channel capacity - clay bank - RB	
		12+70 - 12+90	Bank undercutting due to excess shear stress - LE	
		17+80 - 18+00	Moderate erosion due to excess shear stress - LB	
		18+45 - 18+65	Moderate erosion due to shifting of upstream pool to RF	
Bank erosion - severe	Reach 1	0+25 - 0+45	Erosion under tree root due to excess shear stress -RE	2
		5+75 - 6+05	No bank protection on downstream end of bend resulting in severe erosion - LB	
	Reach 2	9+20 - 9+40	Severe bank erosion and failure due to insufficient channel capacity and high shear stress - LB
