**LYLE CREEK MITIGATION SITE**  
*Catawba County, NC*  
*DENR Contract 003241*  
*NCEEP Project Number 94643*

**Monitoring Year 2 Annual Report**  
**FINAL**

**LYLE CREEK MITIGATION SITE  
Monitoring Year 2 Annual Report**

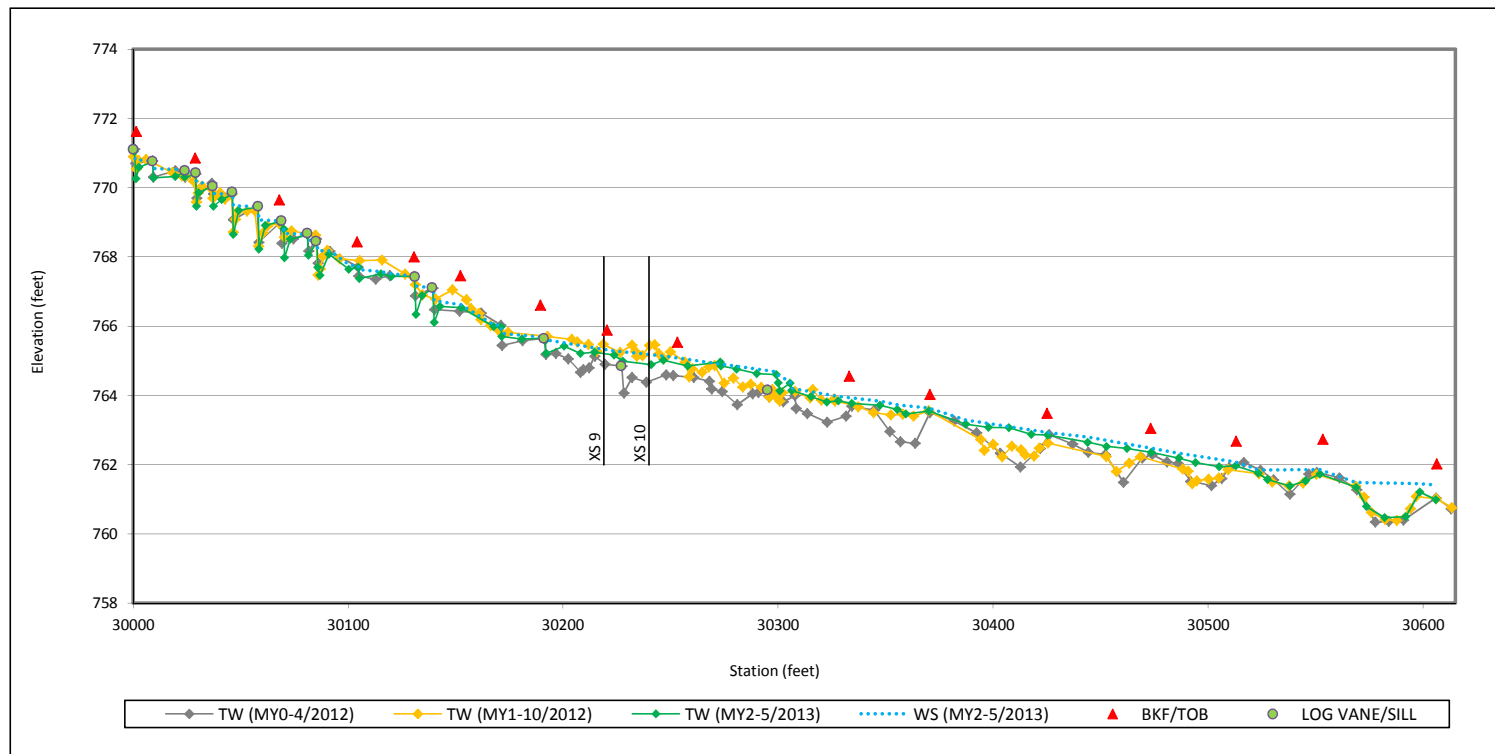
Longitudinal Profile Plots  
Lyle Creek Mitigation Site (EEP Project No. 94643)  
UT1A  
Monitoring Year 2

Morphological surveys for the MY-2 were conducted in May 2013. The majority of the streams within the Site have met the success criteria for MY-2 with the exception of a short length of UT1A. Aggradation is occurring on UT1A from station 301+50 to 304+00. This area of concern is further described below. Please refer to Appendix 2 for the visual assessment table, current condition plan view (CCPV), and photographs and Appendix 4 for morphological data and plots.
