MONITORING YEAR 3 ANNUAL REPORT

LYLE CREEK MITIGATION SITE
Catawba County, NC
DENR Contract 003241
NCEEP Project Number 94643

Data Collection Period: May 2014-June 2014
Draft Submission Date: November 26, 2014
Final Submission Date: January 13, 2015

Wildlands Engineering, Inc.
1430 South Mint Street, Suite 104
Charlotte, NC 28203

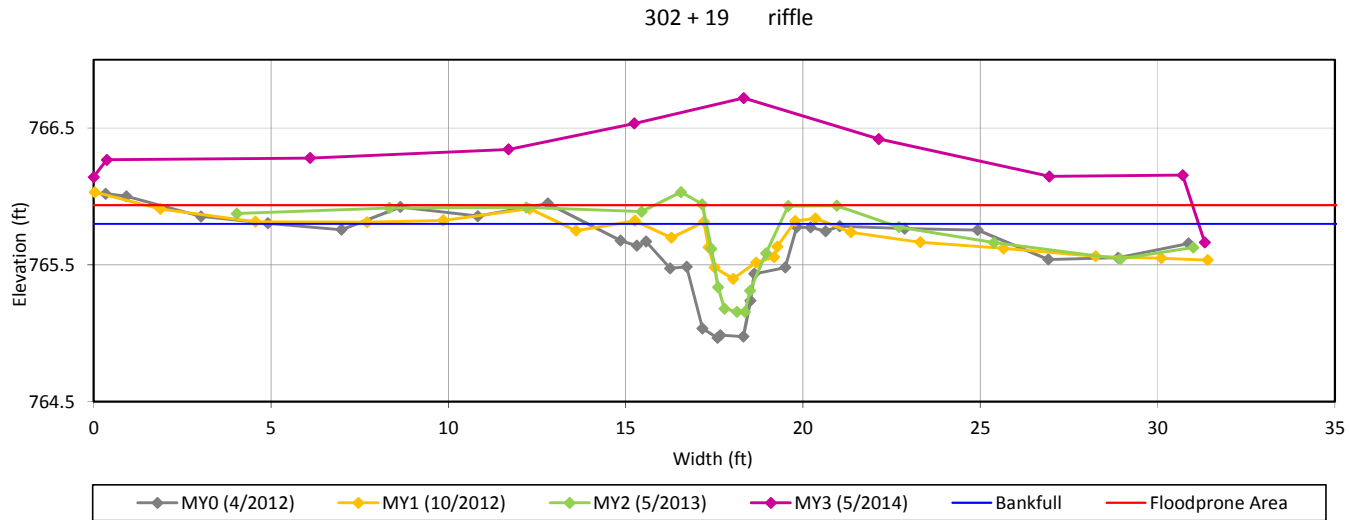
Cross Section 9 - UT1A

Morphological surveys for MY3 were conducted in May 2014. The majority of the streams within the Site have met the success criteria for MY3 with the exception of a short length of UT1A. Aggradation was observed along UT1A from station 301+75 to 304+34. This area of concern is further described below. Aggradation was also observed along UT1B from station 201+46 to 204+75 during the MY3 survey. Following the survey, a field assessment was completed which showed the sediment load in UT1B had naturally transported downstream and stream features were functioning as designed. Due to the natural rehabilitation of the reach there are no reportable areas of concern within UT1B for MY3. Please refer to Appendix 2 for the visual assessment table, Integrated Current Condition Plan View (CCPV), photographs, and Appendix 4 for morphological data and plots. It should be noted that the morphological plots in Appendix 4 show the aggradation in UT1B at the time of survey but do not depict the stream's natural rehabilitation condition observed during a follow-up field assessment.

0.0	x-section area (ft.sq.)
0.2	width (ft)
0.1	mean depth (ft)
0.1	max depth (ft)
0.2	wetted parimeter (ft)
0.1	hyd radi (ft)
2.5	width-depth ratio
