MONITORING YEAR 4 ANNUAL REPORT Final

LYLE CREEK MITIGATION SITE

Catawba County, NC
NCDEQ Contract 003241
NCDMS Project Number 94643

Data Collection Period: May 2015-June 2015
Draft Submission Date: November 30, 2015
Final Submission Date: March 4, 2016

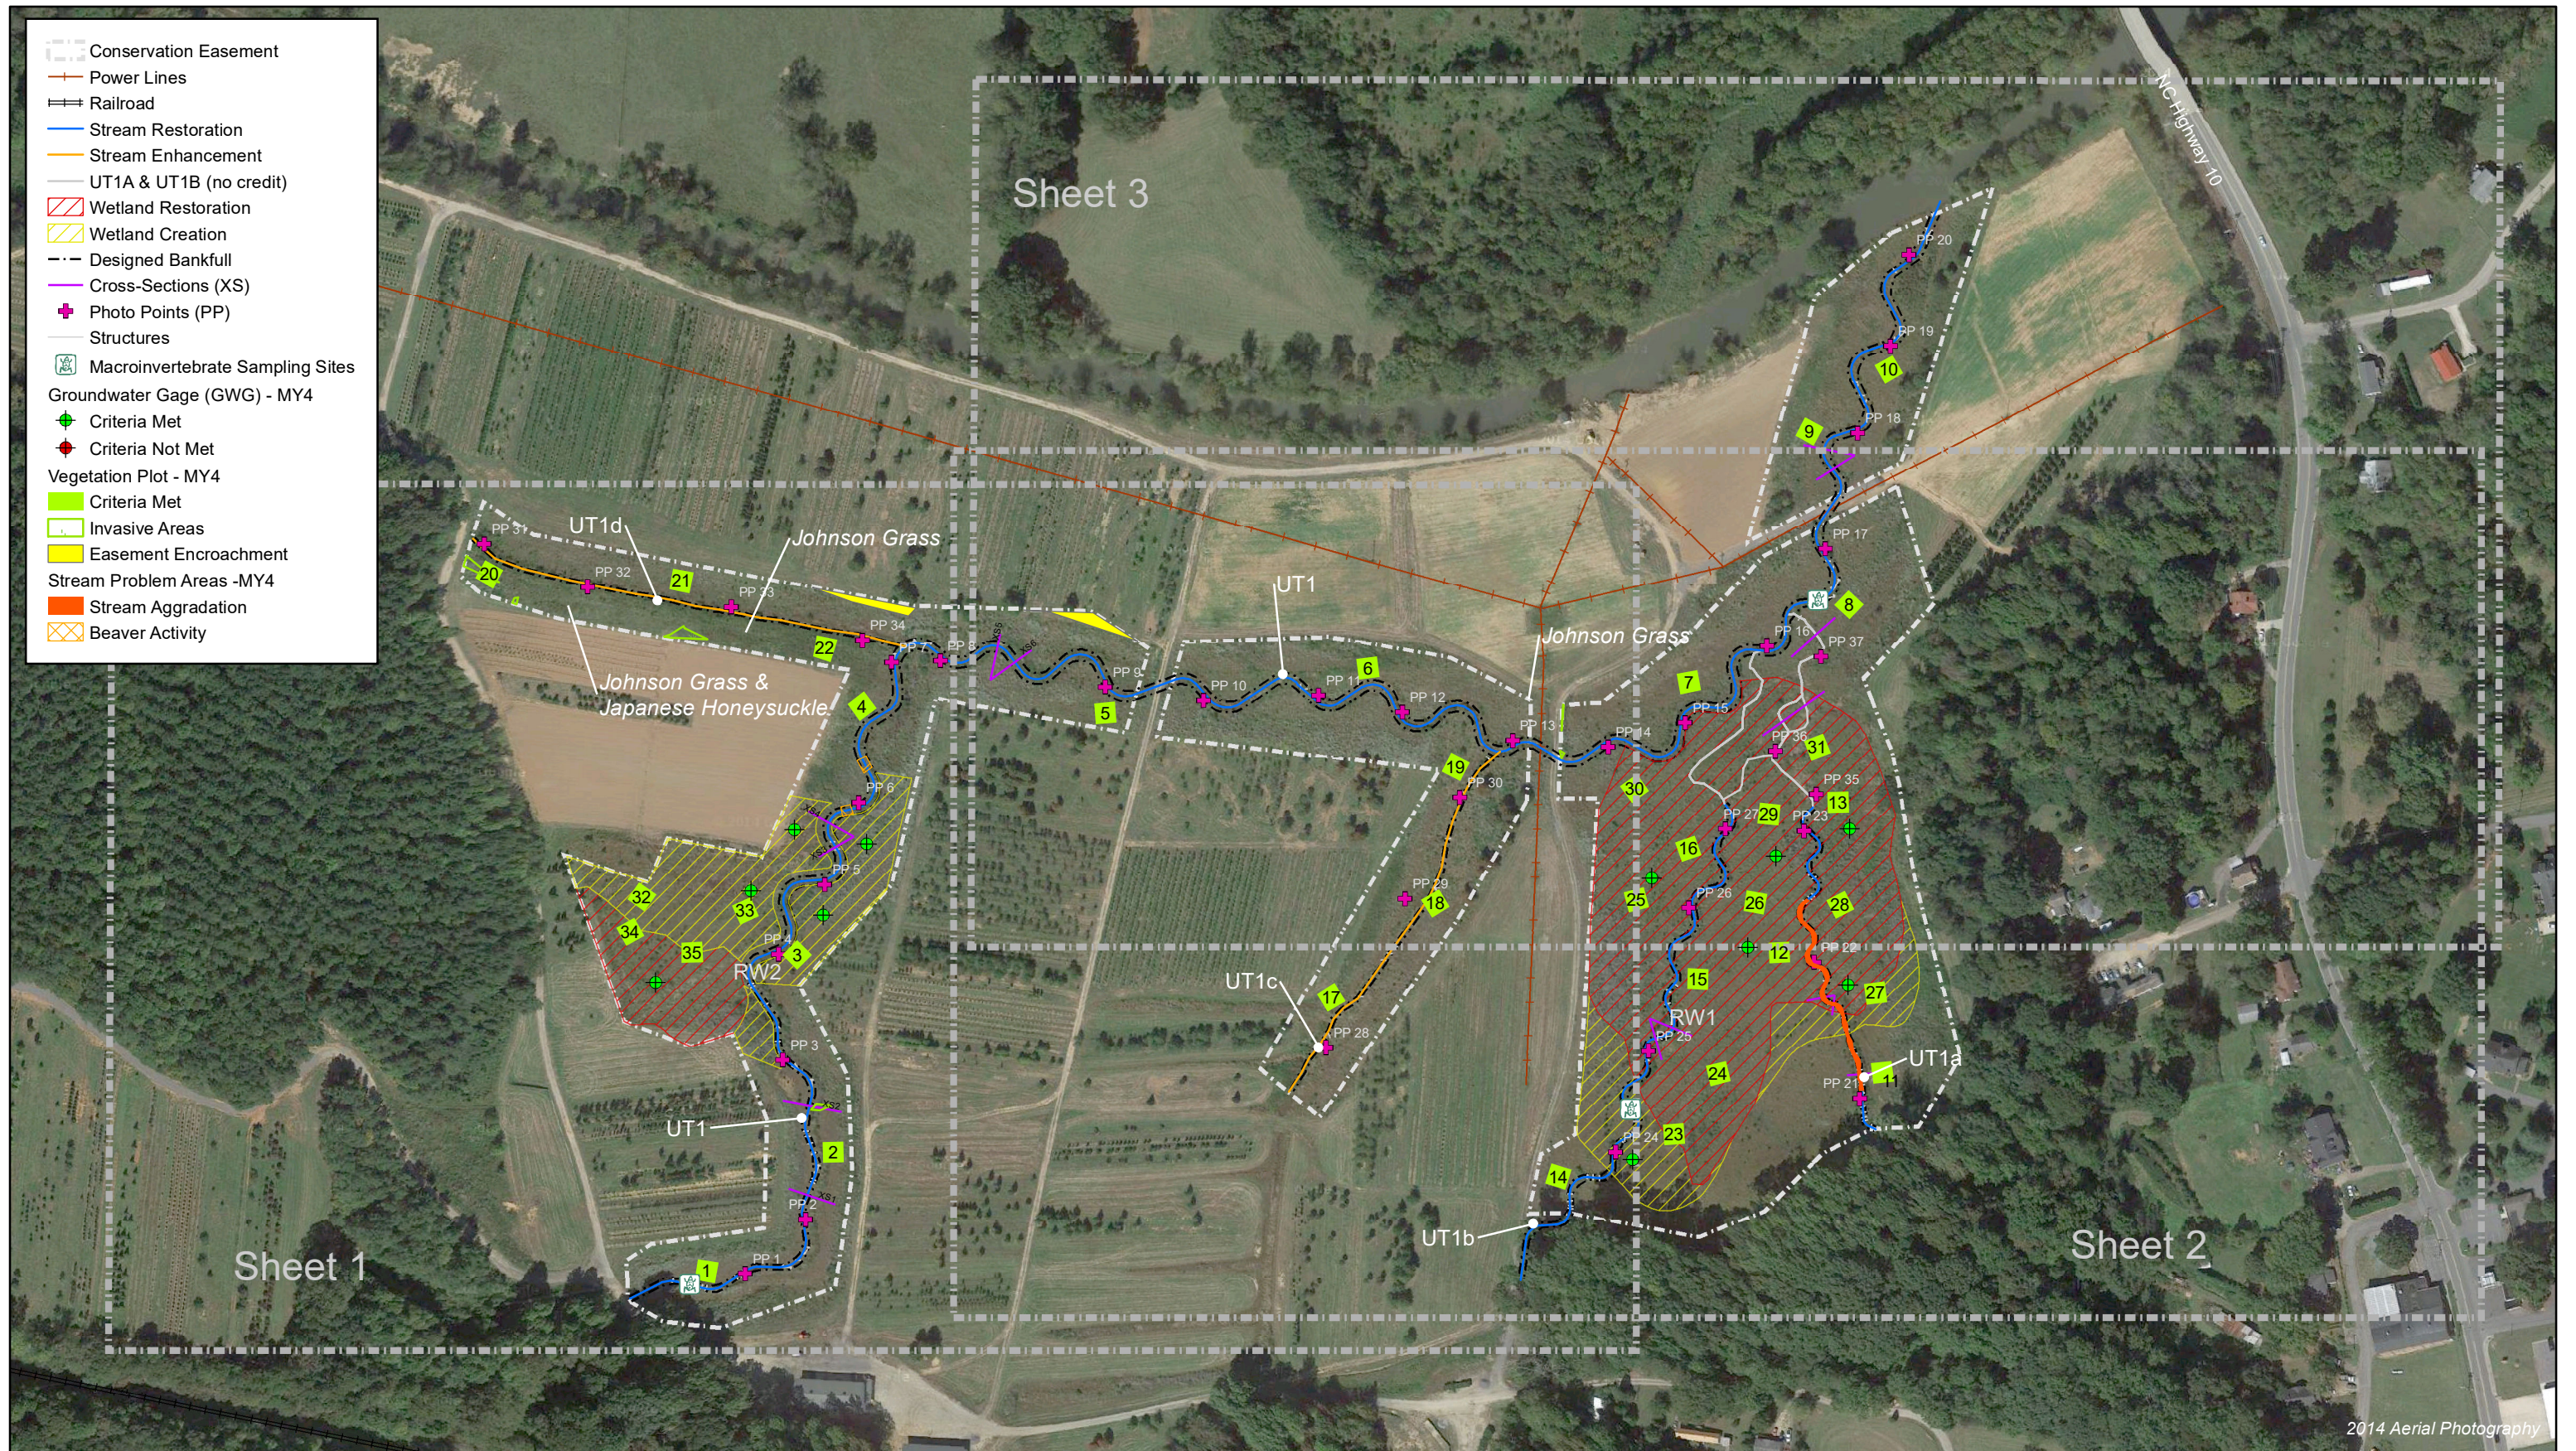
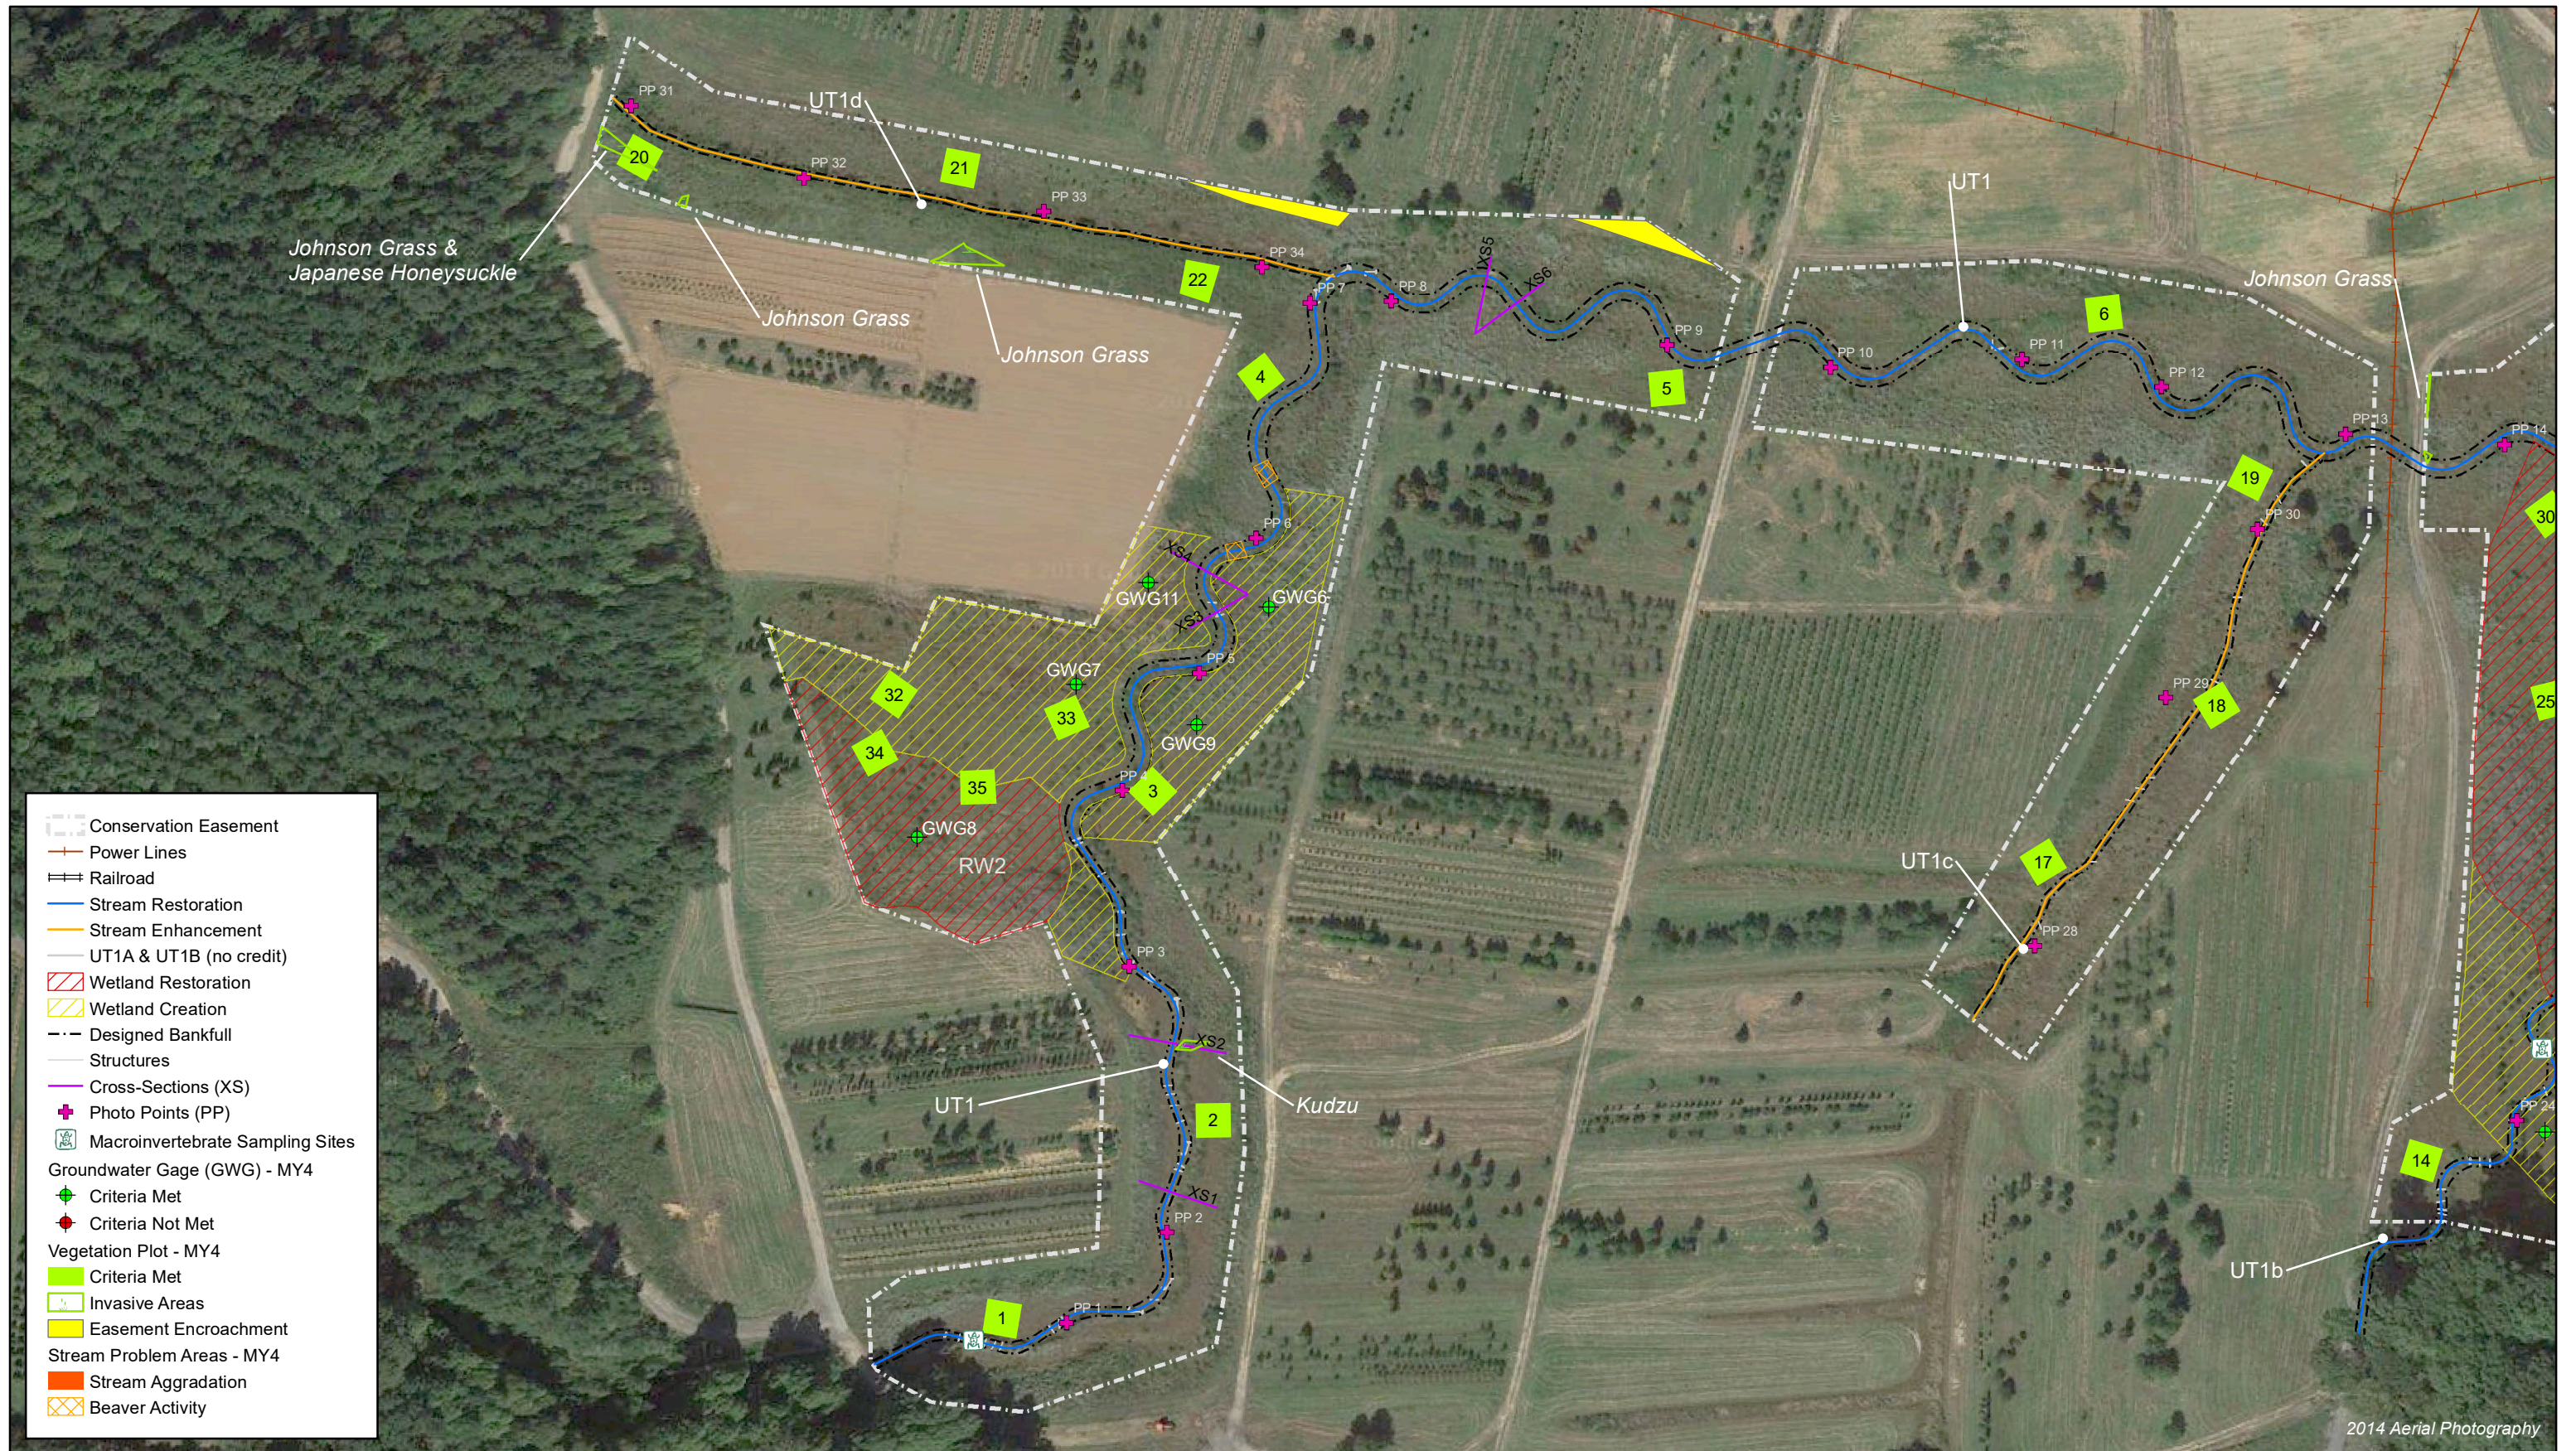
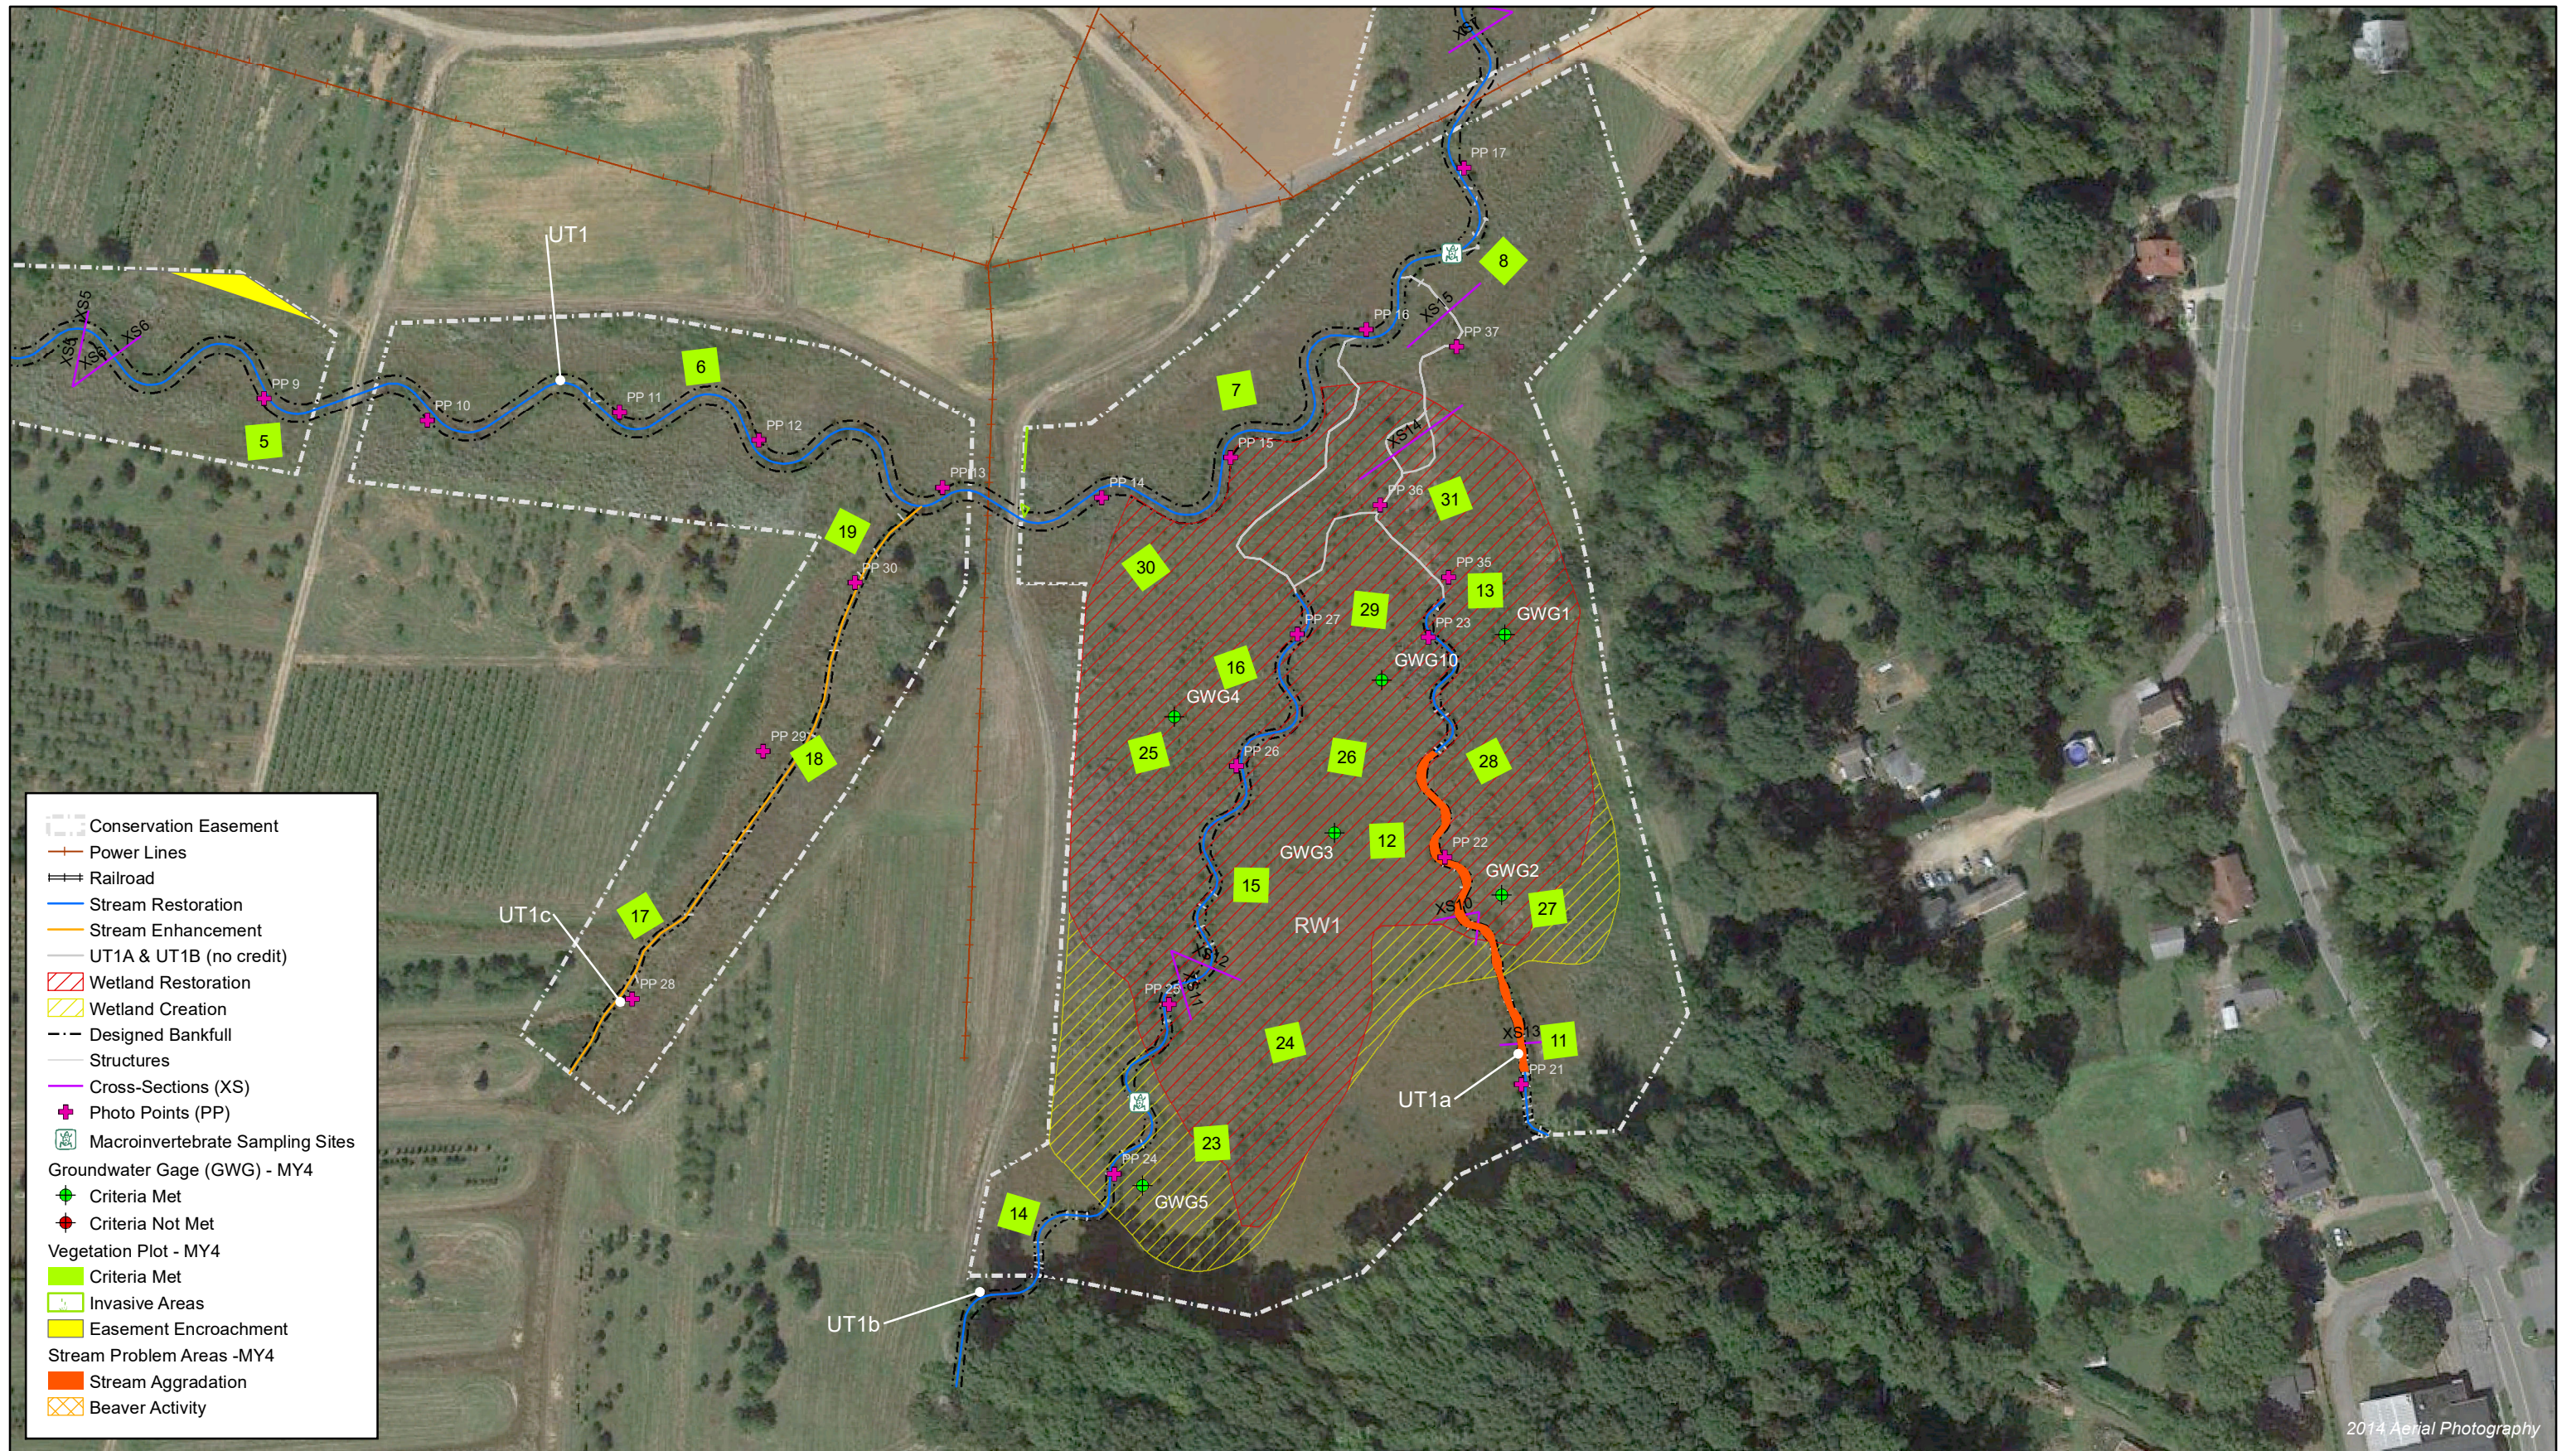
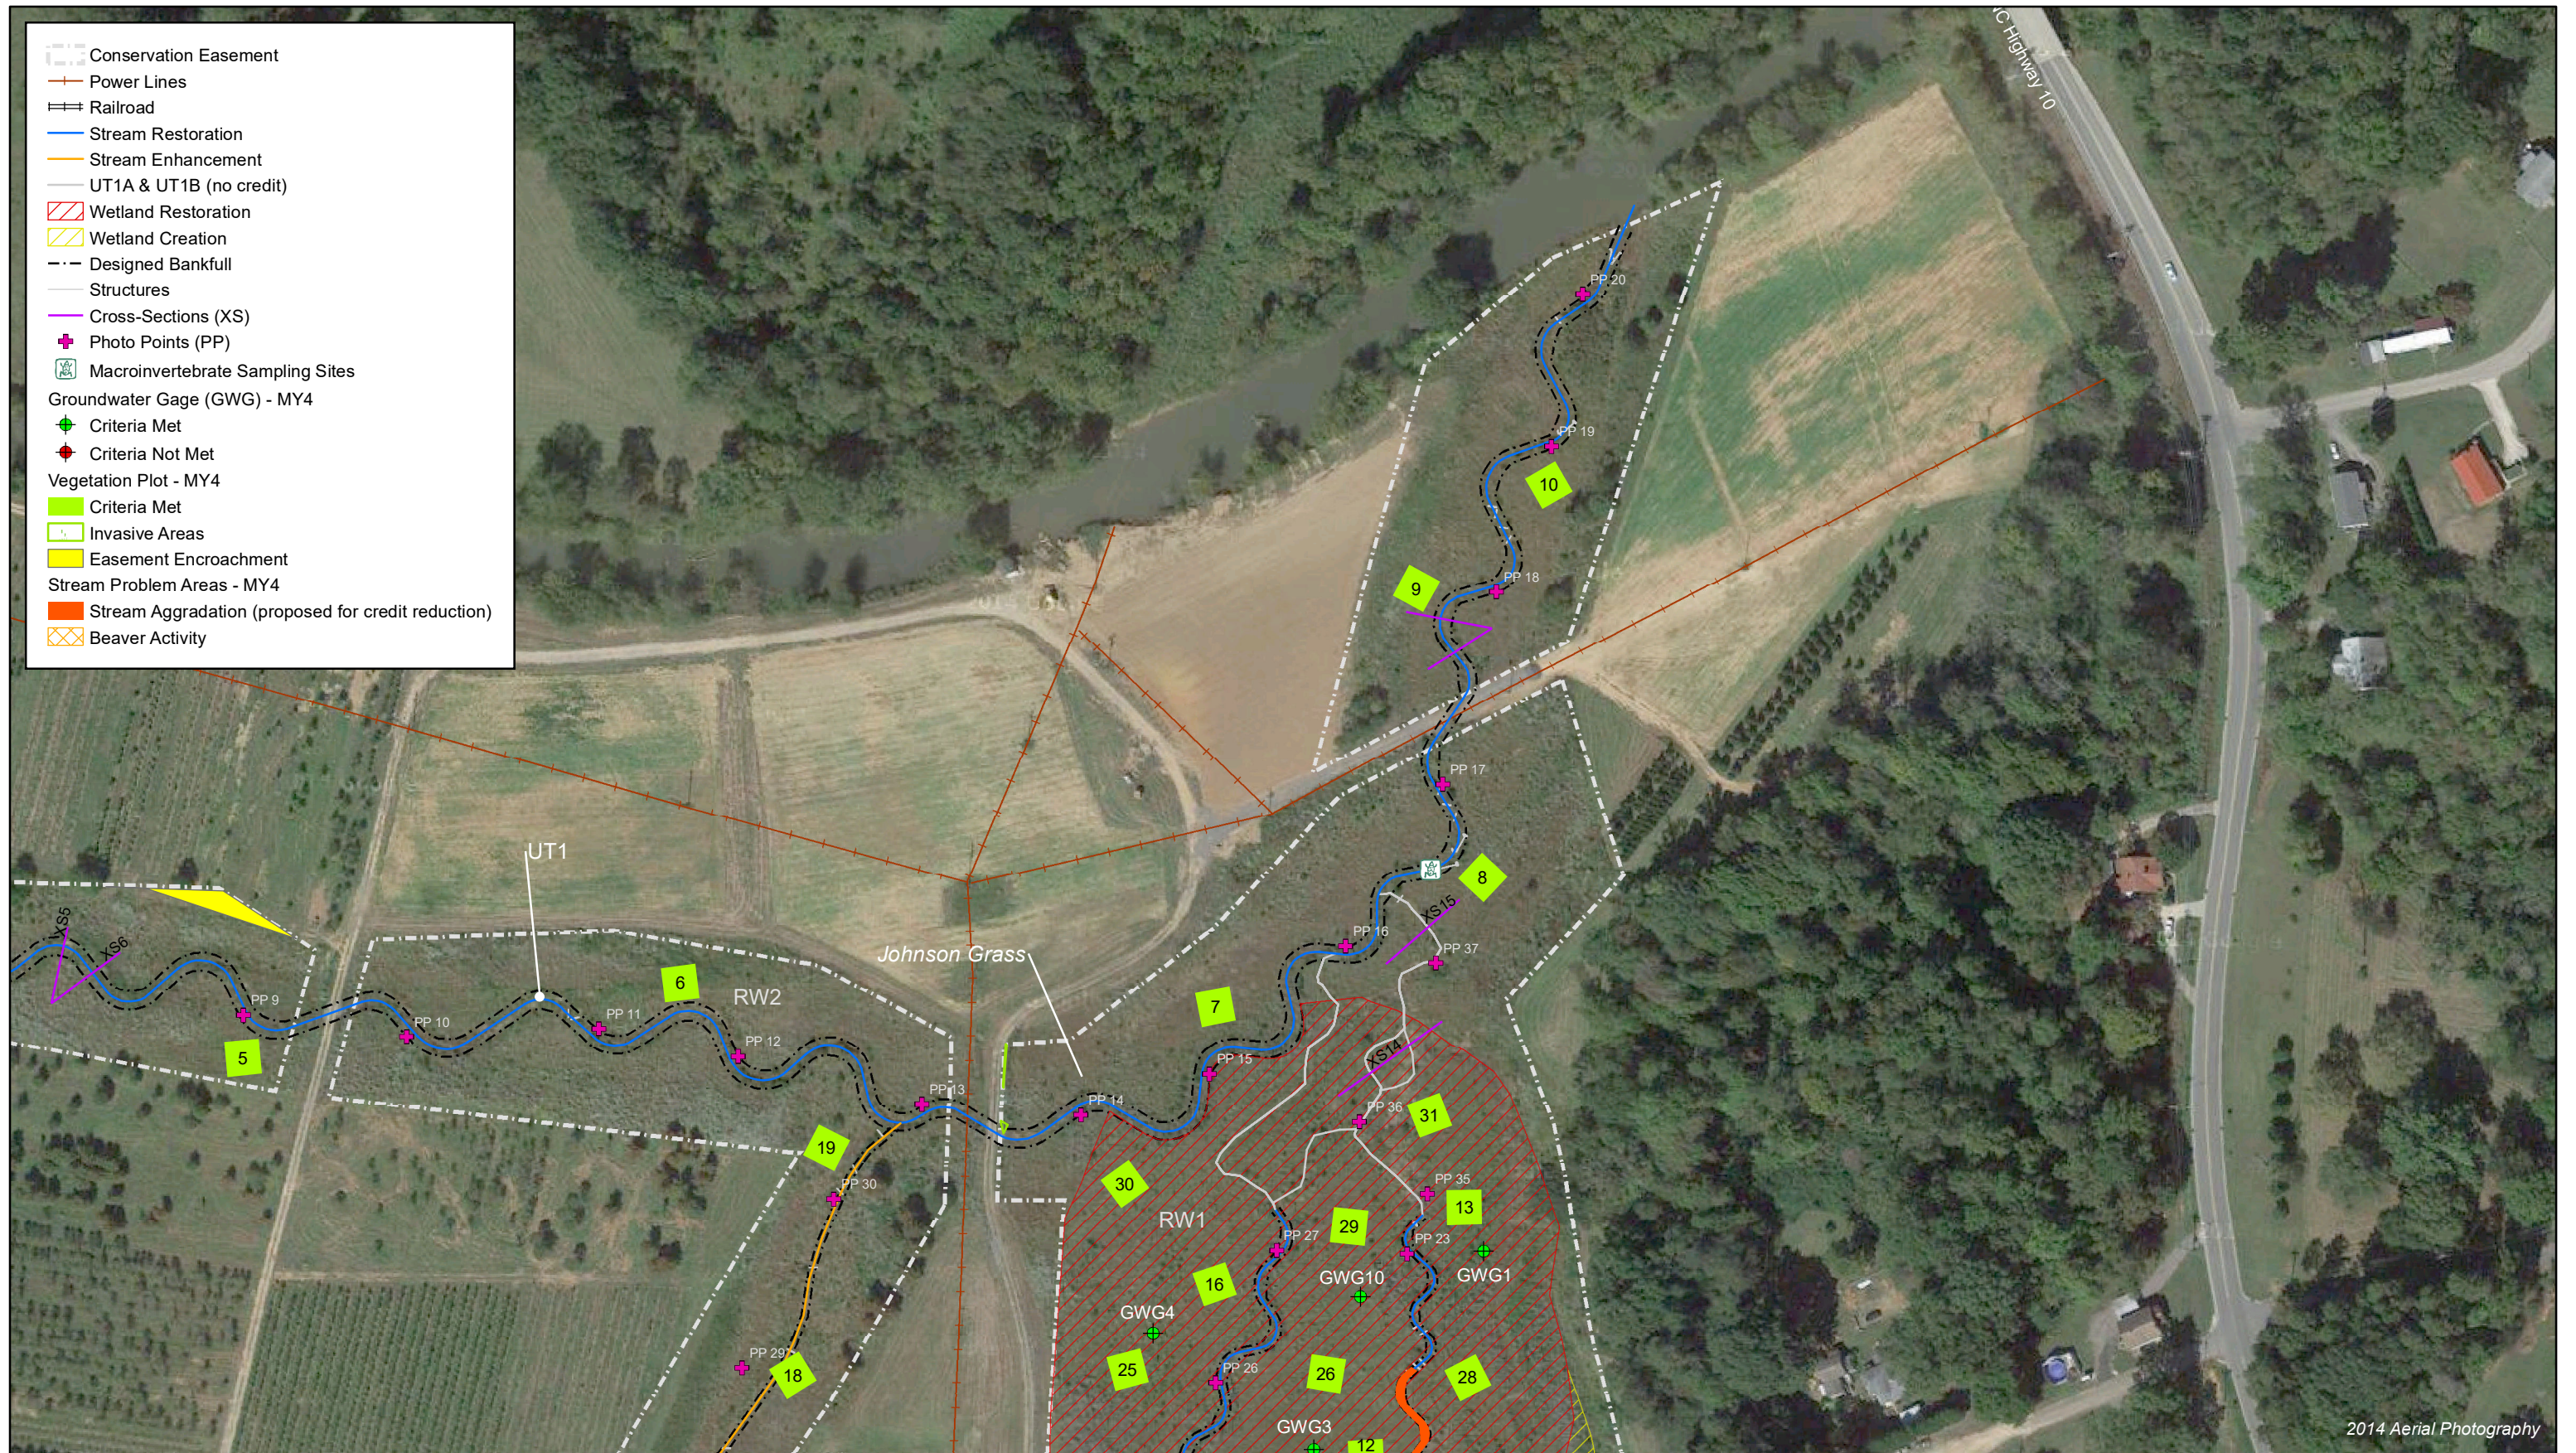
Figure 3.0 Integrated Current Condition Plan View (key)
 Lyle Creek Mitigation Site
 NCDMS Project Number 94643
 Monitoring Year 4

The MY4 vegetation monitoring and visual assessment revealed few vegetation areas of concern, mostly carrying over from MY3. Invasive species including Kudzu (*Pueraria lobata*), Johnson grass (*Sorghum halepense*), and cattails (*Typha latifolia*) were actively managed during MY4. The presence of these species does not currently appear to be affecting the survivability of planted stems, however, as discussed in the maintenance plan Wildlands will perform maintenance as needed. Minor encroachment of the conservation easement was observed in the left floodplain of UT1 (Stations 117+50 to 118+30) and left floodplain of UT1D (Stations 505+70 to 507+00) during adjacent field grading performed by the surrounding tree farm. Please refer to Appendix 3 for vegetation summary tables and raw data tables and to Appendix 2 for vegetation plot photographs, the vegetation condition assessment table and Figures 3.0-3.3 for the Integrated Current Condition Plan View which outlines these areas of concern.

Morphological surveys for MY4 were conducted between May and November 2015. The majority of the streams within the site have met the success criteria for MY4. An exception is the upper portion of UT1A that continues to experience aggradation from its contributing upstream watershed. During MY3 aggradation was observed between Stations 301+75 to 304+34 of UT1A. Since then aggradation has extended upstream to Station 300+36. Minor aggradation was also observed between Stations 201+46 and 204+75 of UT1B during MY3. Follow up field assessments in MY3 indicated UT1B had naturally transported the additional sediment and the channel was functioning as designed. During MY4, minor aggradation was again observed in approximately the same section of UT1B (201+46 to 204+75). The minor aggradation appears cyclic and not impacting the overall stability of UT1B. A small section of aggradation was also observed at the top of UT1 (Station 100+17 to 100+95). The minor amount of additional sediment has not impacted the channels' stability or function. Therefore, there are no reportable areas of concern related to this section of UT1 or UT1B. Over time UT1 and UT1B should naturally transport this sediment.

A beaver dam was observed at Station 111+50 of UT1 during an October site visit and removed. The beaver dam had been rebuilt at Station 111+50 during a November site visit and an additional dam was present downstream at Station 112+40. Both were removed during the November visit. Please refer to

At the downstream end of UT1, near the confluence with Lyle Creek, minor aggradation documented in previous monitoring years continues to persist. This aggradation is most likely attributed to backwater conditions from Lyle Creek. Lyle Creek is under backwater influence of the managed Lake Norman/Catawba River system. Due to the sand/silt nature of the substrate throughout the project, fluctuations in bed elevations were observed and expected. These fluctuations within UT1 are temporary and seem to typically correspond to storm events.

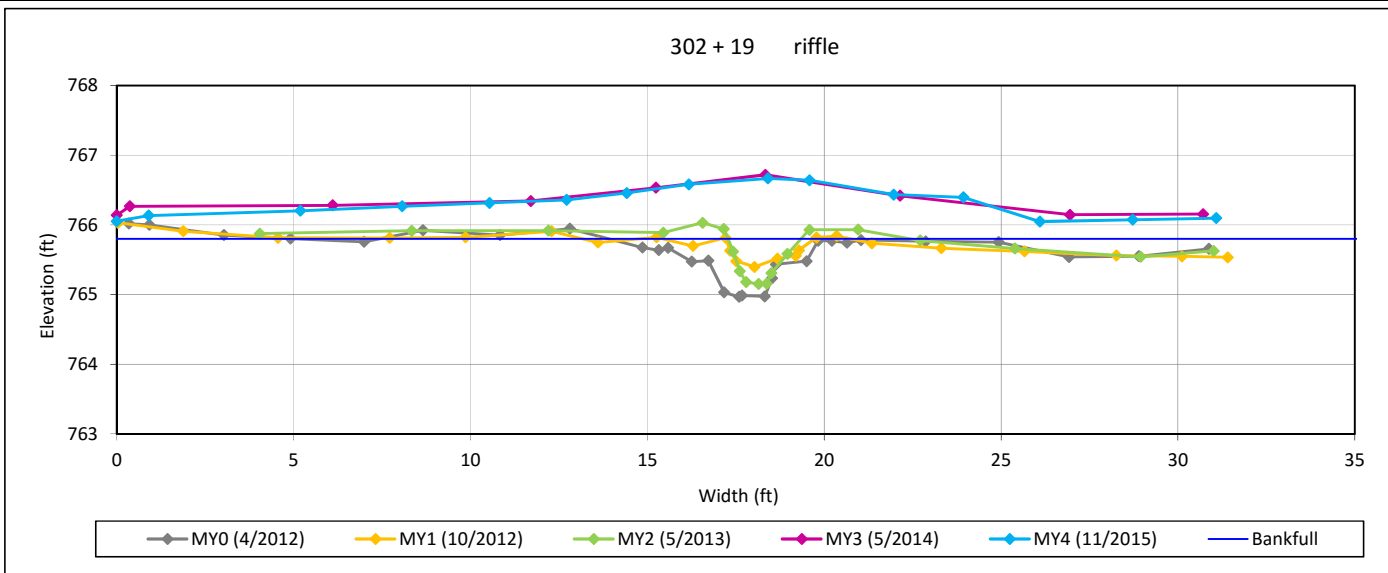
Cross Section 9 - UT1A

- 0.0 x-section area (ft.sq.)
- 0.0 width (ft)
- 0.0 mean depth (ft)
- 0.0 max depth (ft)
- 0.0 wetted perimeter (ft)
- 0.0 hyd radi (ft)
- 0.0 width-depth ratio

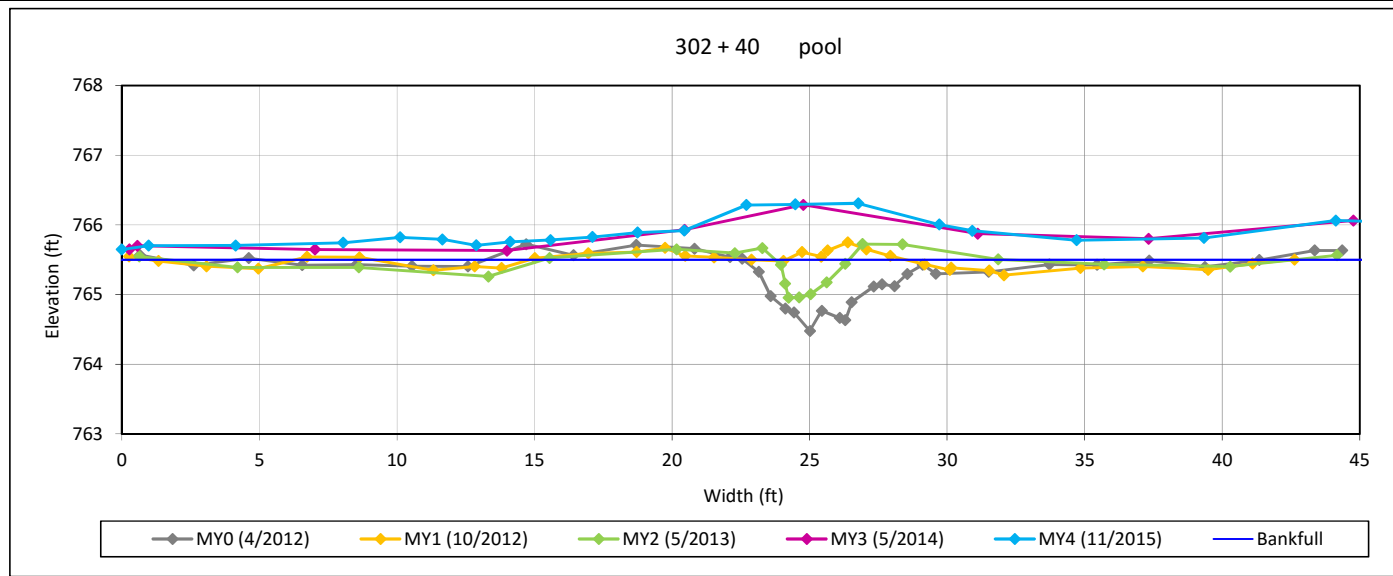
Cross Section 10 - UT1A

0.0 x-section area (ft.sq.)
 0.0 width (ft)
 0.0 mean depth (ft)
 0.0 max depth (ft)
 0.0 wetted perimeter (ft)
 0.0 hyd radi (ft)
 0.0 width-depth ratio

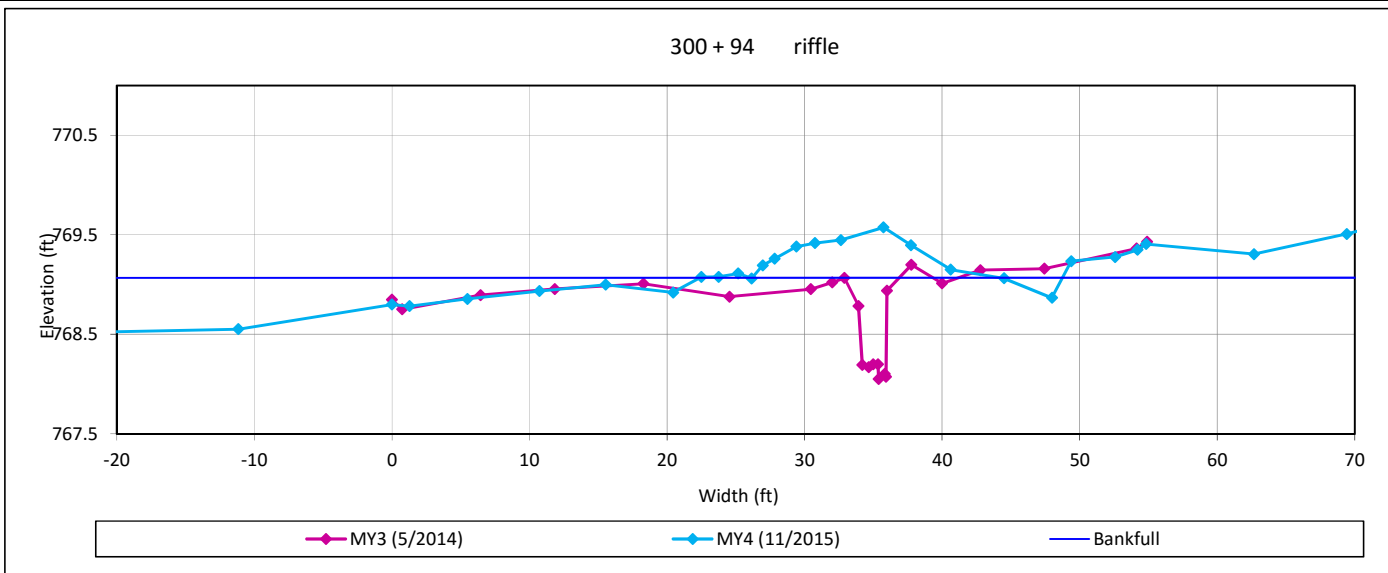
Cross Section 13 - UT1A

- 0.0 x-section area (ft.sq.)
- 0.0 width (ft)
- 0.0 mean depth (ft)
- 0.0 max depth (ft)
- 0.0 wetted parimeter (ft)
- 0.0 hyd radi (ft)
- 0.0 width-depth ratio
