# **MONITORING YEAR 5 ANNUAL REPORT**

## **LYLE CREEK MITIGATION SITE**

Catawba County, NC  
DEQ Contract 003241  
DMS Project Number 94643

Data Collection Period: February - November 2016  
Draft Submission Date: November 30, 2016  
Final Submission Date: December 5, 2016

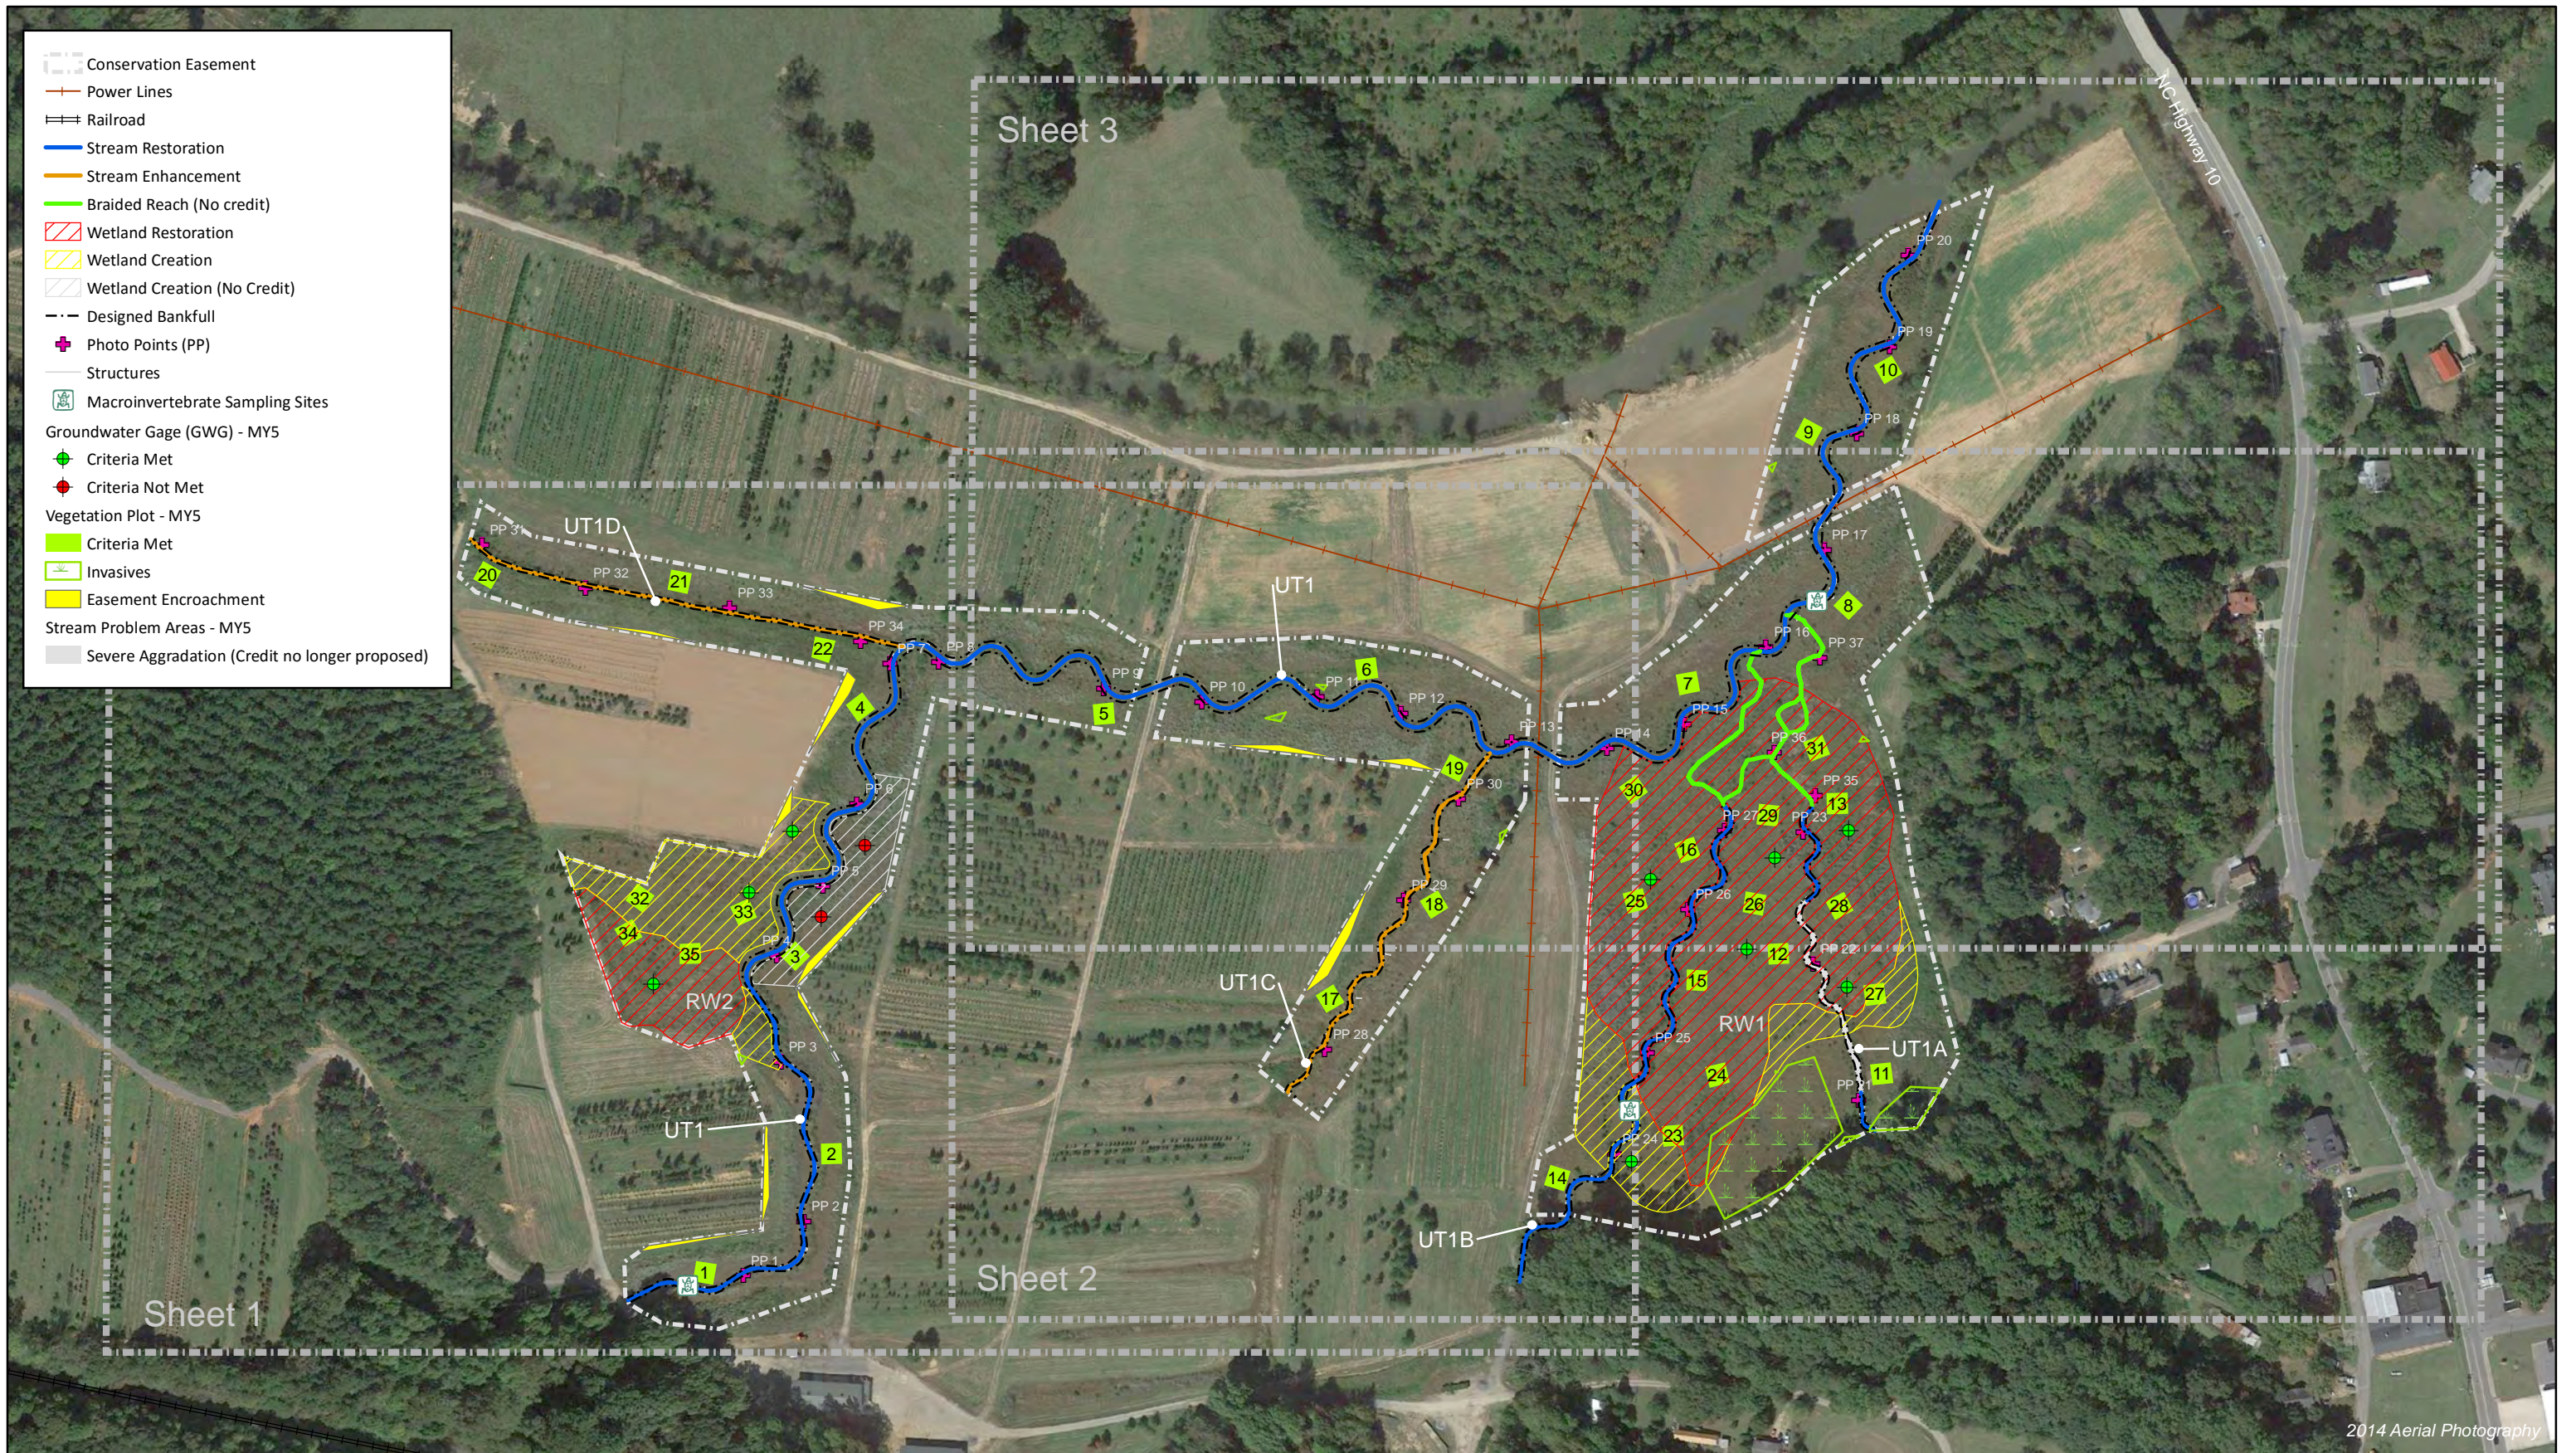
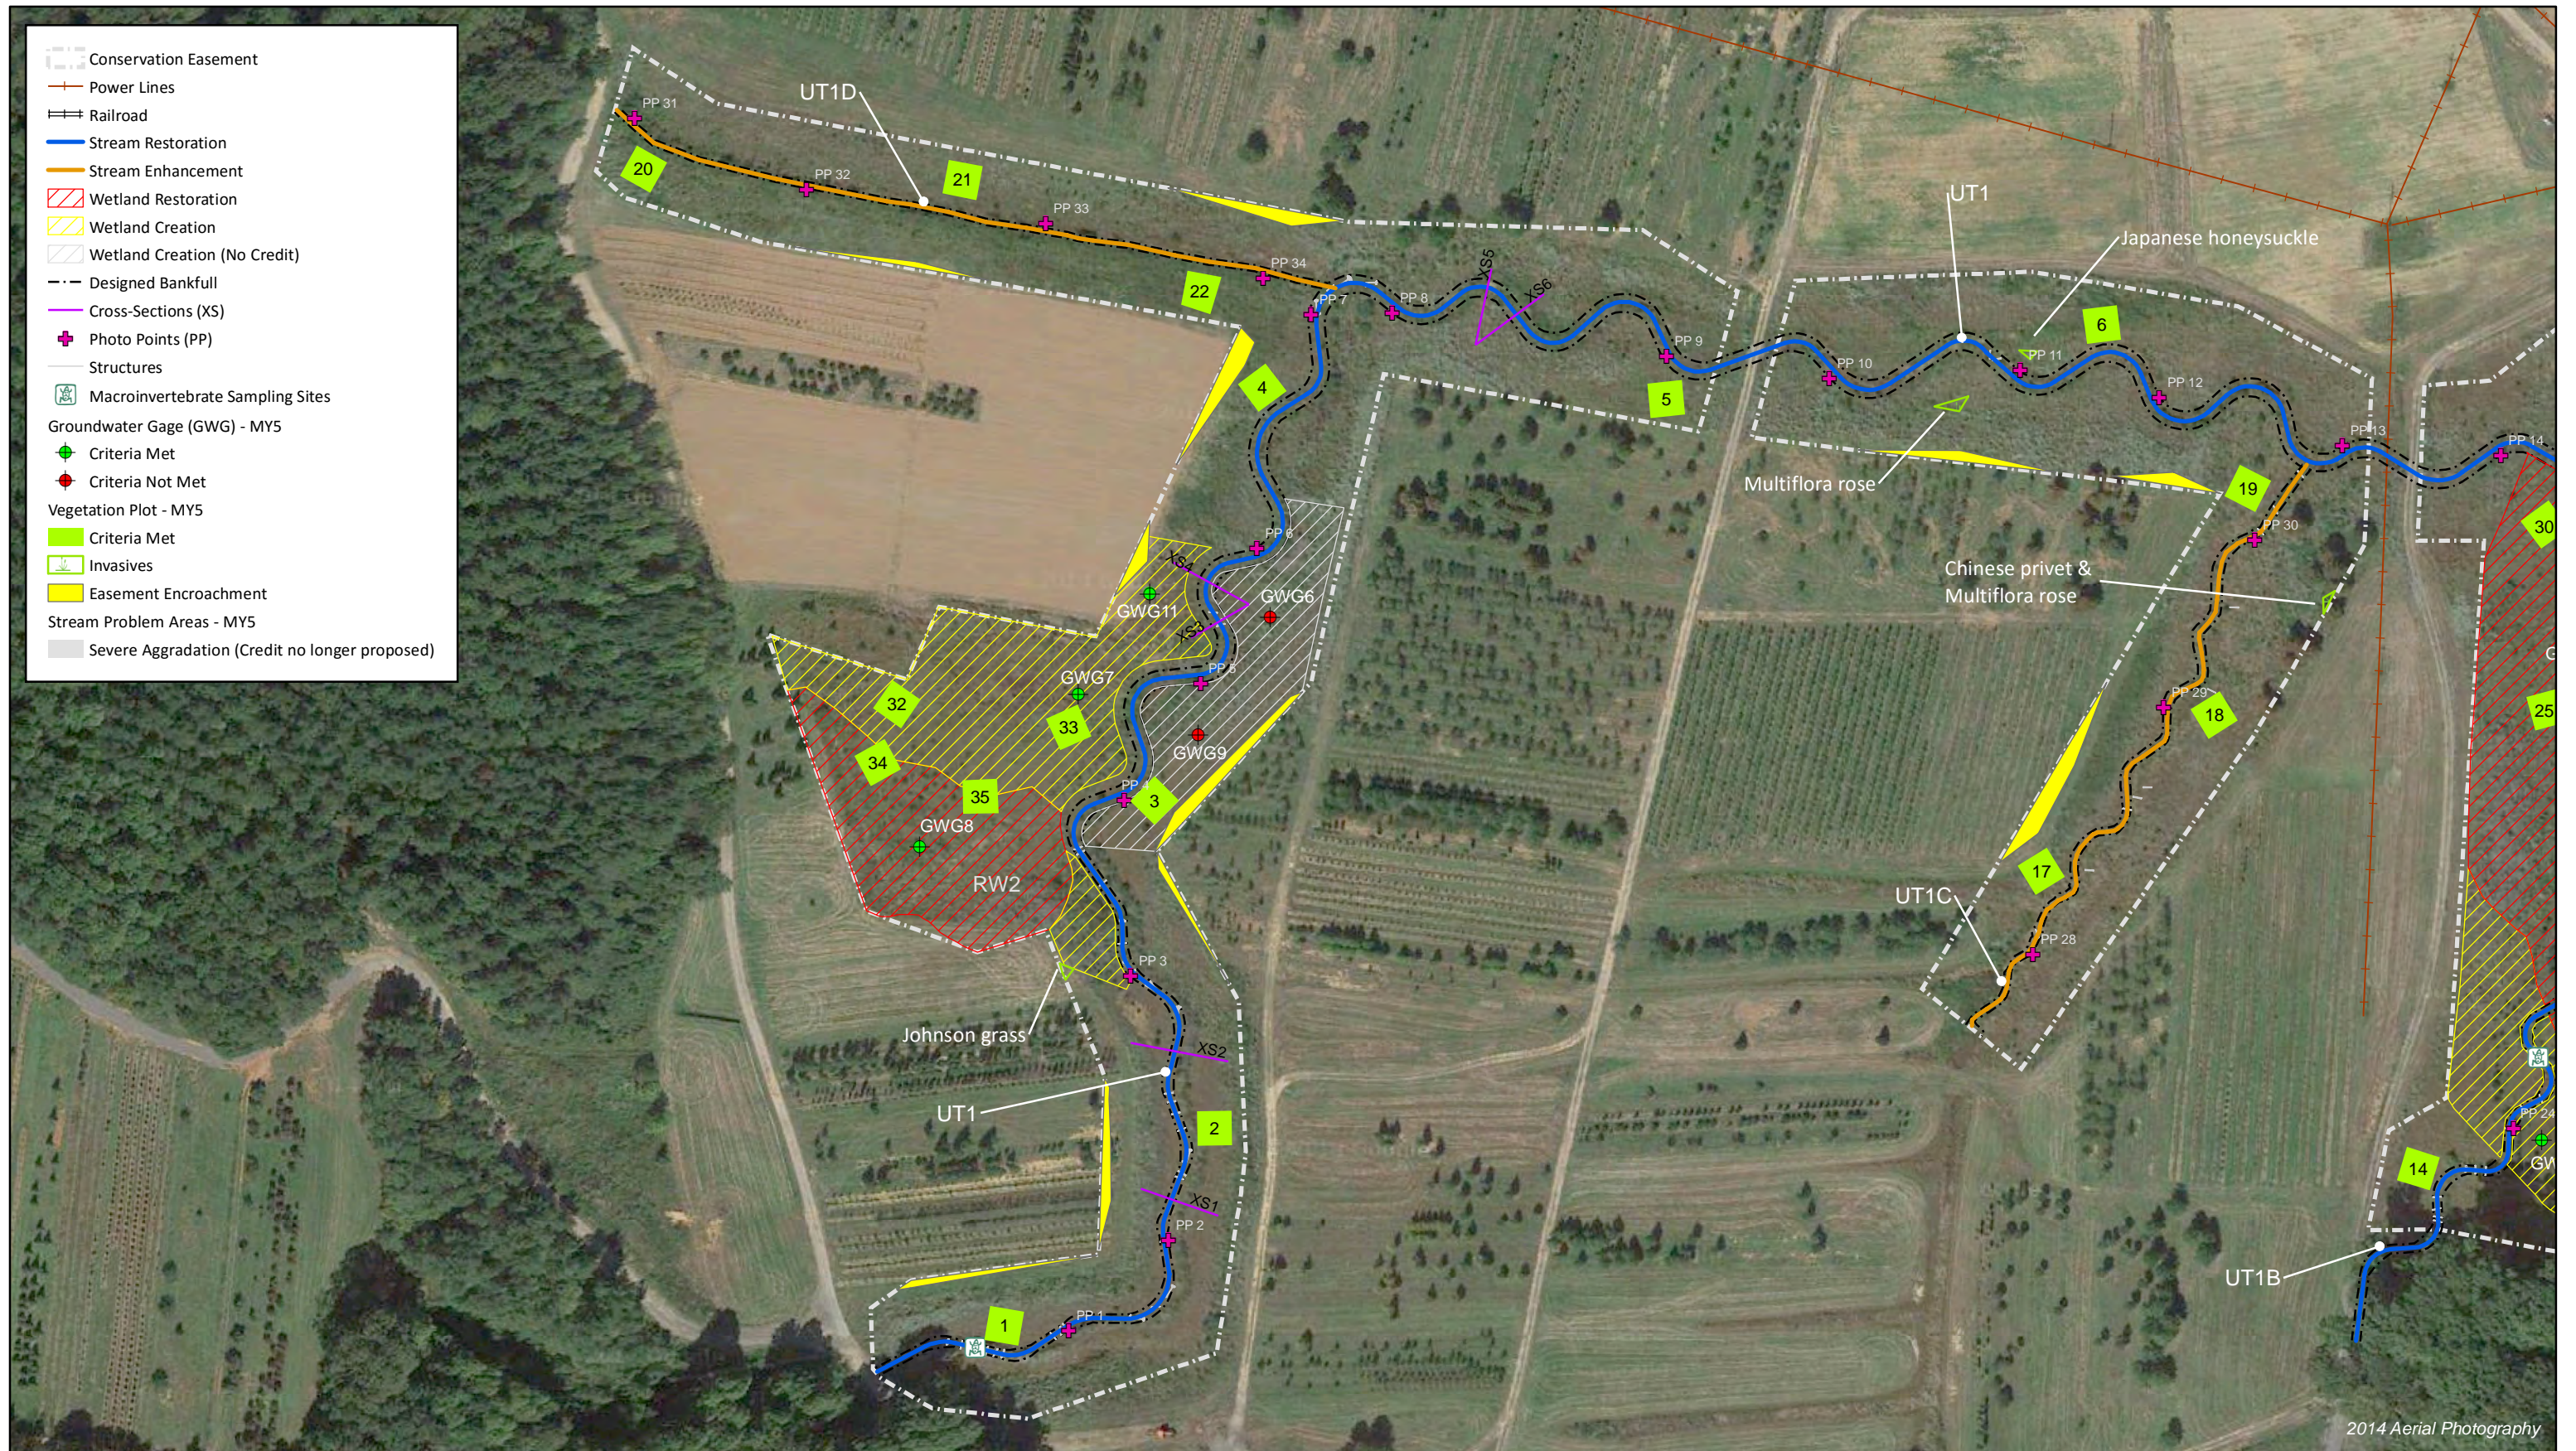
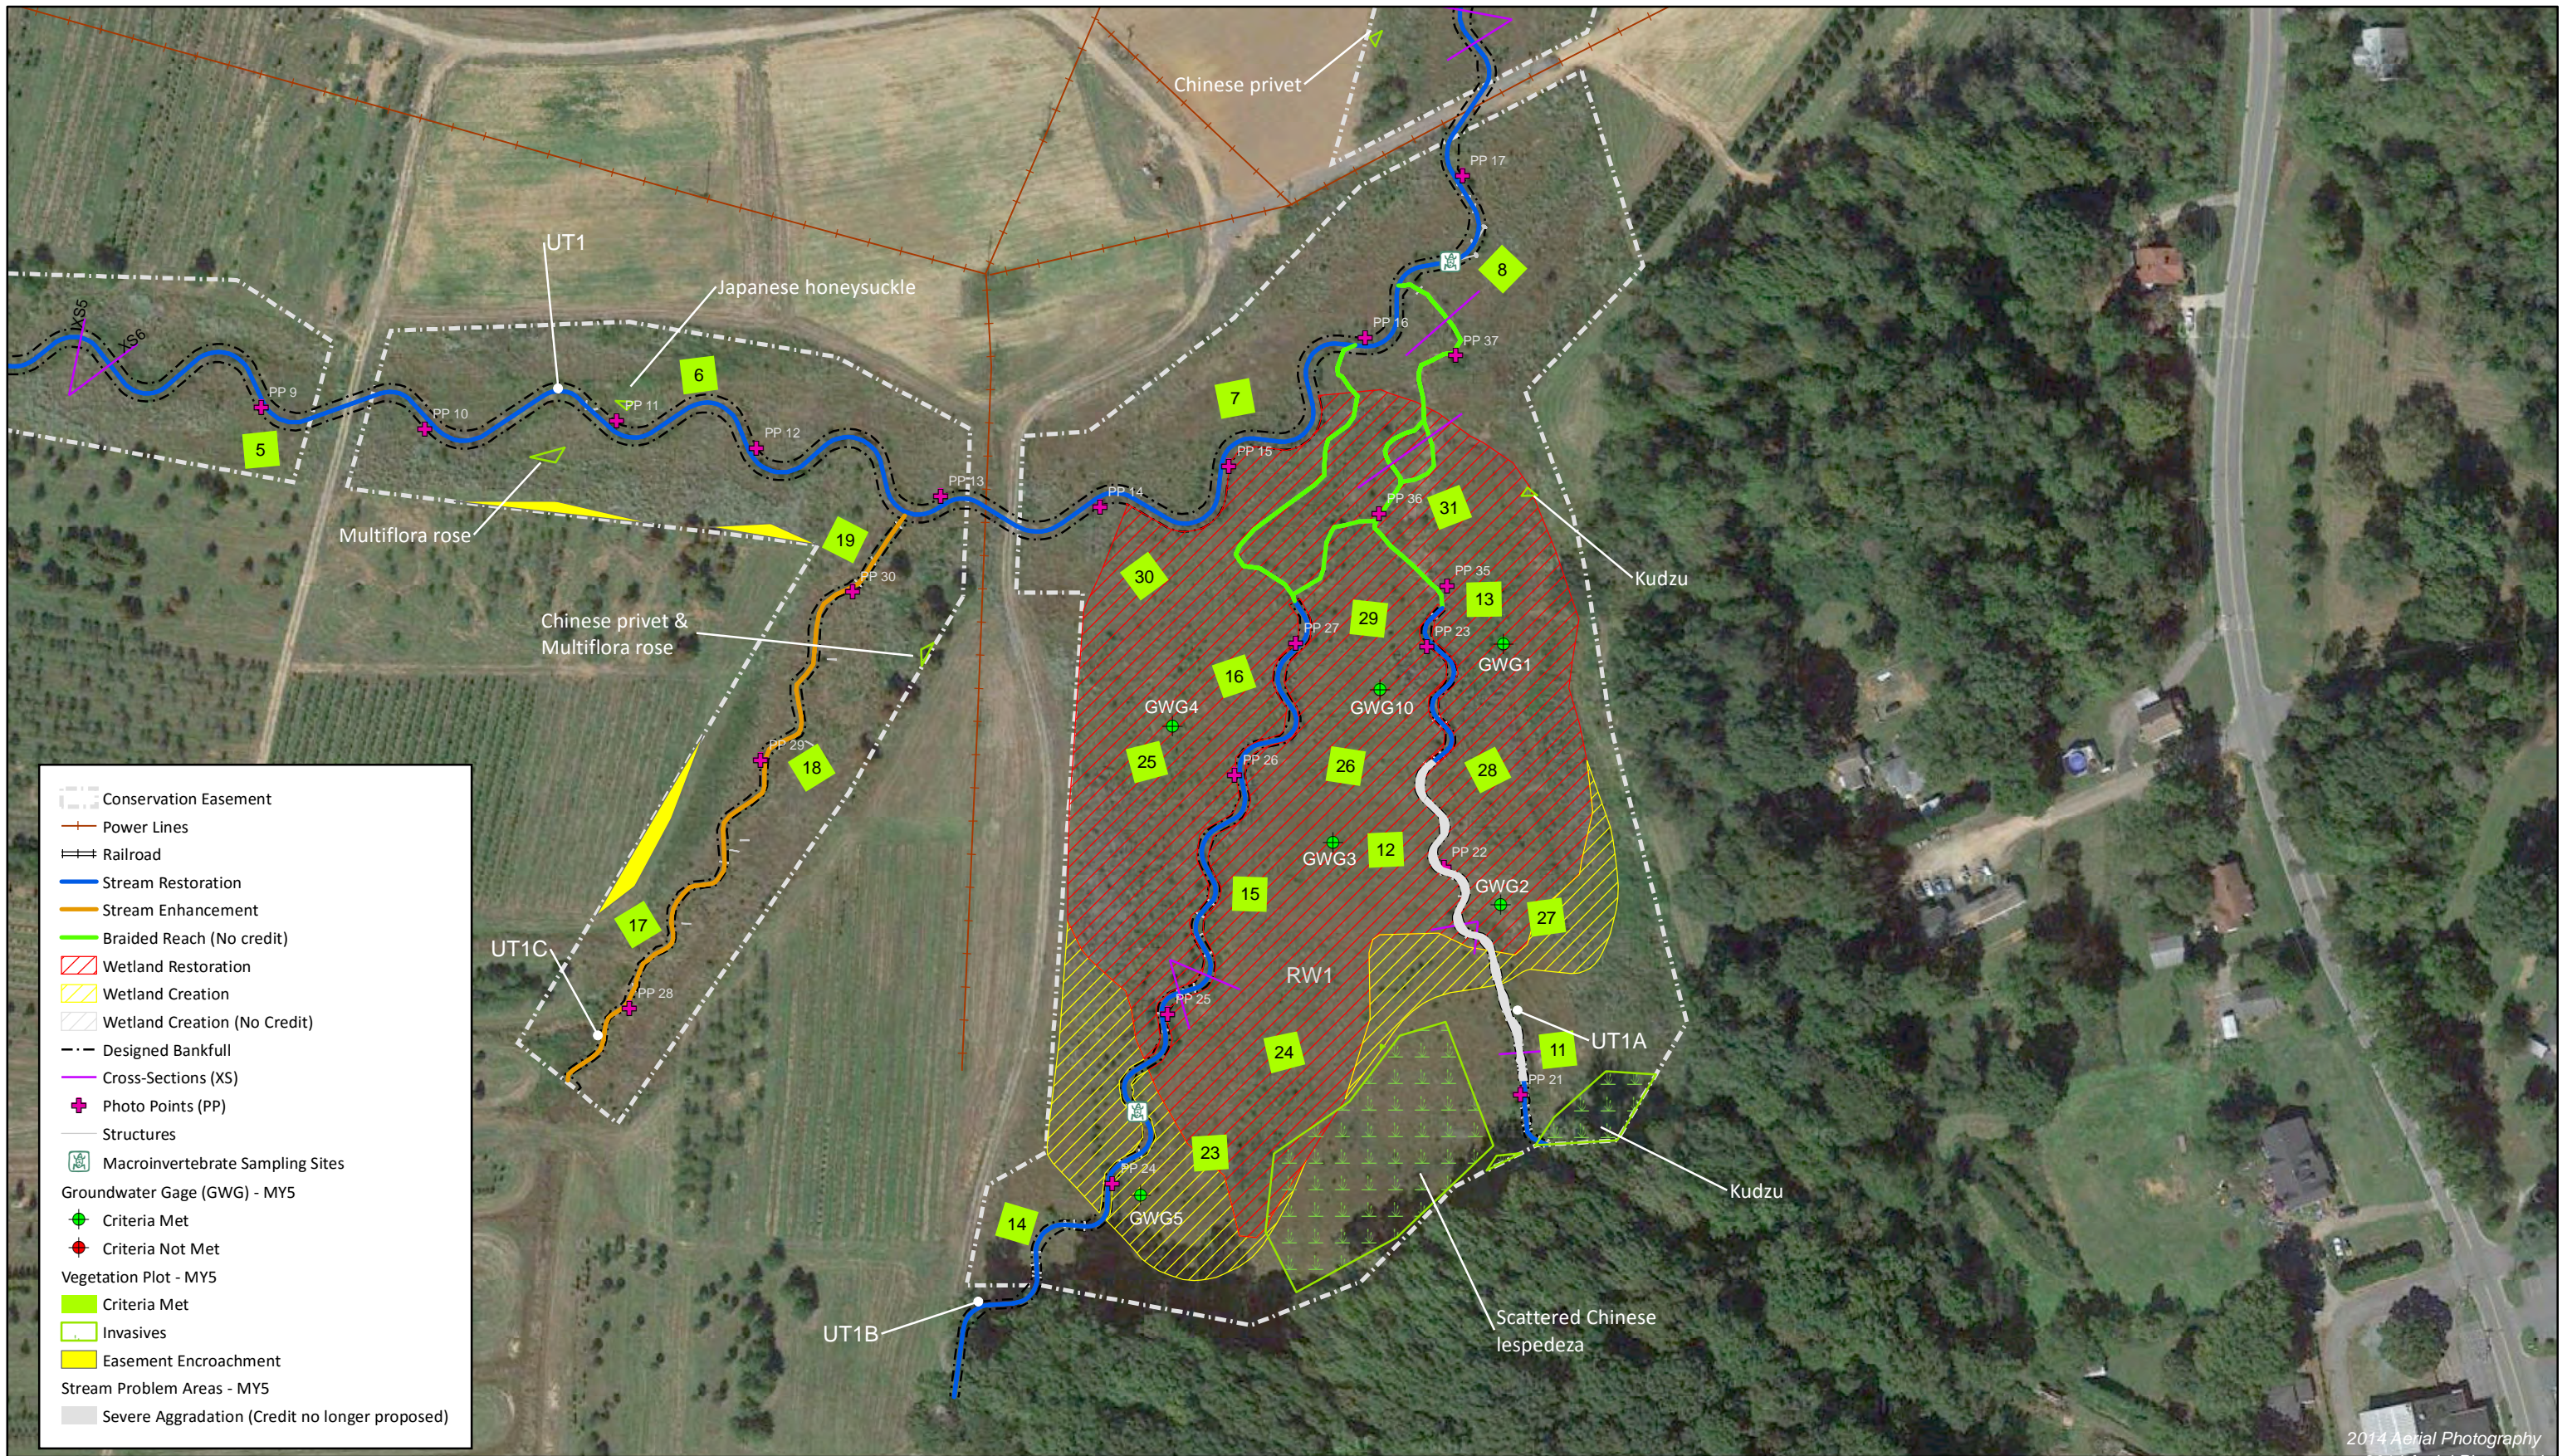
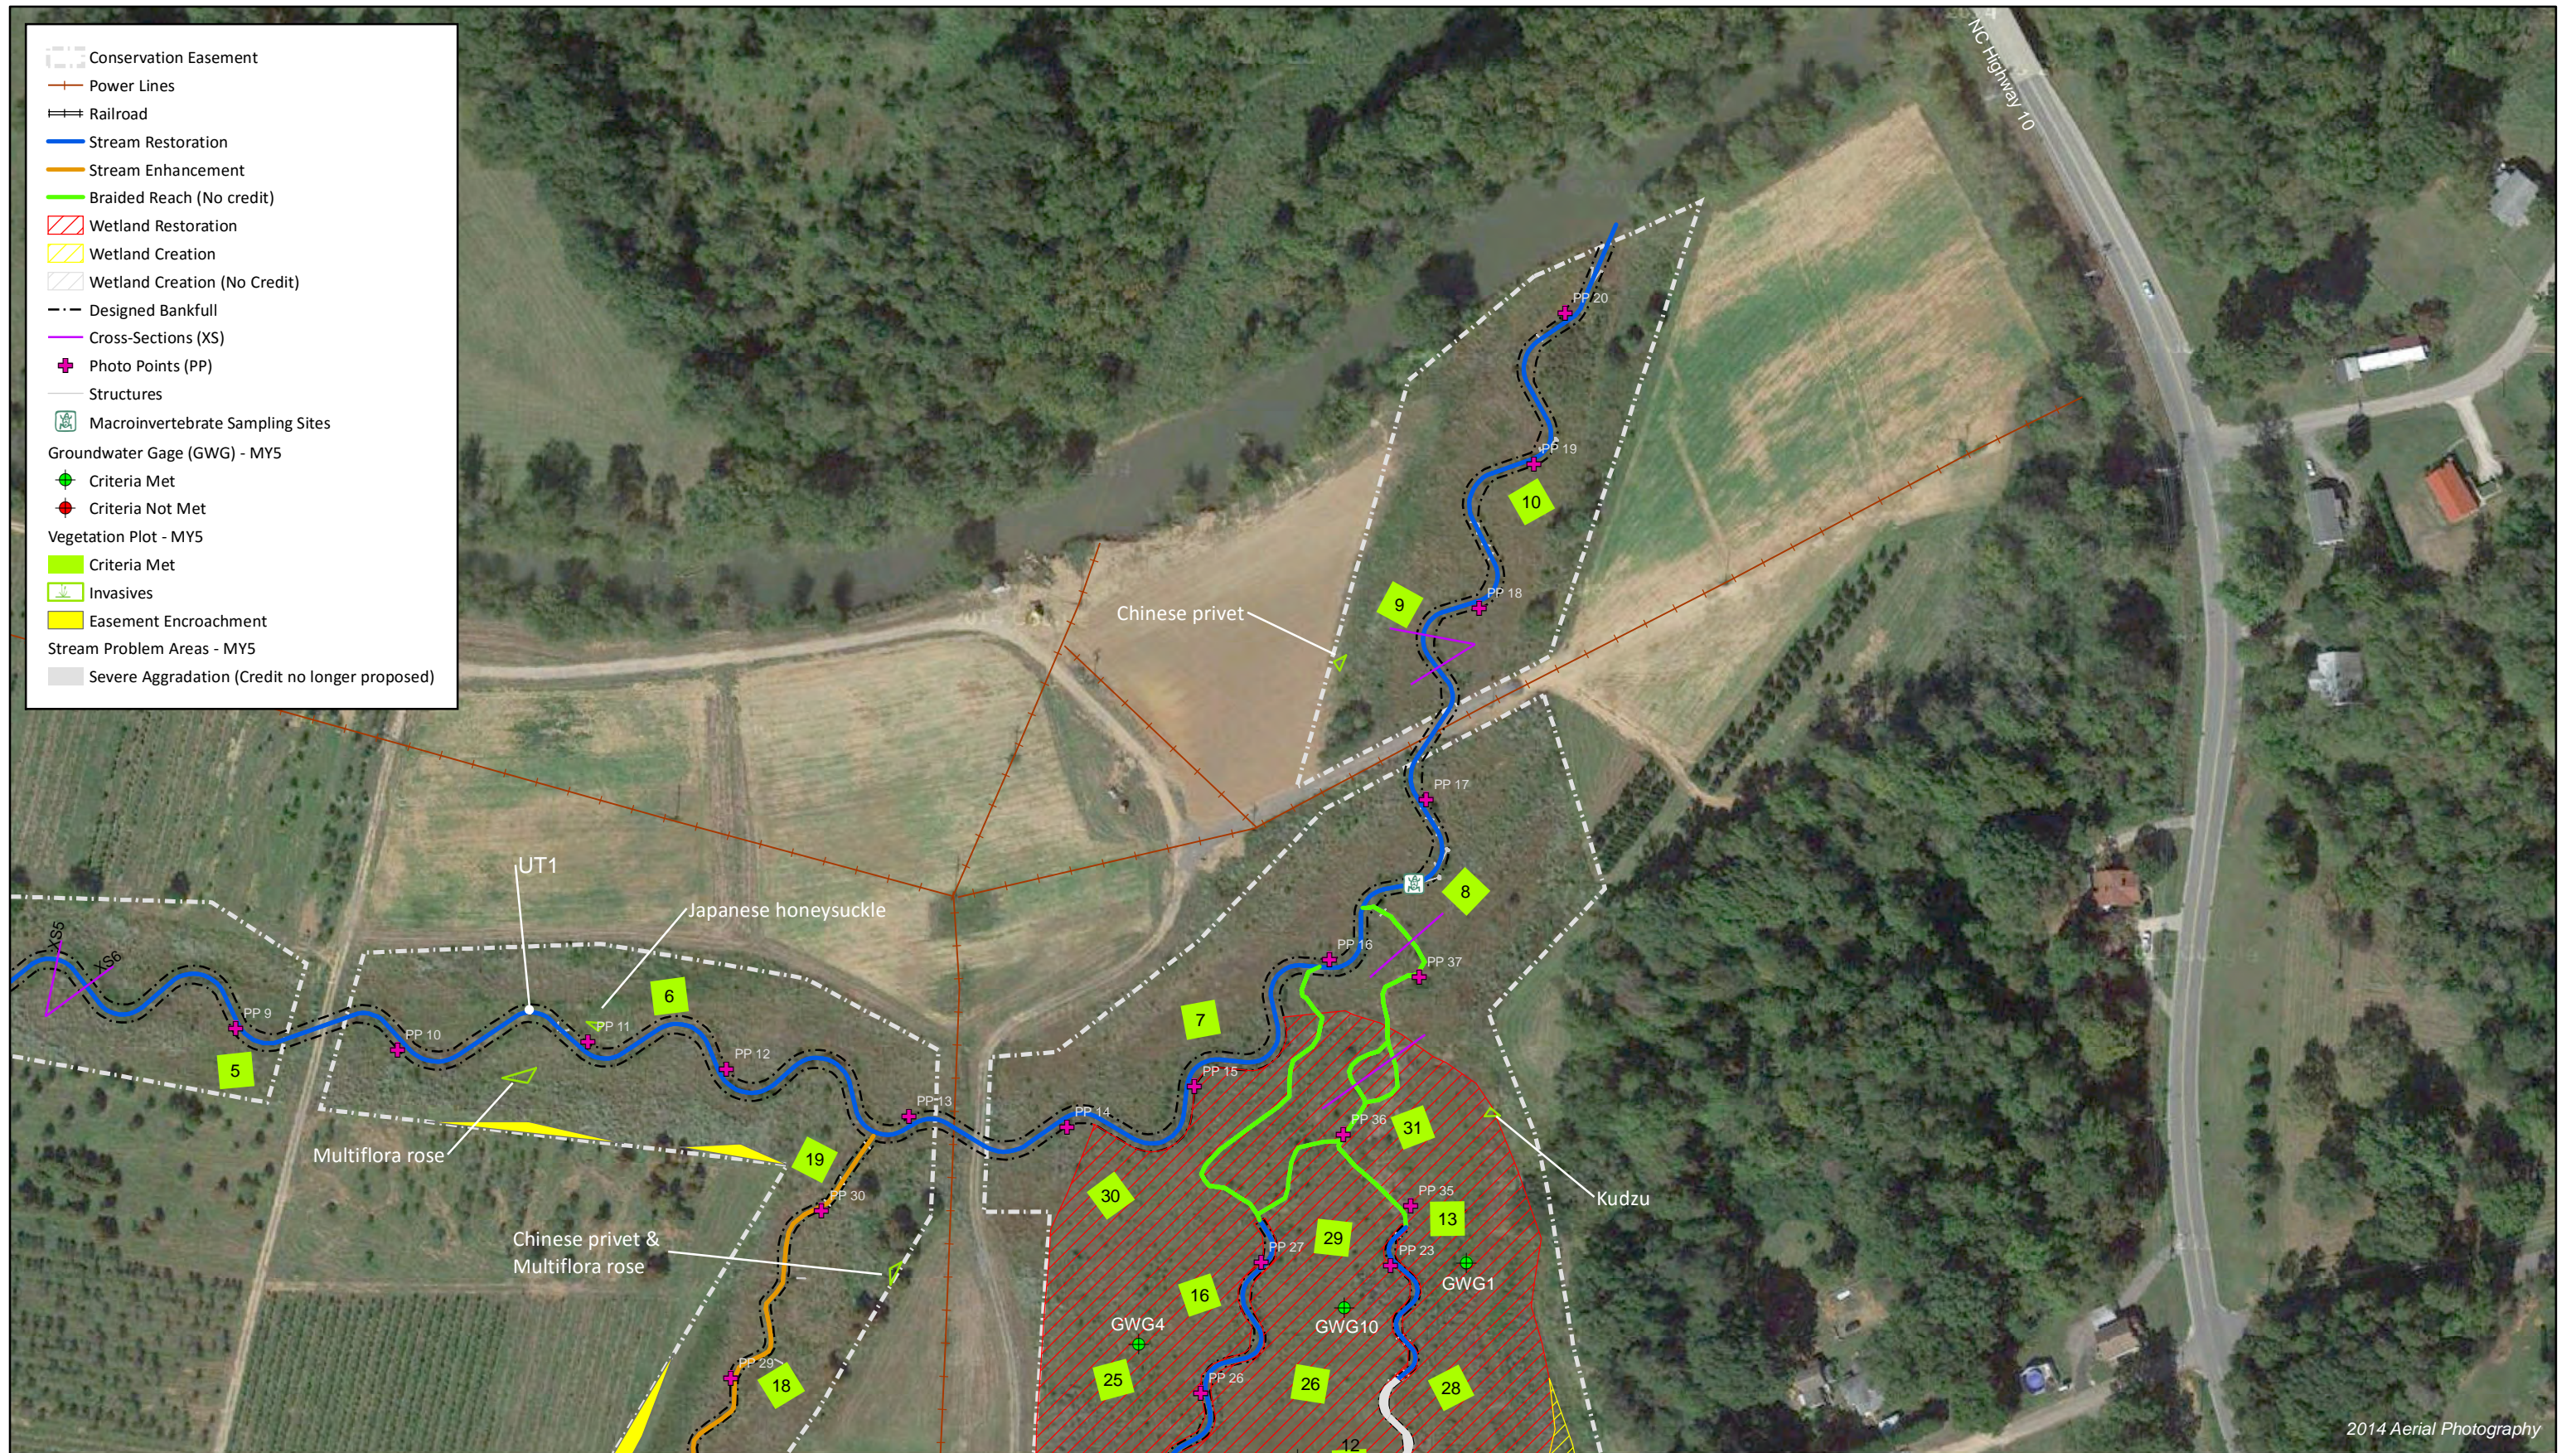
Figure 3.2 Integrated Current Condition Plan View (Sheet 2 of 3)  
 Lyle Creek Mitigation Site  
 DMS Project Number 94643  
 Monitoring Year 5

Morphological surveys for MY5 were conducted between May and September 2016. The majority of the streams within the site have met the success criteria for MY5. Aggradation was documented on the upper portions of UT1, UT1A, and UT1B as a result of their contributing upstream watersheds. The aggradation at the top of UT1 (Stations 100+17 and 100+95) is contained within the active channel and resulted in a slight rise in channel bed elevation through this section. The minor amount of sediment was first observed in MY4 and currently is not impacting the channel's overall stability and function. Aggradation in UT1A was initially documented during MY3 between Stations 301+75 to 304+34 and continued through MY4 when sediment filled the channel between Stations 300+36 to 304+34. During MY5 sediment filled UT1A from Station 300+36 to 304+30. This portion of UT1A has served as a reservoir for off-site sediment which has completely filled in this portion of channel. UT1B experienced minor aggradation between Stations 201+52 and 204+30 to a lesser degree than UT1A. This aggradation is not impacting the overall stability of UT1B as the channel has remained a single thread system with some decrease in pool length and depth. Over time UT1 and UT1B should naturally transport this sediment. Refer to Appendix 2 for the visual assessment table, Integrated Current Condition Plan View (CCPV), photographs, and Appendix 4 for morphological data and plots.

Streams within the site are stable and functioning as designed. Aggradation documented in UT1A persists. Wildlands has removed this 394 LF from the credit request. Lesser amounts of aggradation were observed on the upper portion of UT1 and UT1B however these channels are stable and functioning as single thread channels. It is anticipated that aggraded sediment in UT1 and UT1B will be evacuated from the system. The average stem density for the site has met the MY5 success criteria. There have been more than two bankfull events recorded in separate monitoring years along each restored project reach since construction commenced; therefore, the site has met the MY5 stream hydrology attainment requirement. A majority of groundwater gages (9 out of 11 gages) met the wetland hydrology success criteria for MY5. Wildlands has removed 0.6 acres of wetland creation located on the west side of UT1 in the area represented by GWG 6 and 9 from our credit request.
