**BASELINE MONITORING
DOCUMENT AND AS-BUILT
BASELINE REPORT**
Final

LYON HILLS MITIGATION SITE

Wilkes County, NC
NCDEQ Contract No. 7620
DMS Project Number 100085
USACE Action ID Number SAW-2018-01784
NCDWR Project Number 2018-1274 v1

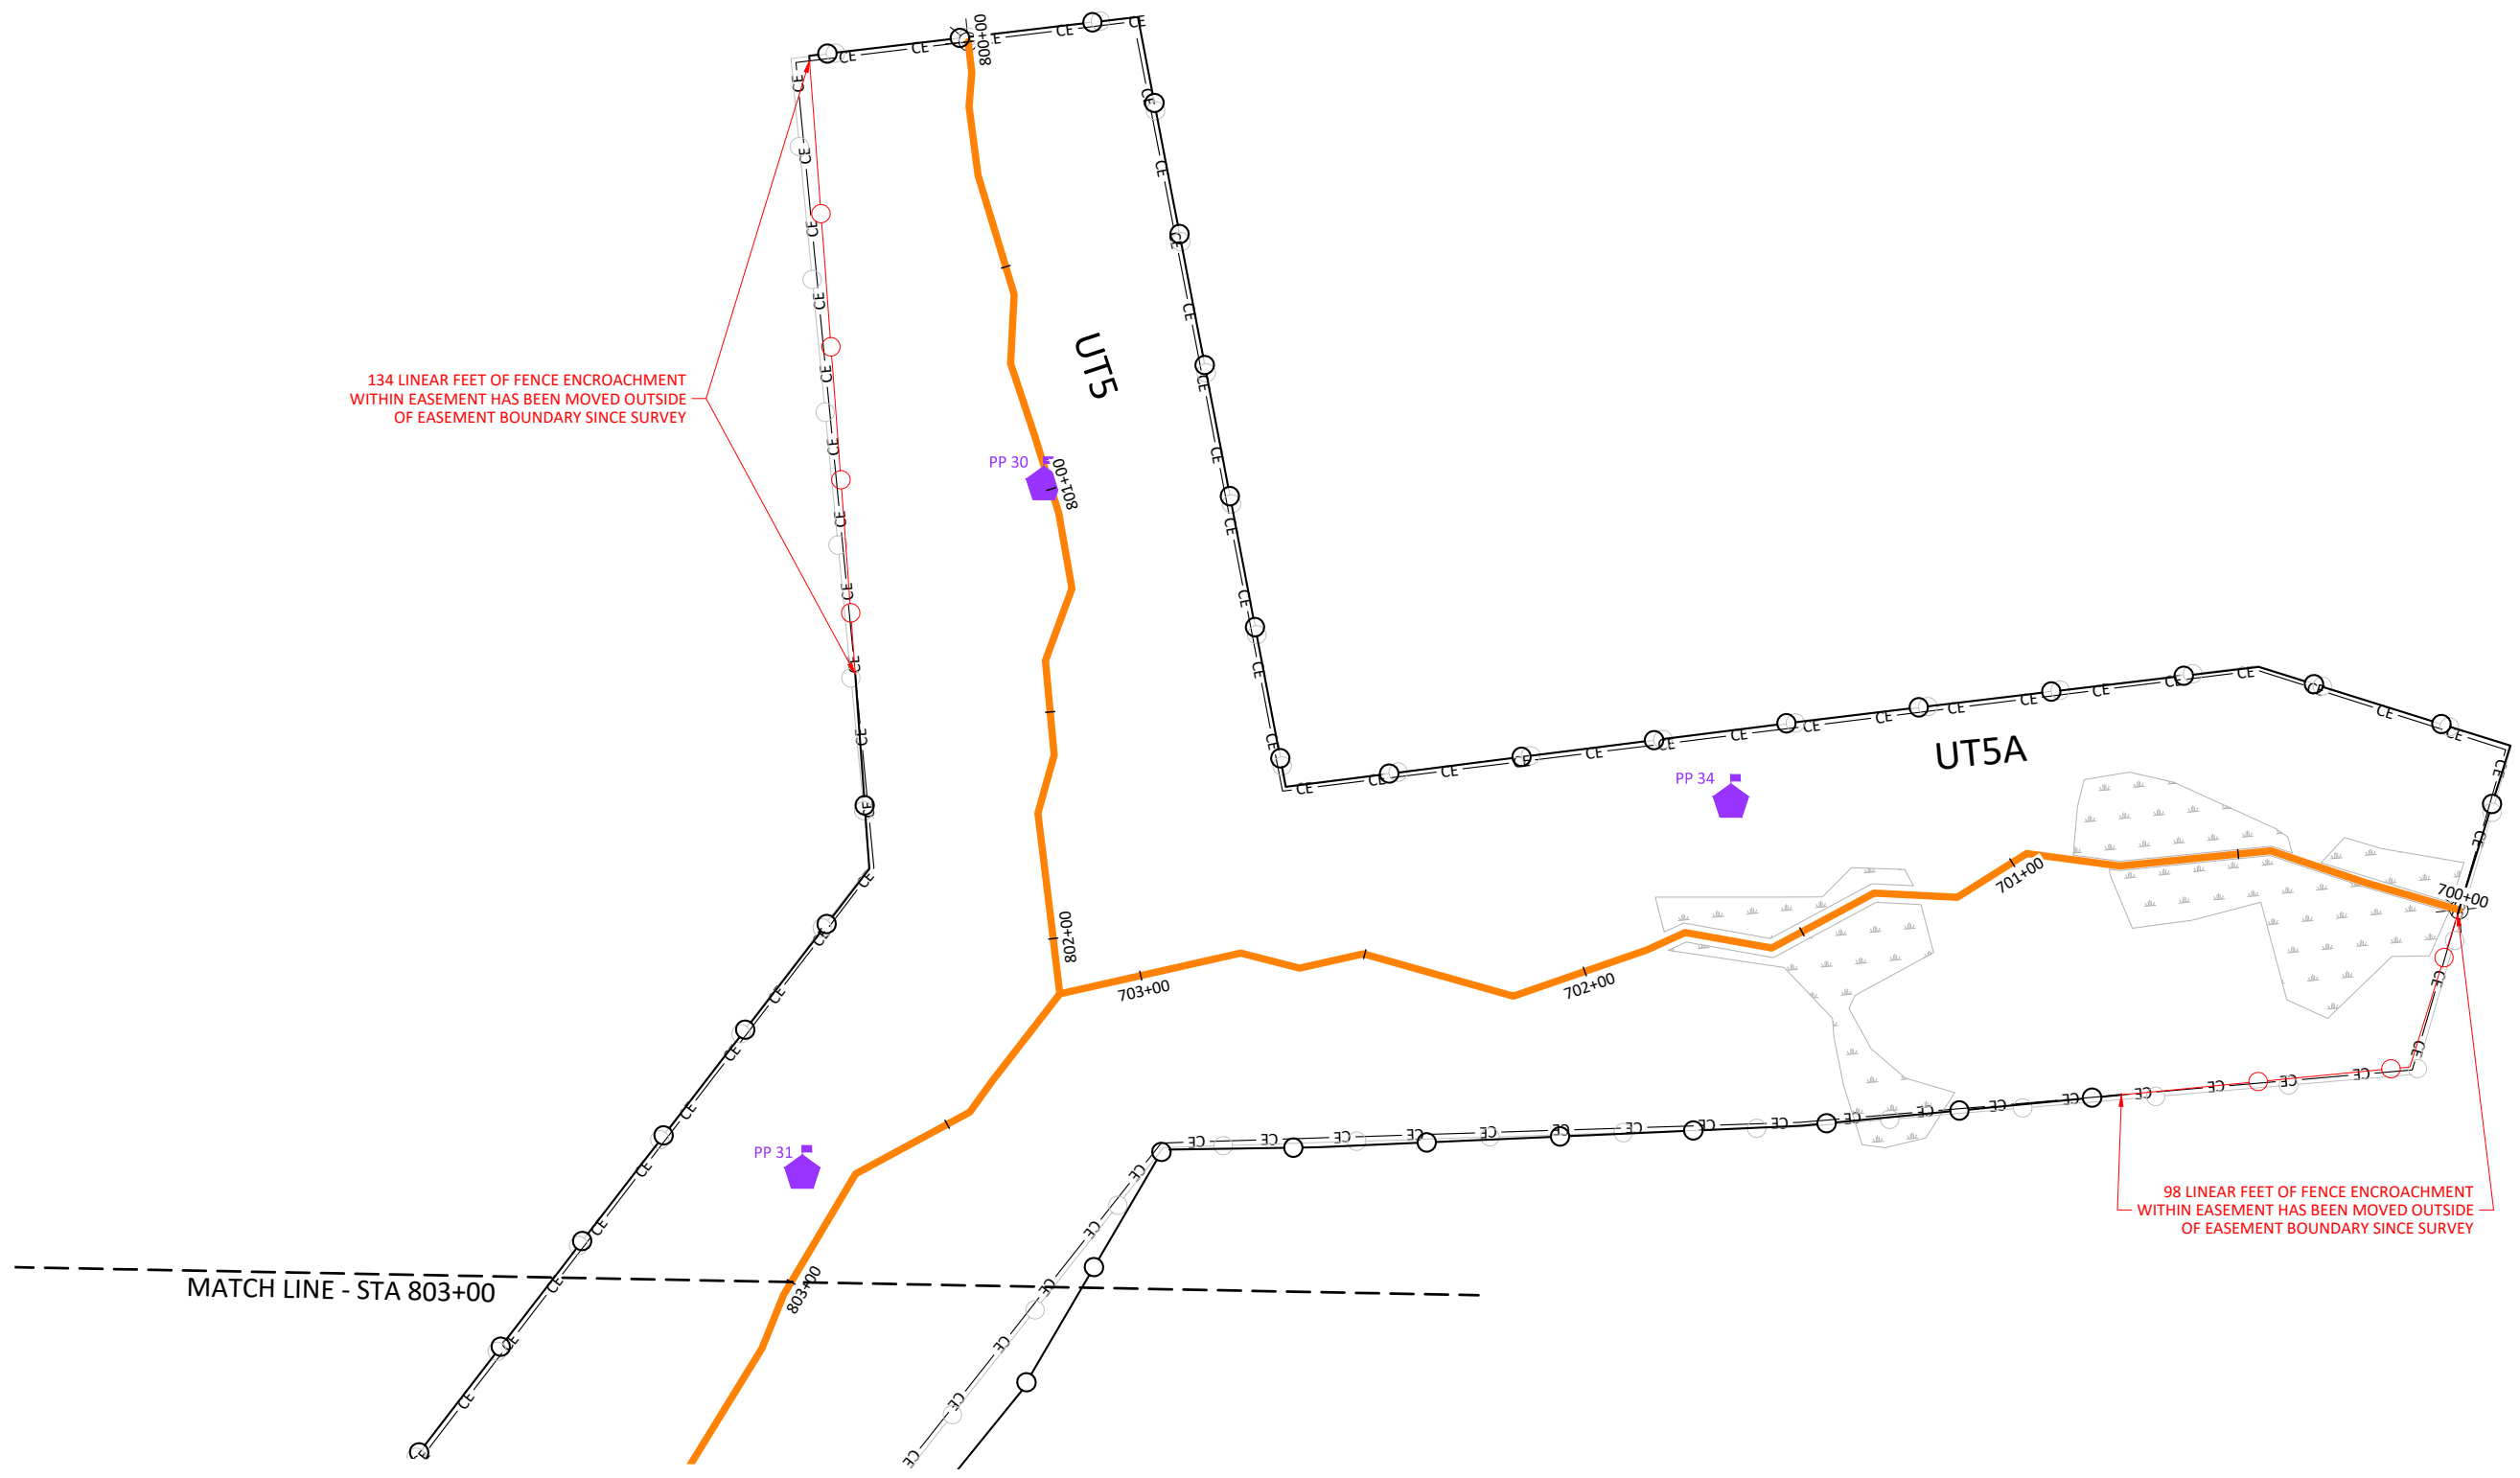
134 LINEAR FEET OF FENCE ENCROACHMENT WITHIN EASEMENT HAS BEEN MOVED OUTSIDE OF EASEMENT BOUNDARY SINCE SURVEY

98 LINEAR FEET OF FENCE ENCROACHMENT WITHIN EASEMENT HAS BEEN MOVED OUTSIDE OF EASEMENT BOUNDARY SINCE SURVEY
