**MONITORING YEAR 2
ANNUAL REPORT**
Final

January 2023

LYON HILLS MITIGATION SITE

Wilkes County, NC
Yadkin River Basin
HUC 03040101

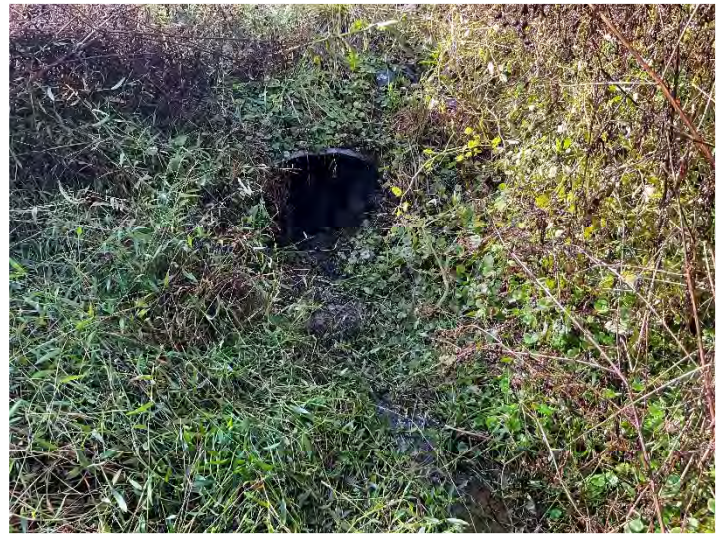
UT5 R2 - Looking Downstream (10/17/2022)

During MY2 in-stream vegetation was only observed sporadically along UT5 Reach 2 (Figure 1c). This area of in-stream vegetation should continue to become less problematic as trees continue to grow and ultimately shade the stream and suppress the in-stream vegetation. After a chemical and manual in-stream vegetation treatment in August 2022, most of the accumulated sediment flushed through UT5. Wildlands will continue to monitor in-stream vegetation growth and will continue to treat it as necessary.

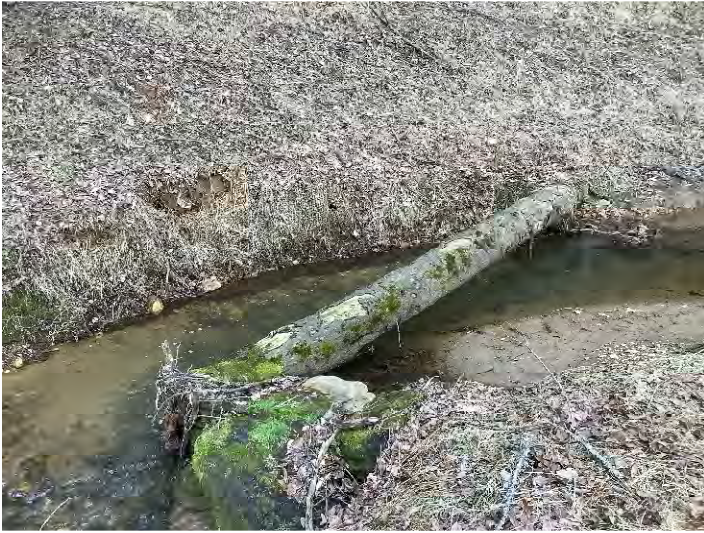
Hanks Branch R2 – J-Hook Before (3/25/2022)

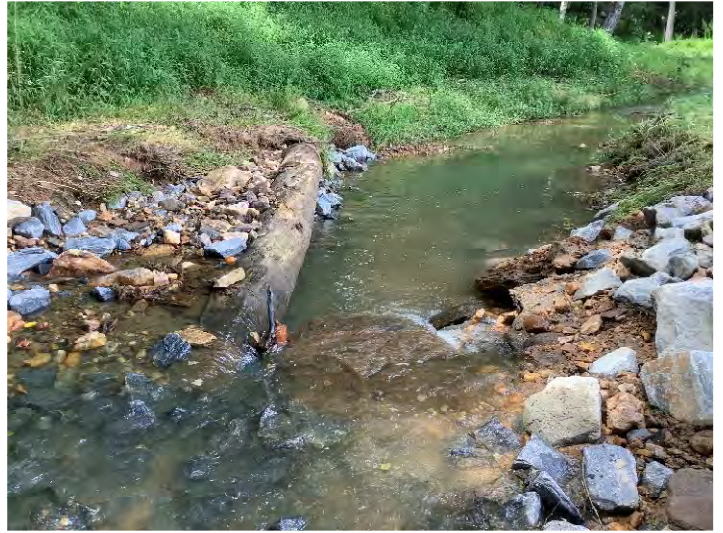
Hanks Branch R2 – Repaired J-Hook (8/17/2022)

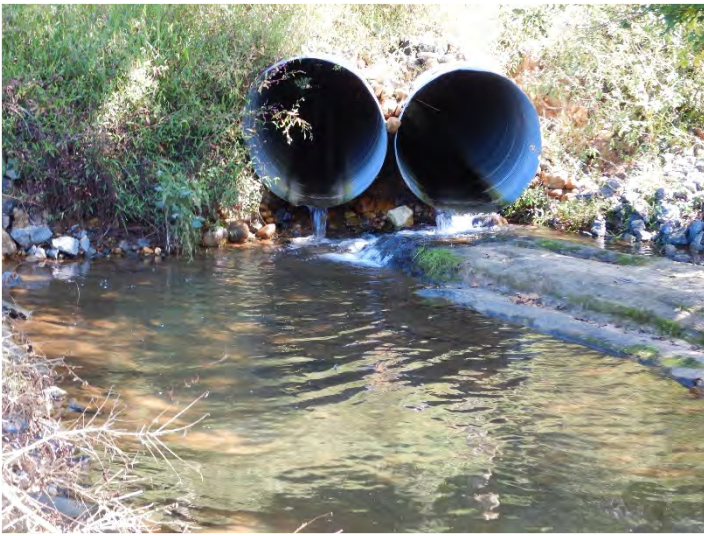
There are no culvert crossing issues noted for MY2. The perched culvert on Hanks Branch Reach 3 that was noted in MY1 was repaired in August 2022. This culvert was repaired mechanically by building a series of boulder sills downstream in order to back water into the outlet of the culvert allowing for aquatic passage to occur. Wildlands will continue to monitor all six culverts on Site annually to assess their continued stability. While equipment was on Site, an unstable J-Hook at approximately STA 219+80 along Hanks Branch Reach 2, was mechanically repaired. This J-Hook is currently stable and functioning as intended. Refer to Appendix F for Repair Photographs and CCPV Figure 1b.

Hanks Branch R3 – Perched Culvert Outlet (9/27/2021)

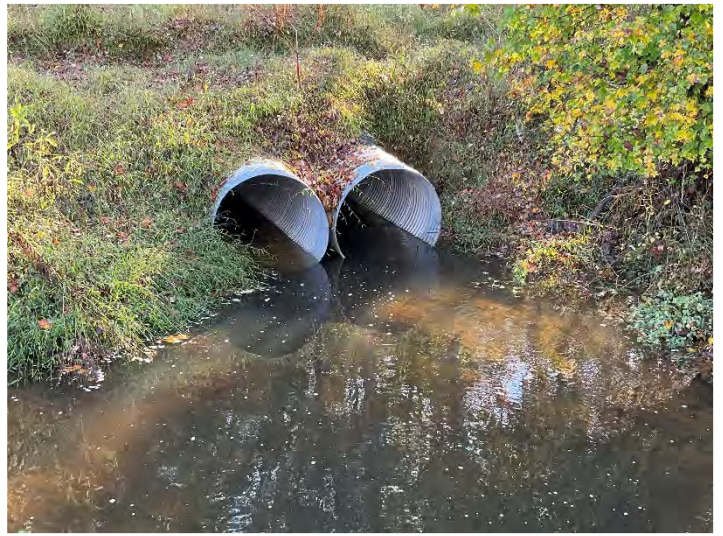
Hanks Branch R3 – Repaired Culvert Outlet (10/17/2022)
