MONITORING YEAR 3 ANNUAL REPORT FINAL

LYON HILLS MITIGATION SITE

Wilkes County, NC
Yadkin River Basin
HUC 03040101

DMS Project No. 100085
NCDEQ Contract No. 7620
USACE Action ID No. SAW-2018-01784
DWR Project No. 2018-1274 v1
Data Collection Dates: January-November 2023

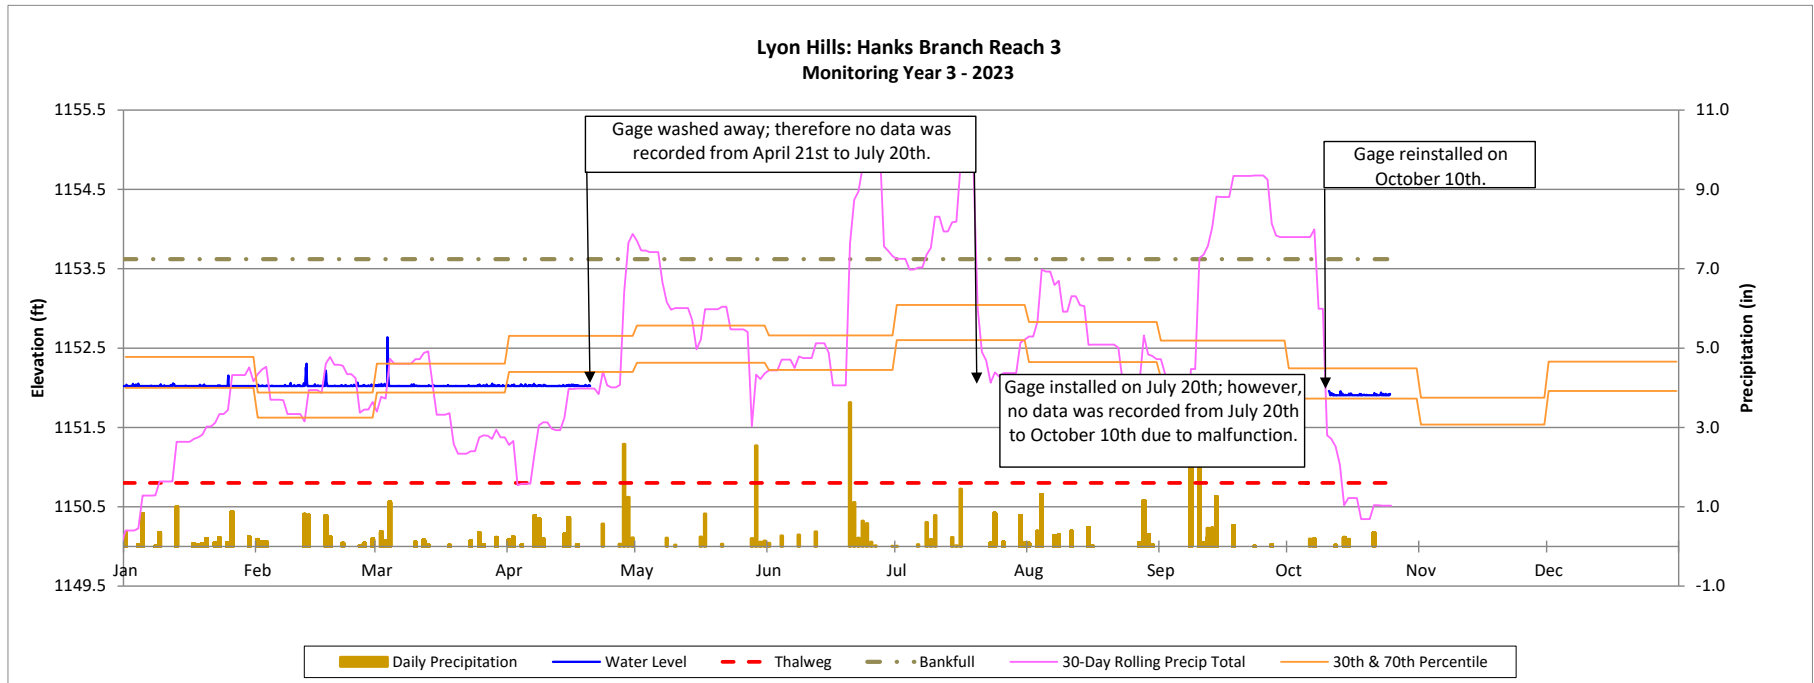
Recorded Bankfull Events Plot

**Crest gage 1 (CG1) on Hanks Branch Reach 3 was washed away after multiple large storm events. Though a bankfull event was not recorded by an automated pressure transducer in MY3, bankfull indicators, such as wrack lines were observed and documented in June and October 2023.

Multiple large storm events caused crest gage 1 (CG1) to be washed away. The replacement crest gage was installed on July 20th; however, no data was recorded from July 20th through October 10th due to malfunction. CG1 was reinstalled on October 10th and is functioning as intended.

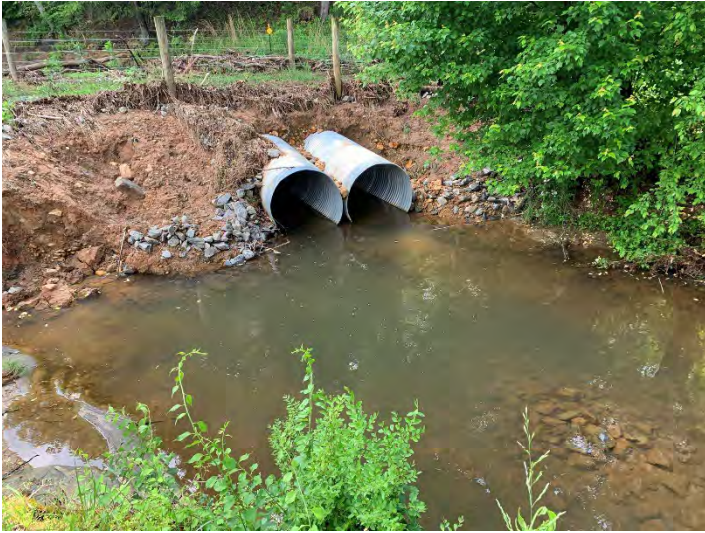
Wildlands' Response: In the summer of 2023, debris from several large storm events blocked the culvert inlet. The blocked inlet caused water to flow over the crossing during a large storm event and erode the rip-rap reinforcement on the downstream side of the culvert. To repair the culvert revetment, Wildlands conducted some light grading and redressed the headwall with Class-1 and Class-2 stone size rip-rap. The report text has been modified to include the additional repair and material details. Wildlands will continue to monitor all internal crossings for signs of blockage and instability.

Continuous storm events, occurring between June and July 2023 and resulting in a culmination of 12.54 inches of precipitation, resulted in the loss of most of the rip-rap protection on the downstream side of the culvert crossing on Hanks Branch Reach 3. To keep the crossing stable and minimize any additional erosion around the culvert, Wildlands conducted some light grading and redressed the headwall with Class-1 and Class-2 stone size rip-rap in August 2023. Wildlands will continue to monitor all the culverts within the project area, for continued stability. Refer to Appendix F for Repair Photos, and CCPV Figures b and 1c for the location of the repair.

Hanks Branch R3 – Culvert Outlet (6/21/2023)

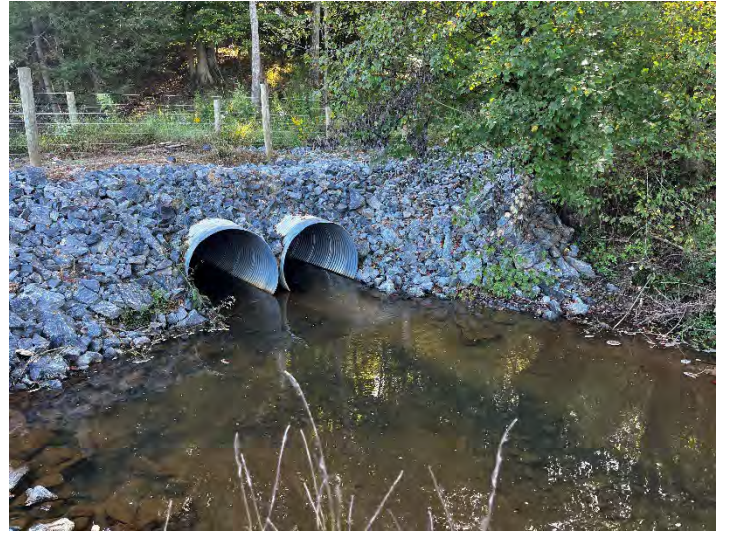
Hanks Branch R3 – Repaired Culvert Outlet (10/17/2023)
