FINAL
AS-BUILT BASELINE
MONITORING REPORT (MY0)

MAJOR HILL STREAM AND WETLAND MITIGATION SITE
Alamance County, North Carolina

DMS Project ID No. 100015
Full Delivery Contract No. 7193
USACE Action ID No. SAW-2017-01472
DWR No. 17-0921
RFP No. 16-006990

Data Collection: September 2018 – January 2019
Submission: March 2019

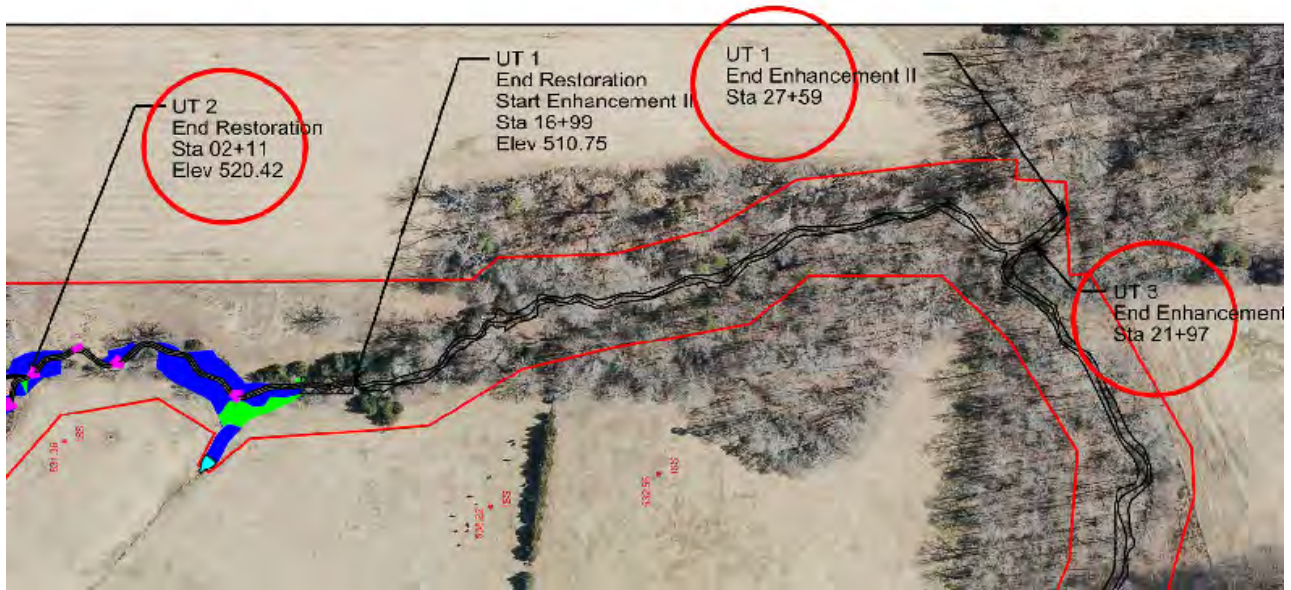
Detailed Plan – Figure 6 (Restoration Plan) Stationing

Based on information provided above we request a credit alteration at the Site. The credit alteration results from stationing discrepancies from the Detailed Restoration Plan and Construction Plans. The alteration is in the amount of 52 SMUs and represents what was constructed/enhanced at the Site.
