MONITORING REPORT
2019 (Year 1)

MAJOR HILL STREAM AND WETLAND MITIGATION SITE
Alamance County, North Carolina

DMS Project ID No. 100015
Full Delivery Contract No. 7193
USACE Action ID No. SAW-2017-01472
DWR No. 17-0921
RFP No. 16-006990

Data Collection: January 2019 – November 2019
Submission: January 2020

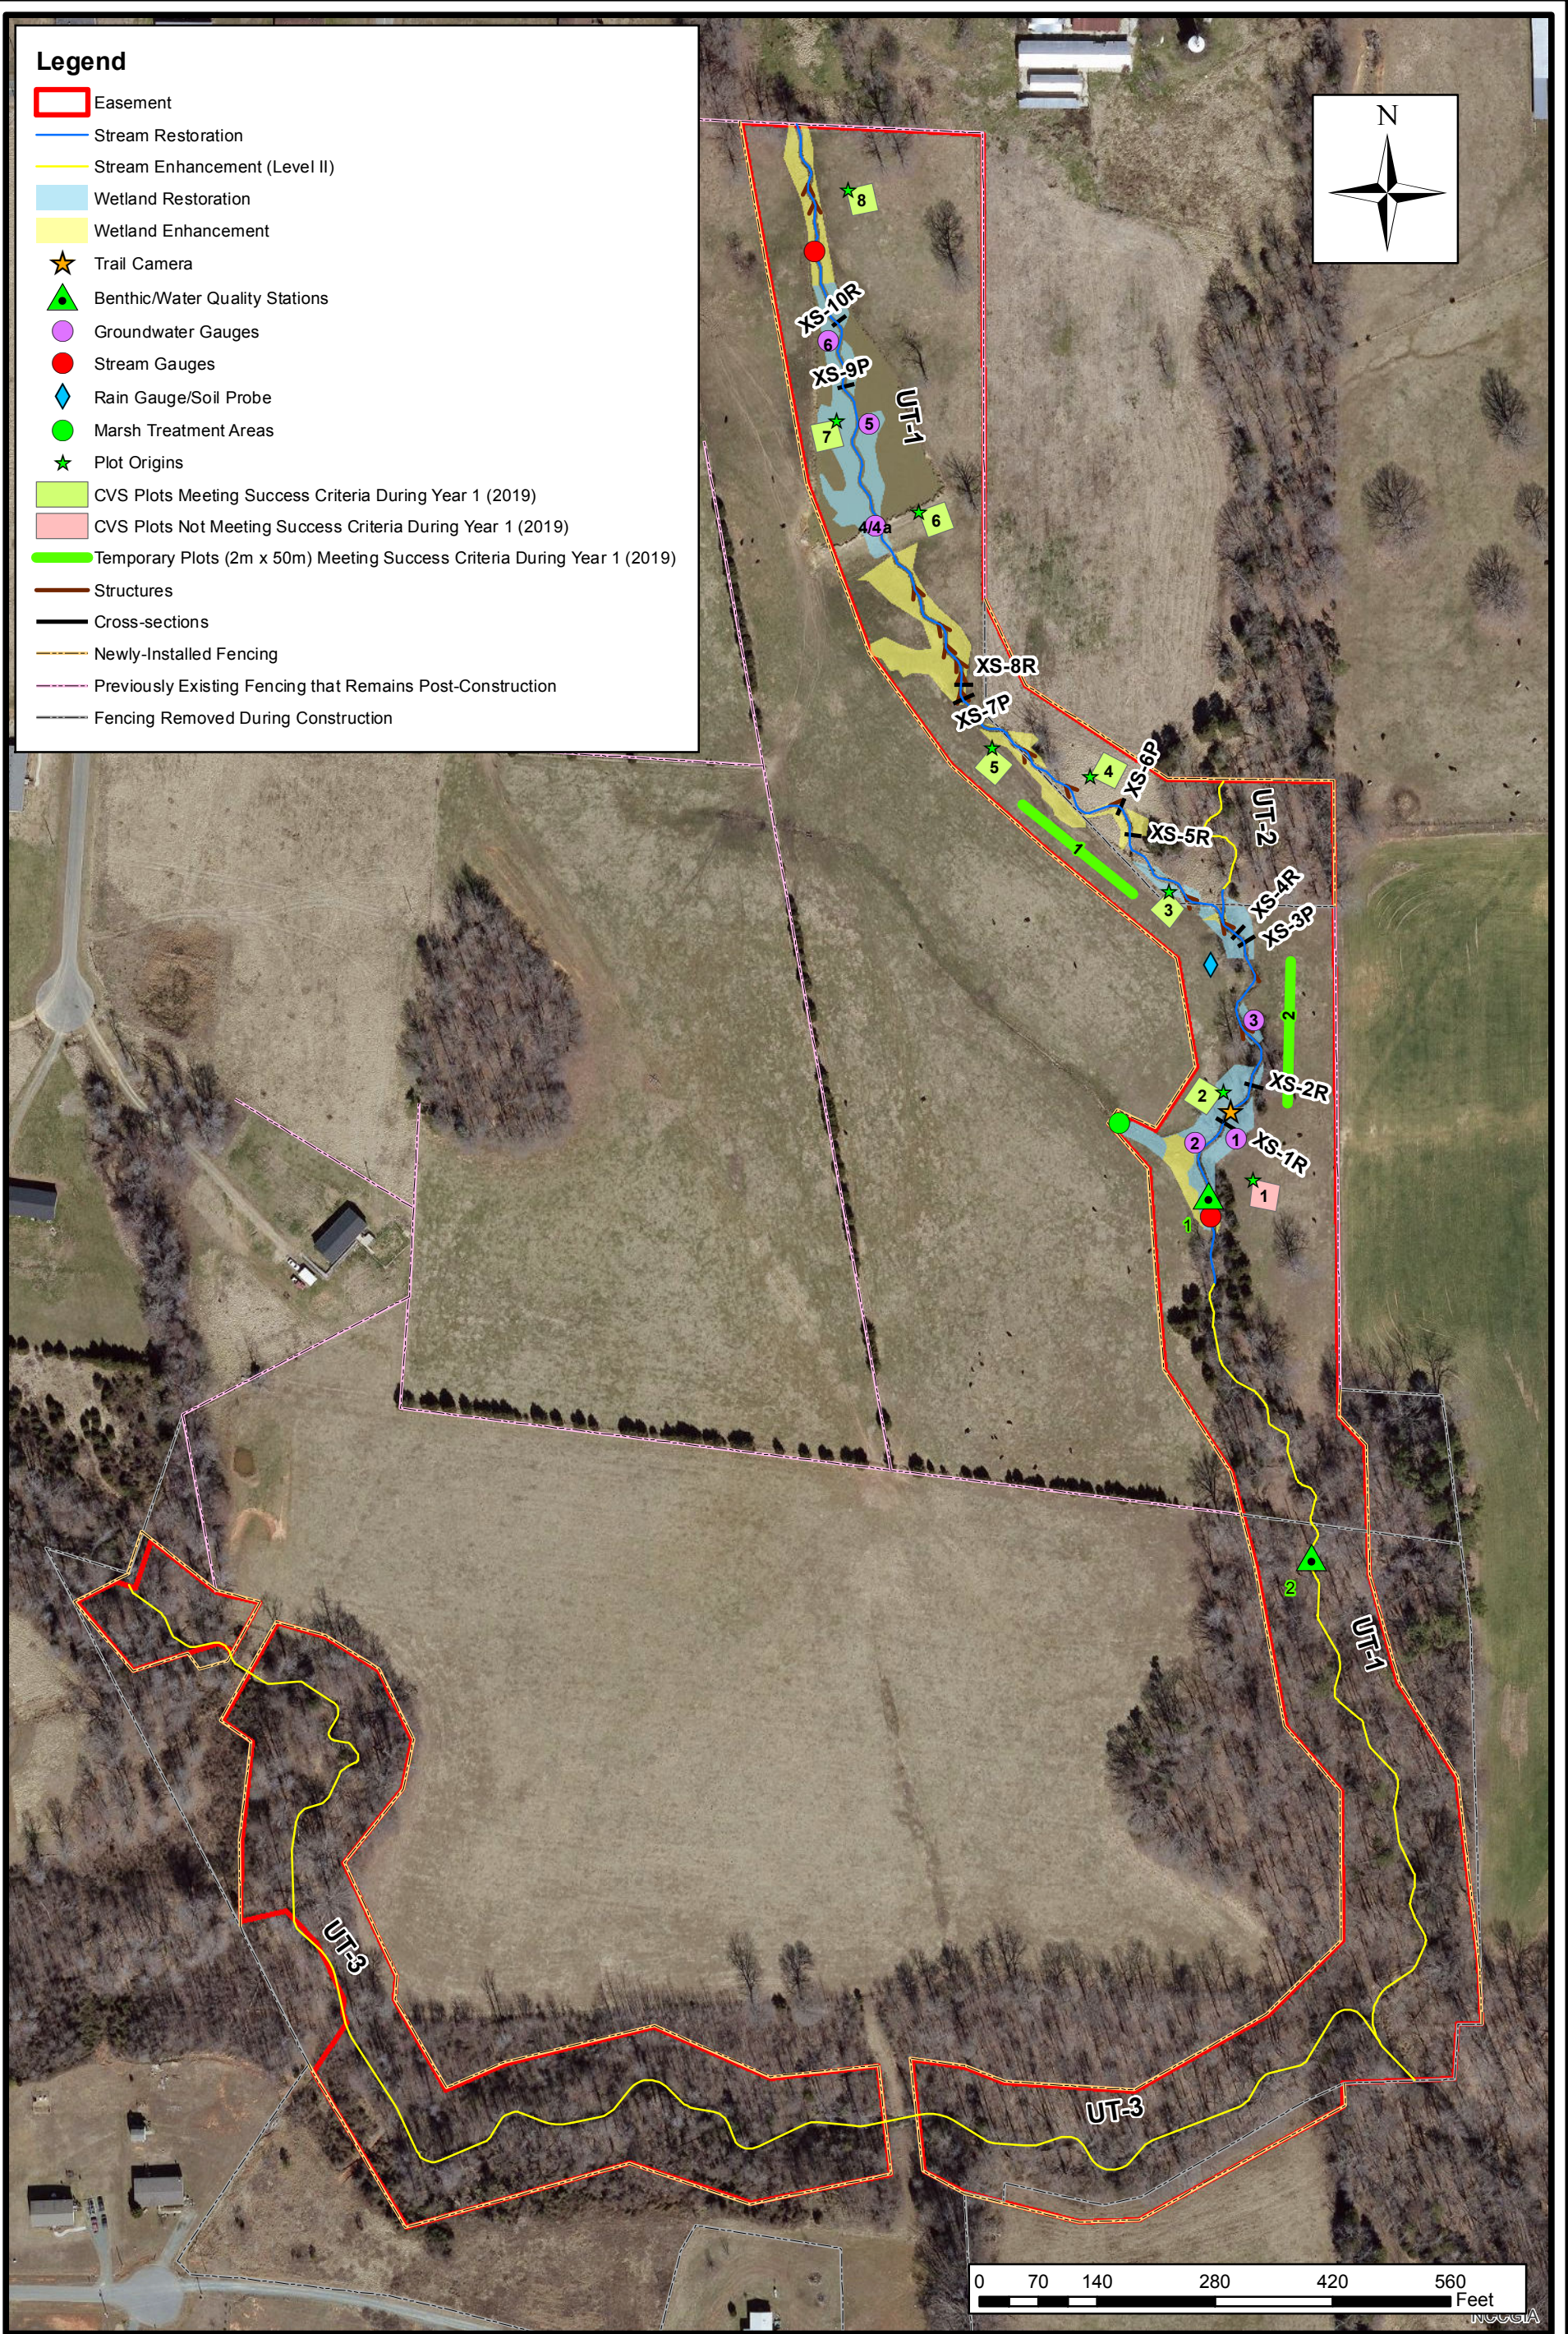
CURRENT CONDITIONS PLAN VIEW
 Major Hill Stream and Wetland Mitigation
 Alamance County, North Carolina

All streams are functioning as designed, and no stream areas of concern were observed during year 1 (2019) monitoring. Stream morphology and water quality data is available in Appendix D.

Six groundwater monitoring gauges were installed within the drained pond area and the remaining wetland restoration areas to take measurements after hydrological modifications were performed at the Site (Figure 2, Appendix B). Hydrological sampling will continue throughout the entire year at intervals necessary to satisfy jurisdictional hydrology success criteria. In addition, an on-site rain gauge will document rainfall data for comparison of groundwater conditions with extended drought conditions and a trail camera was installed to confirm overbank flooding events. Growing season soil temperatures will also be documented using a continuously logging soil temperature probe, this data will be provided with wetland hydrology data.

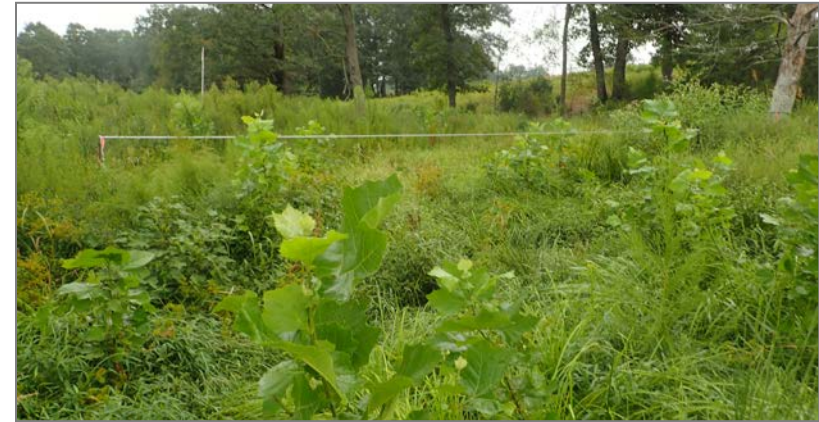
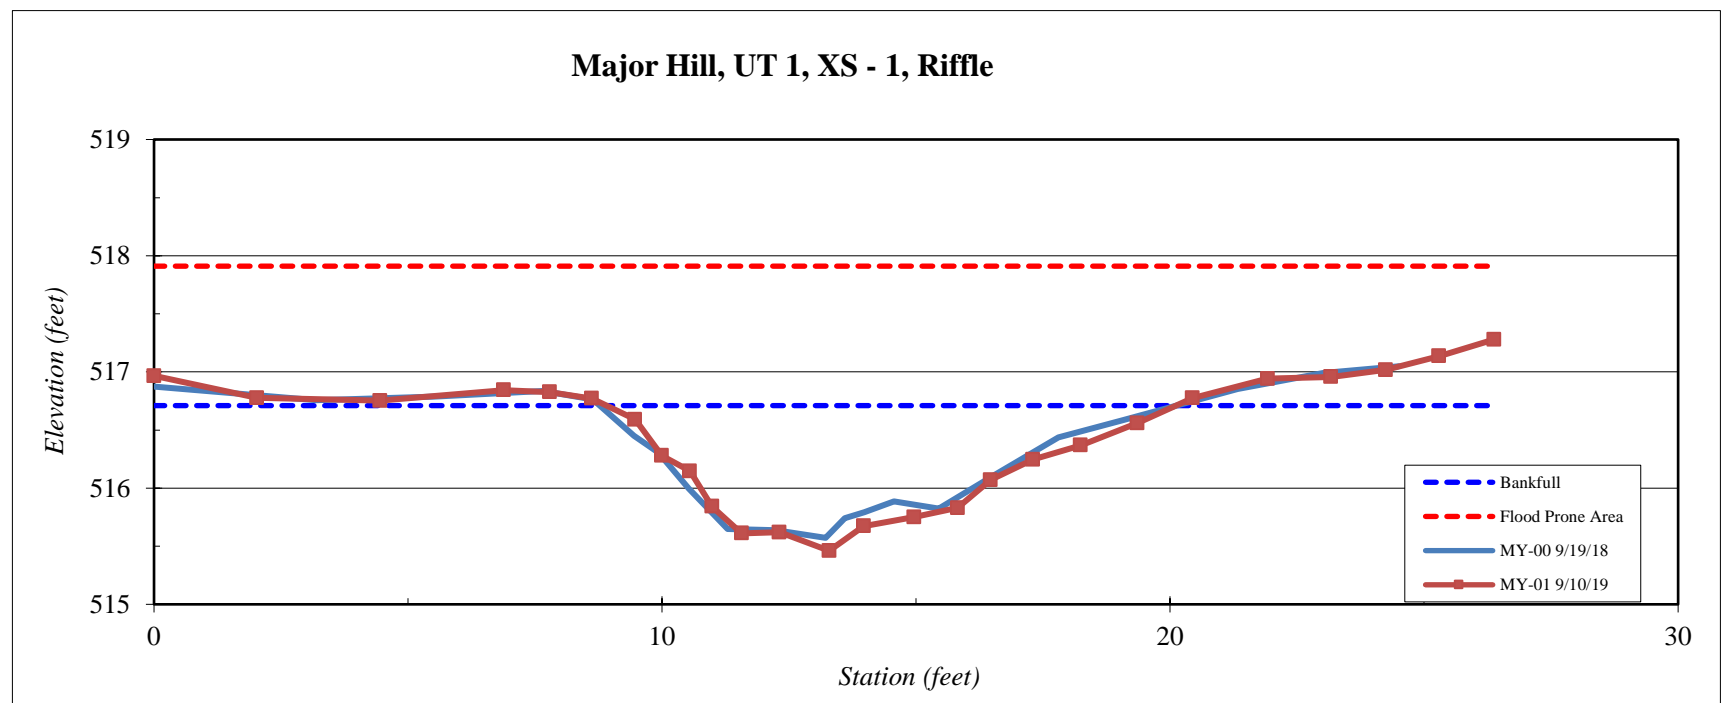
Site	Major Hill
Watershed:	Cape Fear, 0303002
XS ID	UT 1, XS - 1, Riffle
Feature	Riffle
Date:	9/10/2019
Field Crew:	Perkinson, Radecki

SUMMARY DATA	
Bankfull Elevation:	516.7
LTOB Elevation:	516.8
Bankfull Cross-Sectional Area:	7.5
Bankfull Width:	11.2
Flood Prone Area Elevation:	517.9
Flood Prone Width:	40.0
Max Depth at Bankfull:	1.2
Low Bank Height:	1.3
Mean Depth at Bankfull:	0.7
W / D Ratio:	16.7
Entrenchment Ratio:	3.6
Bank Height Ratio:	1.1

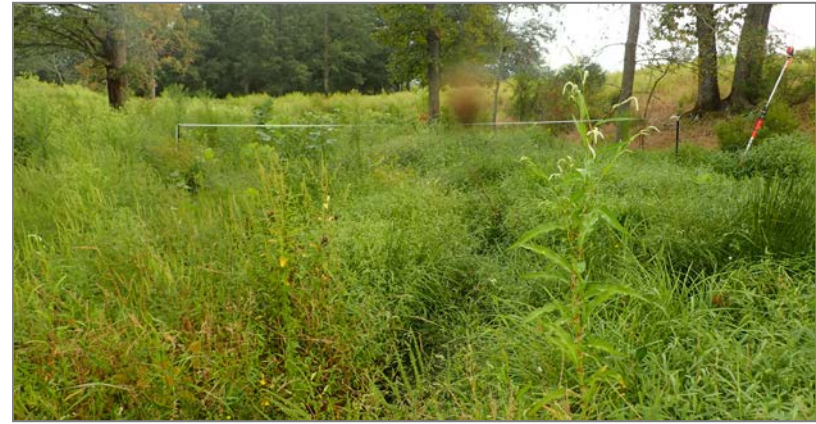
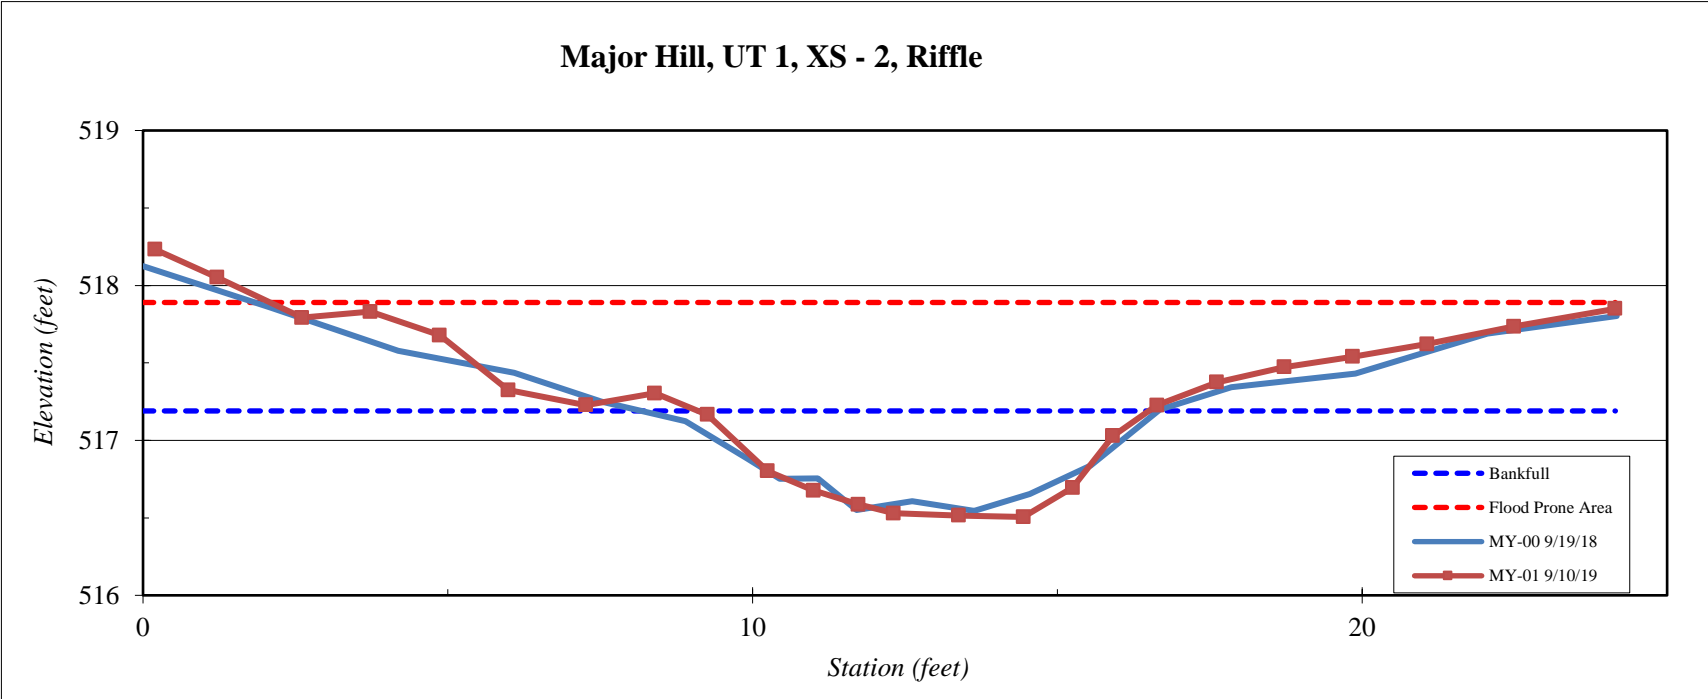
Site	Major Hill
Watershed:	Cape Fear, 0303002
XS ID	UT 1, XS - 2, Riffle
Feature	Riffle
Date:	9/10/2019
Field Crew:	Perkinson, Radecki

SUMMARY DATA	
Bankfull Elevation:	517.2
LTOB Elevation:	517.3
Bankfull Cross-Sectional Area:	3.5
Bankfull Width:	7.4
Flood Prone Area Elevation:	517.9
Flood Prone Width:	22.0
Max Depth at Bankfull:	0.7
Low Bank Height:	0.8
Mean Depth at Bankfull:	0.5
W / D Ratio:	15.6
Entrenchment Ratio:	3.0
Bank Height Ratio:	1.1

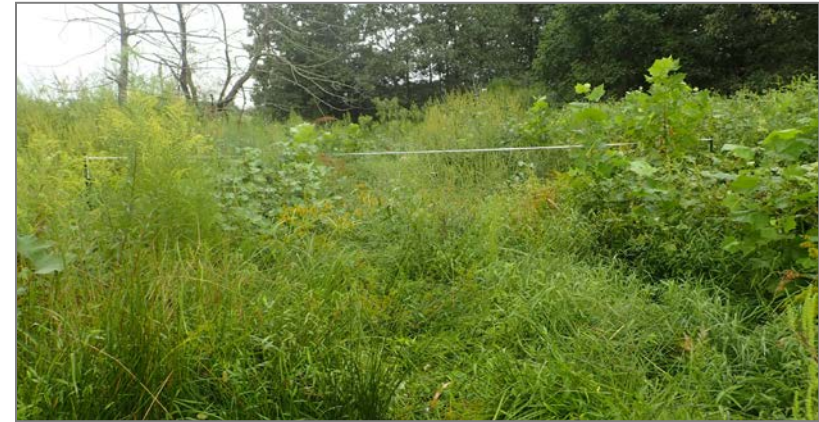
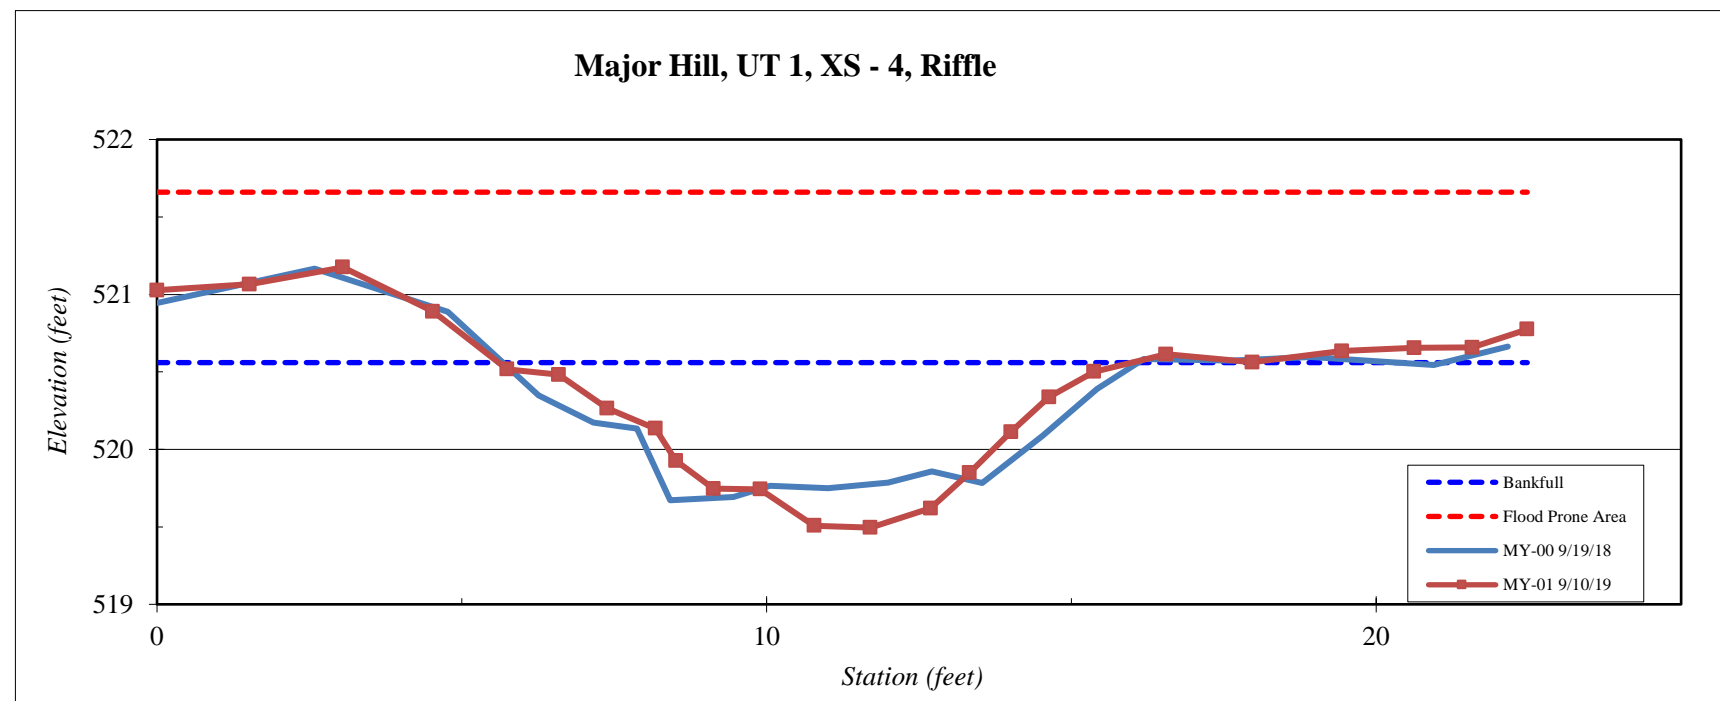
Site	Major Hill
Watershed:	Cape Fear, 0303002
XS ID	UT 1, XS - 4, Riffle
Feature	Riffle
Date:	9/10/2019
Field Crew:	Perkinson, Radecki

SUMMARY DATA	
Bankfull Elevation:	520.6
LTOB Elevation:	520.6
Bankfull Cross-Sectional Area:	5.8
Bankfull Width:	10.4
Flood Prone Area Elevation:	521.7
Flood Prone Width:	40.0
Max Depth at Bankfull:	1.1
Low Bank Height:	1.1
Mean Depth at Bankfull:	0.6
W / D Ratio:	18.6
Entrenchment Ratio:	3.8
Bank Height Ratio:	1.0

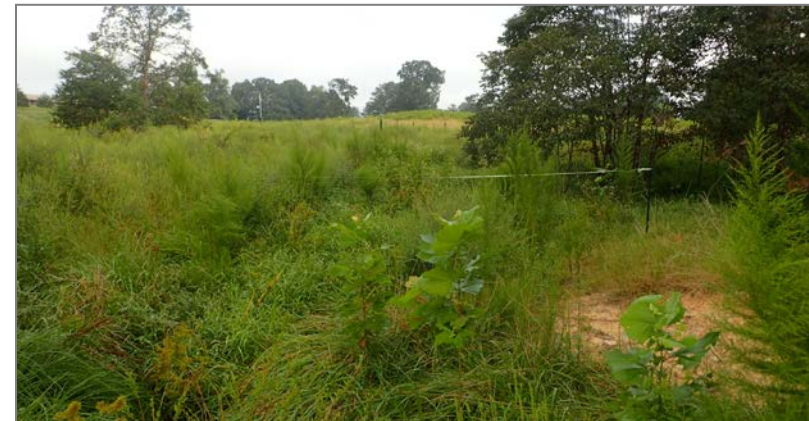
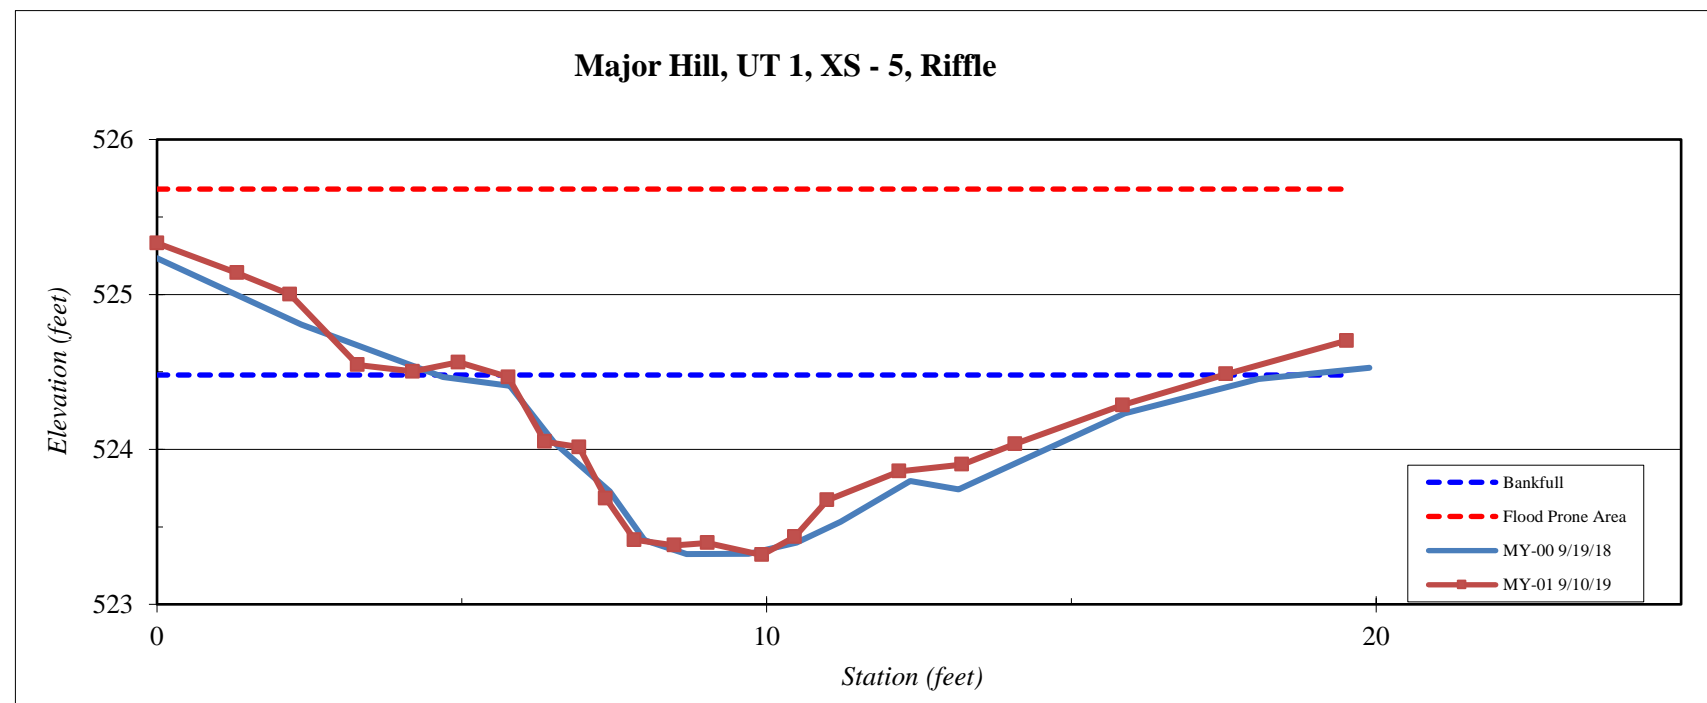
Site	Major Hill
Watershed:	Cape Fear, 0303002
XS ID	UT 1, XS - 5, Riffle
Feature	Riffle
Date:	9/10/2019
Field Crew:	Perkinson, Radecki

SUMMARY DATA	
Bankfull Elevation:	524.5
LTOB Elevation:	524.6
Bankfull Cross-Sectional Area:	7.1
Bankfull Width:	11.8
Flood Prone Area Elevation:	525.7
Flood Prone Width:	40.0
Max Depth at Bankfull:	1.2
Low Bank Height:	1.2
Mean Depth at Bankfull:	0.6
W / D Ratio:	19.6
Entrenchment Ratio:	3.4
Bank Height Ratio:	1.0

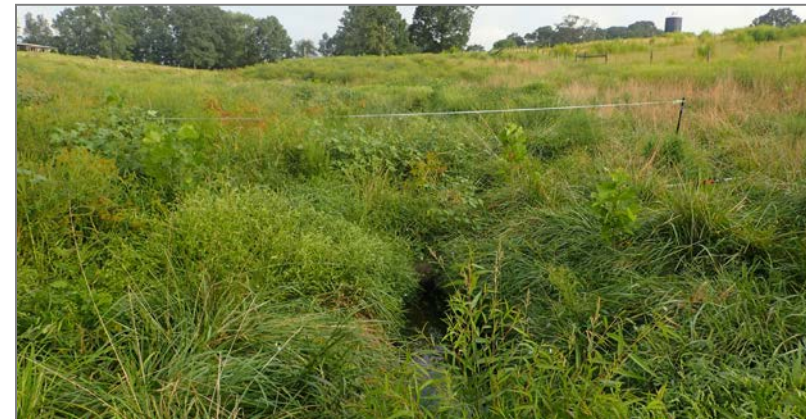
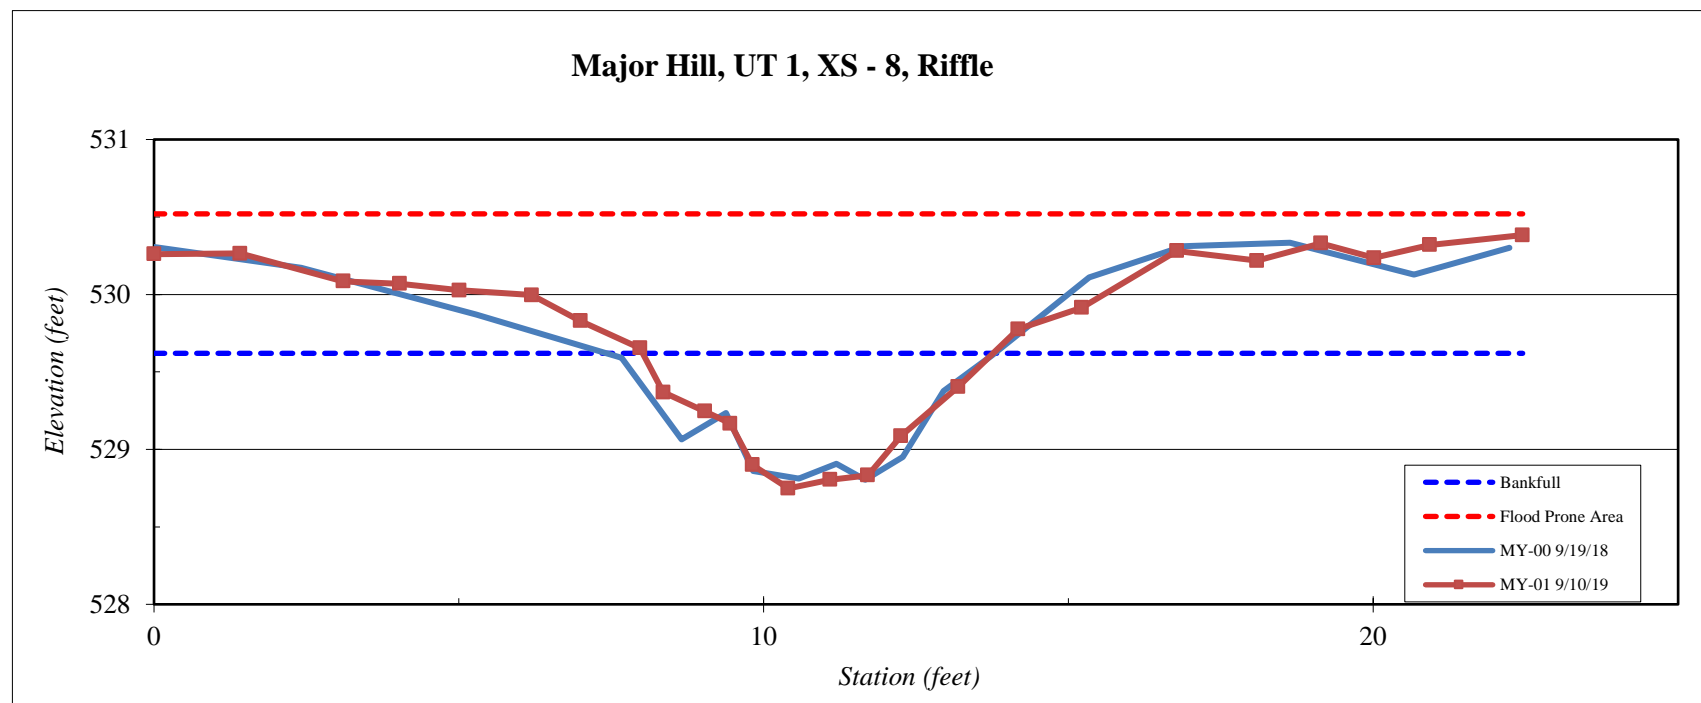
Site	Major Hill
Watershed:	Cape Fear, 0303002
XS ID	UT 1, XS - 8, Riffle
Feature	Riffle
Date:	9/10/2019
Field Crew:	Perkinson, Radecki

SUMMARY DATA	
Bankfull Elevation:	529.6
LTOB Elevation:	529.7
Bankfull Cross-Sectional Area:	3.0
Bankfull Width:	5.7
Flood Prone Area Elevation:	530.5
Flood Prone Width:	23.0
Max Depth at Bankfull:	0.9
Low Bank Height:	0.9
Mean Depth at Bankfull:	0.5
W / D Ratio:	10.8
Entrenchment Ratio:	4.0
Bank Height Ratio:	1.0

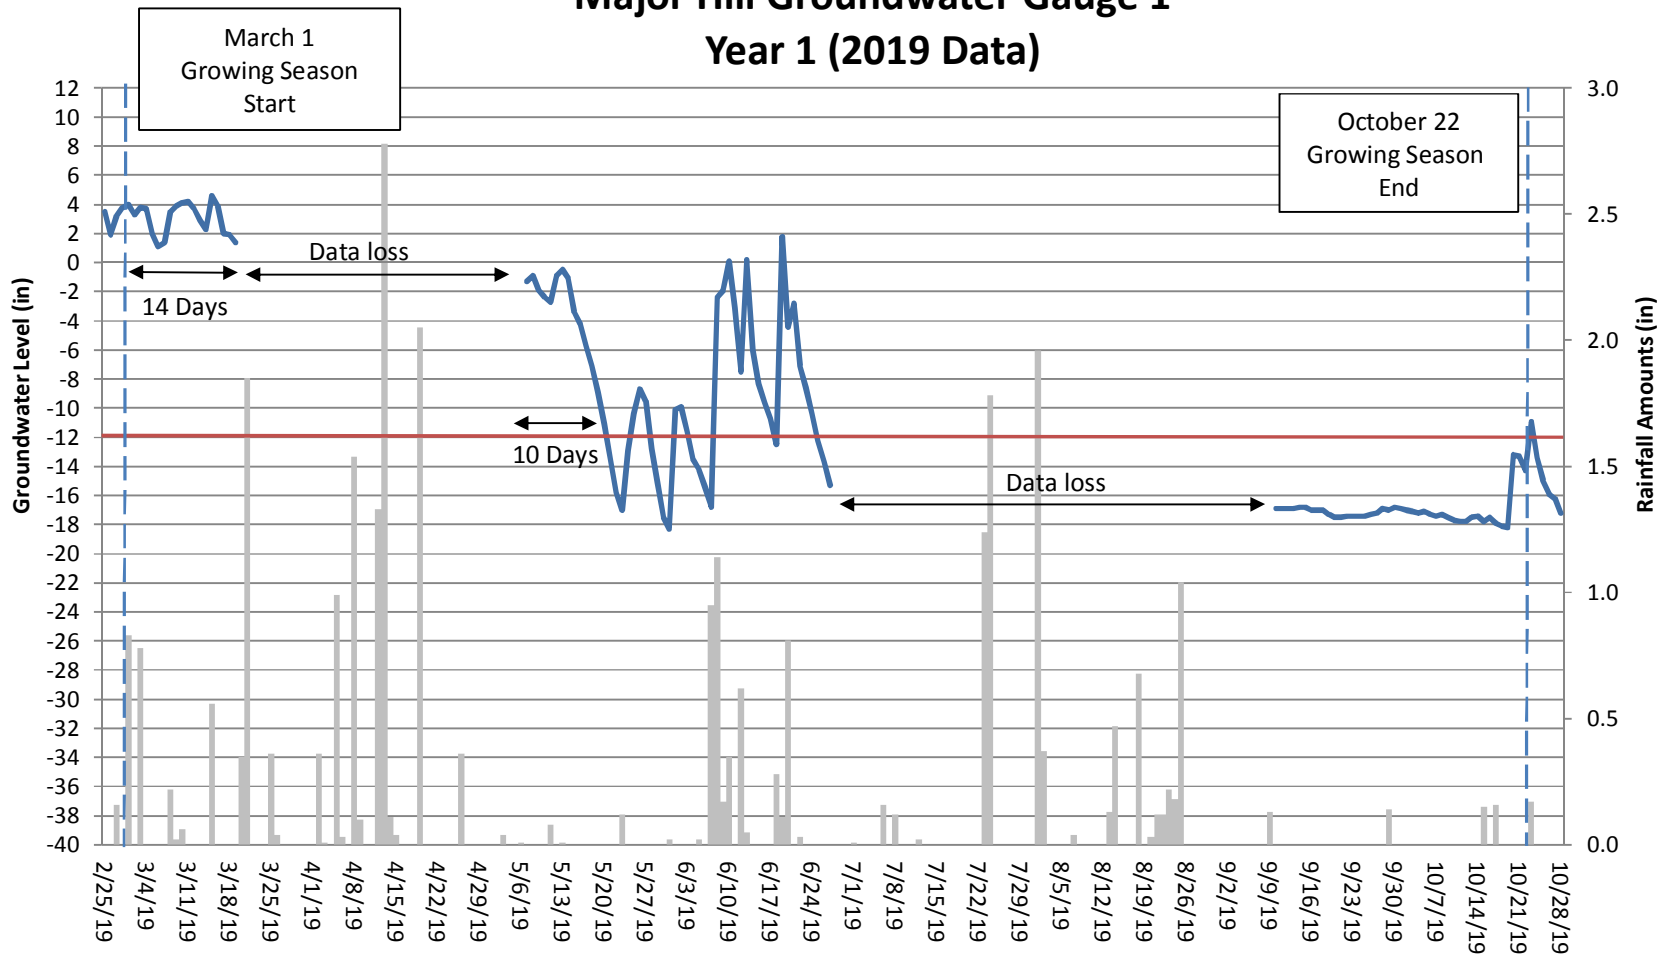
Major Hill Groundwater Gauge 1 Year 1 (2019 Data)

* These gauges did not meet success criteria due to a data shuttle failure that resulted in the loss of data. Based on rainfall and hydrology data that was not lost, all gauges would have likely met success criteria had the loss of data not occurred.

We will be prepared to explain the data loss, and the gauges will be replaced prior to the 2020 growing season.
