MONITORING REPORT
2020 (Year 2)

MAJOR HILL STREAM AND WETLAND MITIGATION SITE
Alamance County, North Carolina

DMS Project ID No. 100015
Full Delivery Contract No. 7193
USACE Action ID No. SAW-2017-01472
DWR No. 17-0921
RFP No. 16-006990

Data Collection: July 2020 – October 2020
Submission: January 2021

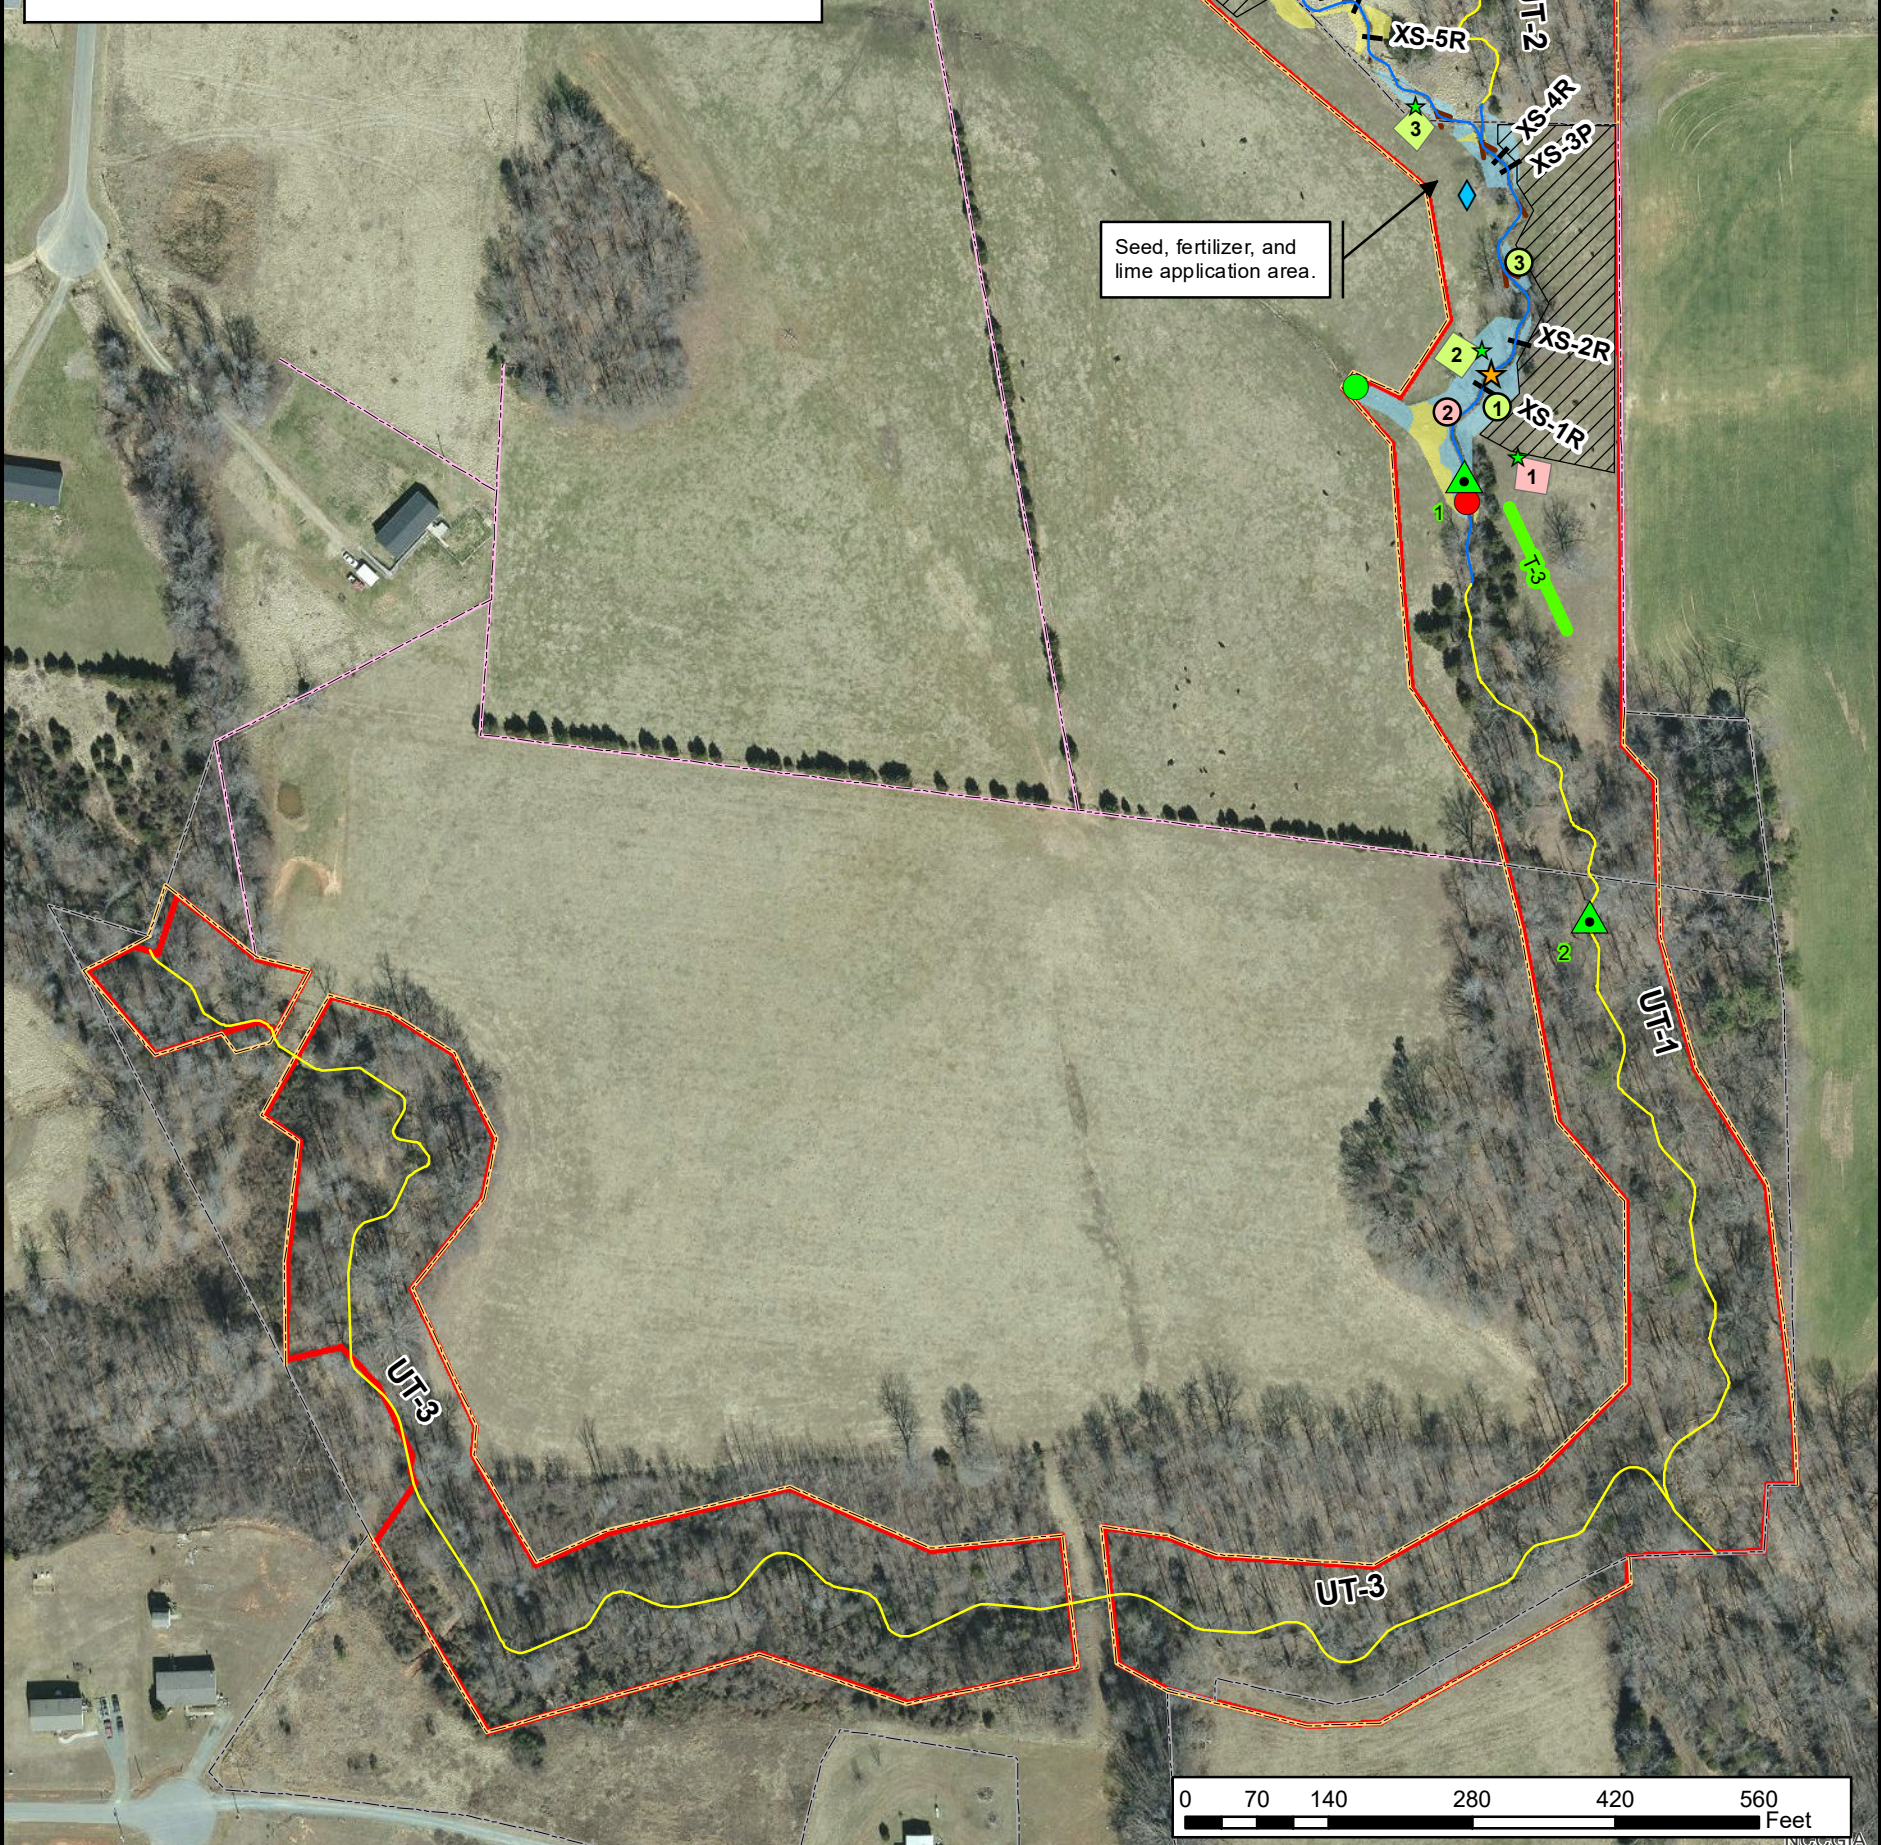
CURRENT CONDITIONS PLAN VIEW
Major Hill Stream and Wetland Mitigation
Alamance County, North Carolina

All streams are functioning as designed, and no stream areas of concern were observed during year 2 (2020) monitoring. Stream morphology and water quality data is available in Appendix D.

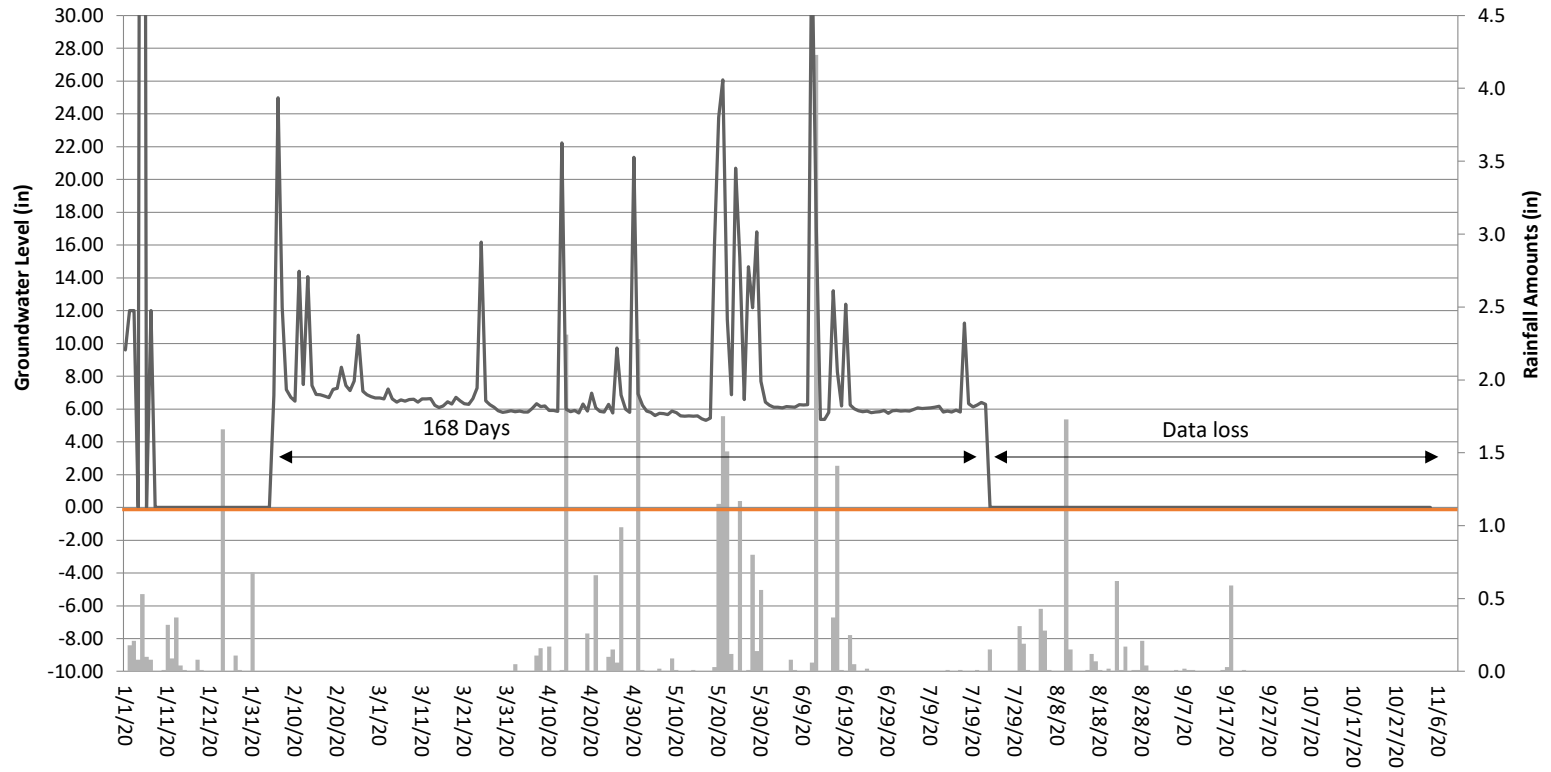
Major Hill Stream Flow Gauge UT1 Downstream Year 2 (2020 Data)

Other:		Bankfull event documented.

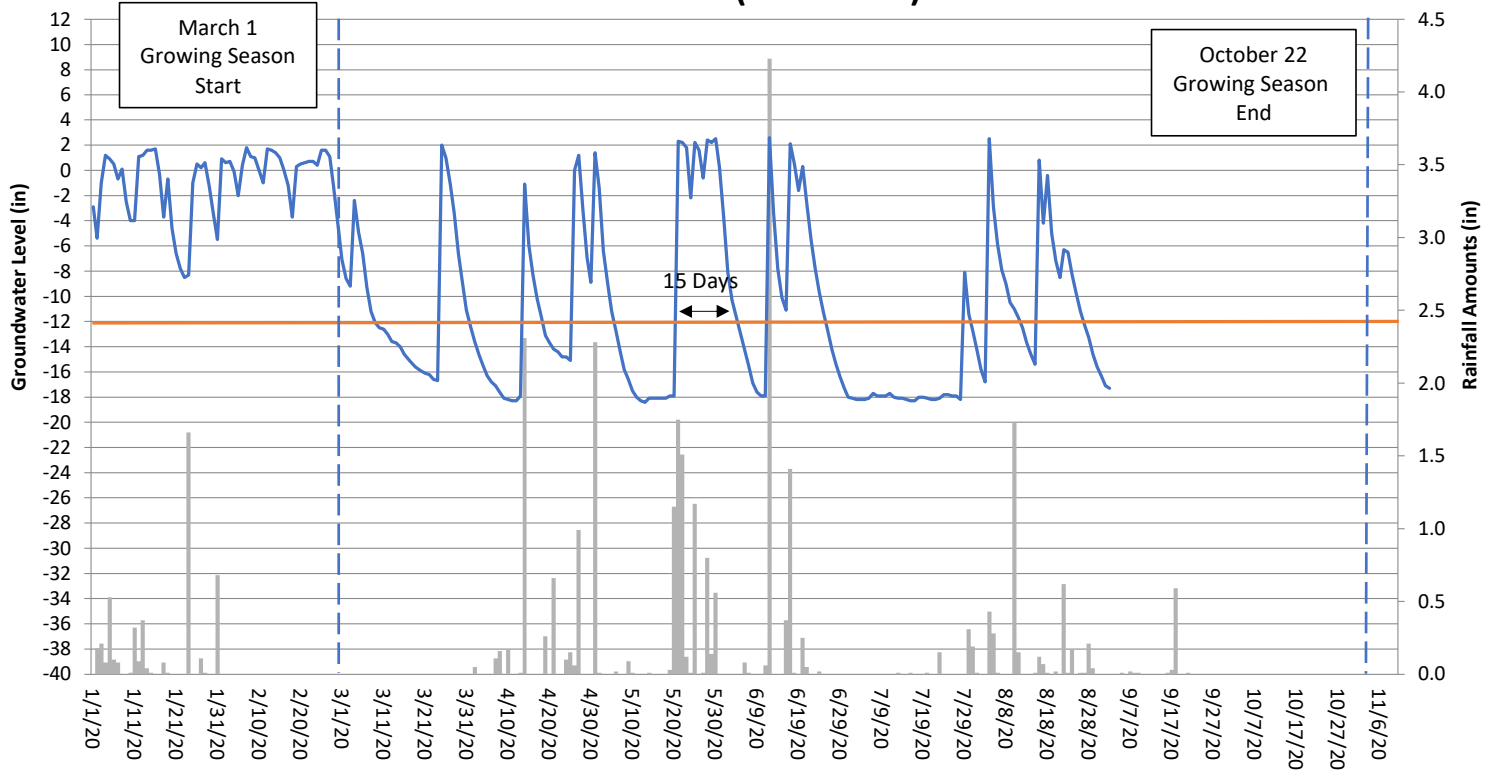
Major Hill Groundwater Gauge 2 Year 2 (2020 Data)

- Five of six groundwater gauges met success for the Year 2 (2020) monitoring period. Wetland hydrology data is in Appendix E. Gauge 2 did not meet success, however it was successful for 8% of the growing season.
