FINAL
MONITORING REPORT
2021 (Year 3)

MAJOR HILL STREAM AND WETLAND MITIGATION SITE

Alamance County, North Carolina

DMS Project ID No. 100015
Full Delivery Contract No. 7193
USACE Action ID No. SAW-2017-01472
DWR No. 17-0921
RFP No. 16-006990

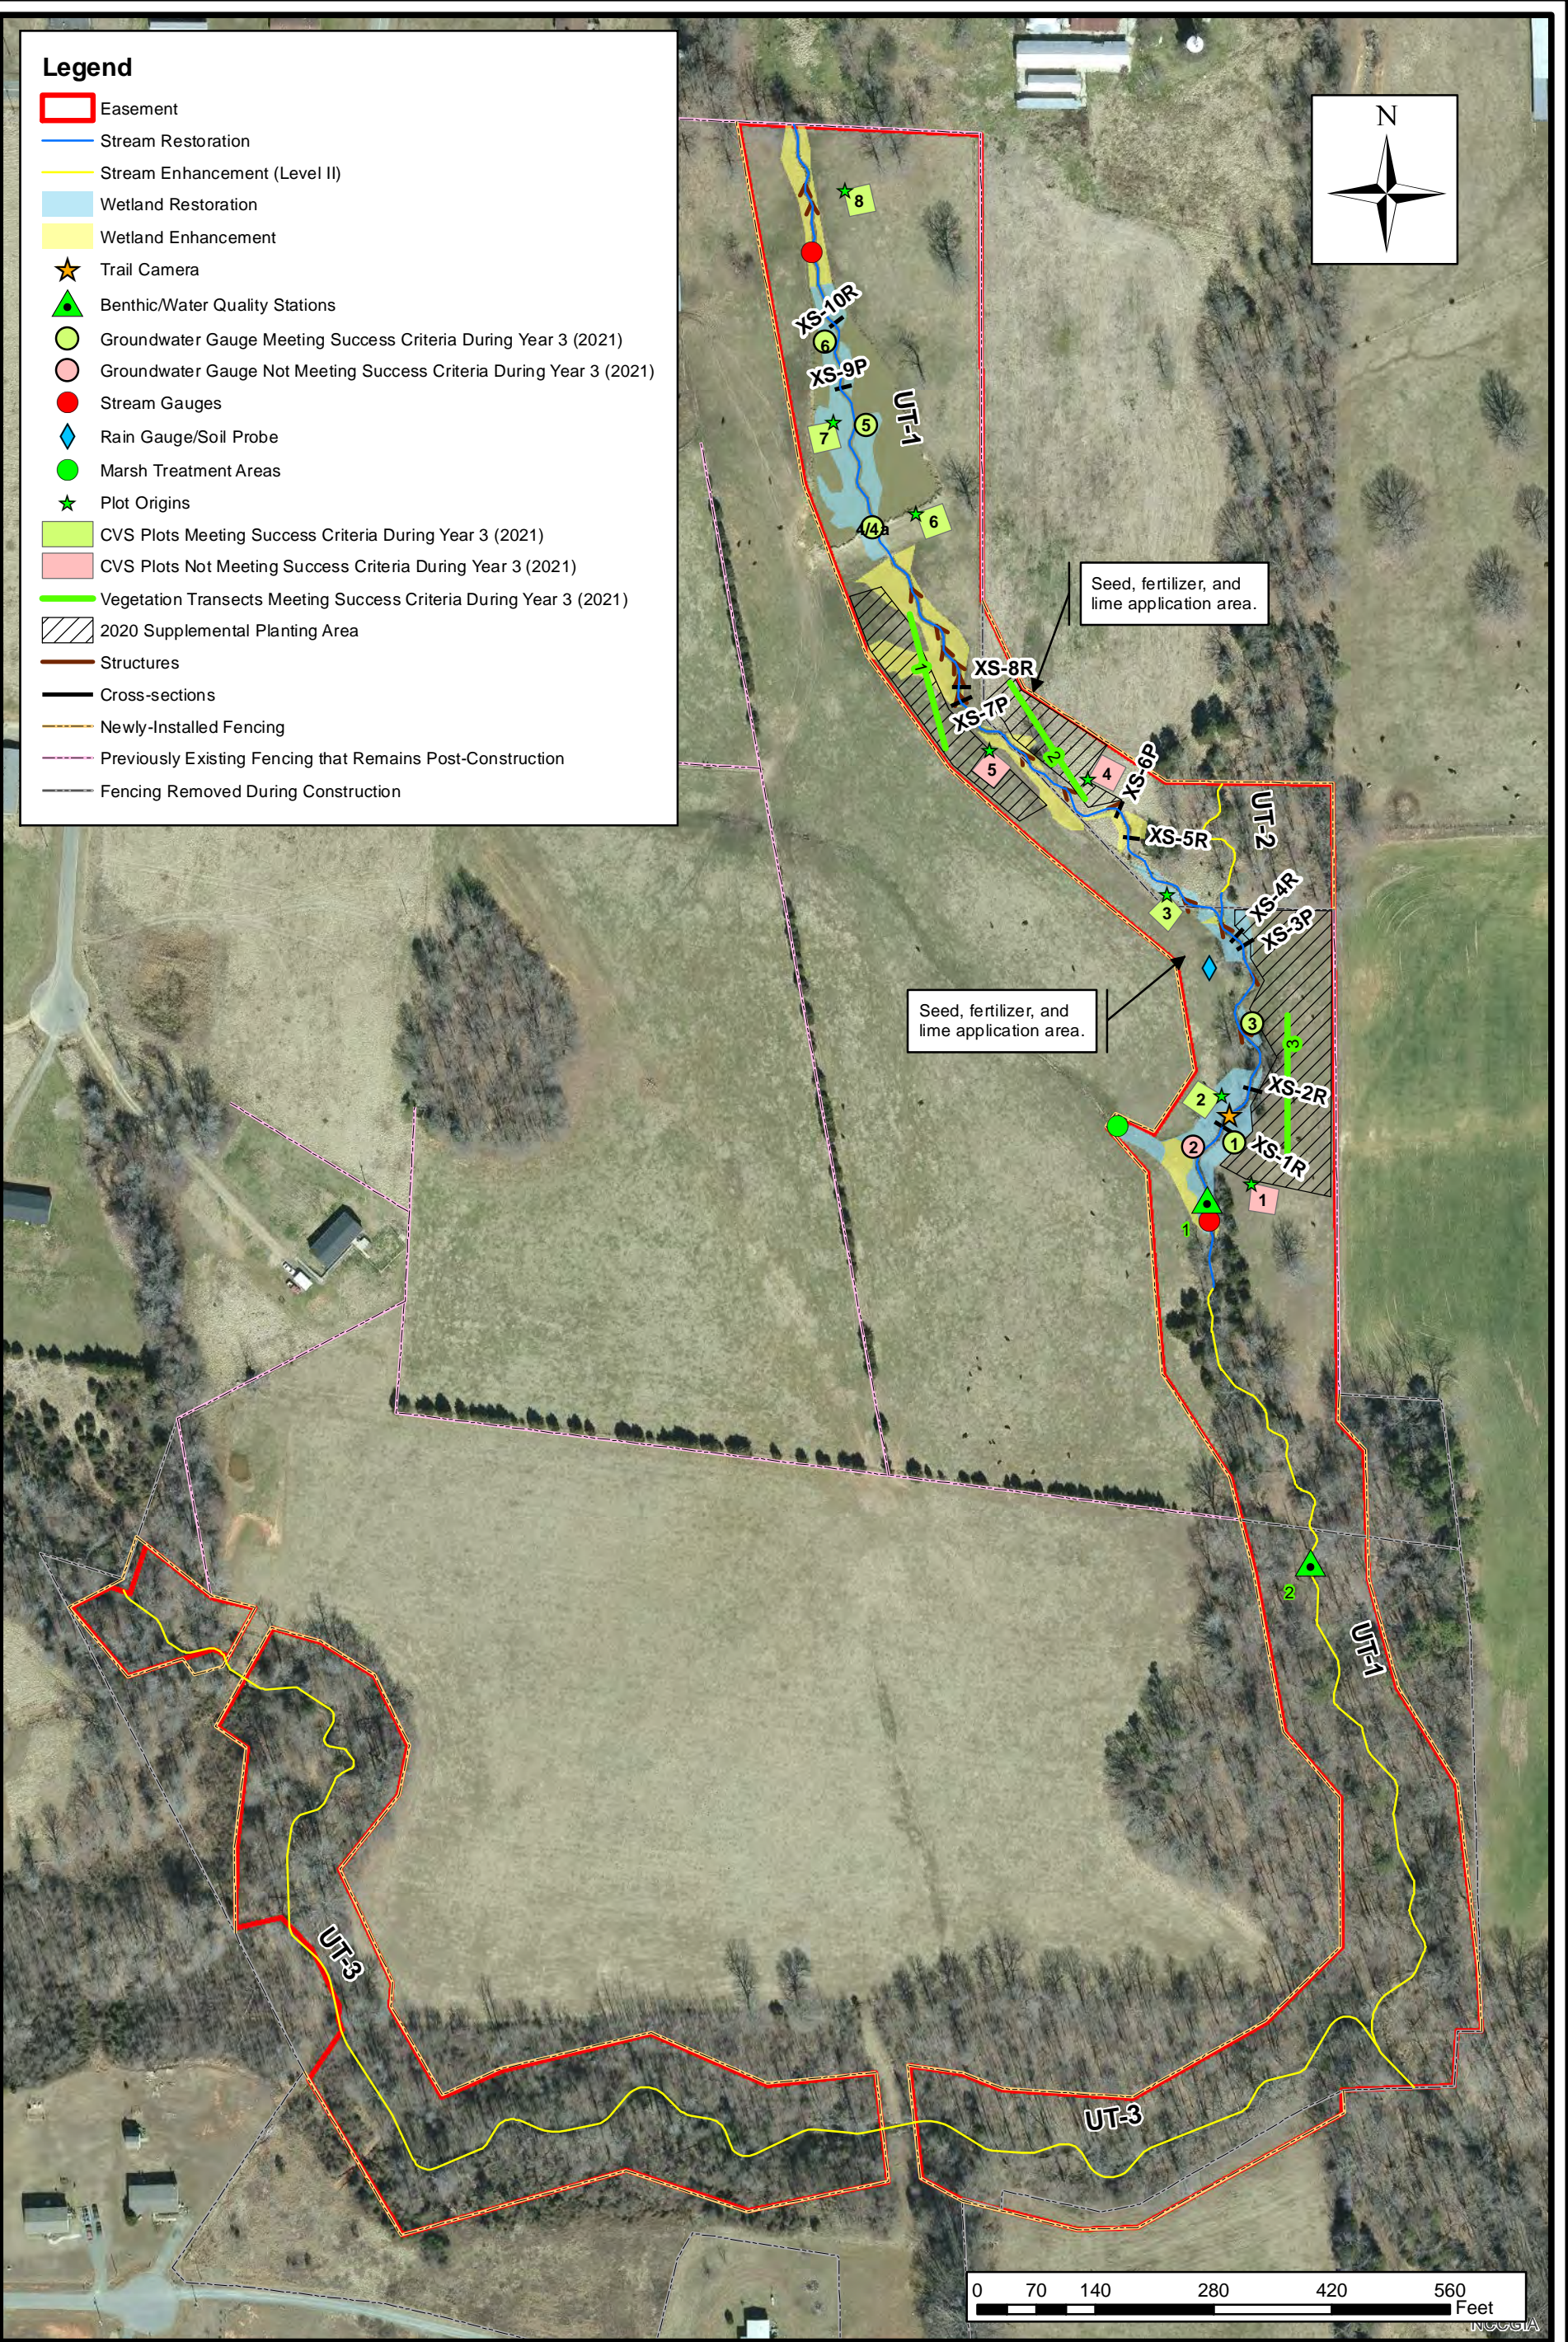
Dwn. By: KRJ	FIGURE 2
Date: Nov 2021	
Project: 17-009

All streams are functioning as designed, and no stream areas of concern were observed during year 3 (2021) monitoring. Stream morphology and water quality data is available in Appendix D, and benthic macroinvertebrate data is in Appendix F.

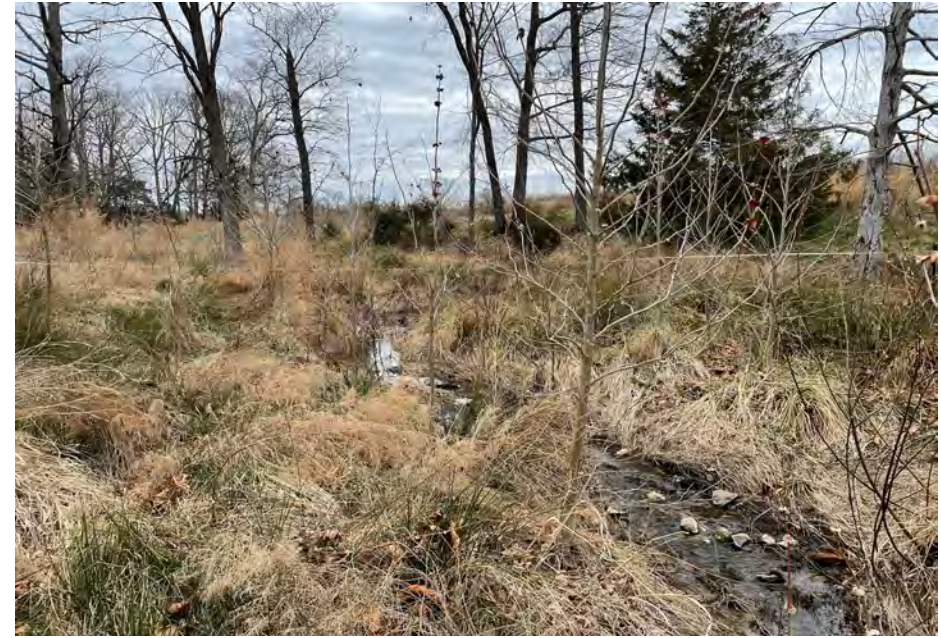
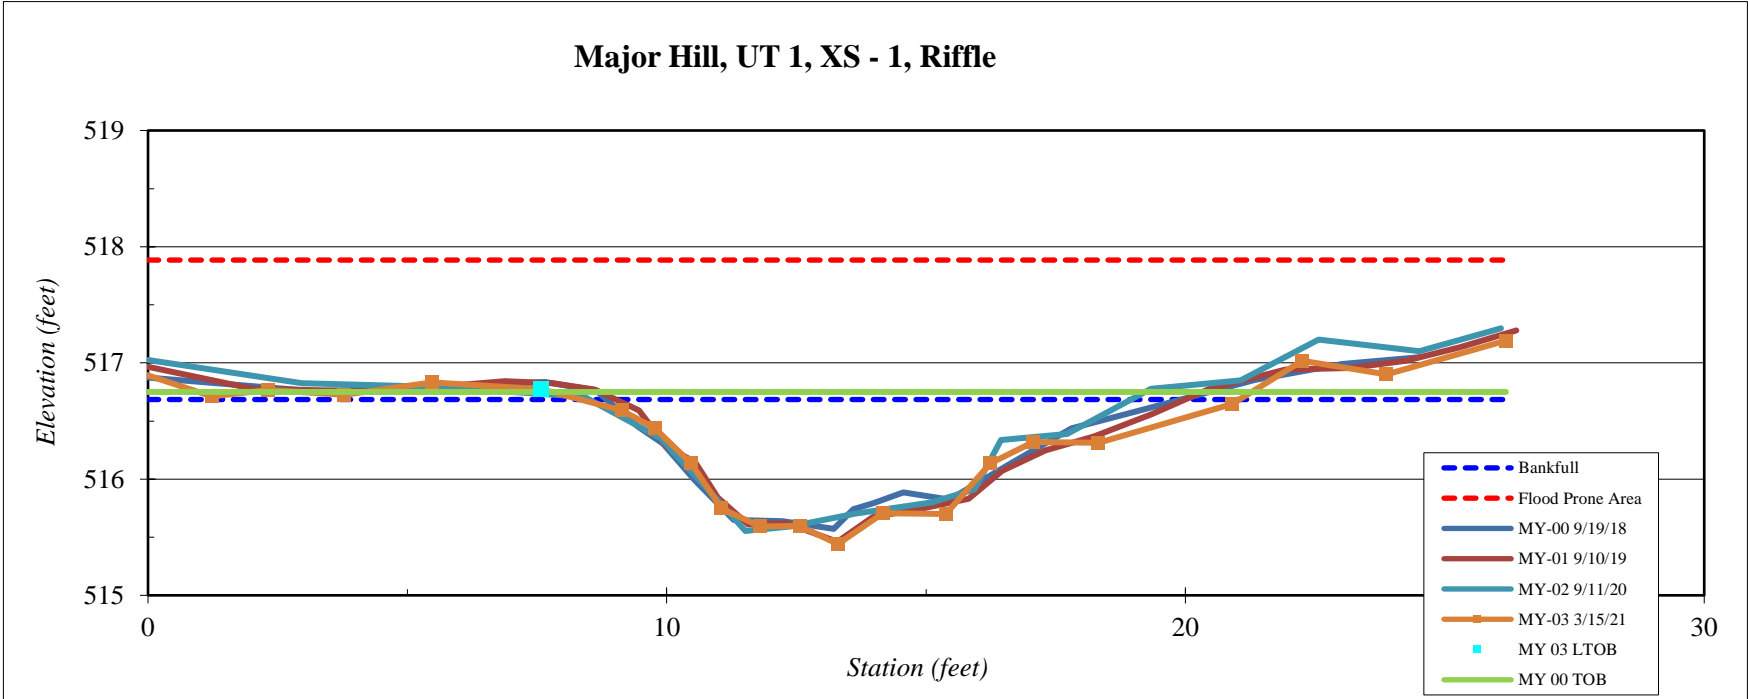
Site	Major Hill
Watershed:	Cape Fear, 0303002
XS ID	UT 1, XS - 1, Riffle
Feature	Riffle
Date:	3/15/2021
Field Crew:	Adams, Lawson

SUMMARY DATA	
Bankfull Elevation:	516.7
LTOB Elevation:	516.8
Bankfull Cross-Sectional Area:	7.5
Bankfull Width:	12.7
Flood Prone Area Elevation:	517.9
Flood Prone Width:	40.0
Max Depth at Bankfull:	1.2
Low Bank Height:	1.3
Mean Depth at Bankfull:	0.6
W / D Ratio:	21.6
Entrenchment Ratio:	3.1
Bank Height Ratio:	1.1

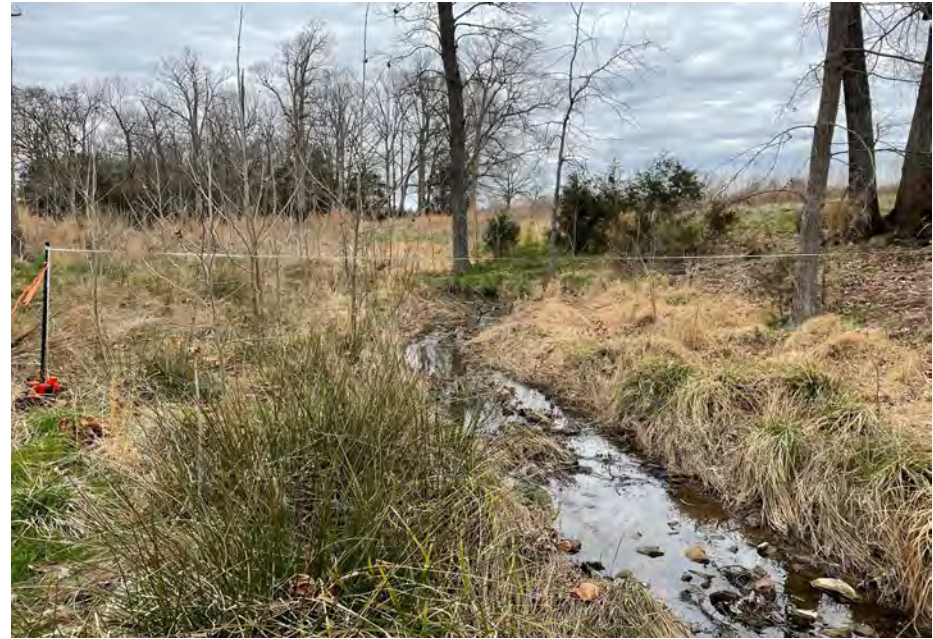
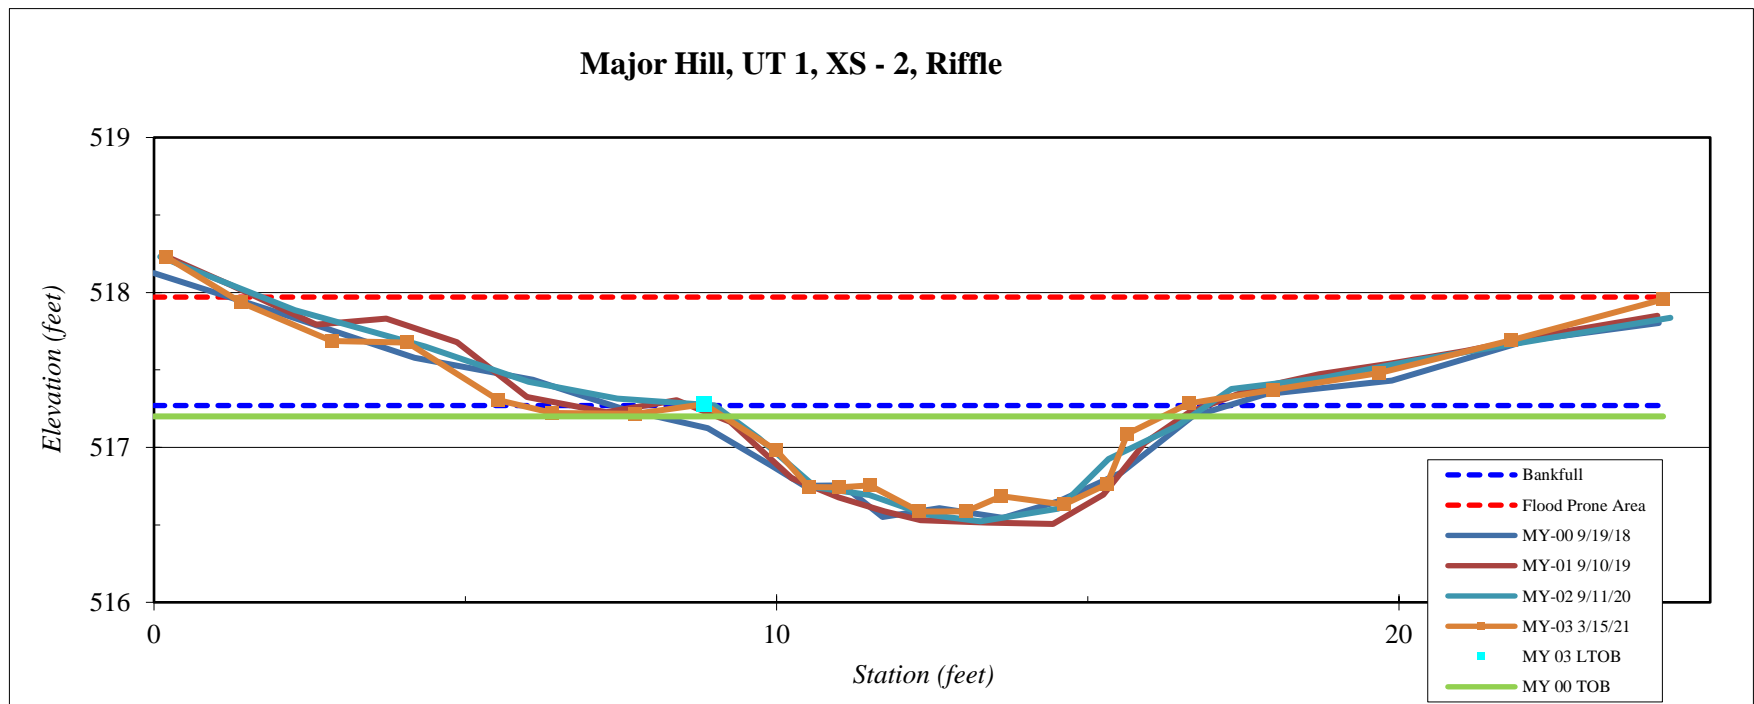
Site	Major Hill
Watershed:	Cape Fear, 0303002
XS ID	UT 1, XS - 2, Riffle
Feature	Riffle
Date:	3/15/2021
Field Crew:	Adams, Lawson

SUMMARY DATA	
Bankfull Elevation:	517.3
LTOB Elevation:	517.3
Bankfull Cross-Sectional Area:	3.5
Bankfull Width:	7.7
Flood Prone Area Elevation:	518.0
Flood Prone Width:	22.0
Max Depth at Bankfull:	0.7
Low Bank Height:	0.7
Mean Depth at Bankfull:	0.4
W / D Ratio:	17.1
Entrenchment Ratio:	2.9
Bank Height Ratio:	1.0

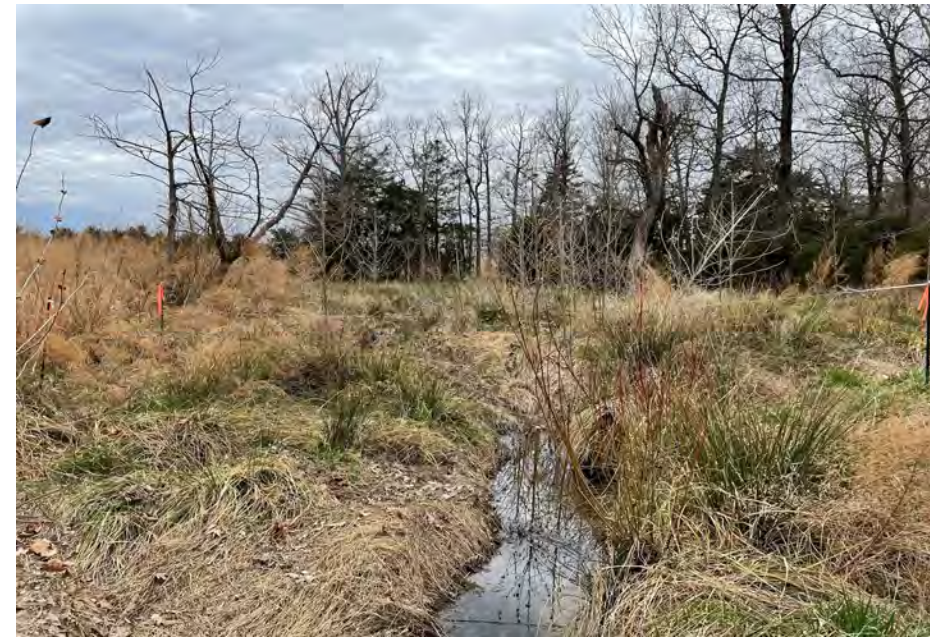
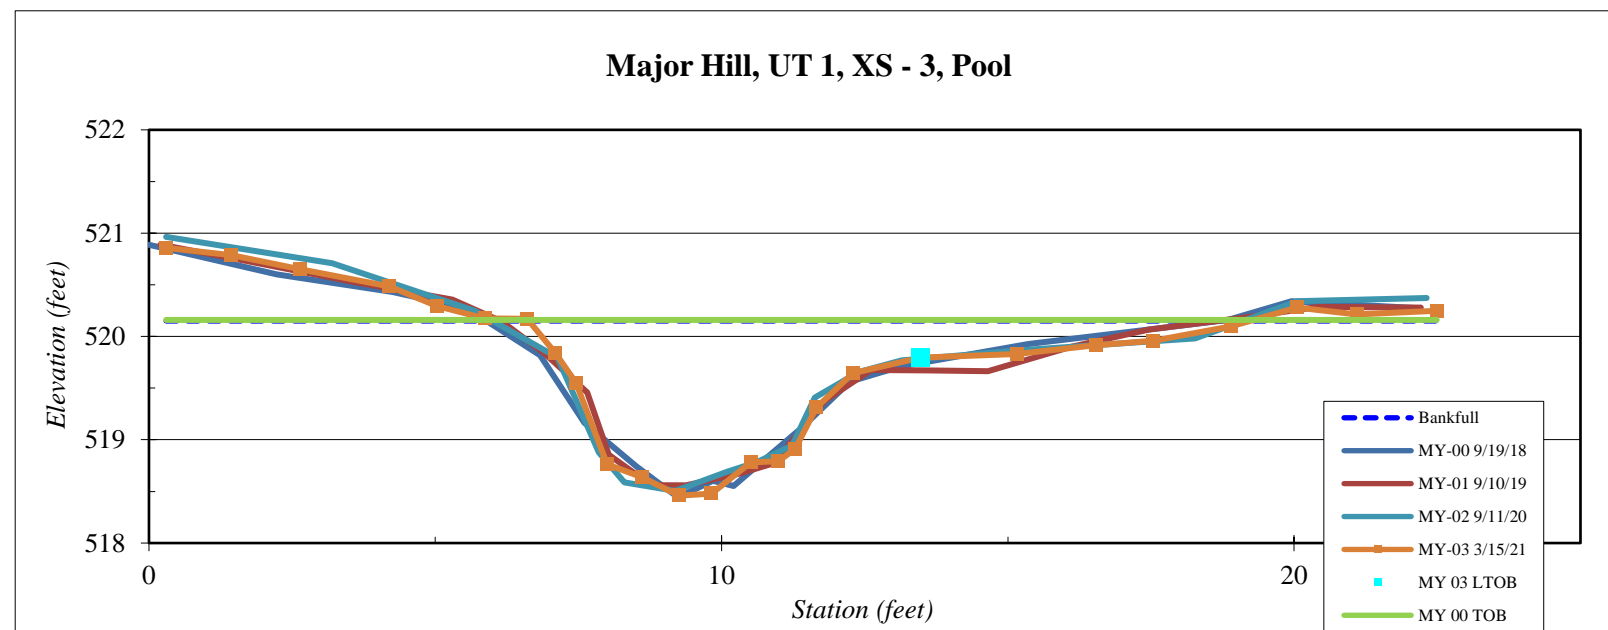
Site	Major Hill
Watershed:	Cape Fear, 0303002
XS ID	UT 1, XS - 3, Pool
Feature	Pool
Date:	3/15/2021
Field Crew:	Adams, Lawson

SUMMARY DATA	
Bankfull Elevation:	520.2
LTOB Elevation:	519.8
Bankfull Cross-Sectional Area:	8.4
Bankfull Width:	12.6
Flood Prone Area Elevation:	NA
Flood Prone Width:	NA
Max Depth at Bankfull:	1.7
Low Bank Height:	1.3
Mean Depth at Bankfull:	0.7
W / D Ratio:	NA
Entrenchment Ratio:	NA
Bank Height Ratio:	0.8

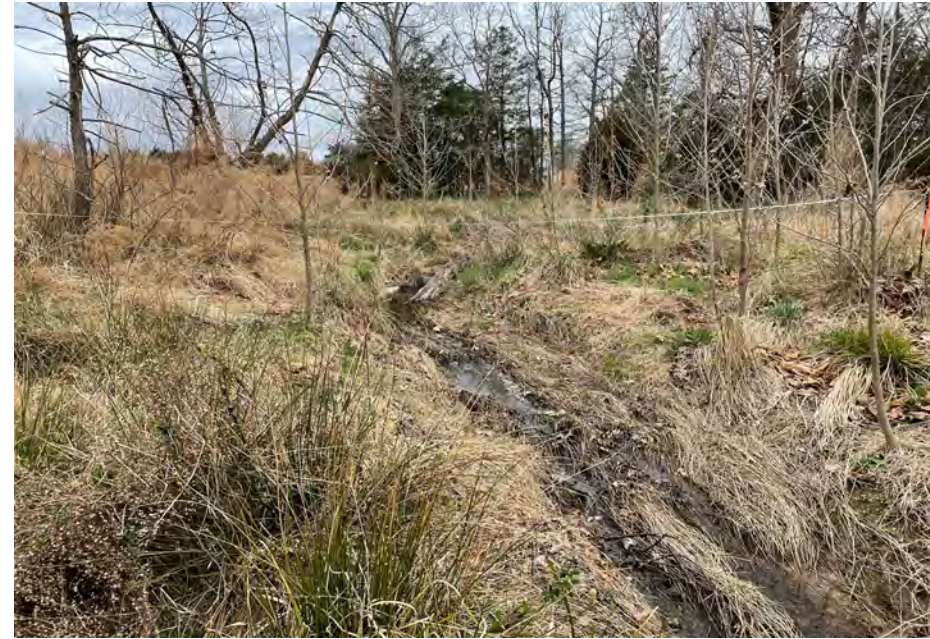
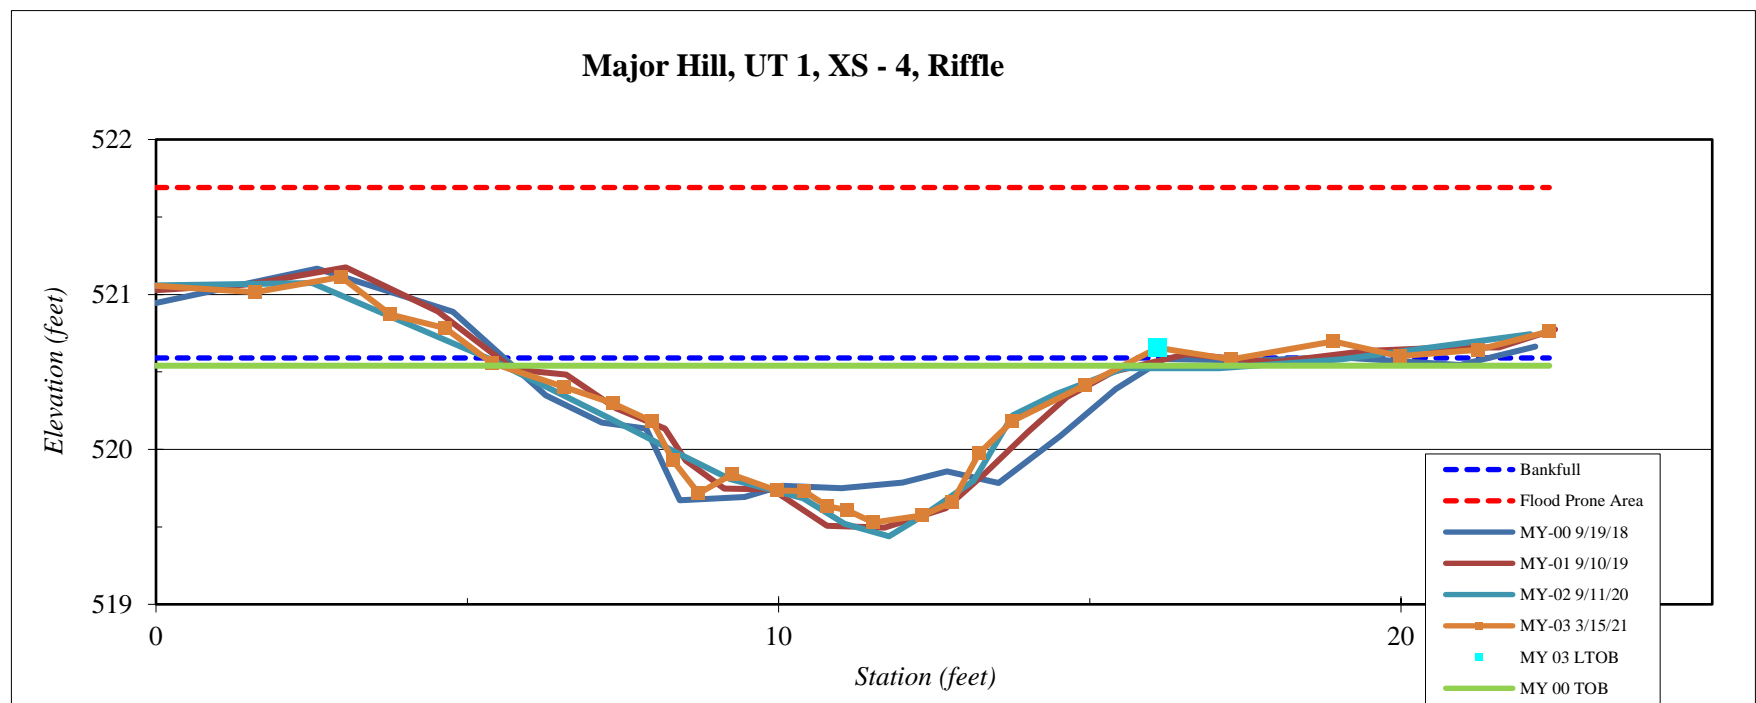
Site	Major Hill
Watershed:	Cape Fear, 0303002
XS ID	UT 1, XS - 4, Riffle
Feature	Riffle
Date:	3/15/2021
Field Crew:	Adams, Lawson

SUMMARY DATA	
Bankfull Elevation:	520.6
LTOB Elevation:	520.7
Bankfull Cross-Sectional Area:	5.8
Bankfull Width:	10.8
Flood Prone Area Elevation:	521.7
Flood Prone Width:	40.0
Max Depth at Bankfull:	1.1
Low Bank Height:	1.1
Mean Depth at Bankfull:	0.5
W / D Ratio:	19.9
Entrenchment Ratio:	3.7
Bank Height Ratio:	1.0

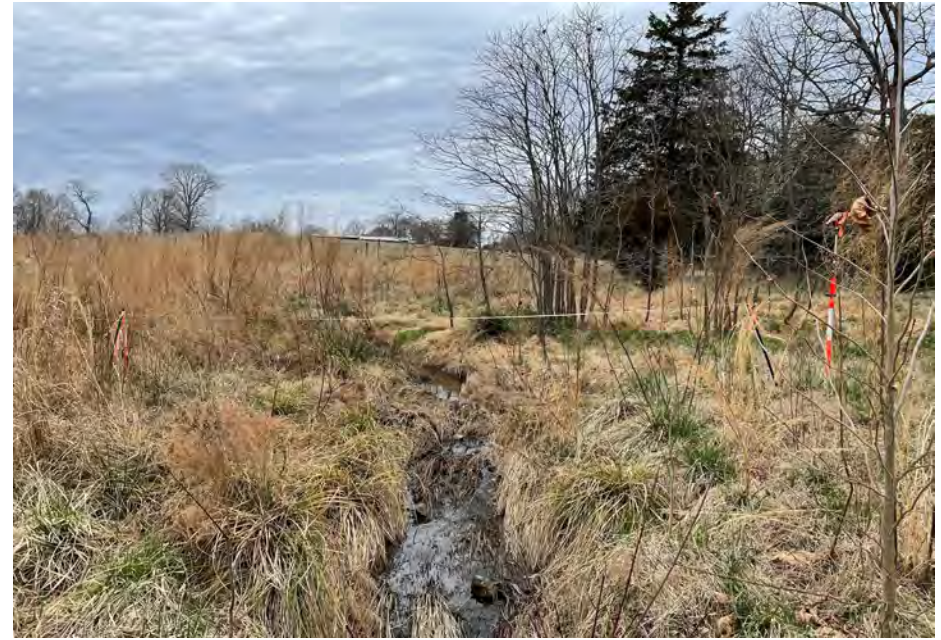
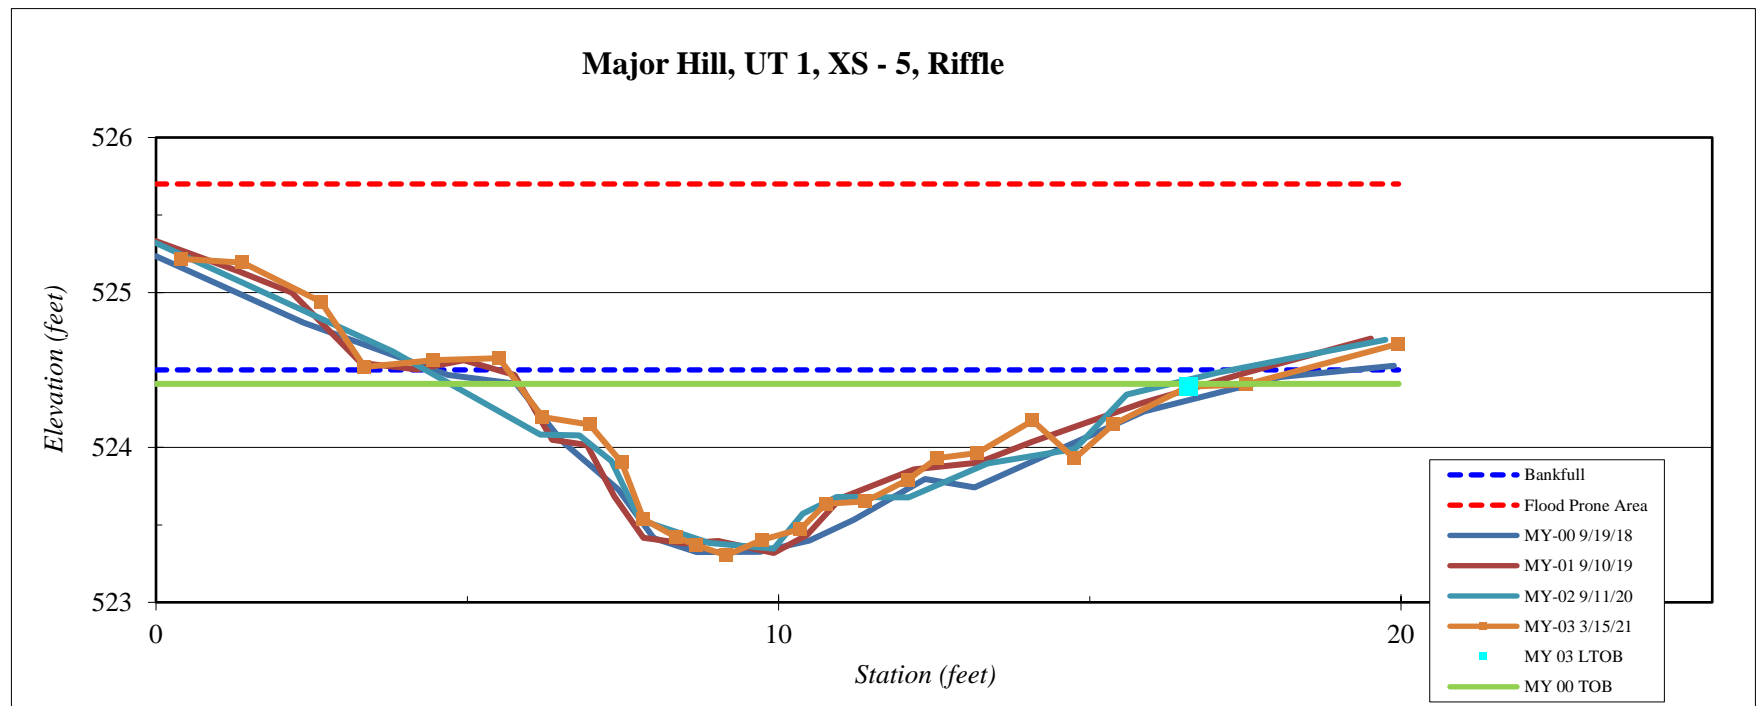
Site	Major Hill
Watershed:	Cape Fear, 0303002
XS ID	UT 1, XS - 5, Riffle
Feature	Riffle
Date:	3/15/2021
Field Crew:	Adams, Lawson

SUMMARY DATA	
Bankfull Elevation:	524.5
LTOB Elevation:	524.4
Bankfull Cross-Sectional Area:	7.1
Bankfull Width:	12.7
Flood Prone Area Elevation:	525.7
Flood Prone Width:	40.0
Max Depth at Bankfull:	1.2
Low Bank Height:	1.1
Mean Depth at Bankfull:	0.6
W / D Ratio:	22.8
Entrenchment Ratio:	3.1
Bank Height Ratio:	0.9

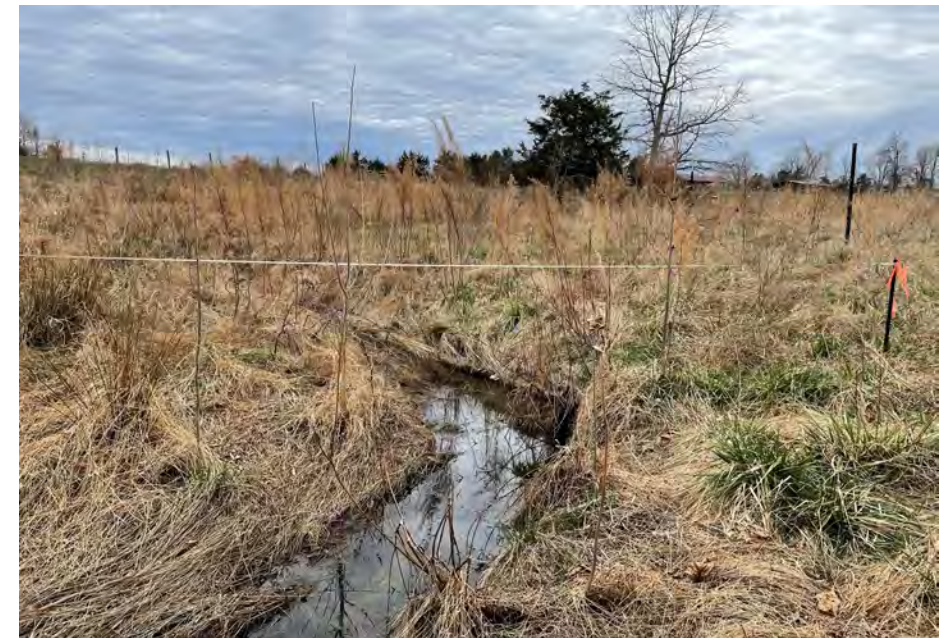
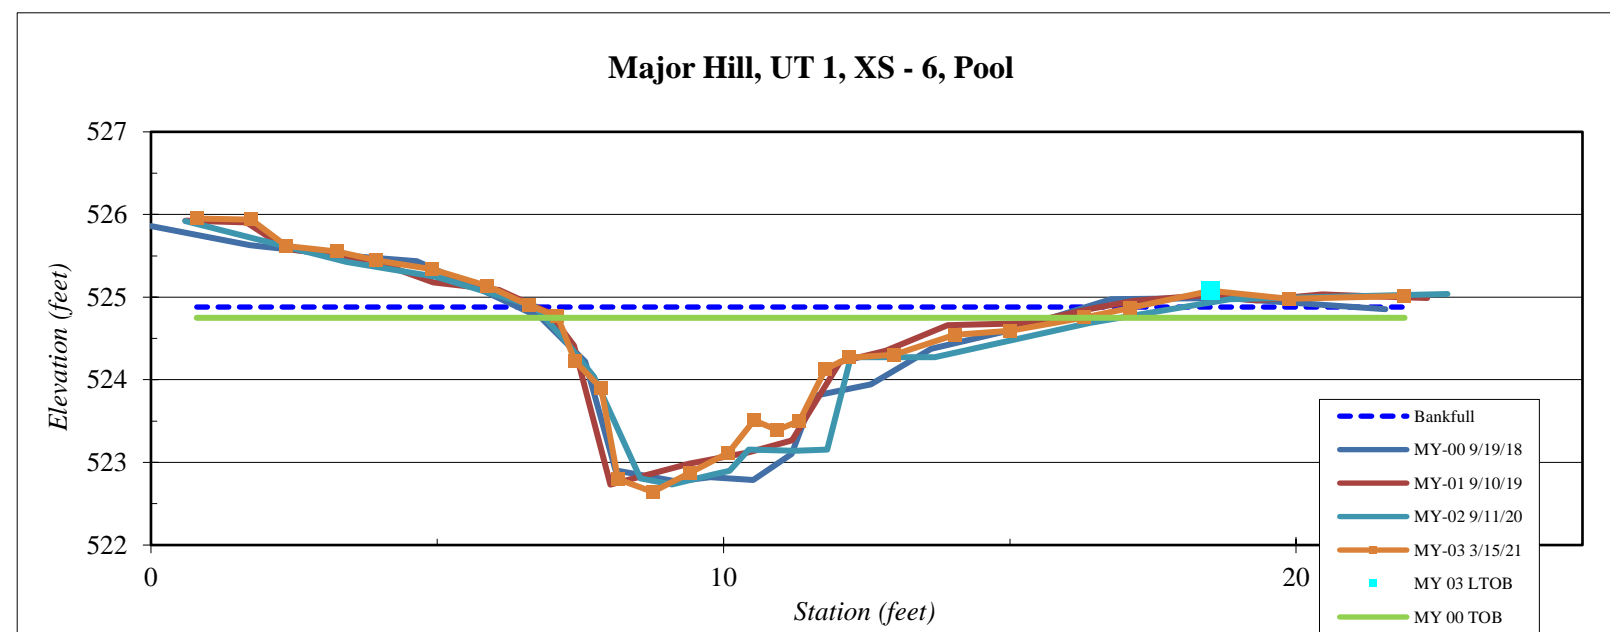
Site	Major Hill
Watershed:	Cape Fear, 0303002
XS ID	UT 1, XS - 6, Pool
Feature	Pool
Date:	3/15/2021
Field Crew:	Adams, Lawson

SUMMARY DATA	
Bankfull Elevation:	524.9
LTOB Elevation:	525.1
Bankfull Cross-Sectional Area:	9.1
Bankfull Width:	10.5
Flood Prone Area Elevation:	NA
Flood Prone Width:	NA
Max Depth at Bankfull:	2.2
Low Bank Height:	2.4
Mean Depth at Bankfull:	0.9
W / D Ratio:	NA
Entrenchment Ratio:	NA
Bank Height Ratio:	1.1

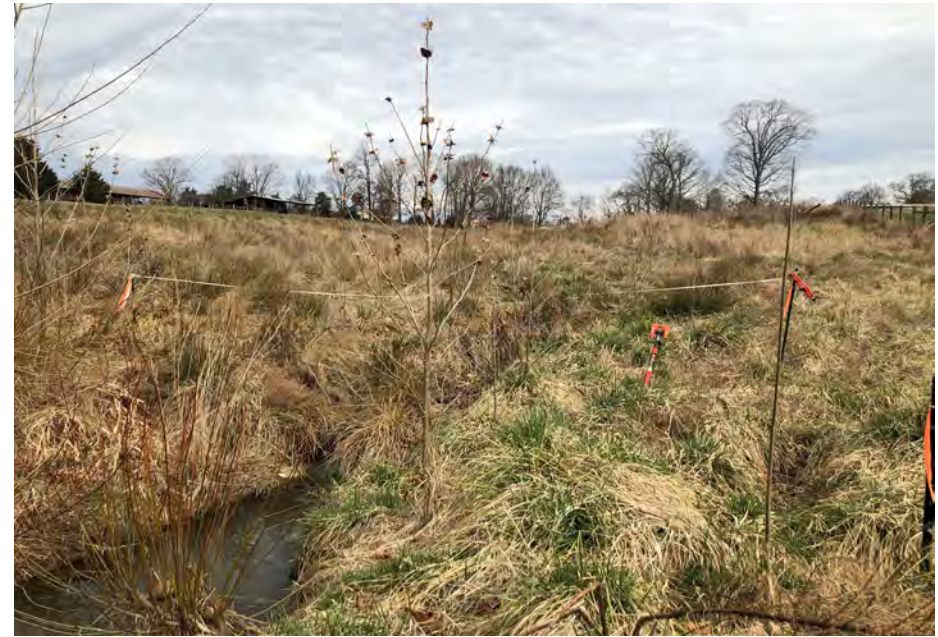
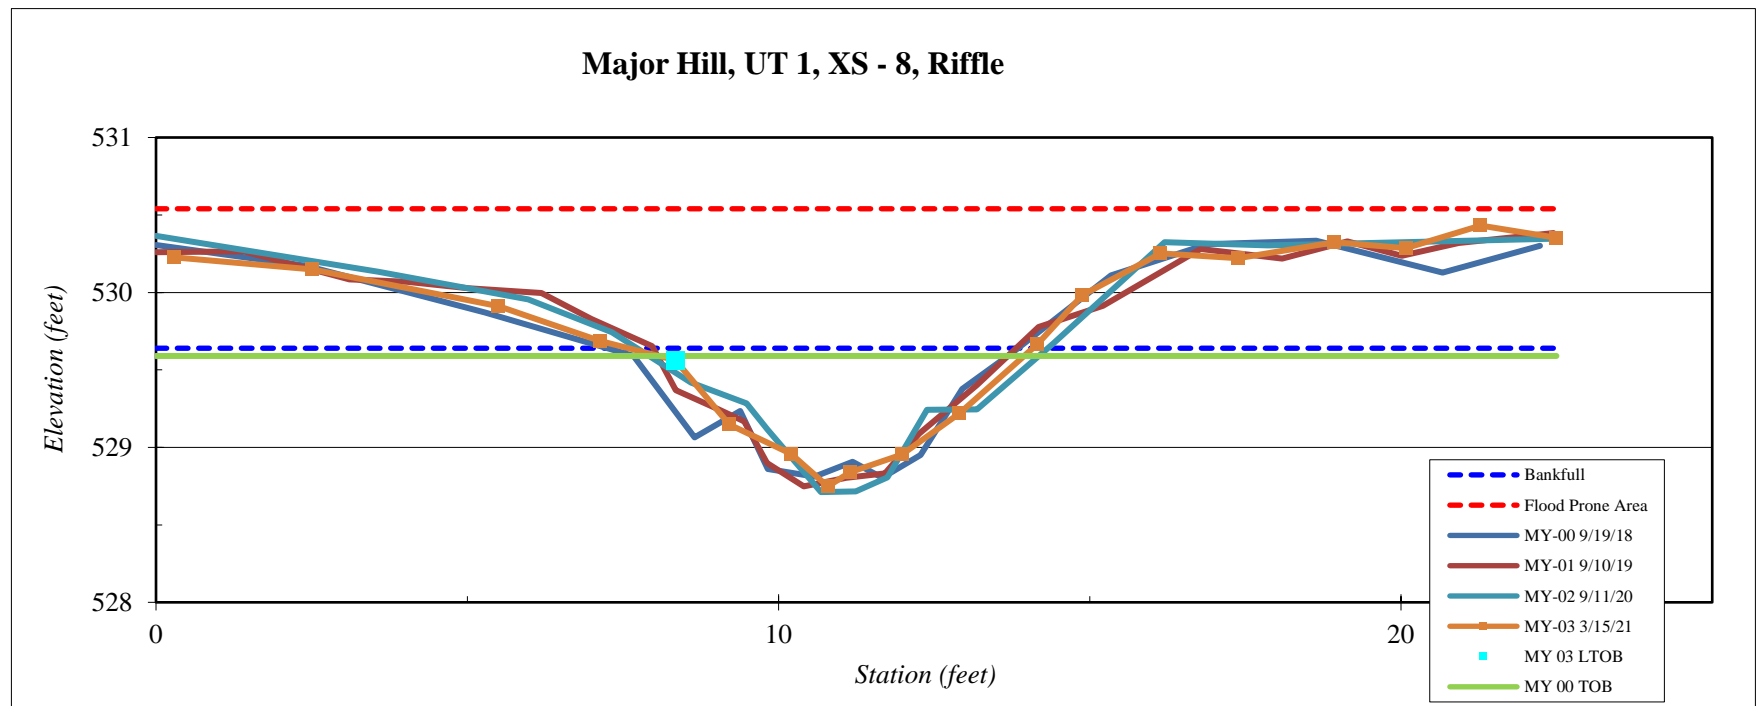
Site	Major Hill
Watershed:	Cape Fear, 0303002
XS ID	UT 1, XS - 8, Riffle
Feature	Riffle
Date:	3/15/2021
Field Crew:	Adams, Lawson

SUMMARY DATA	
Bankfull Elevation:	529.6
LTOB Elevation:	529.6
Bankfull Cross-Sectional Area:	3.0
Bankfull Width:	6.5
Flood Prone Area Elevation:	530.5
Flood Prone Width:	23.0
Max Depth at Bankfull:	0.9
Low Bank Height:	0.8
Mean Depth at Bankfull:	0.5
W / D Ratio:	14.0
Entrenchment Ratio:	3.5
Bank Height Ratio:	0.9

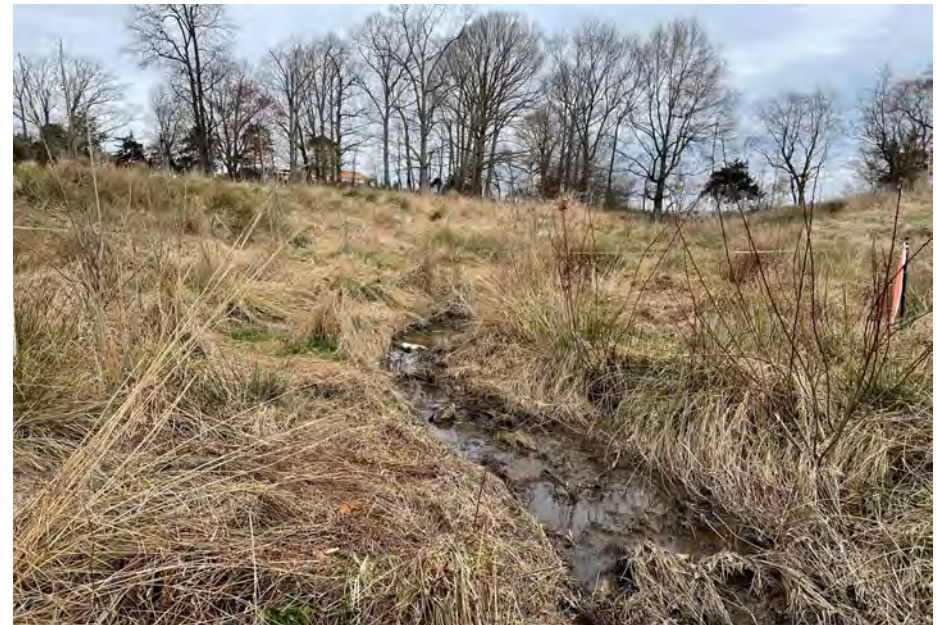
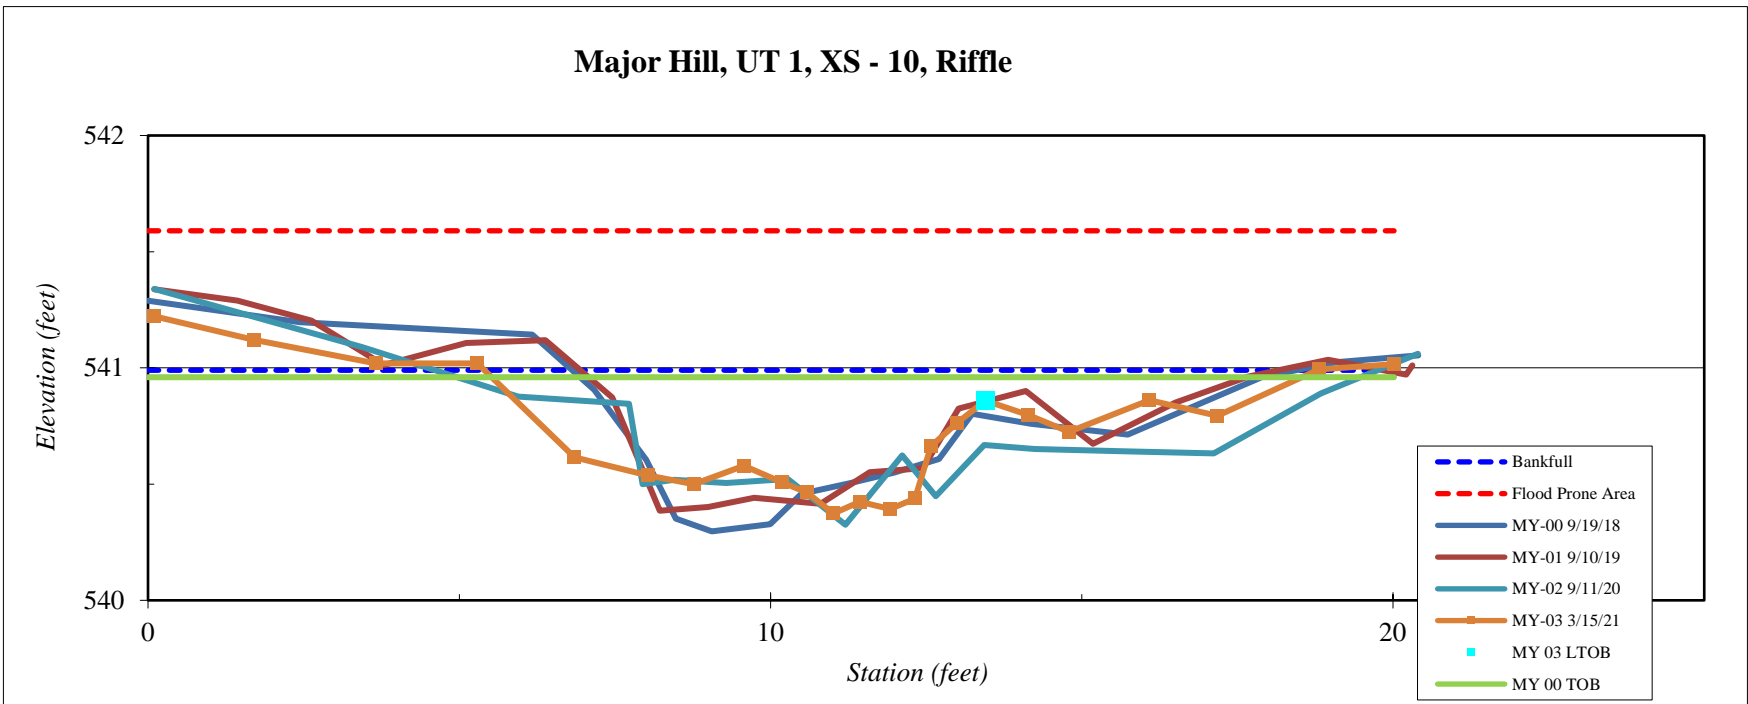
Site	Major Hill
Watershed:	Cape Fear, 0303002
XS ID	UT 1, XS - 10, Riffle
Feature	Riffle
Date:	3/15/2021
Field Crew:	Adams, Lawson

SUMMARY DATA	
Bankfull Elevation:	541.0
LTOB Elevation:	540.9
Bankfull Cross-Sectional Area:	3.5
Bankfull Width:	9.4
Flood Prone Area Elevation:	541.6
Flood Prone Width:	40.0
Max Depth at Bankfull:	0.6
Low Bank Height:	0.5
Mean Depth at Bankfull:	0.4
W / D Ratio:	0.3
Entrenchment Ratio:	4.3
Bank Height Ratio:	0.8

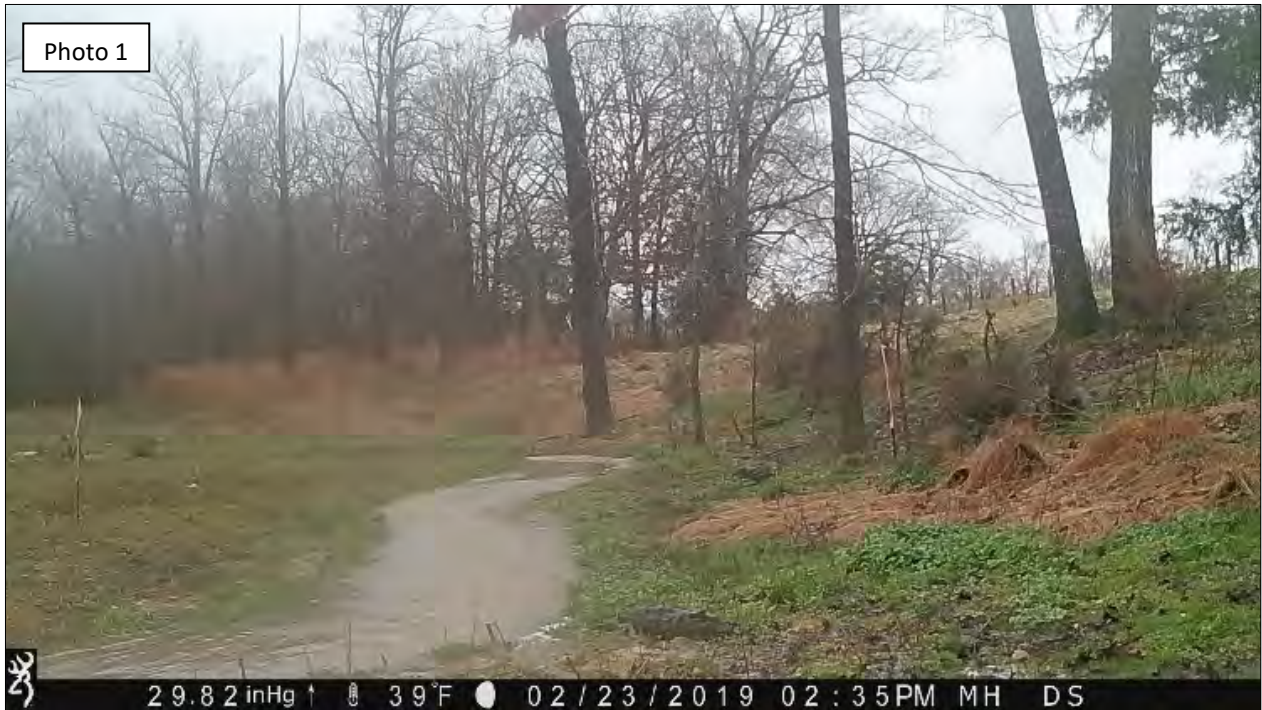
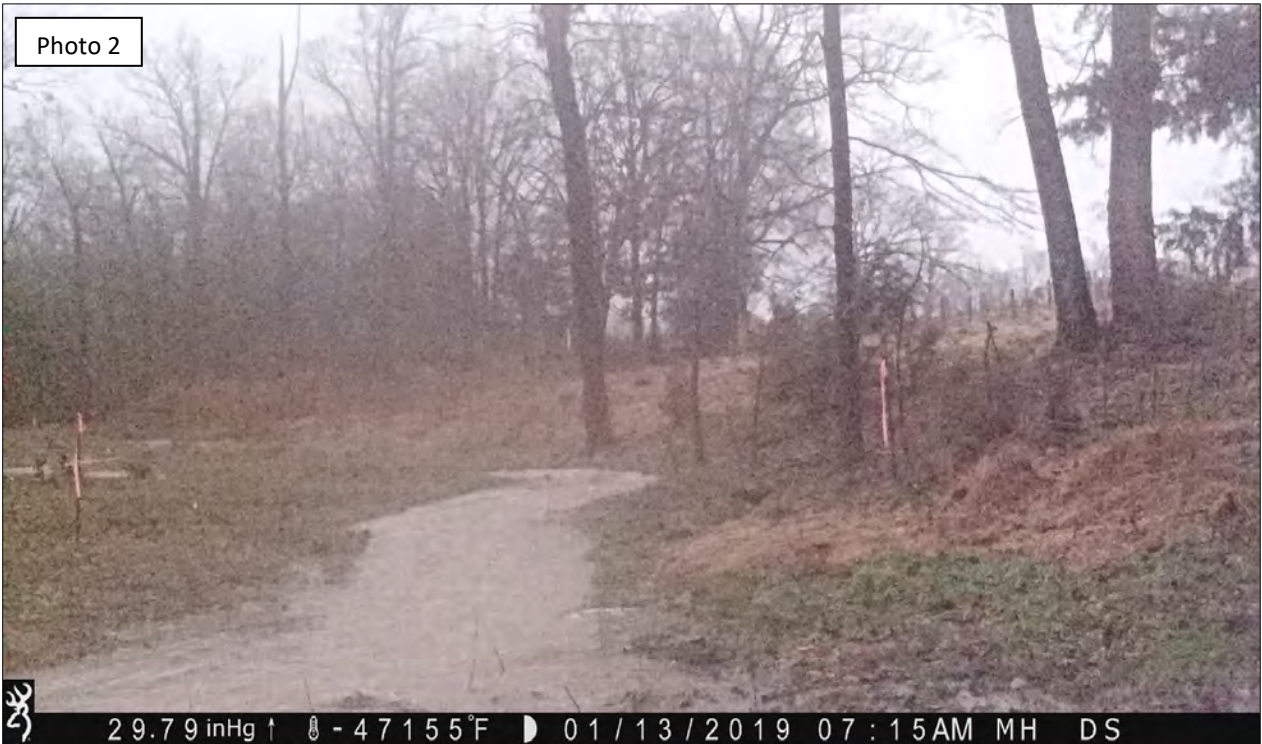
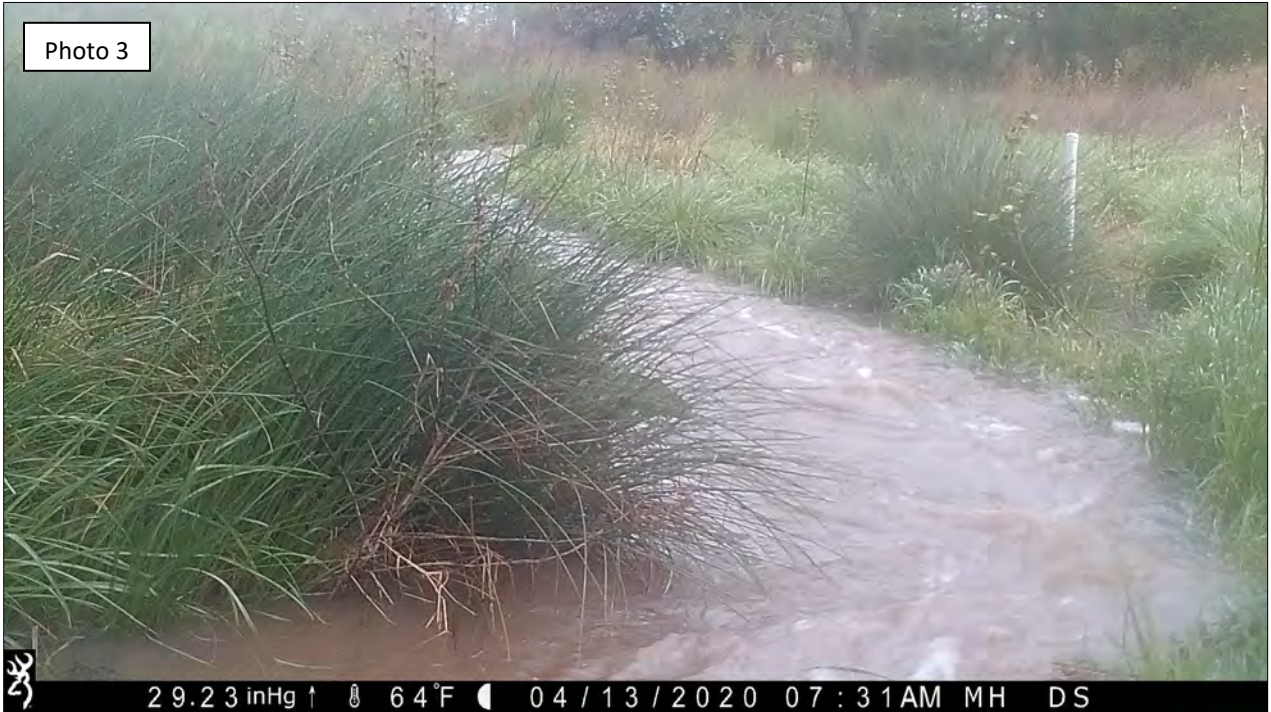
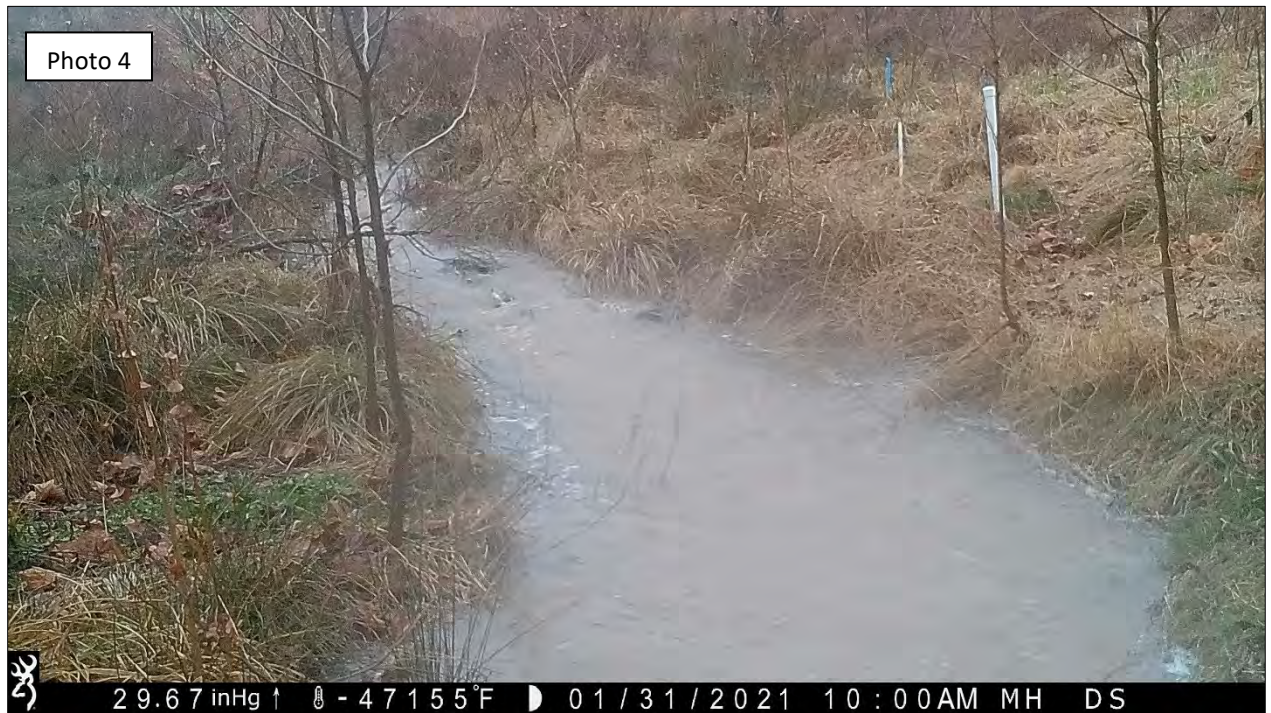
Table 15. Verification of Bankfull Events

Date of Data Collection	Date of Occurrence	Method	Photo (if available)
March 19, 2019	January 13, 2019	A trail camera captured the stream at bankfull after 1.10 inches of rain was documented on January 13, 2019 at an onsite rain gauge.	1
March 19, 2019	February 23, 2019	A trail camera captured the stream at bankfull after 2.74 inches of rain was documented between February 22-23, 2019 at an onsite rain gauge.	2
June 27, 2019	April 13, 2019	Stream gauge data indicates a bankfull event occurred after 4.11 inches of rain was documented between April 12-13, 2019 at an onsite rain gauge.	--
September 9, 2019	July 24, 2019	A bankfull event likely occurred after 3.02 inches of rain was documented between July 23-24, 2019 at an onsite rain gauge.	--
September 9, 2019	August 1, 2019	A bankfull event likely occurred after 1.96 inches of rain was documented on August 1, 2019 at an onsite rain gauge.	--
April 13, 2020	April 13, 2020	A bankfull event was documented via trail camera after approximately 2.31 inches of rain was recorded at an onsite rain gauge	3

January 31, 2021	January 31, 2021	A bankfull event was documented via trail camera after approximately 1.19 inches of rain was recorded at an onsite rain gauge	4
March 11, 2021	February 15, 2021	Wrack and laid-back vegetation were observed along the top of bank and floodplain of UT-1 indicating a bankfull event occurred after 2.93 inches of rain was documented between February 11 and 15, 2021.	5
