MONITORING REPORT
2022 (Year 4)

MAJOR HILL STREAM AND WETLAND MITIGATION SITE

Alamance County, North Carolina

Data Collection: January 2022 – October 2022
Submission: February 2023

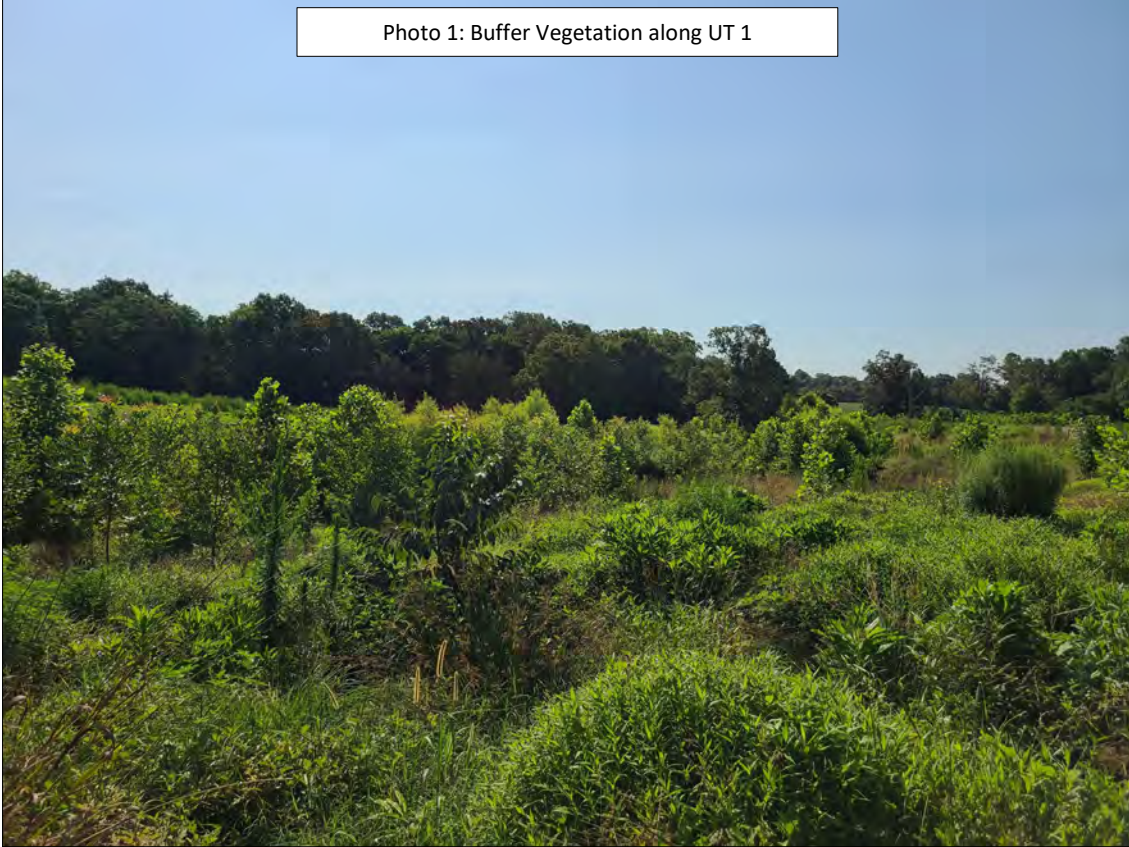
Photo 1: Buffer Vegetation along UT 1

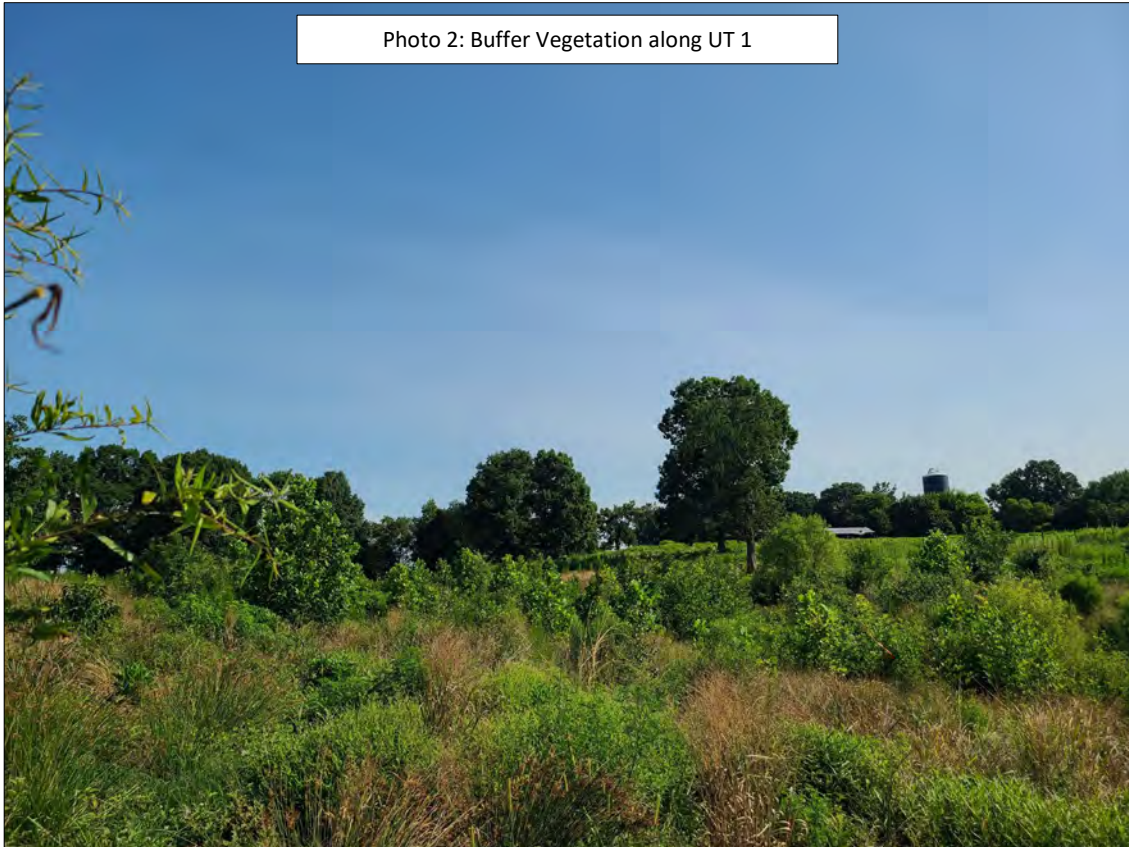
Photo 2: Buffer Vegetation along UT 1

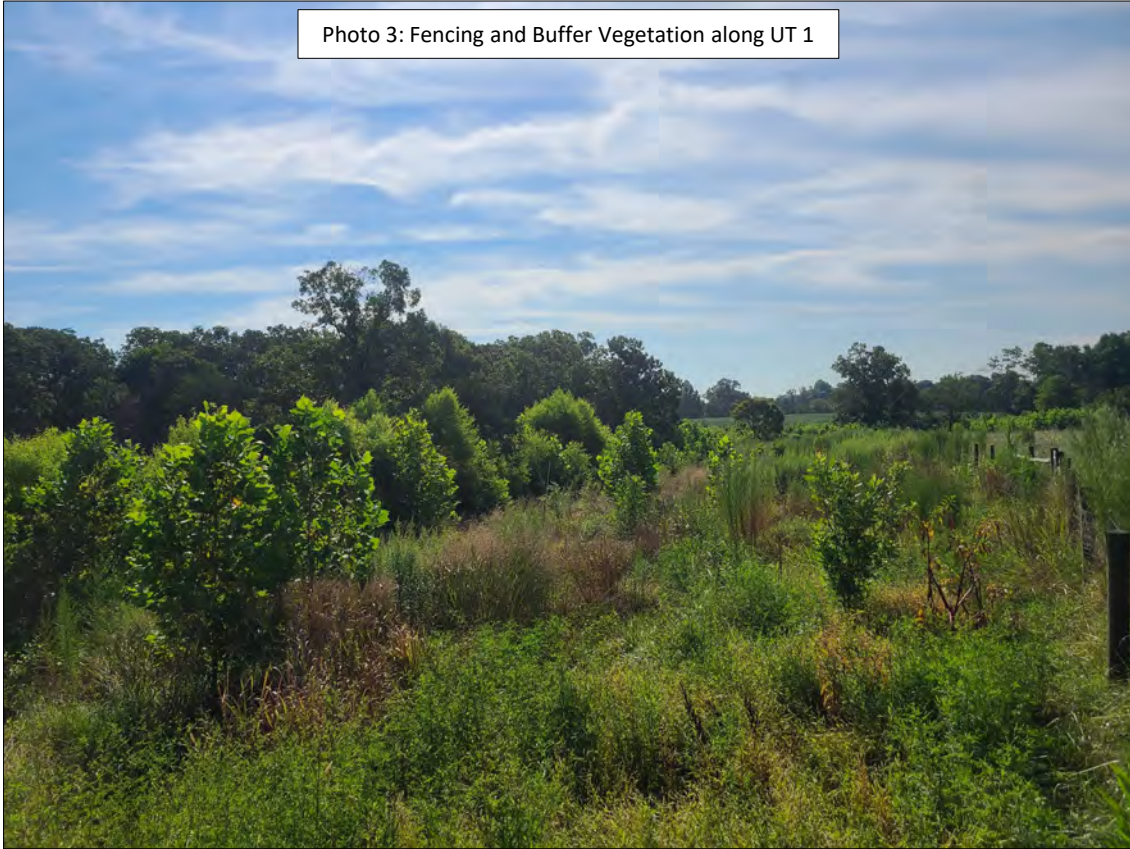
Photo 3: Fencing and Buffer Vegetation along UT 1

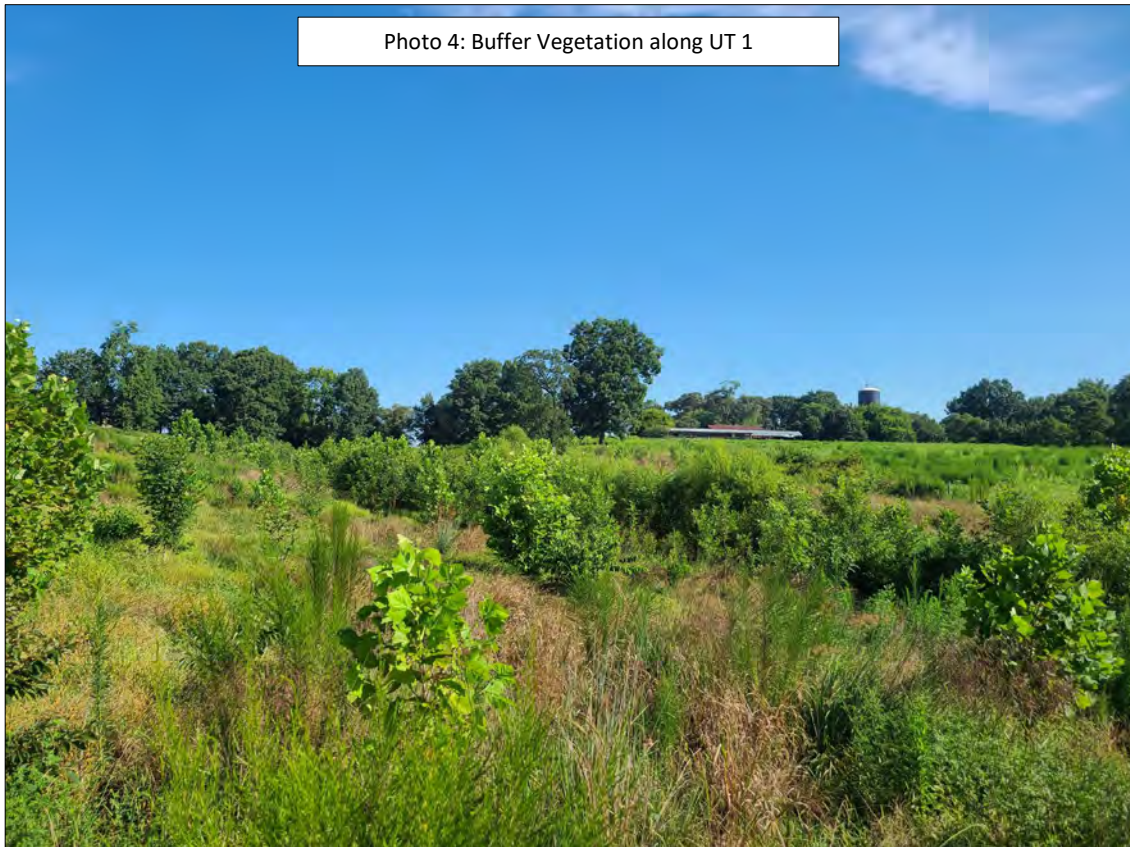
Photo 4: Buffer Vegetation along UT 1

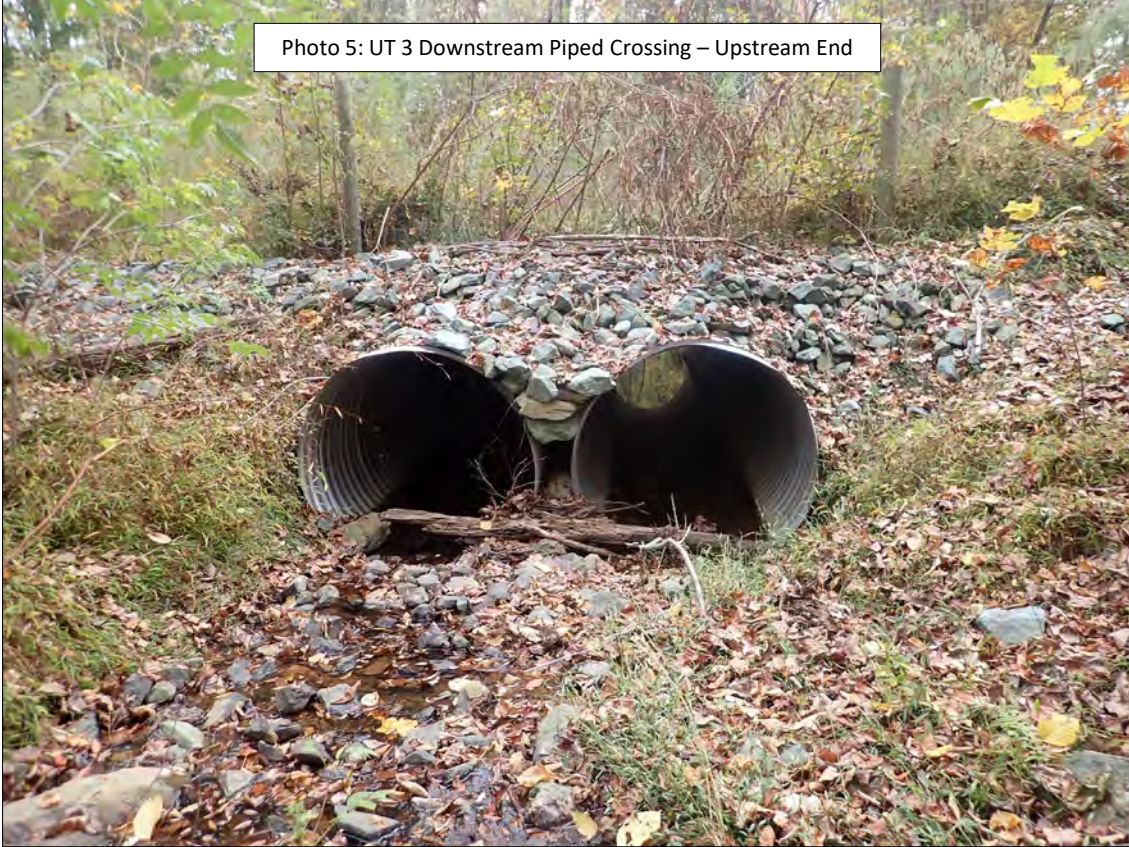
Photo 5: UT 3 Downstream Piped Crossing – Upstream End

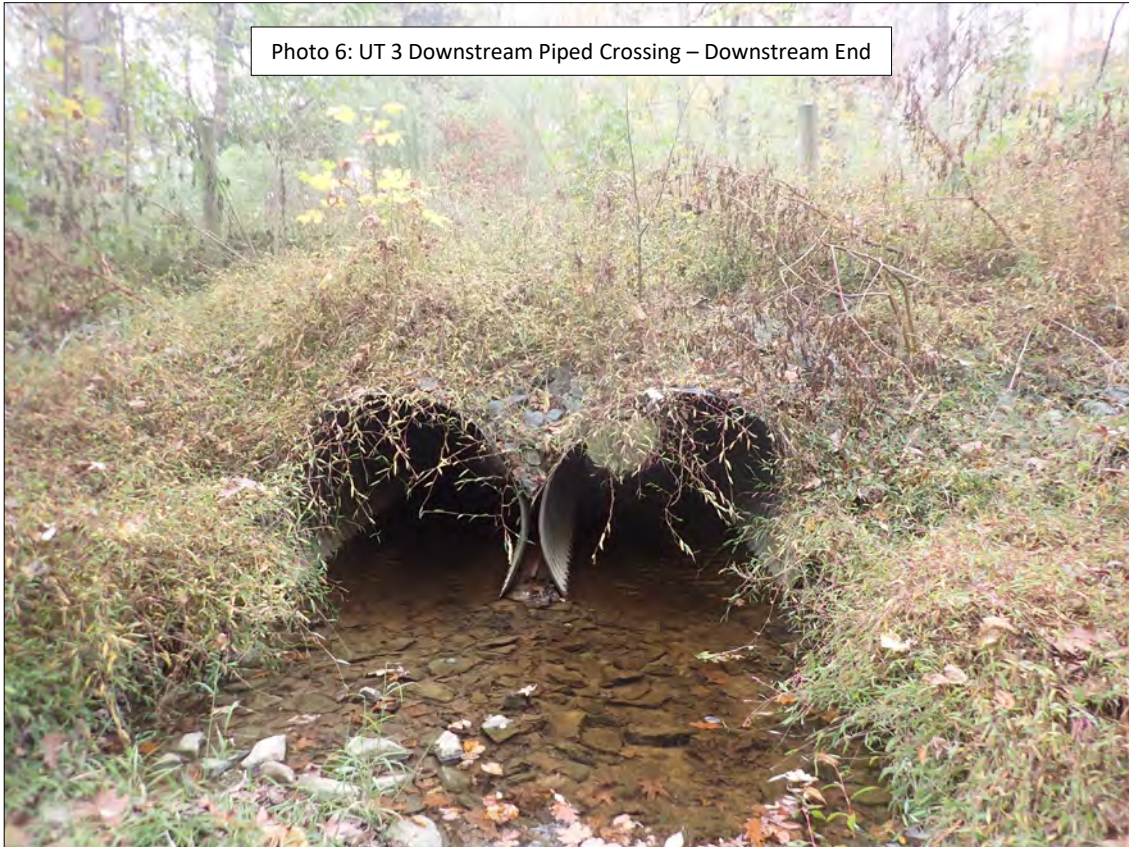
Photo 6: UT 3 Downstream Piped Crossing – Downstream End

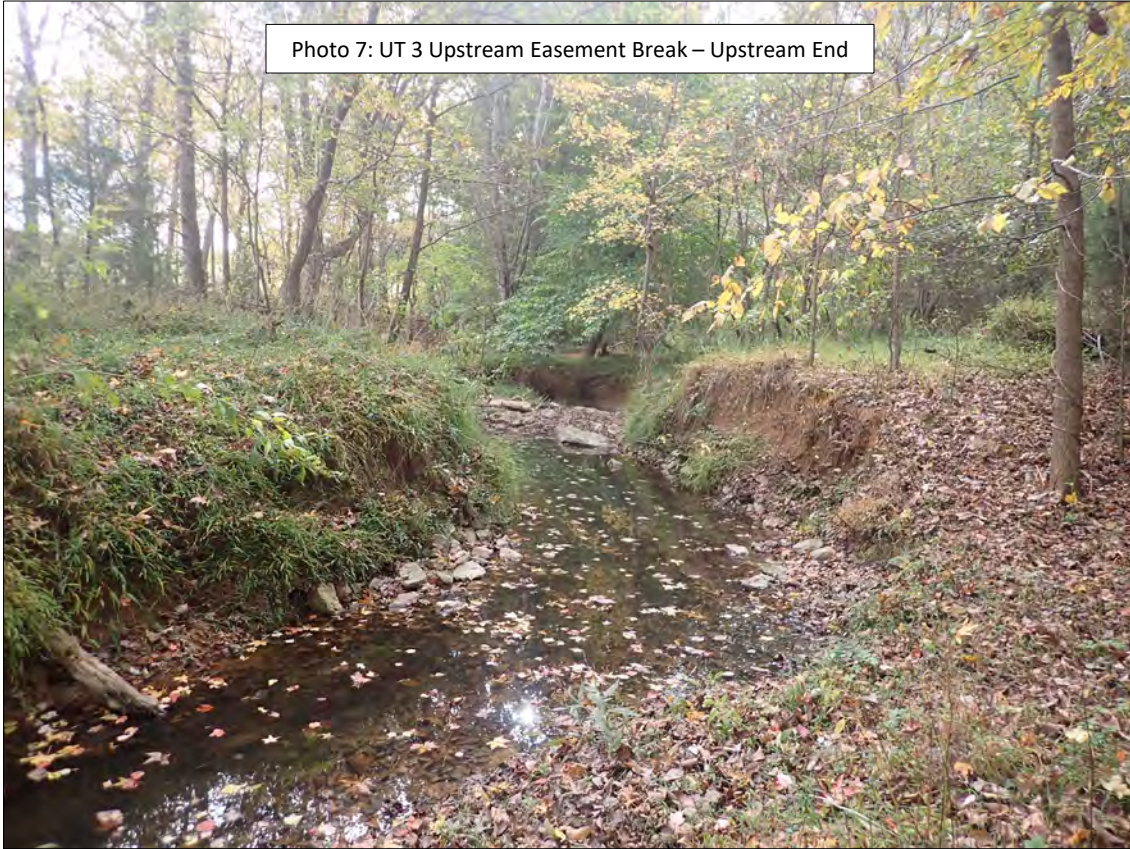
Photo 7: UT 3 Upstream Easement Break – Upstream End

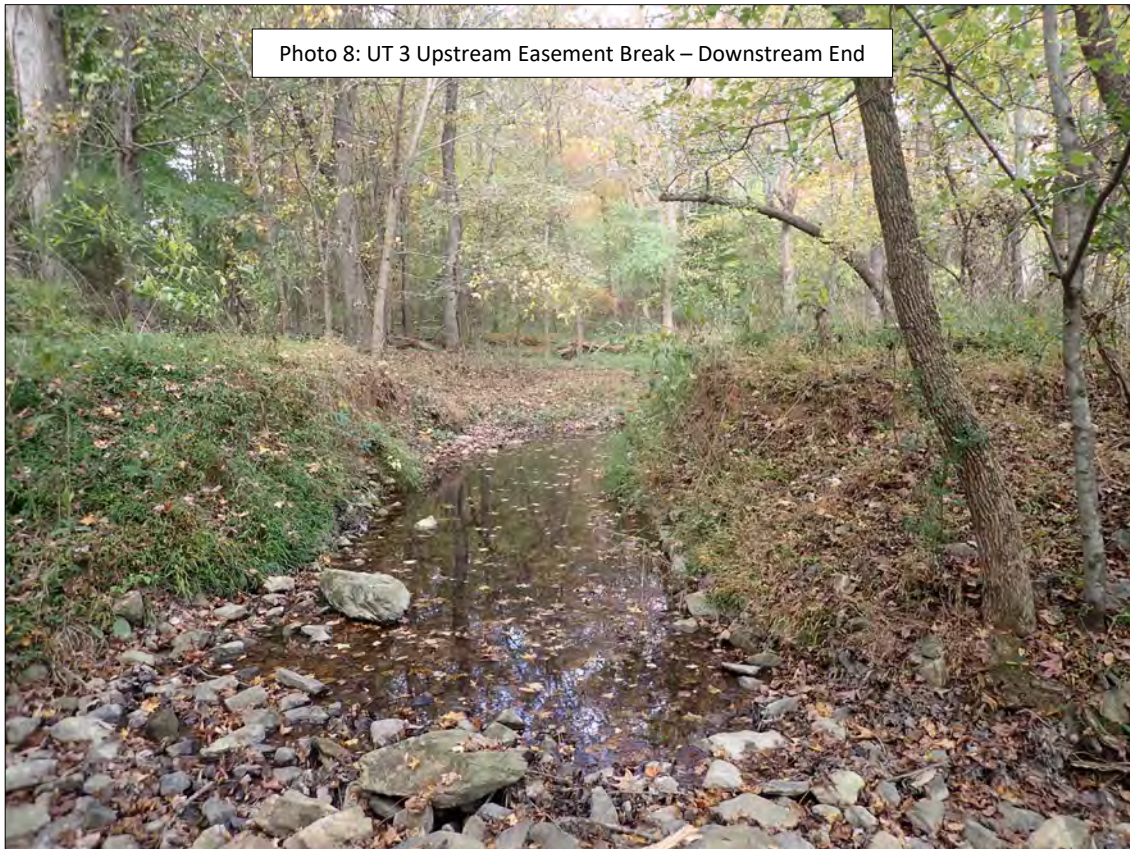
Photo 8: UT 3 Upstream Easement Break – Downstream End

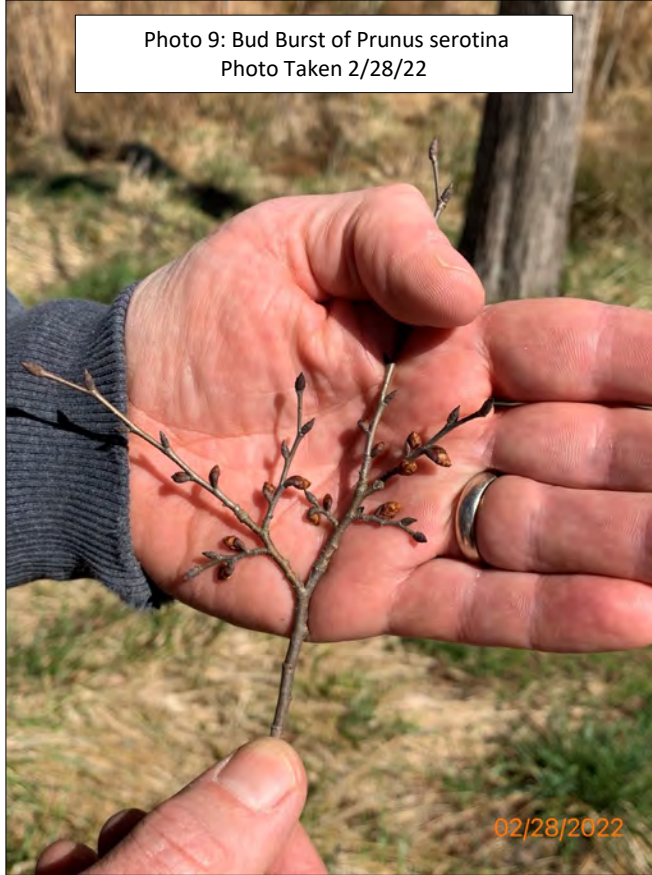
Photo 9: Bud Burst of *Prunus serotina*
Photo Taken 2/28/22

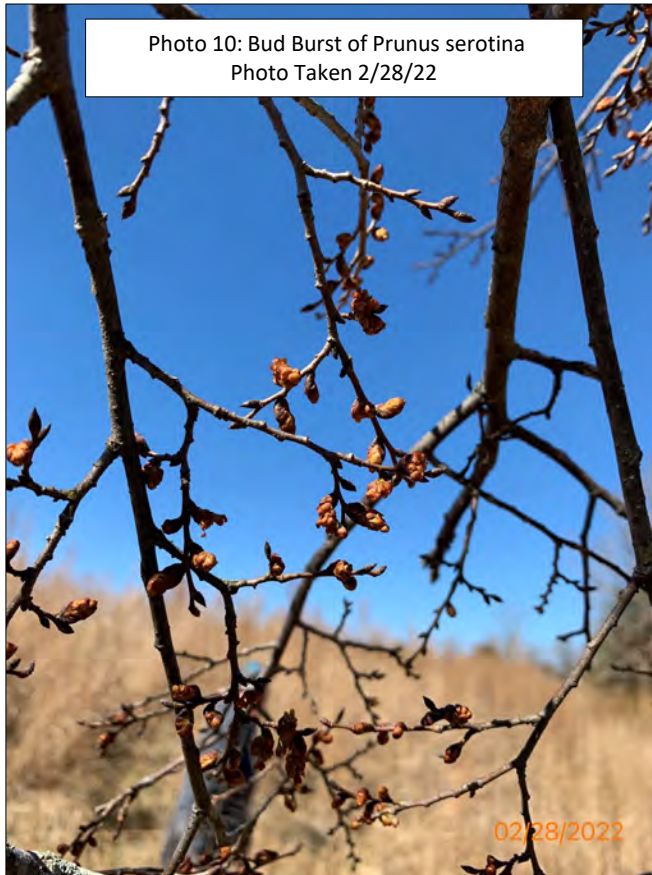
Photo 10: Bud Burst of *Prunus serotina*
Photo Taken 2/28/22

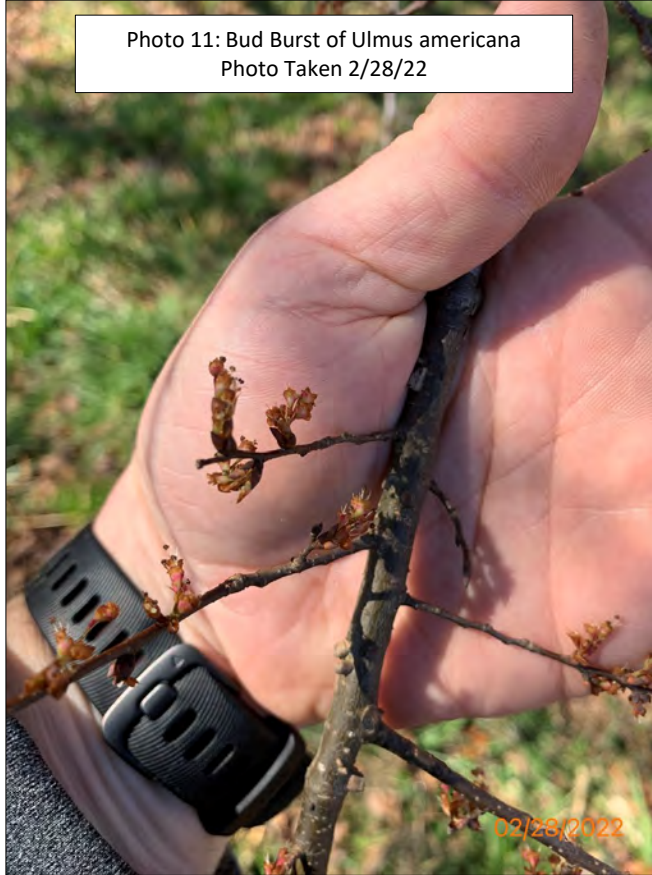
Photo 11: Bud Burst of *Ulmus americana*
Photo Taken 2/28/22

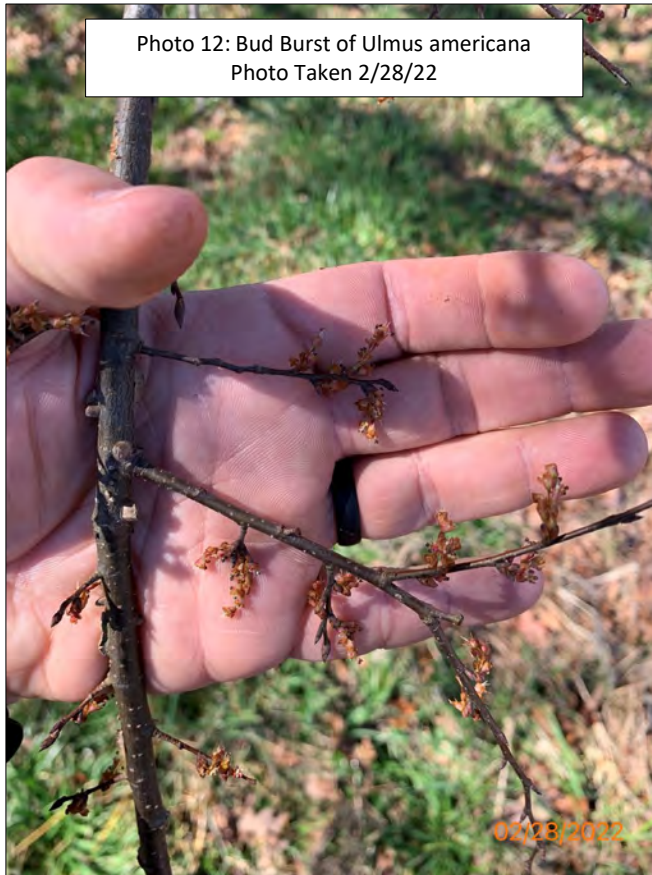
Photo 12: Bud Burst of *Ulmus americana*
Photo Taken 2/28/22
