**MONITORING REPORT**  
**2023 (Year 5)**

**MAJOR HILL STREAM AND WETLAND MITIGATION SITE**

Alamance County, North Carolina

DMS Project ID No. 100015  
Full Delivery Contract No. 7193  
USACE Action ID No. SAW-2017-01472  
DWR No. 17-0921  
RFP No. 16-006990

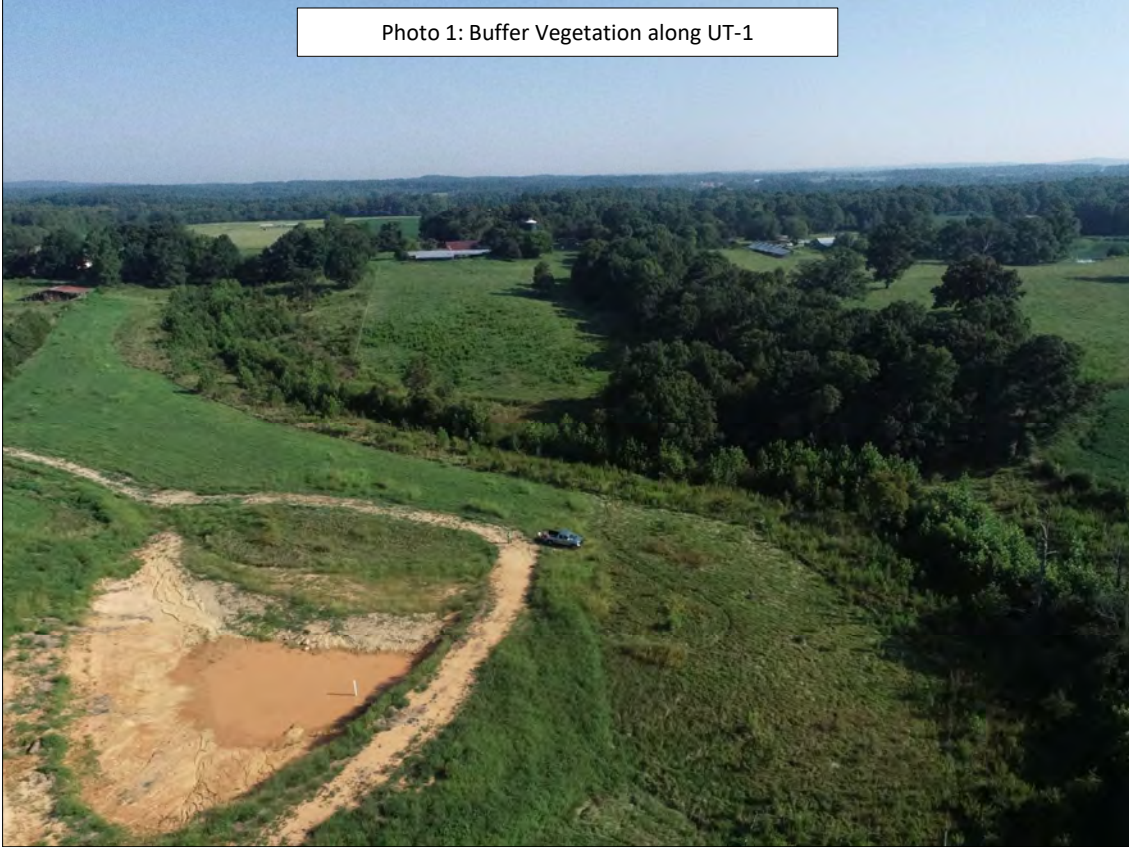
Photo 1: Buffer Vegetation along UT-1

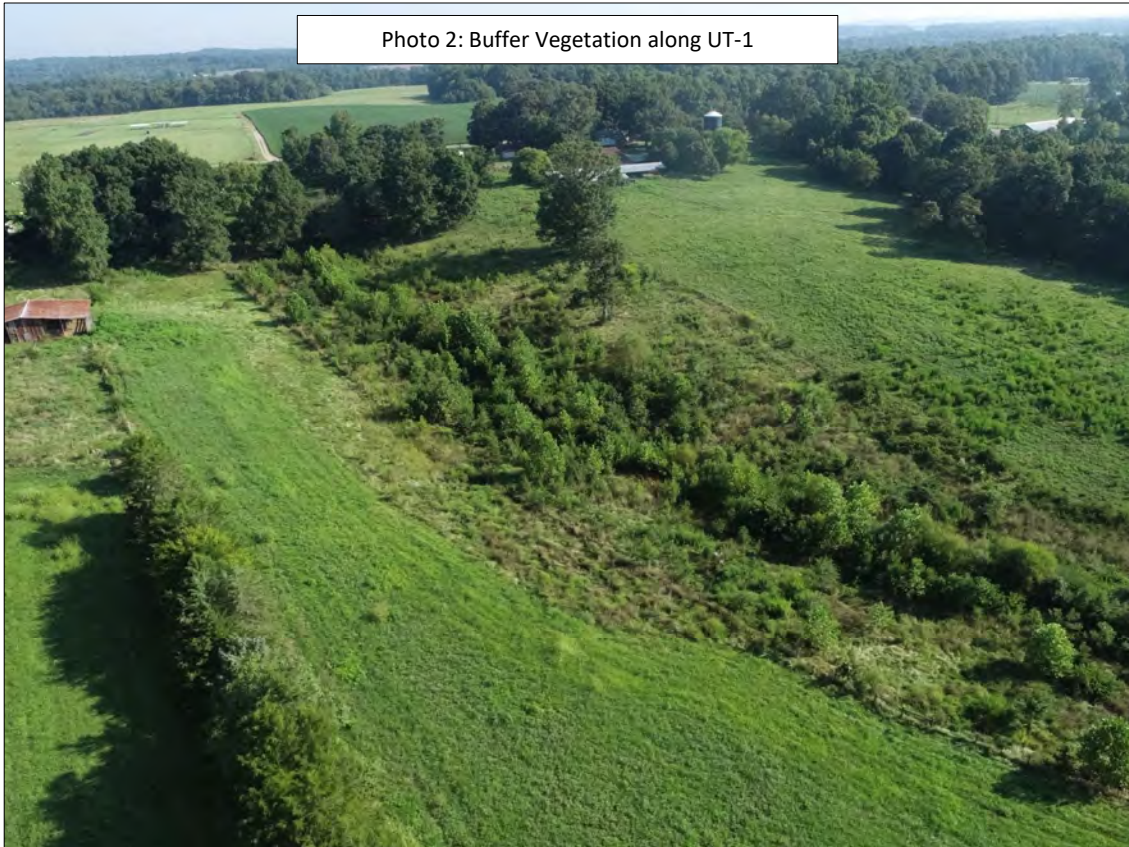
Photo 2: Buffer Vegetation along UT-1

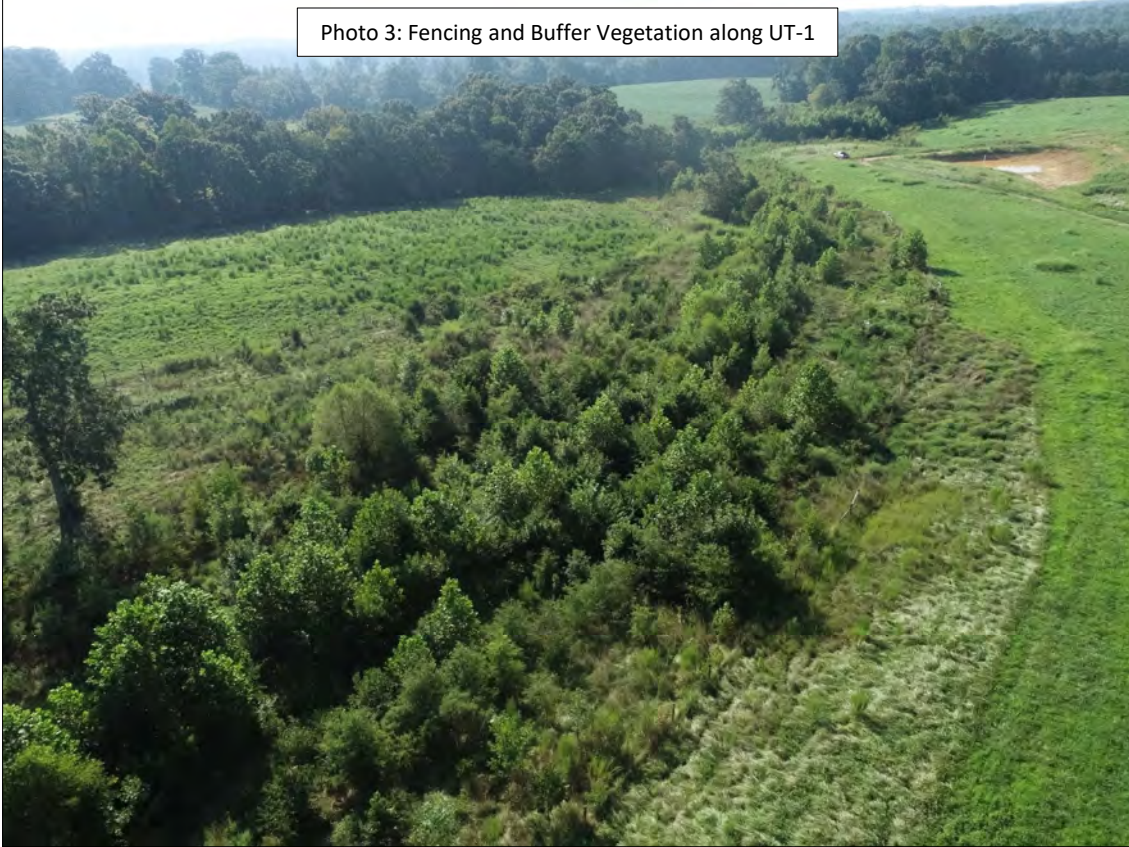
Photo 3: Fencing and Buffer Vegetation along UT-1

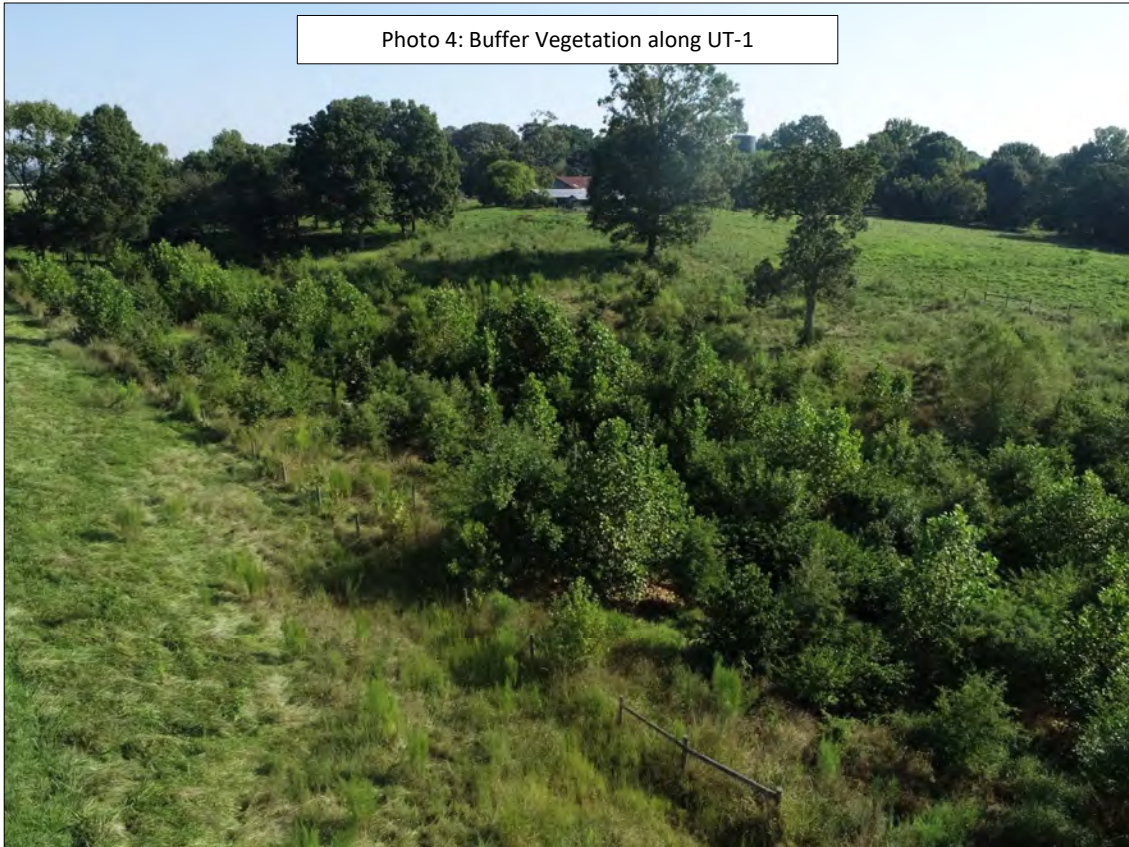
Photo 4: Buffer Vegetation along UT-1

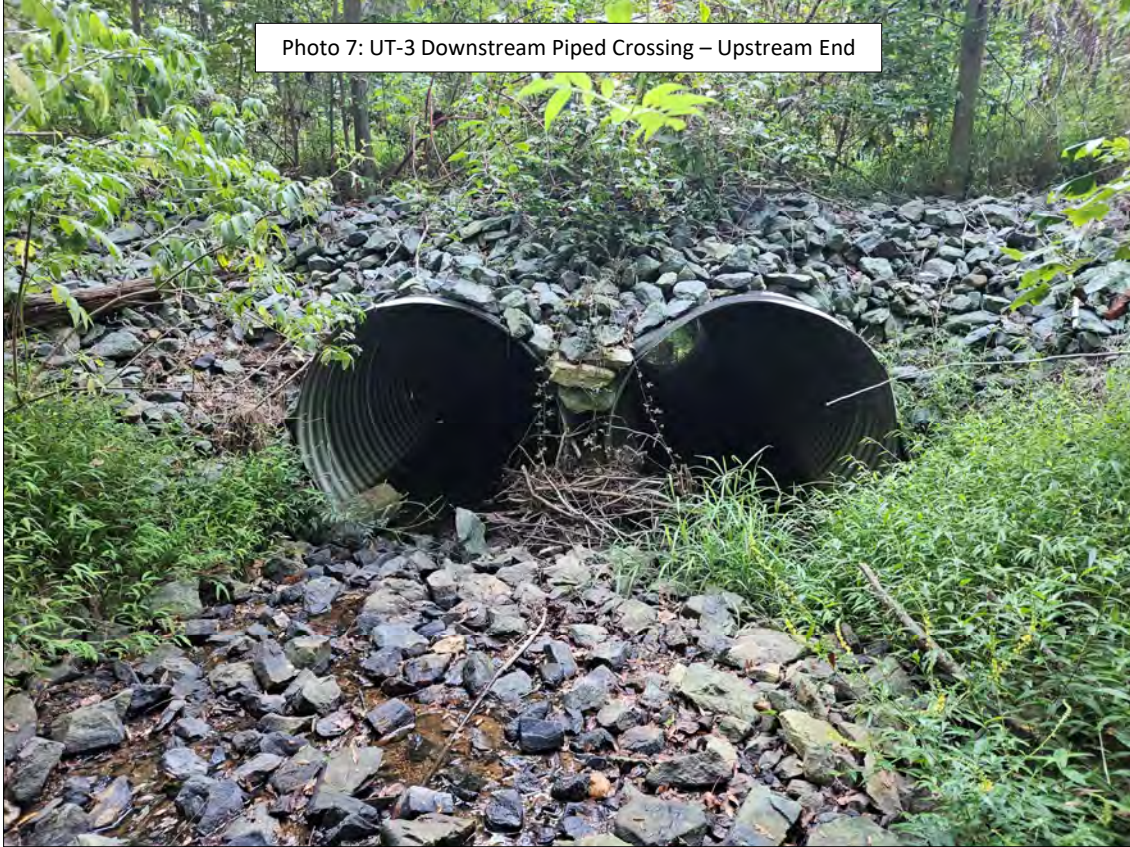
Photo 7: UT-3 Downstream Piped Crossing – Upstream End

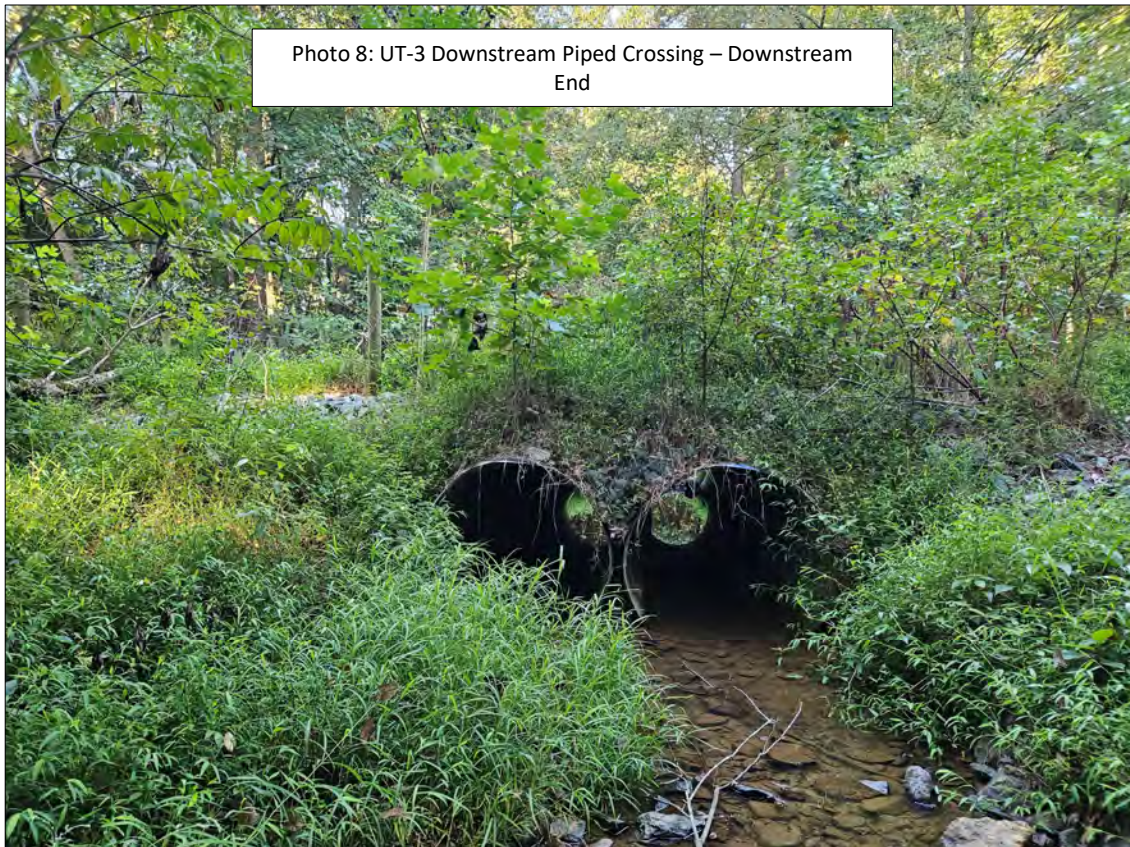
Photo 8: UT-3 Downstream Piped Crossing – Downstream End

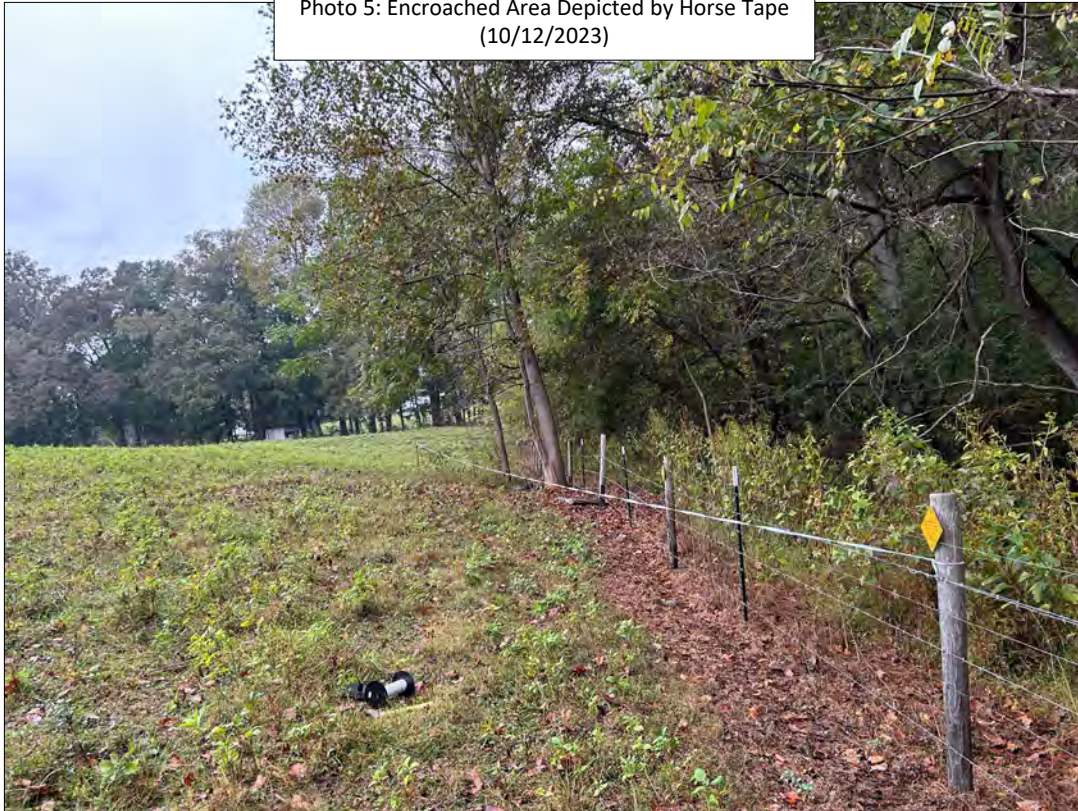
Photo 5: Encroached Area Depicted by Horse Tape  
(10/12/2023)
