# ANNUAL REPORT FOR 2000

**Mallard Creek Mitigation Site  
Mecklenburg County  
Project No. 8.1999974 (M-316)  
TIP No. R-211 WM**

Prepared By:  
Natural Systems Unit & Roadside Environmental Unit  
North Carolina Department of Transportation  
December 2000

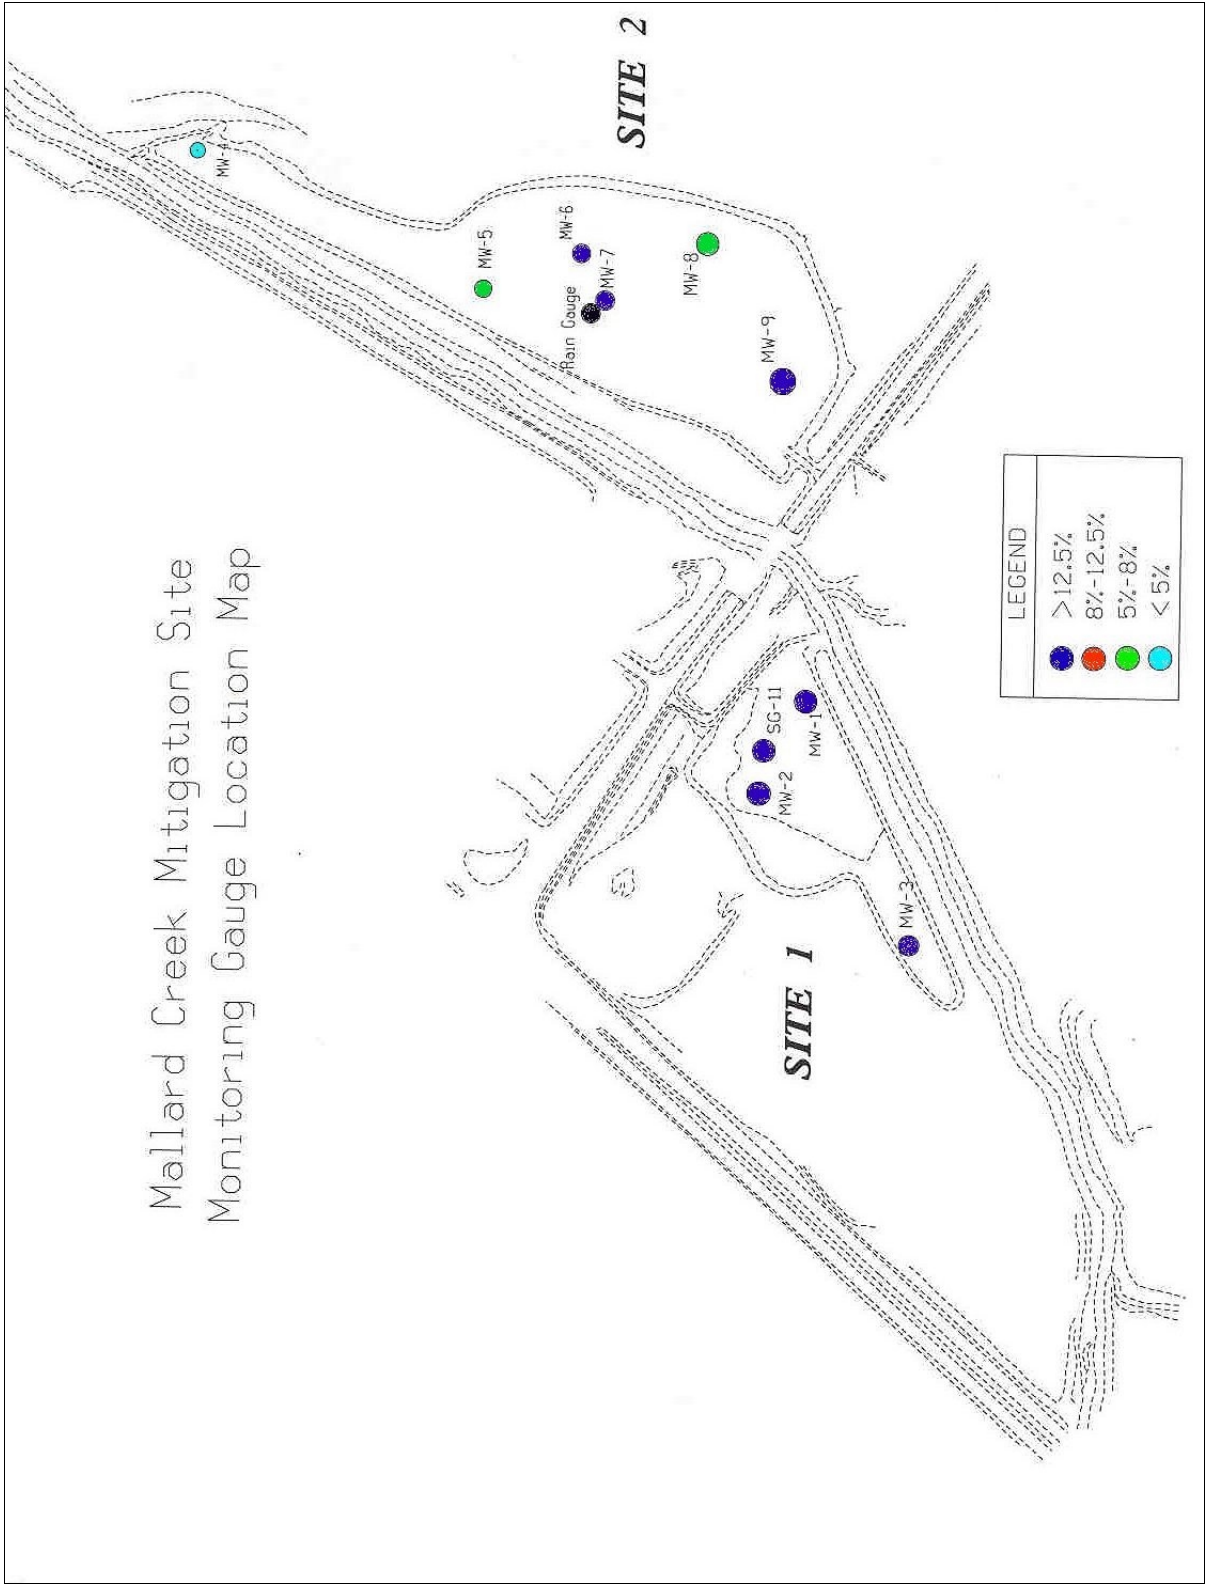
### Figure 3. Hydrologic Monitoring Results.

Site 1 hydrologic data indicates that the site meets the hydrologic success criteria established by the USACE permit. The site was saturated or inundated for more than 26 days of the growing season. The surface gauge located on Site 1 also showed consistent inundation throughout the growing season. A 12" water main leak adjacent to his site has effected the hydrology at this location. The extent of the effect is unknown at this time.

Site 2 hydrologic data indicates that only three of six gauges met the hydrologic success criteria established for the site. Only gauges 6, 7, and 9 showed saturation or inundation greater than 26 days of the growing season. Gauges 4, 5, and 8 failed to meet the hydrologic success criteria. The data for Site 2, as in 1999, still indicates that the groundwater levels drop quickly after rainfall.

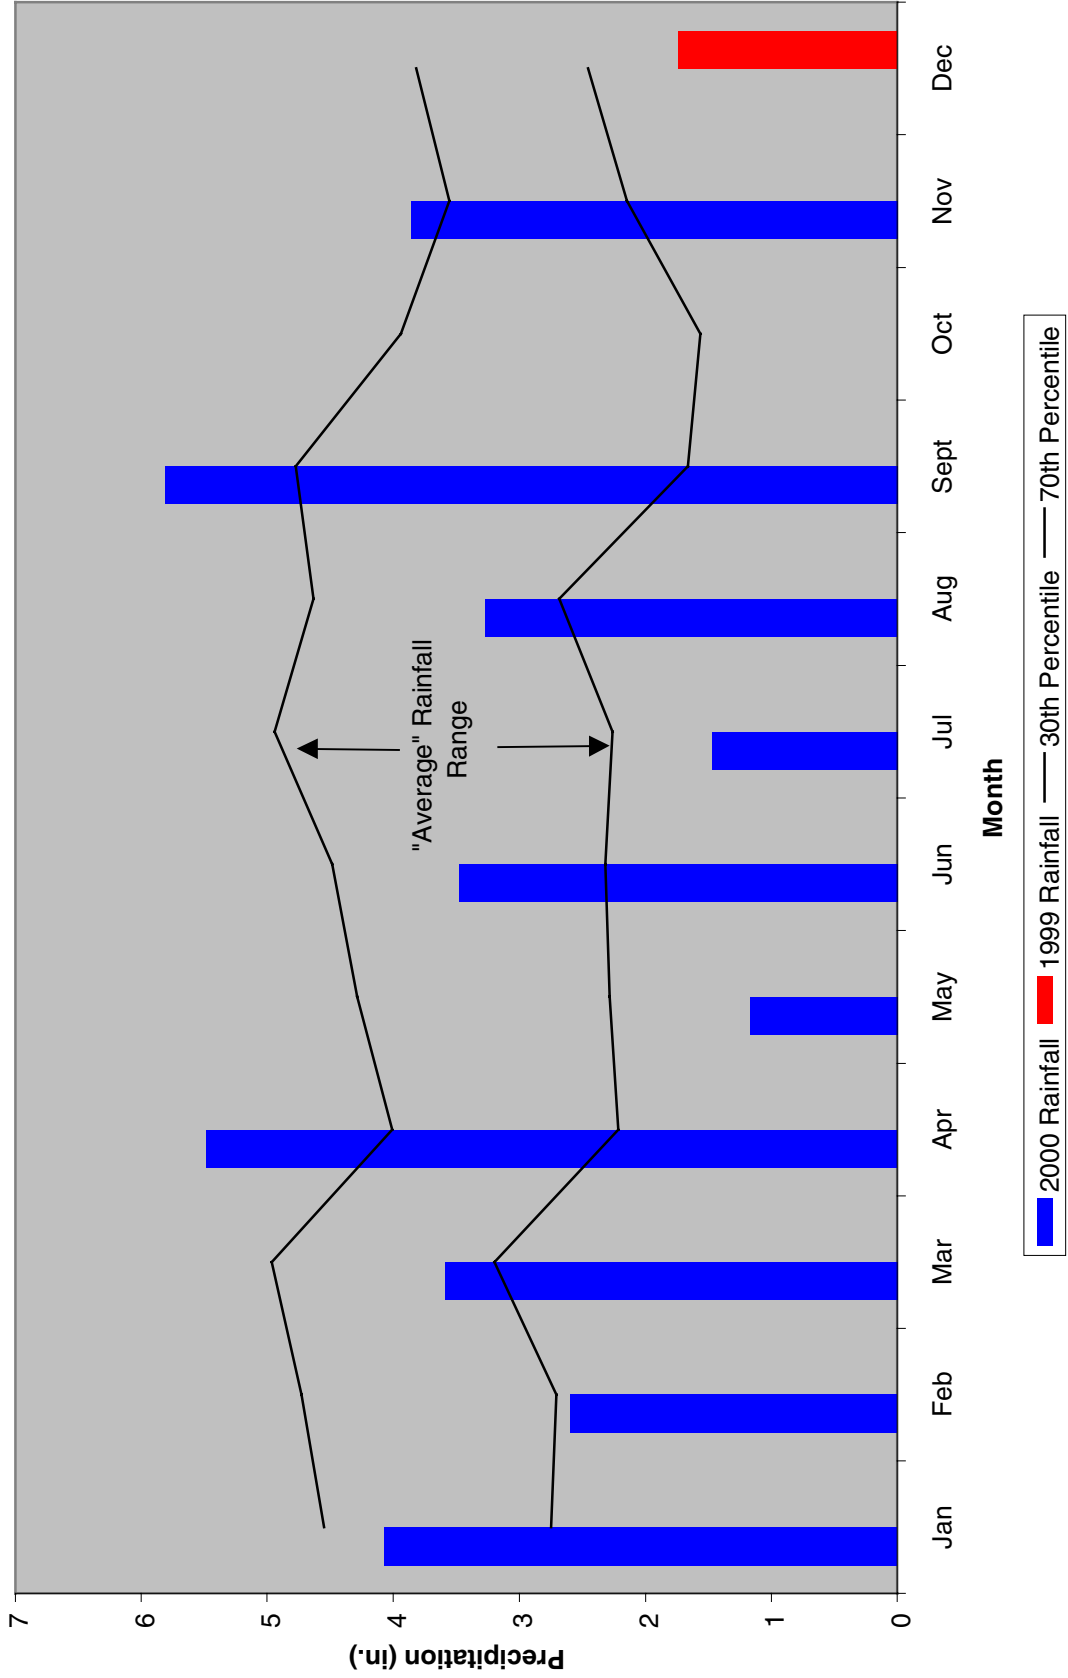
**Figure 4. 30-70 Percentile Graph.  
Mallard Creek 30-70 Percentile Graph  
Charlotte, NC**

Figure 4 shows the monthly rainfall totals for the period of December 1999 through November 2000. The data for this period shows above average rainfall for three months (April, September, and November) and below average rainfall for five months of the monitoring period (February, May, July, October, and December). The observed cumulative rainfall of 36.53 inches is below the twenty nine year average rainfall range of 44 to 46 inches (1961-1990).

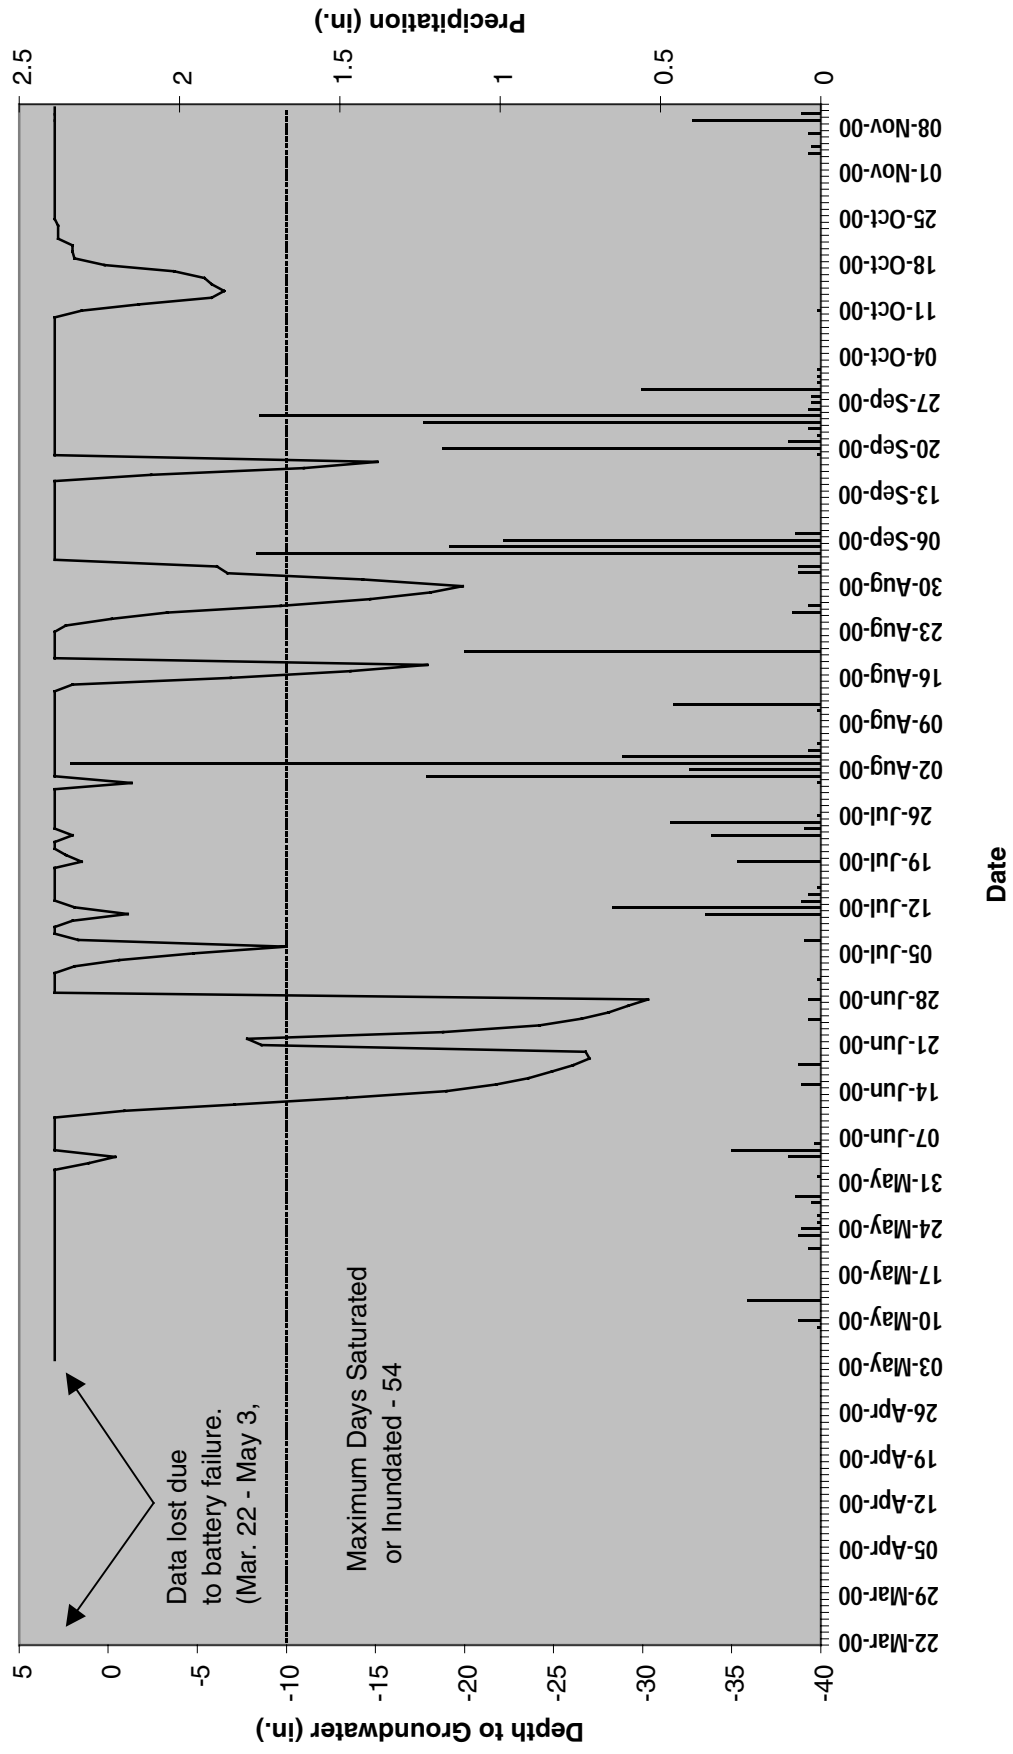
### Mallard Creek MW-1

MW 1: Data was lost due to battery failure from March 22 to May 3, 2000.

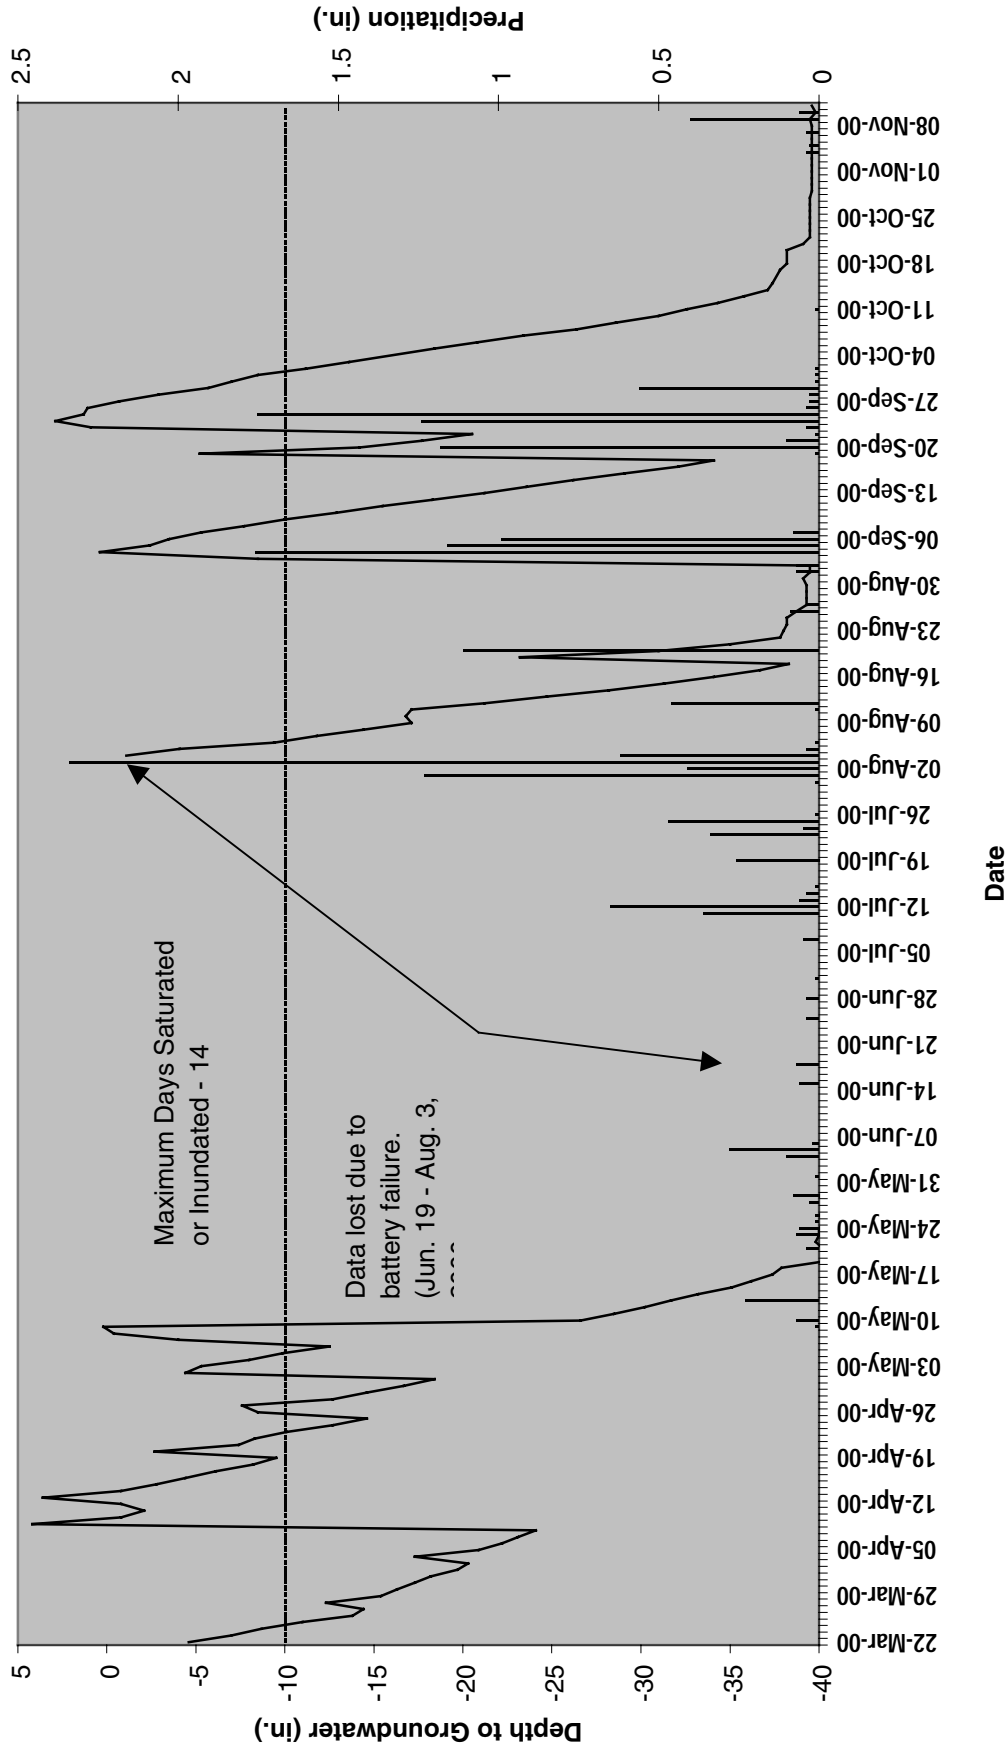
# Mallard Creek MW-5

MW 5: Data was lost due to battery failure from June 19 to August 3, 2000.

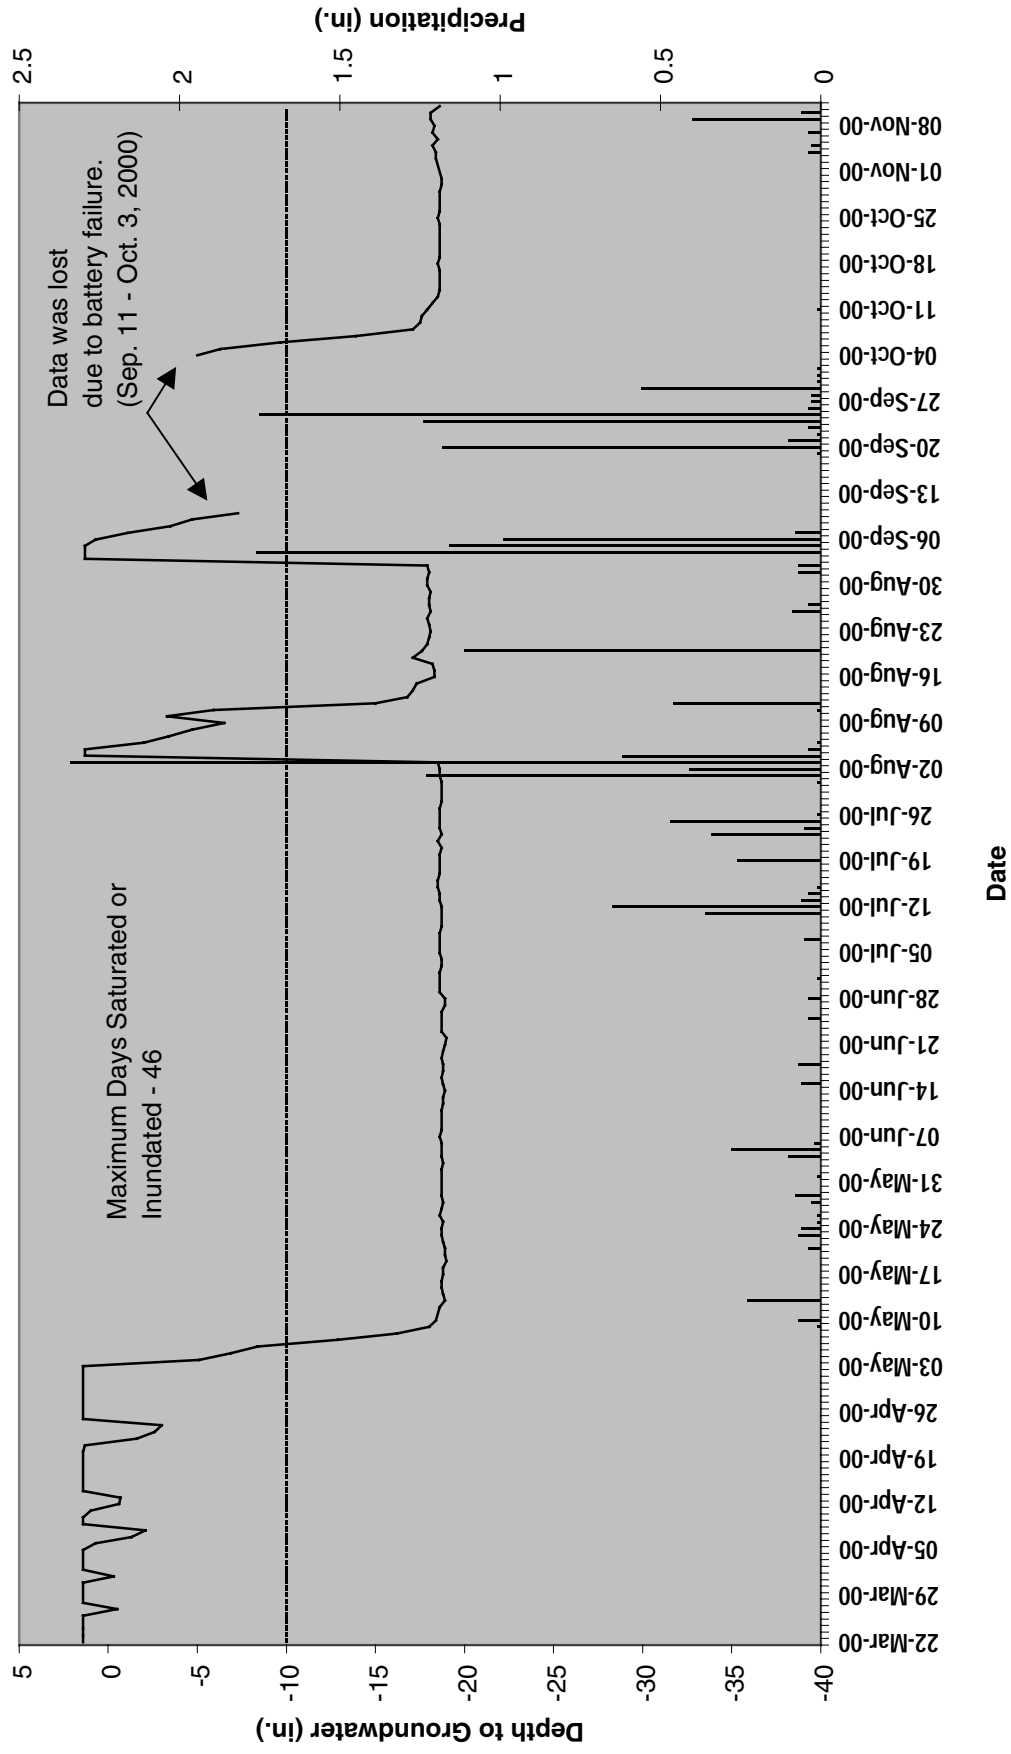
### Mallard Creek MW-6

MW 6: Data was lost due to battery failure from September 11 to October 3, 2000.
