# **Mallard Creek Wetland Restoration**

Project No. 239

2006 Monitoring Report: Year 9 of 9

**March 2007**

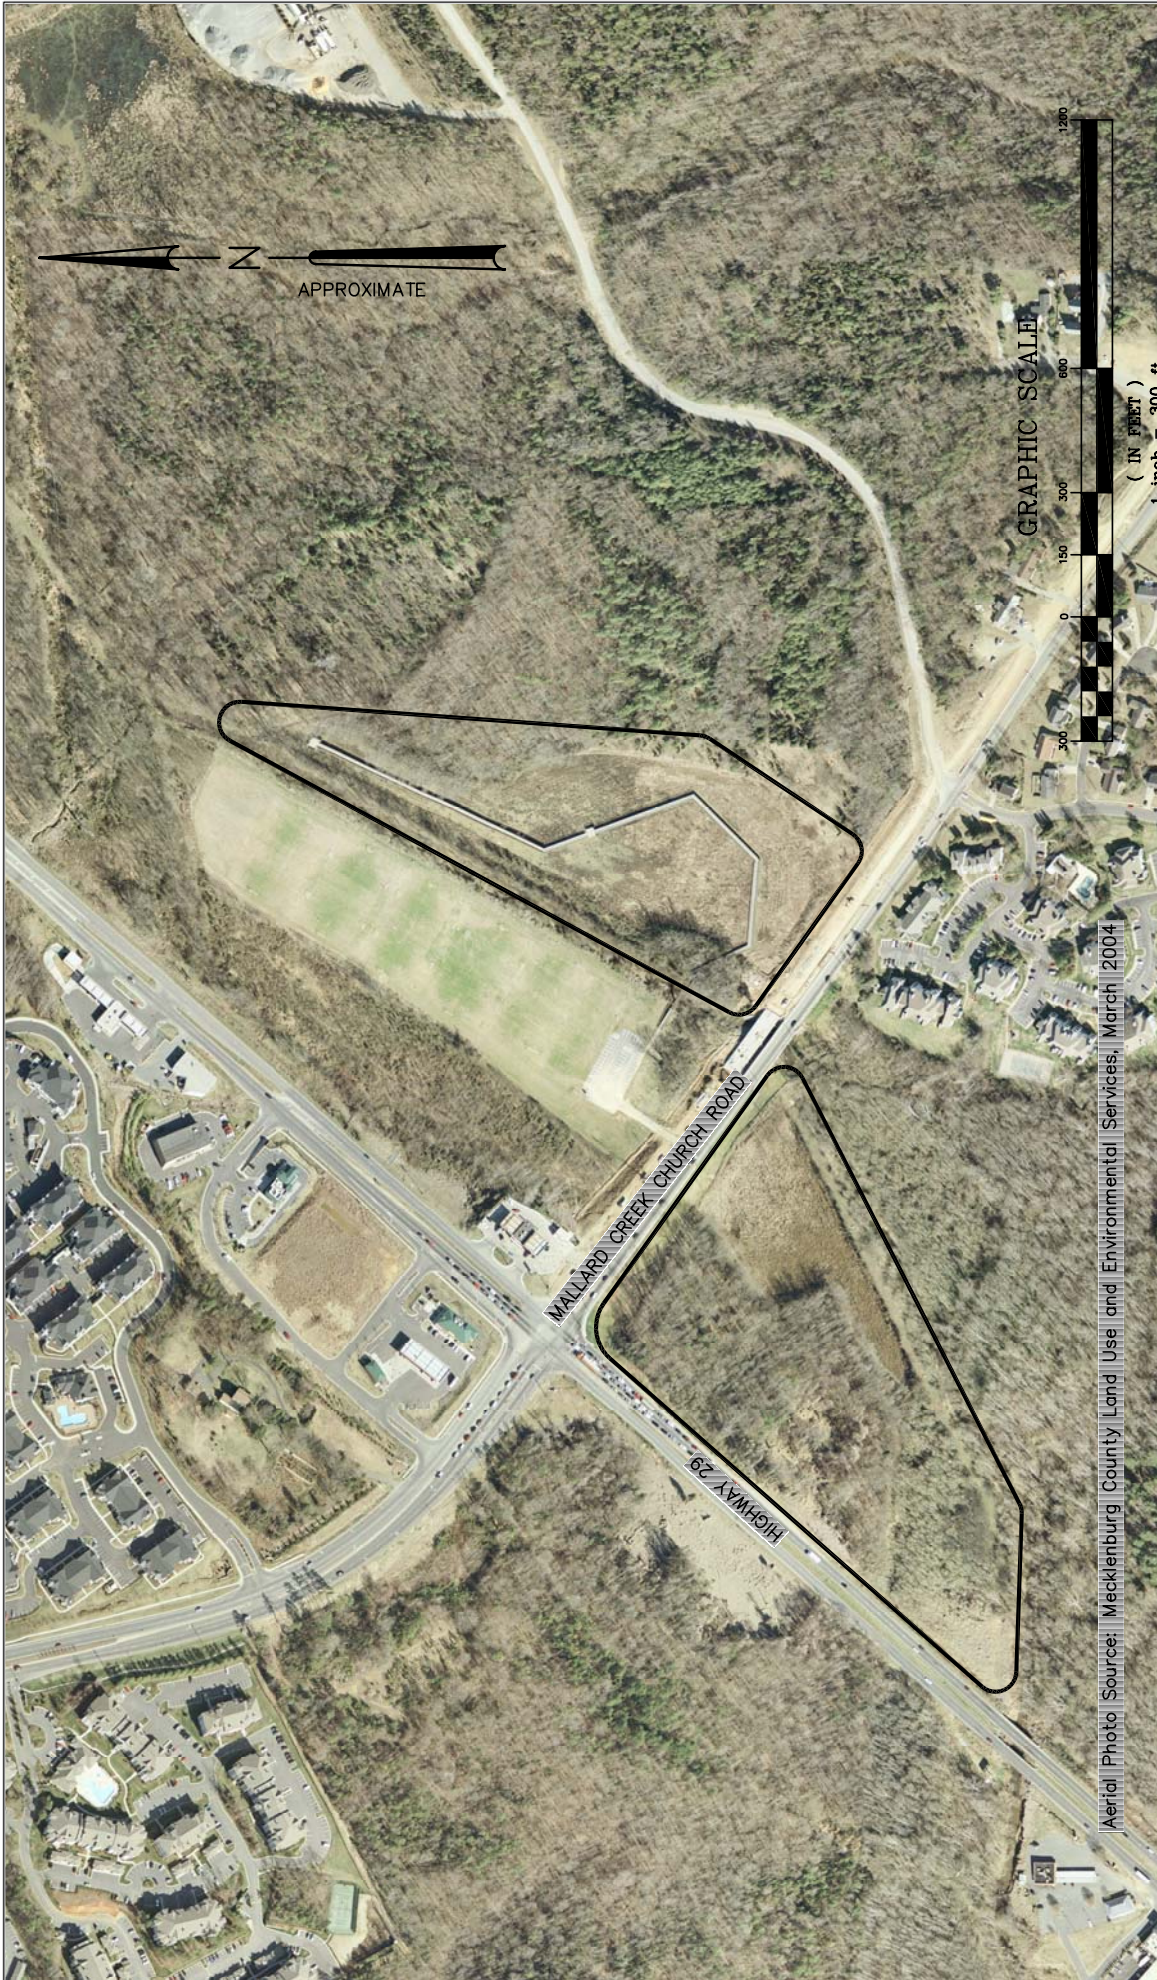
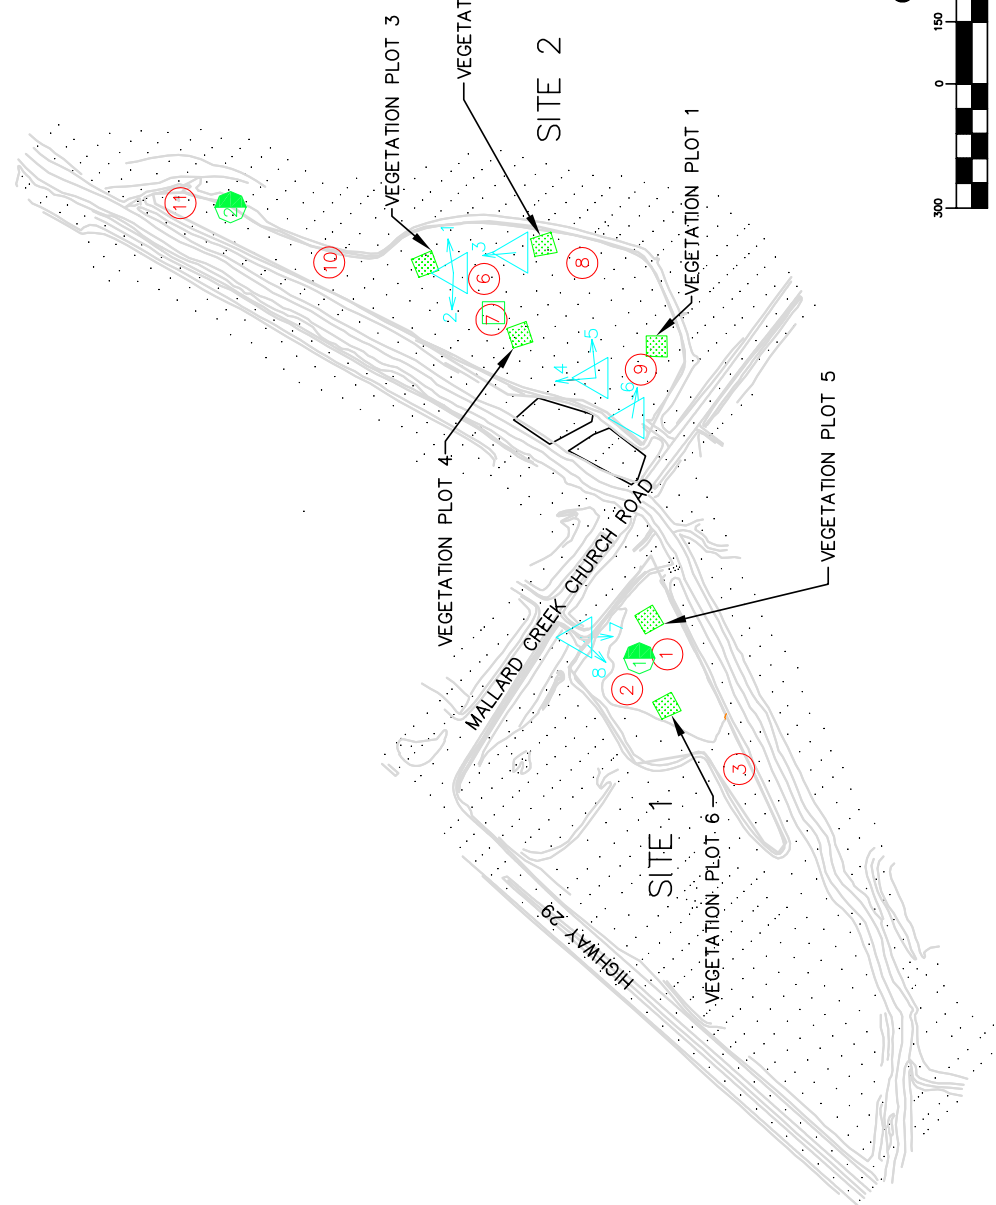
NC ECOSYSTEM ENHANCEMENT PROGRAM  
MALLARD CREEK WETLAND RESTORATION  
APPENDIX A3  
PROBLEM AREAS PLAN VIEW

There are 10 groundwater wells and 2 surface water gauges located on the mitigation site. During the initial assessment conducted in March, six of the original Ecotone WL series gauges were replaced with Ecotone WM series gauges. The gauges were reinstalled at the previous locations. During preparation of the Problem Areas Plan View (Appendix A3), it was noted that three additional ground water gauges and one surface gauge were malfunctioning. These gauges were replaced in June 2006 and were reinstalled at the previous locations.

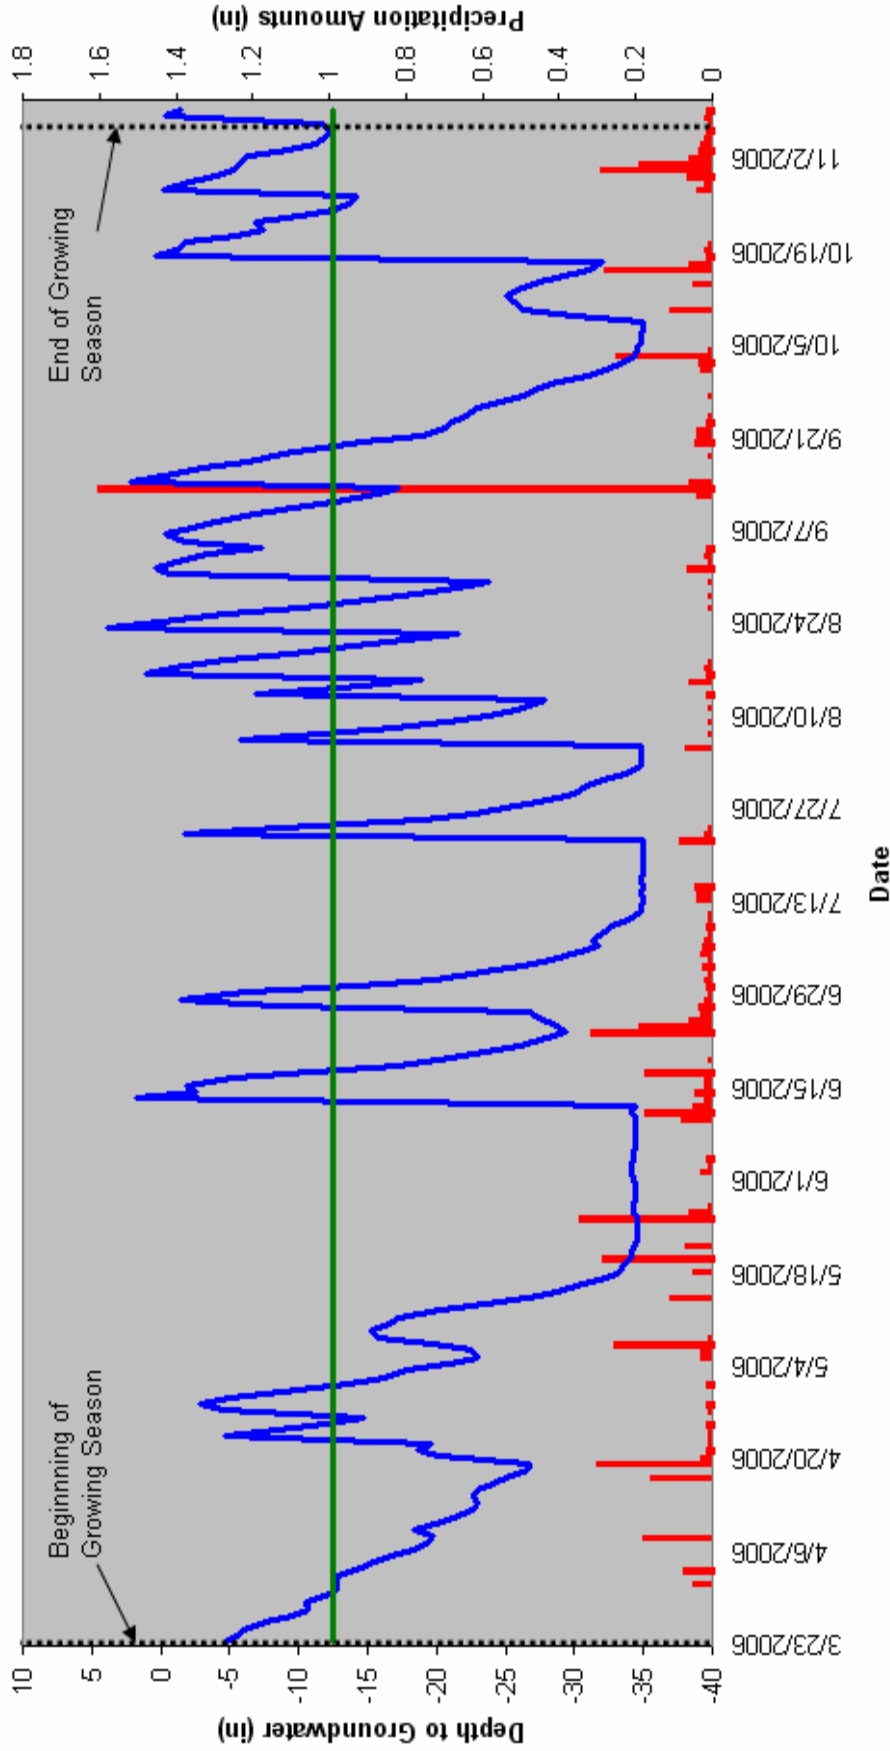
**Mallard Creek Hydrology Monitoring  
Mecklenburg County, North Carolina  
Groundwater Gauge 8**

Nine of the ten groundwater gauges on site achieved wetland success criteria of saturation for 29 consecutive days during the growing season. Well 8 was the only gauge that did not meet this criterion; however, this gauge did experience 24 consecutive days of saturation within 12 inches of the surface. The rain gauge has malfunctioned as previously reported resulting in a lack of precipitation data. However, the rain gauge data from the Back Creek site located approximately one mile south of Mallard Creek was used as comparison. Please refer to Table VII for a summary of gauge success and to Appendix B for the data and charts illustrating water levels as compared to precipitation.
