MONITORING YEAR 1 ANNUAL REPORT

MANEY FARM MITIGATION PROJECT

Chatham County, NC
NCDEQ Contract 005793
DMS ID No. 96314

Data Collection Period: February - September 2016
Final Submission Date: November 23, 2016

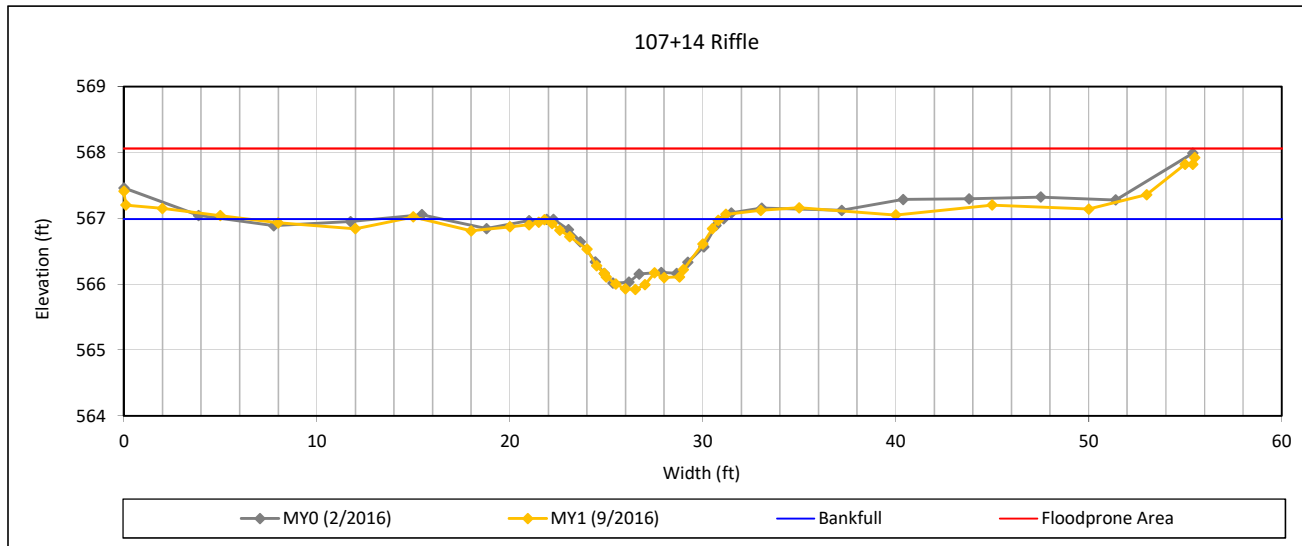
Cross Section 1, UTSF Reach 1

5.7	x-section area (ft.sq.)
8.7	width (ft)
0.7	mean depth (ft)
1.1	max depth (ft)
9.1	wetted parimeter (ft)
0.6	hyd radi (ft)
13.3	width-depth ratio
85.0	W flood prone area (ft)
9.8	entrenchment ratio
1.0	low bank height ratio

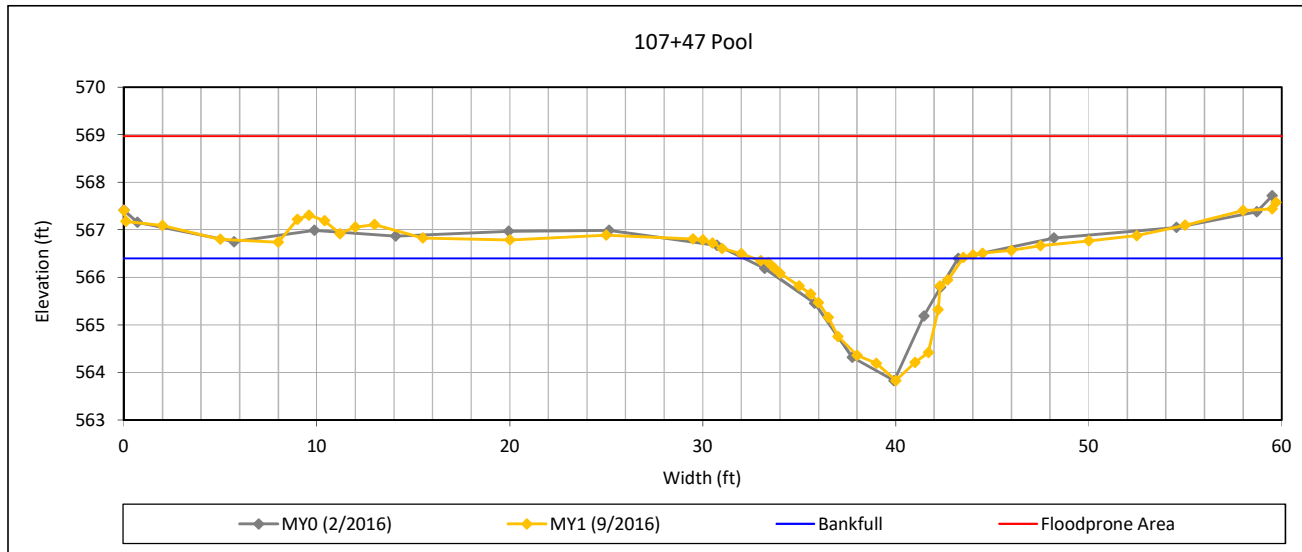
Cross Section 2, UTSF Reach 1

14.0	x-section area (ft.sq.)
10.8	width (ft)
1.3	mean depth (ft)
2.6	max depth (ft)
12.5	wetted parimeter (ft)
1.1	hyd radi (ft)
8.3	width-depth ratio
---	W flood prone area (ft)
---	entrenchment ratio
1.0	low bank height ratio

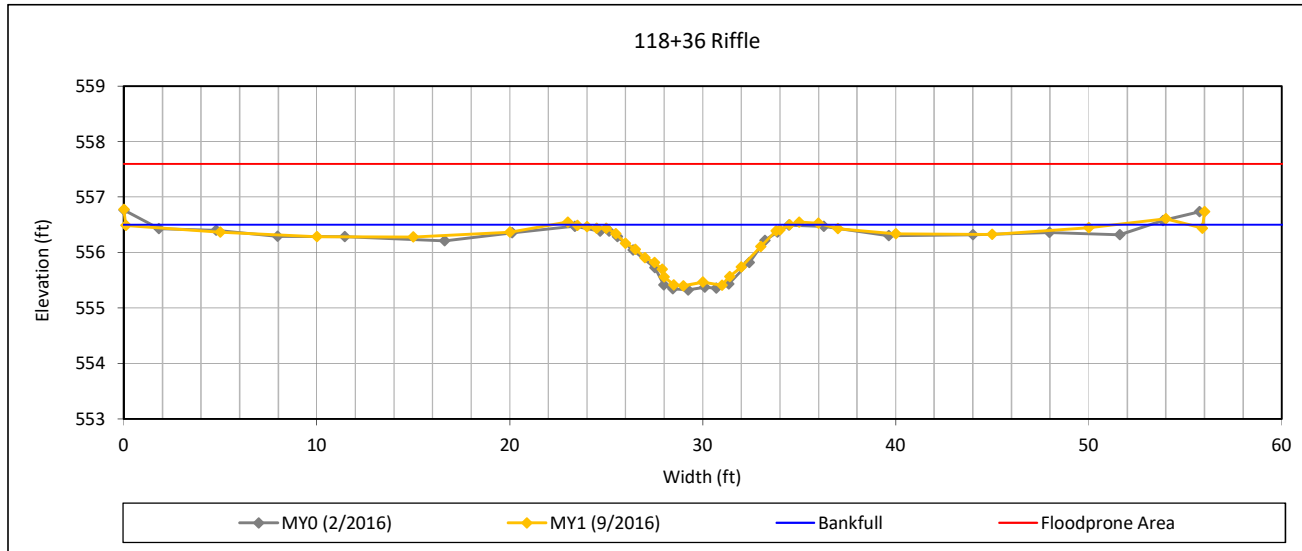
Cross Section 3, UTSF Reach 1

6.2	x-section area (ft.sq.)
9.0	width (ft)
0.7	mean depth (ft)
1.1	max depth (ft)
9.4	wetted perimeter (ft)
0.7	hyd radi (ft)
13.1	width-depth ratio
85.0	W flood prone area (ft)
9.4	entrenchment ratio
1.0	low bank height ratio

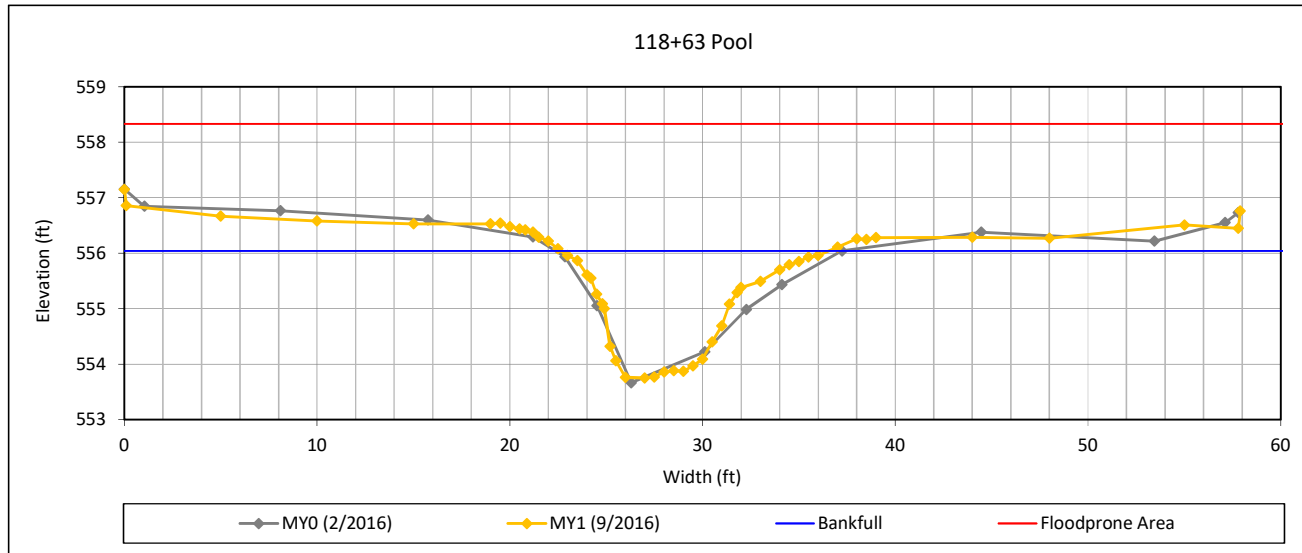
Cross Section 4, UTSF Reach 1

A bank pin array was established on UTSF Reach 1 to monitor potential meander bend, bank erosion at cross section 4. No changes in exposed length of bank pins were observed during the MY1 assessments indicating there has been no erosion of the bank at this cross section.

15.7	x-section area (ft.sq.)
13.9	width (ft)
1.1	mean depth (ft)
2.3	max depth (ft)
15.3	wetted parimeter (ft)
1.0	hyd radi (ft)
12.2	width-depth ratio
---	W flood prone area (ft)
---	entrenchment ratio
1.1	low bank height ratio

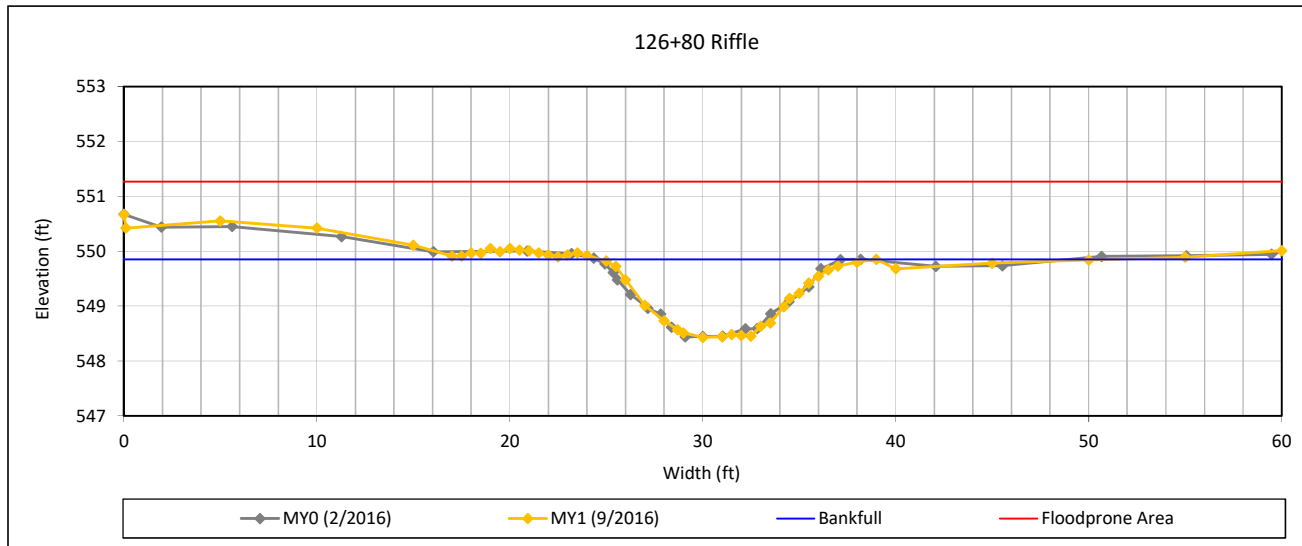
Cross Section 5, UTSF Reach 2

11.0	x-section area (ft.sq.)
12.3	width (ft)
0.9	mean depth (ft)
1.4	max depth (ft)
12.7	wetted parimeter (ft)
0.9	hyd radi (ft)
13.7	width-depth ratio
150.0	W flood prone area (ft)
12.2	entrenchment ratio
1.0	low bank height ratio

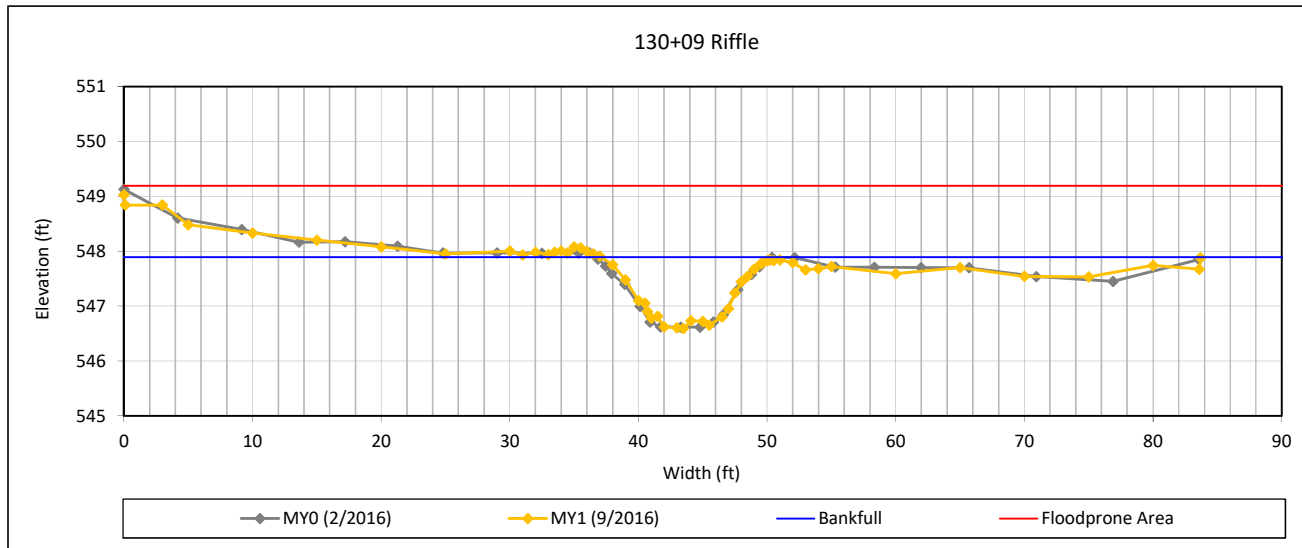
Cross Section 6, UTSF Reach 2

10.2	x-section area (ft.sq.)
13.9	width (ft)
0.7	mean depth (ft)
1.3	max depth (ft)
14.3	wetted perimeter (ft)
0.7	hyd radi (ft)
18.9	width-depth ratio
150.0	W flood prone area (ft)
10.8	entrenchment ratio
1.0	low bank height ratio

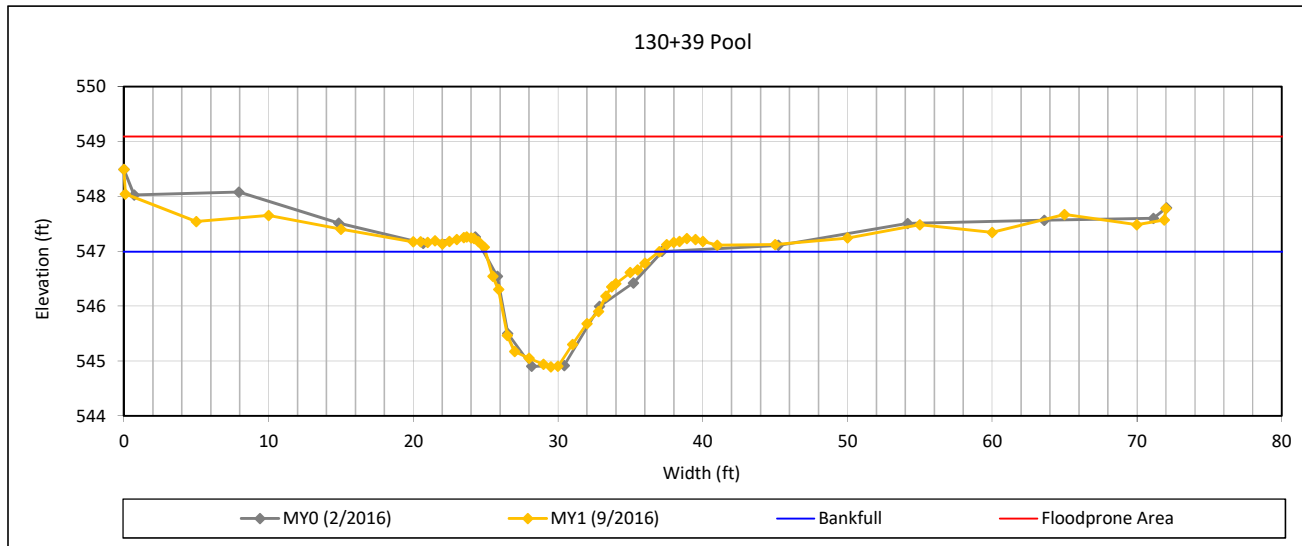
Cross Section 7, UTSF Reach 2

14.0	x-section area (ft.sq.)
12.0	width (ft)
1.2	mean depth (ft)
2.1	max depth (ft)
13.1	wetted perimeter (ft)
1.1	hyd radi (ft)
10.3	width-depth ratio
---	W flood prone area (ft)
---	entrenchment ratio
1.1	low bank height ratio

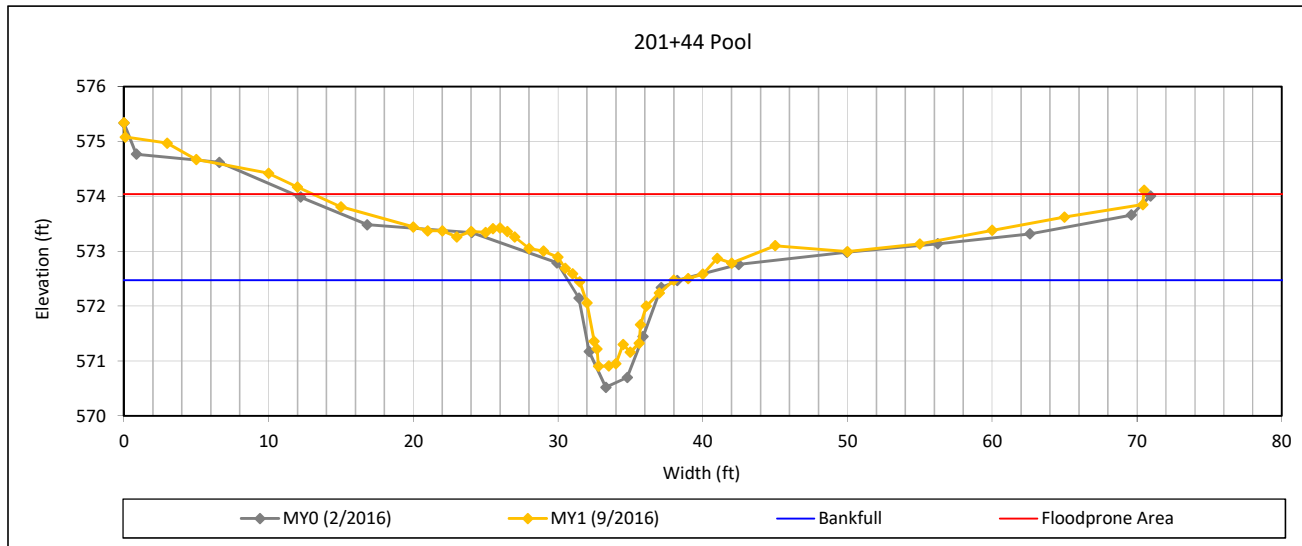
Cross Section 8, UT1C

5.5	x-section area (ft.sq.)
6.6	width (ft)
0.8	mean depth (ft)
1.6	max depth (ft)
8.0	wetted perimeter (ft)
0.7	hyd radi (ft)
7.9	width-depth ratio
---	W flood prone area (ft)
---	entrenchment ratio
1.0	low bank height ratio

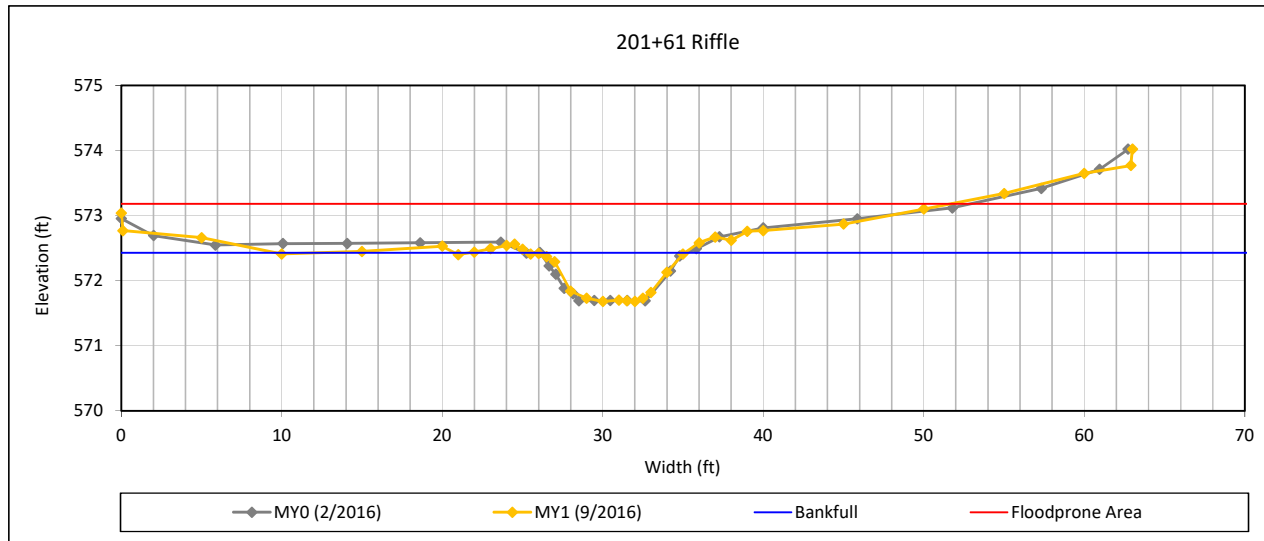
Cross Section 9, UT1C

4.6	x-section area (ft.sq.)
9.8	width (ft)
0.5	mean depth (ft)
0.7	max depth (ft)
10.0	wetted perimeter (ft)
0.5	hyd radi (ft)
20.7	width-depth ratio
60.0	W flood prone area (ft)
6.1	entrenchment ratio
1.1	low bank height ratio

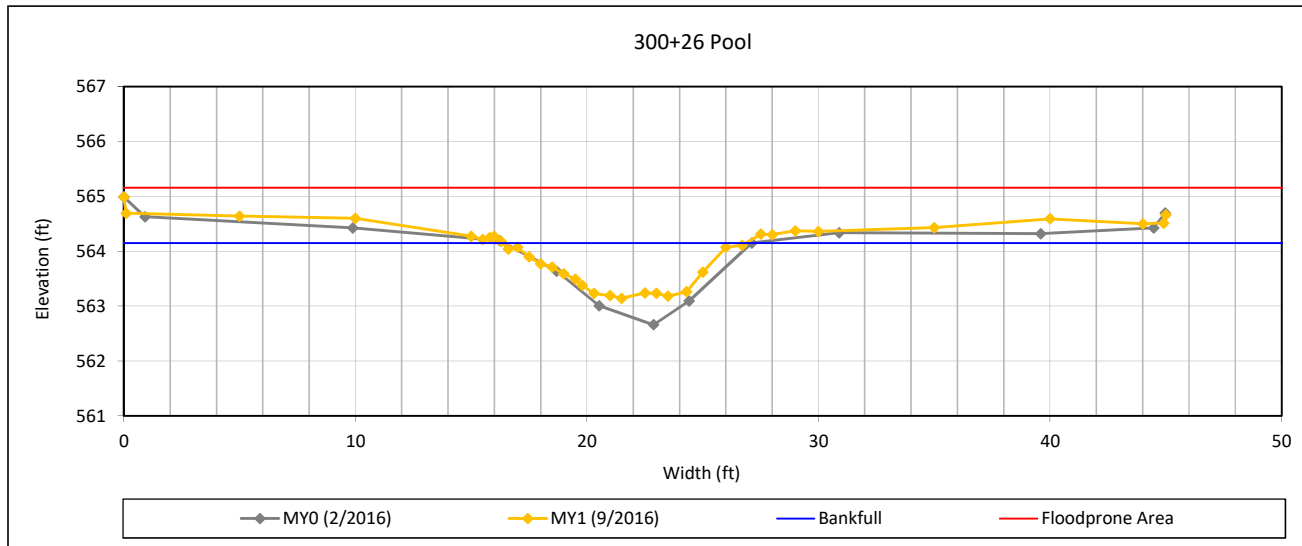
Cross Section 10, UT2B

6.3	x-section area (ft.sq.)
10.5	width (ft)
0.6	mean depth (ft)
1.0	max depth (ft)
10.8	wetted parimeter (ft)
0.6	hyd radi (ft)
17.4	width-depth ratio
---	W flood prone area (ft)
---	entrenchment ratio
1.2	low bank height ratio

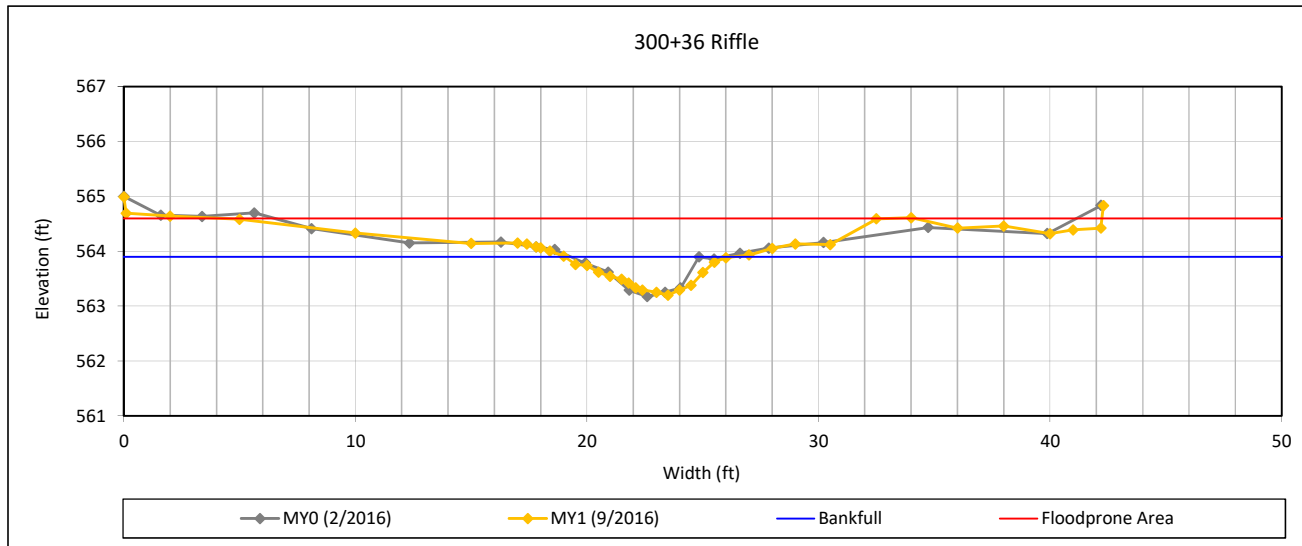
Cross Section 11, UT2B

2.7	x-section area (ft.sq.)
6.5	width (ft)
0.4	mean depth (ft)
0.7	max depth (ft)
6.6	wetted parimeter (ft)
0.4	hyd radi (ft)
15.7	width-depth ratio
60.0	W flood prone area (ft)
9.3	entrenchment ratio
1.0	low bank height ratio

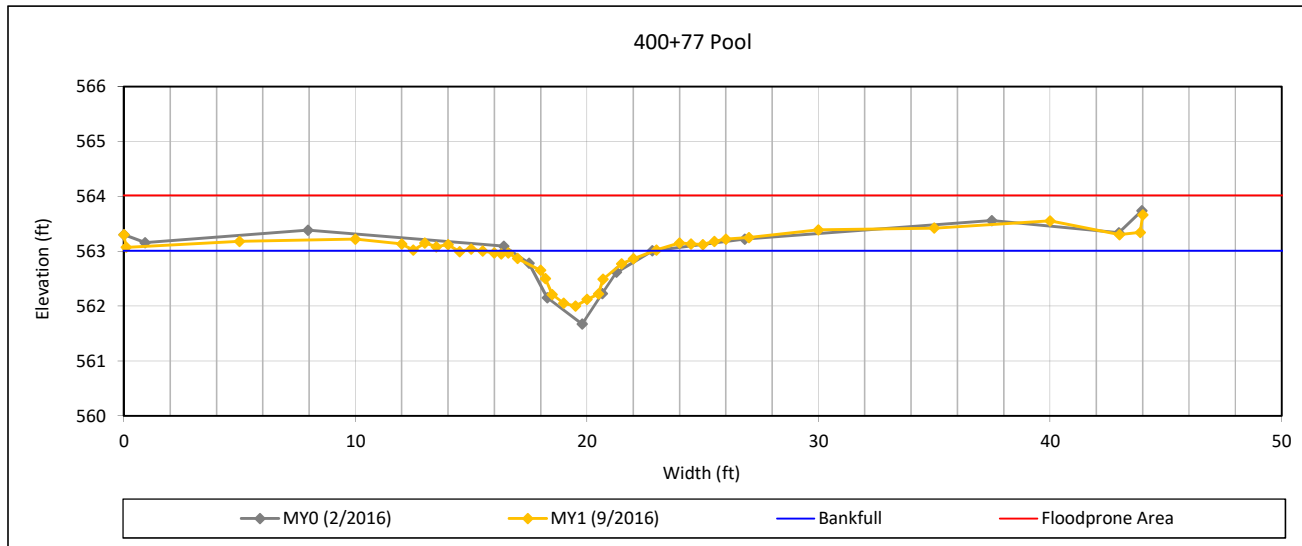
Cross Section 12, UT3B

3.0	x-section area (ft.sq.)
6.3	width (ft)
0.5	mean depth (ft)
1.0	max depth (ft)
6.8	wetted parimeter (ft)
0.4	hyd radi (ft)
13.4	width-depth ratio
---	W flood prone area (ft)
---	entrenchment ratio
1.0	low bank height ratio

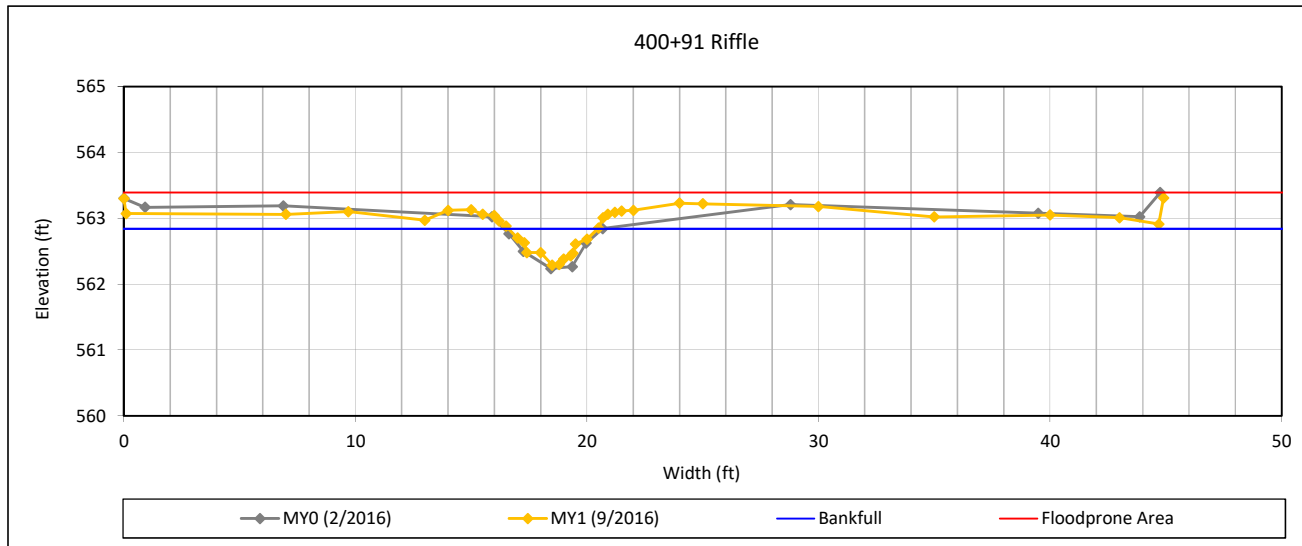
Cross Section 13, UT3B

1.1	x-section area (ft.sq.)
3.9	width (ft)
0.3	mean depth (ft)
0.6	max depth (ft)
4.1	wetted perimeter (ft)
0.3	hyd radi (ft)
13.0	width-depth ratio
60.0	W flood prone area (ft)
15.5	entrenchment ratio
1.2	low bank height ratio

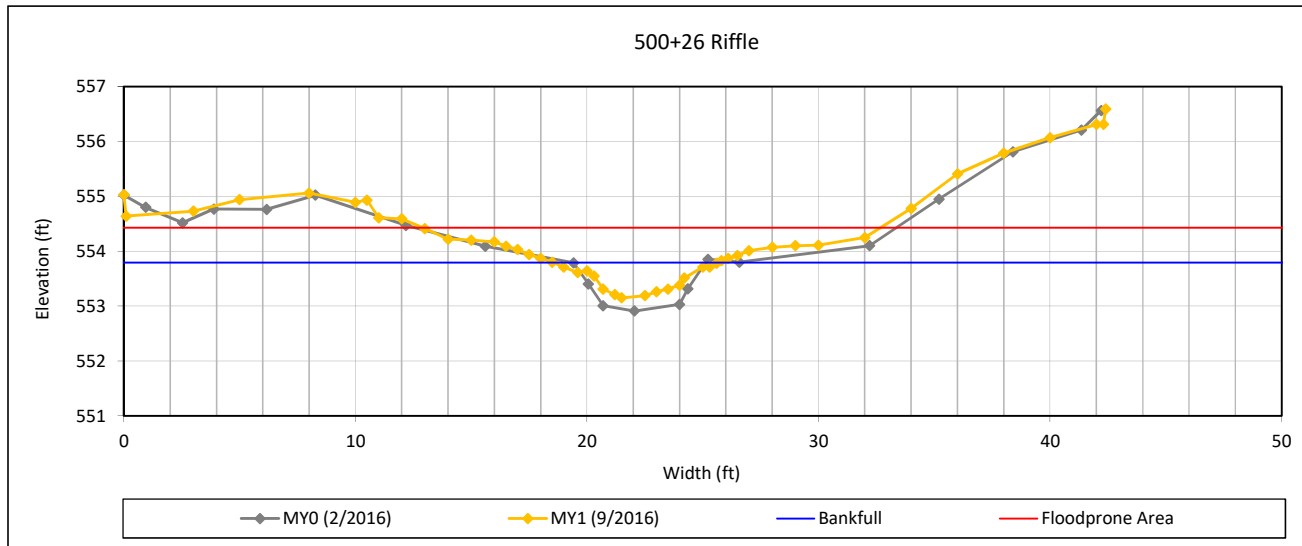
Cross Section 14, UT4B

2.4	x-section area (ft.sq.)
6.4	width (ft)
0.4	mean depth (ft)
0.6	max depth (ft)
6.6	wetted perimeter (ft)
0.4	hyd radi (ft)
17.3	width-depth ratio
25.0	W flood prone area (ft)
3.9	entrenchment ratio
1.0	low bank height ratio

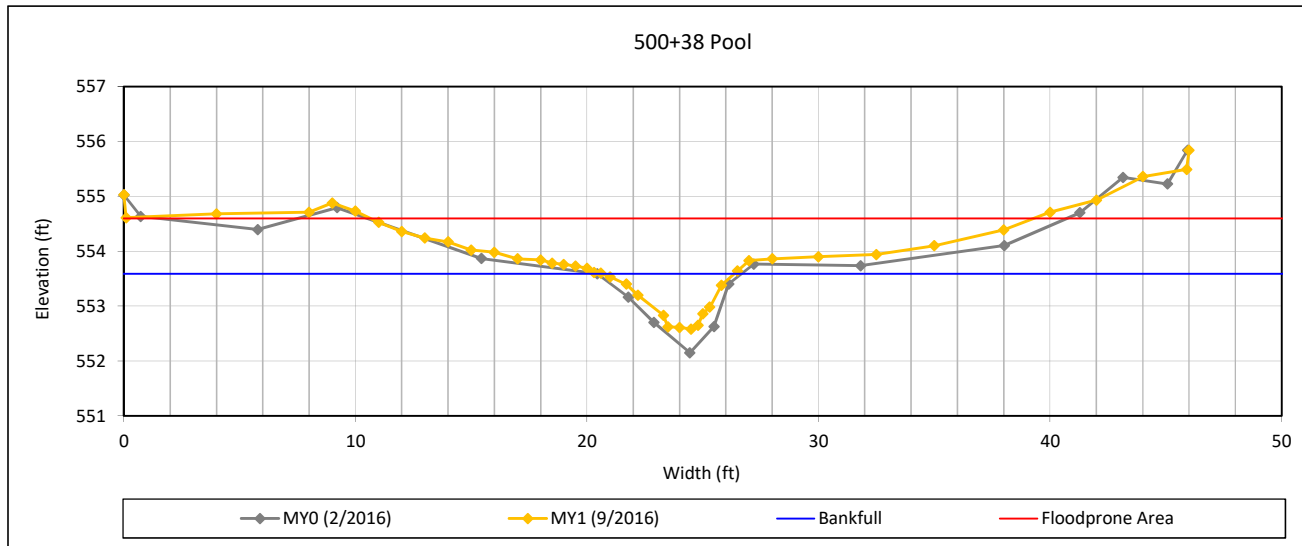
Cross Section 15, UT4B

3.0	x-section area (ft.sq.)
5.7	width (ft)
0.5	mean depth (ft)
1.0	max depth (ft)
6.2	wetted parimeter (ft)
0.5	hyd radi (ft)
11.0	width-depth ratio
---	W flood prone area (ft)
---	entrenchment ratio
1.0	low bank height ratio

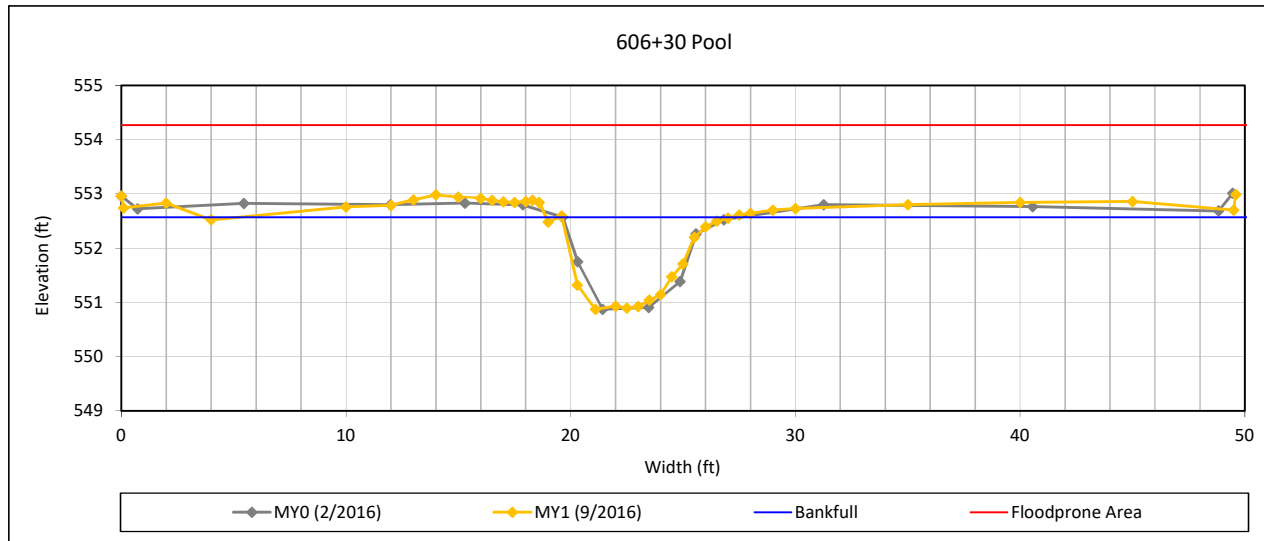
Cross Section 16, UT5

8.0	x-section area (ft.sq.)
7.6	width (ft)
1.1	mean depth (ft)
1.7	max depth (ft)
8.8	wetted perimeter (ft)
0.9	hyd radi (ft)
7.2	width-depth ratio
---	W flood prone area (ft)
---	entrenchment ratio
1.0	low bank height ratio

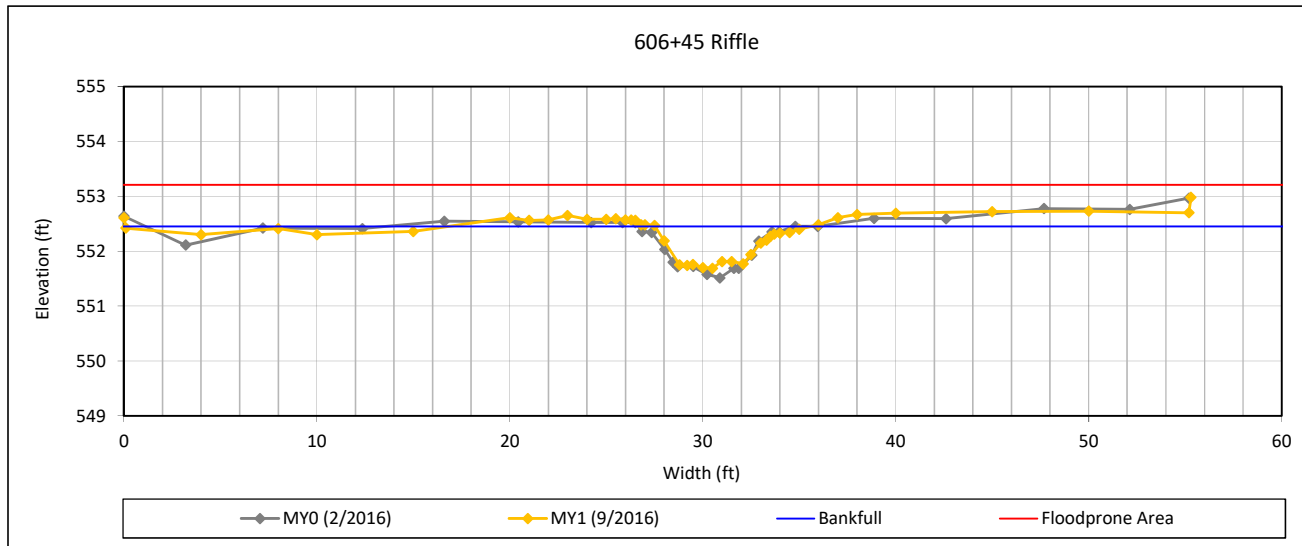
Cross Section 17, UT5

3.5	x-section area (ft.sq.)
8.1	width (ft)
0.4	mean depth (ft)
0.8	max depth (ft)
8.4	wetted parimeter (ft)
0.4	hyd radi (ft)
18.7	width-depth ratio
100.0	W flood prone area (ft)
12.4	entrenchment ratio
1.0	low bank height ratio
