MONITORING YEAR 2 ANNUAL REPORT

MANEY FARM MITIGATION PROJECT

Chatham County, NC
NCDEQ Contract 005793
DMS ID No. 96314

Data Collection Period: March - September 2017
Draft Submission Date: November 14, 2017
Final Submission Date: December 6, 2017

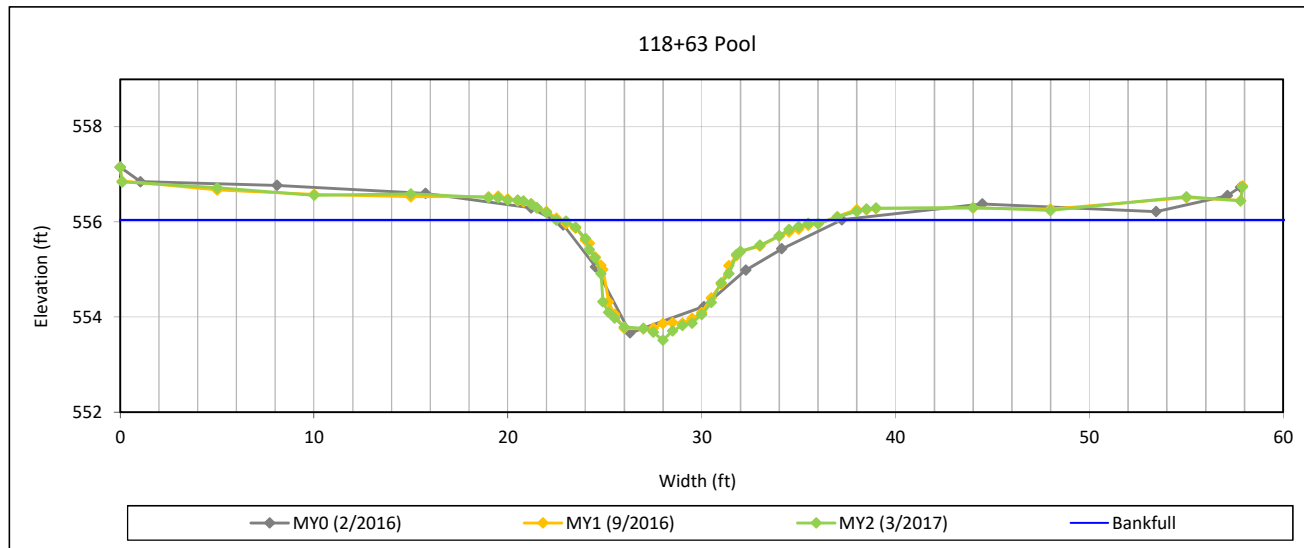
Cross Section 4, UTSF Reach 1

A bank pin array was established on UTSF Reach 1 to monitor potential meander bend bank erosion at cross section 4. No changes in exposed length of bank pins were observed during the MY2 assessments indicating there has been no erosion of the bank at this cross section.

16.3	x-section area (ft.sq.)
14.1	width (ft)
1.2	mean depth (ft)
2.5	max depth (ft)
15.7	wetted perimeter (ft)
1.0	hydraulic radius (ft)
12.1	width-depth ratio
