MONITORING YEAR 3 ANNUAL REPORT

MANEY FARM MITIGATION PROJECT

Chatham County, NC
NCDEQ Contract 005793
DMS ID No. 96314

Data Collection Period: January - October 2018
Draft Submission Date: November 12, 2018
Final Submission Date: December 10, 2018

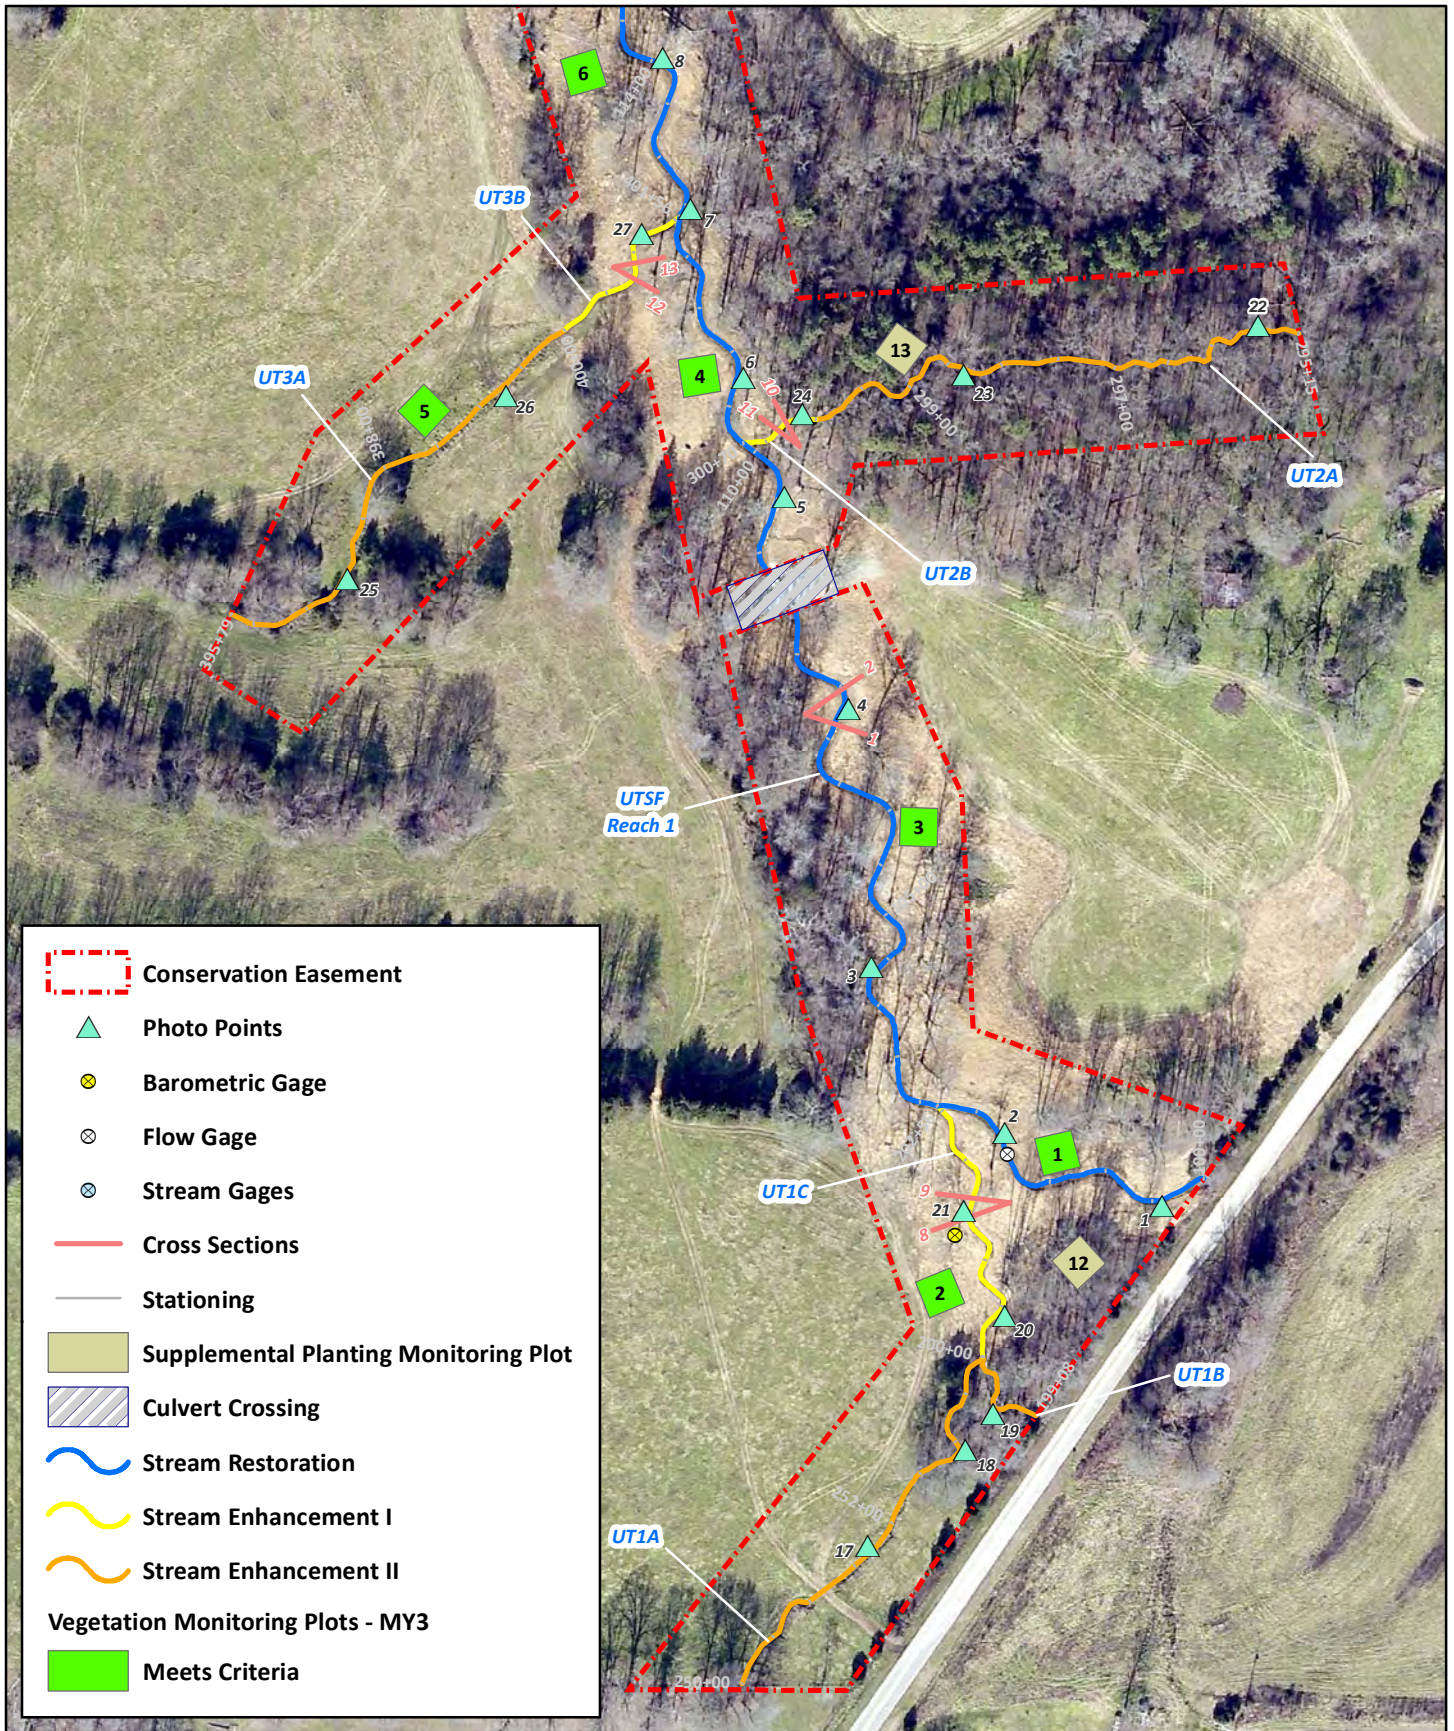
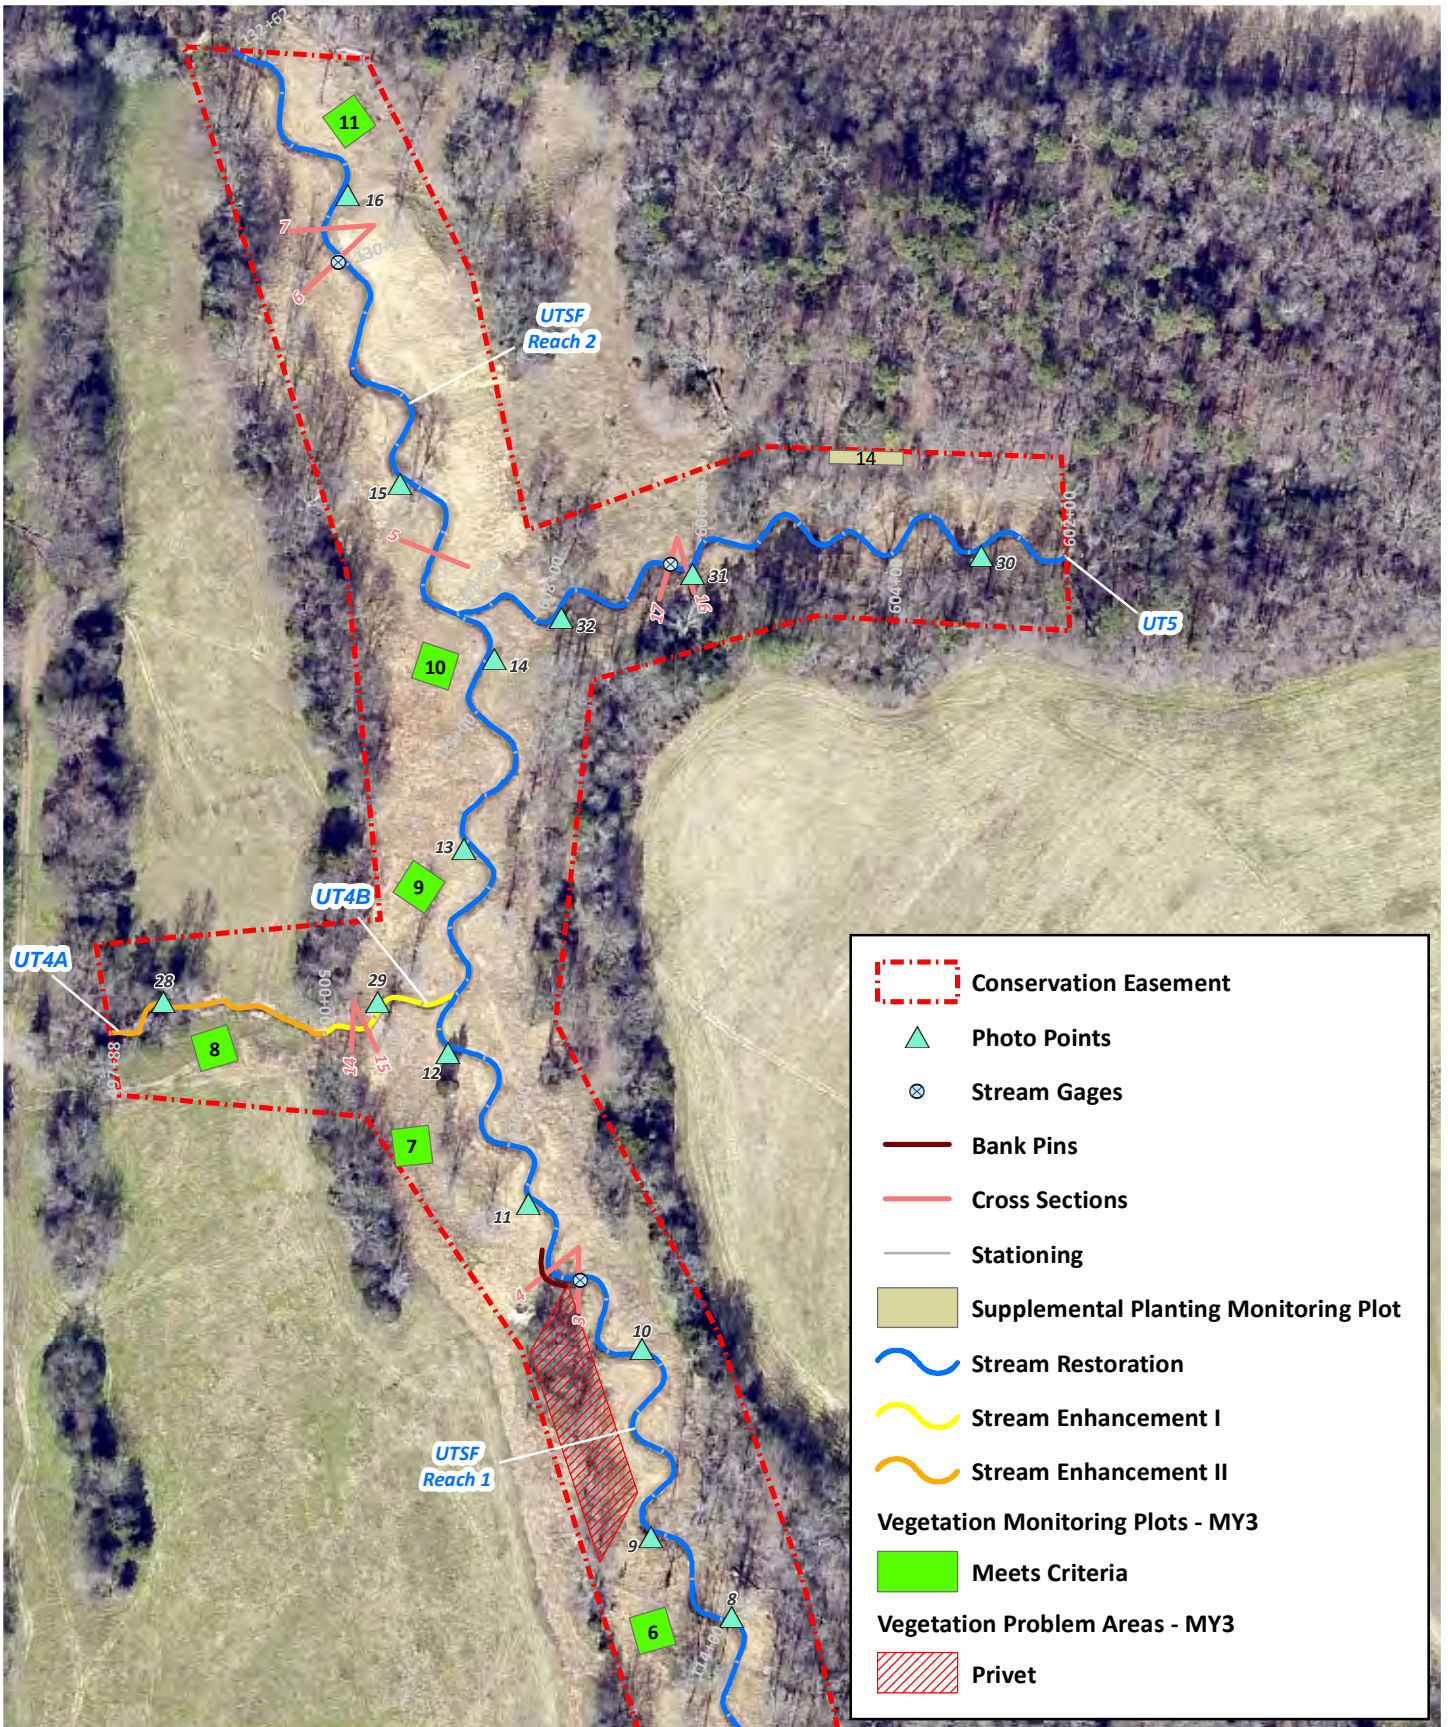
All standard vegetation plots met the MY3 requirement of 320 stems per acre as noted in CCPV. Chinese privet was treated sporadically along the boundary of the conservation easement in October 2018. All streams within the Site are stable and functioning as designed. A malfunction occurred to the crest gauge on UTSF Reach 2, prohibiting data from being collected, but multiple bankfull events were recorded on UTSF Reach 1 and UT5. Multiple bankfull events have been documented within the restored stream reaches at the Site in both MY1 and MY2, therefor the Site has met the Monitoring Year 7 hydrology success criteria. Additionally, the flow gage on UTSF Reach 1 recorded baseflow for 261

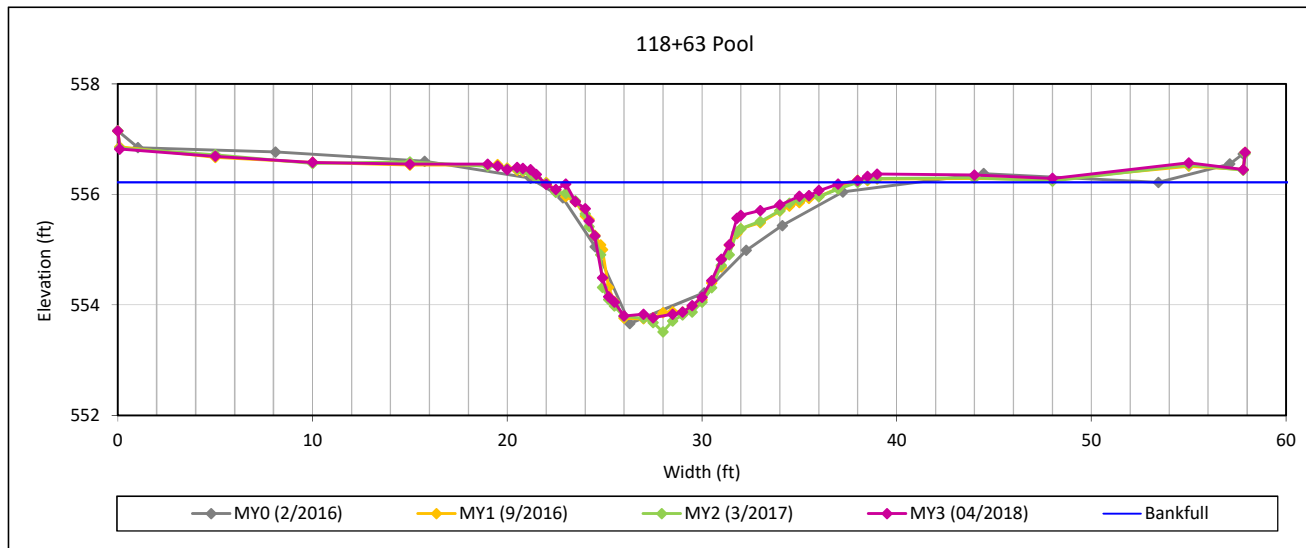
Cross Section 4, UTSF Reach 1

A bank pin array was established on UTSF Reach 1 to monitor potential meander bend bank erosion at cross-section 4. No changes in exposed length of bank pins were observed during the MY3 assessments indicating bank stability .
