# MONITORING YEAR 5 ANNUAL REPORT

## MANEY FARM MITIGATION PROJECT

Chatham County, NC

DMS ID No. 96314

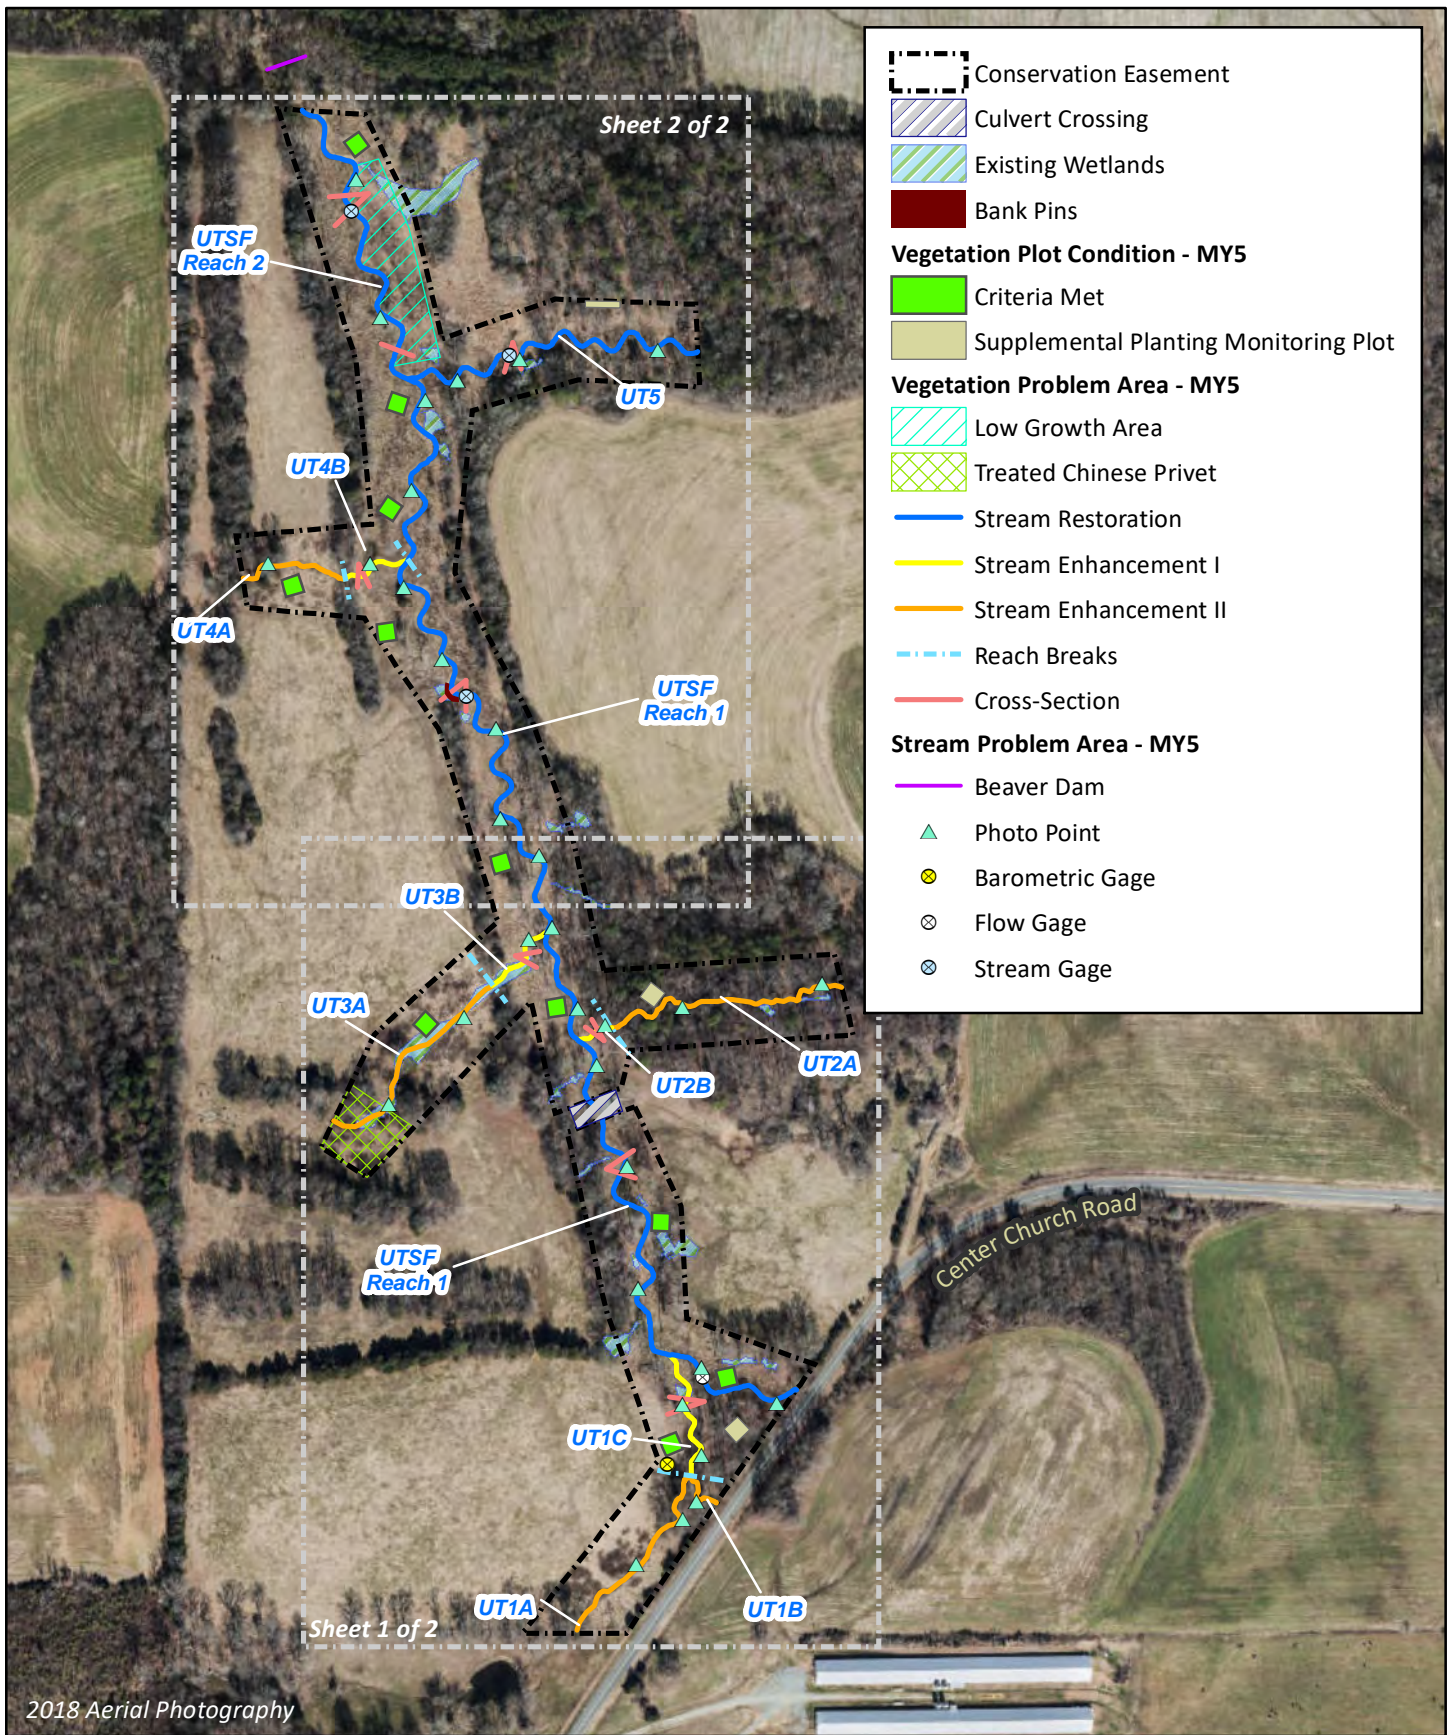
Figure 3.0 Integrated Current Condition Plan View (Key)  
 Maney Farm Mitigation Project  
 DMS Project No. 96314  
 Monitoring Year 5 - 2020

A 0.7 acre area of low vegetative growth was noted along UTSF Reach 2 (Figure 3.0). This area was replanted and soil amendments were added during MY5. Eighty, one gallon container trees were planted in February 2020 which included a mixture of willow oak (*Quercus phellos*), sycamore (*Platanus occidentalis*), and river birch (*Betula nigra*). Soil amendments including a mixture of dolomitic lime, fertilizer, humic acid, and a seed mix of herbaceous vegetation was applied to the low growth area in July 2020. Trees in the area look healthy with signs of new growth, and herbaceous vegetation has fully covered the ground.

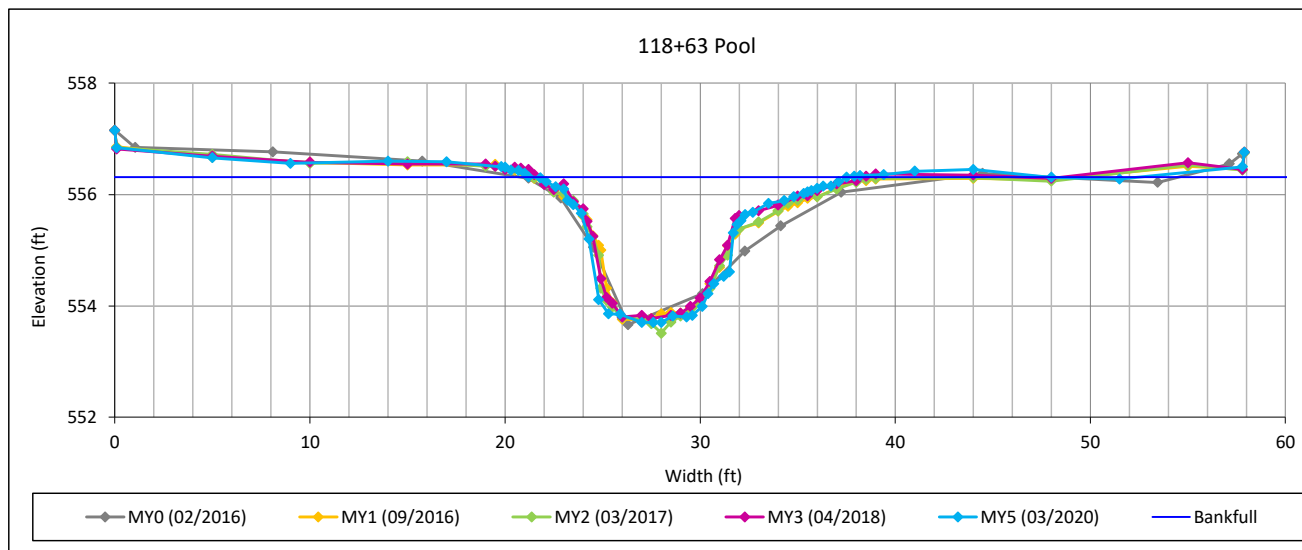
#### Cross-Section 4, UTSF Reach 1

A bank pin array was established on UTSF Reach 1 to monitor potential meander bend bank erosion at cross-section 4. No changes in exposed length of bank pins were observed during the MY5 assessments indicating bank stability.
