# MONITORING YEAR 7 ANNUAL REPORT

## MANEY FARM MITIGATION PROJECT

Chatham County, NC

DMS Project Number 96314

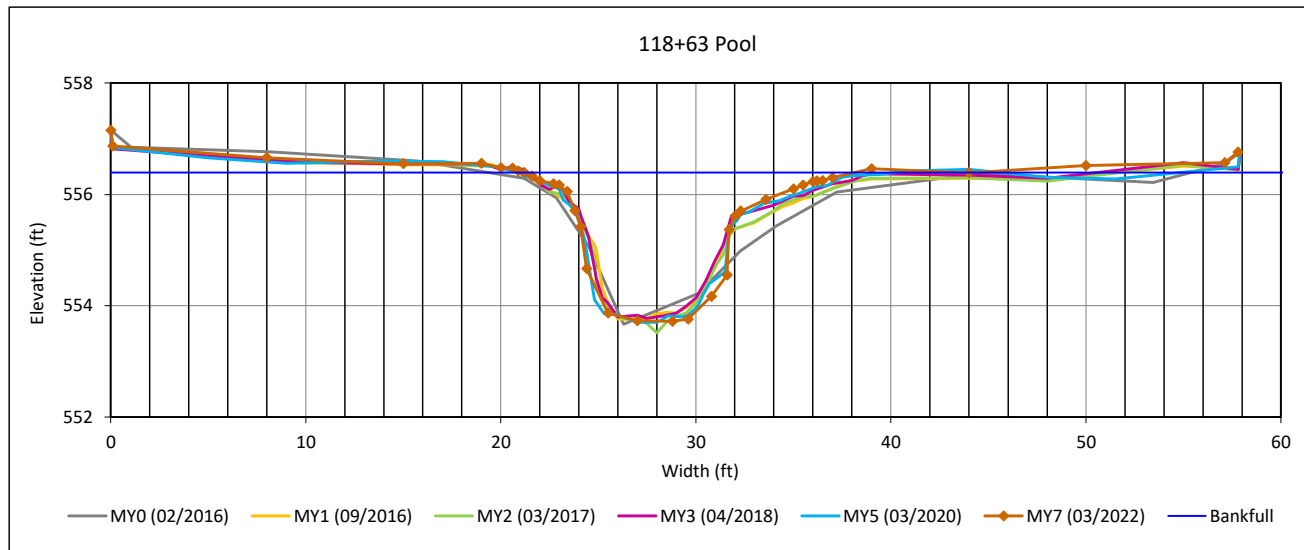
#### Cross-Section 4, UTSF Reach 1

A bank pin array was established on UTSF Reach 1 to monitor potential meander bend bank erosion at cross-section 4. No changes in exposed length of bank pins were observed during the MY7 assessments indicating bank stability.

21.2	x-section area (ft.sq.)
16.9	width (ft)
1.3	mean depth (ft)
2.7	max depth (ft)
19.0	wetted perimeter (ft)
1.1	hydraulic radius (ft)
13.5	width-depth ratio
