**BASELINE MONITORING
DOCUMENT AND AS-BUILT
BASELINE REPORT
FINAL**

MARTIN DAIRY MITIGATION SITE

Orange County, NC

DMS Project Number 97087

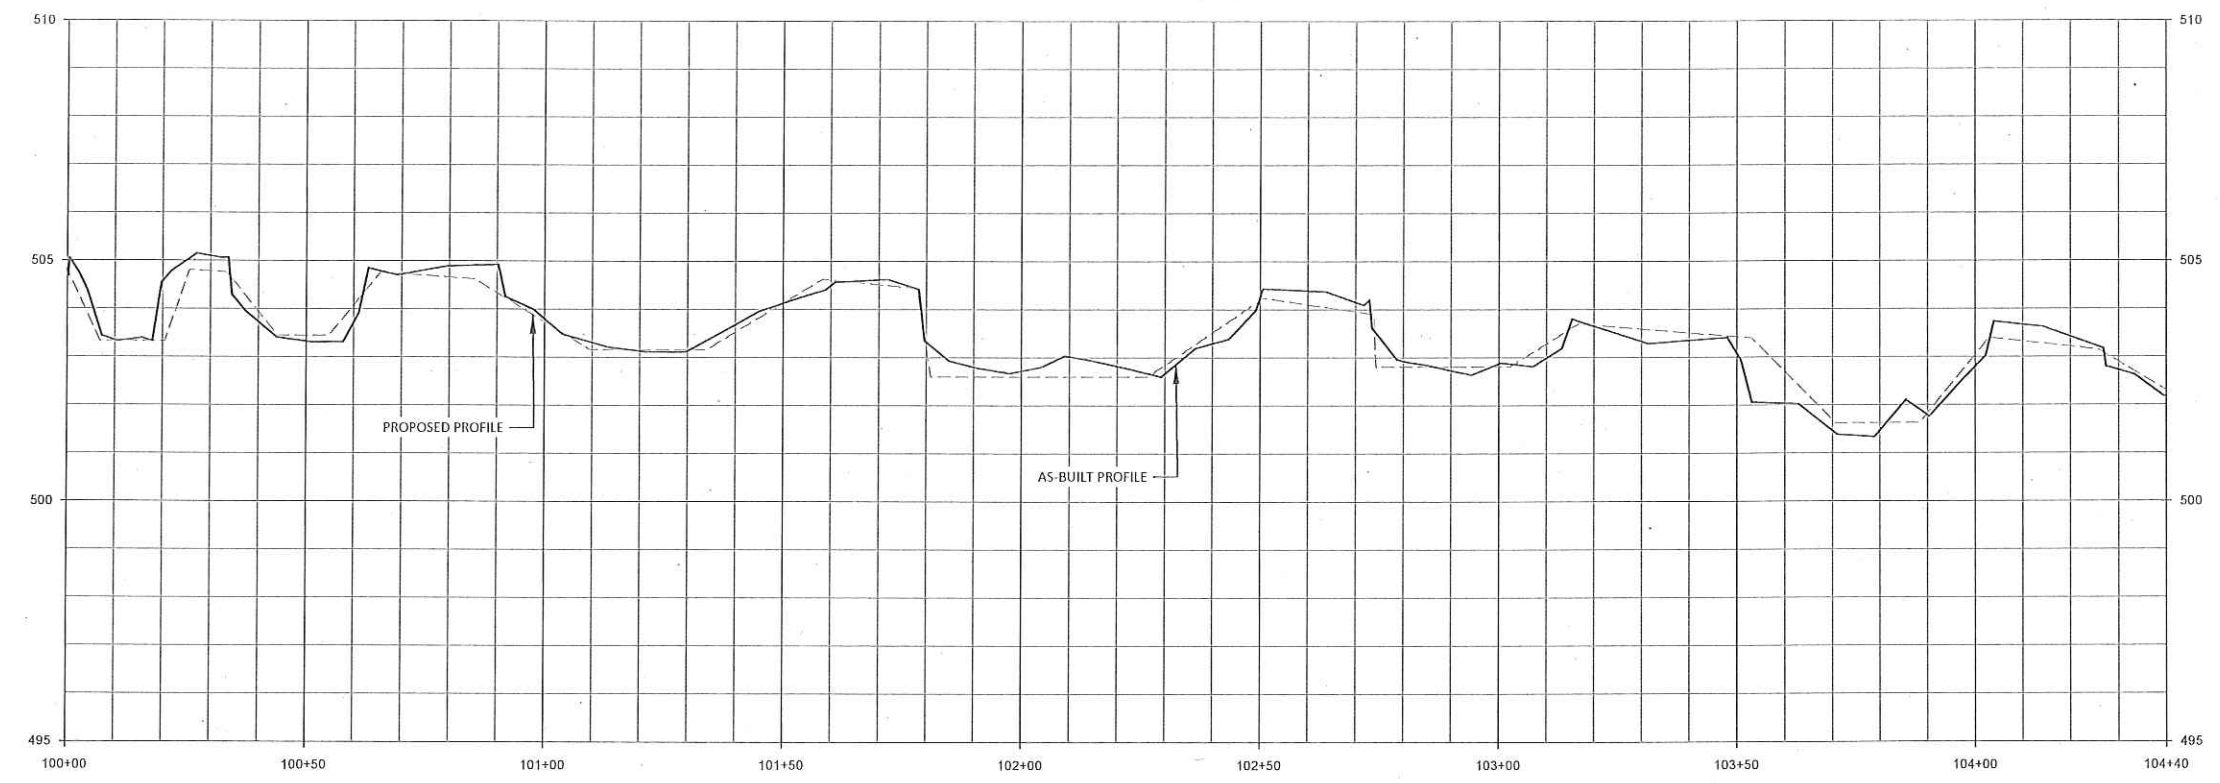
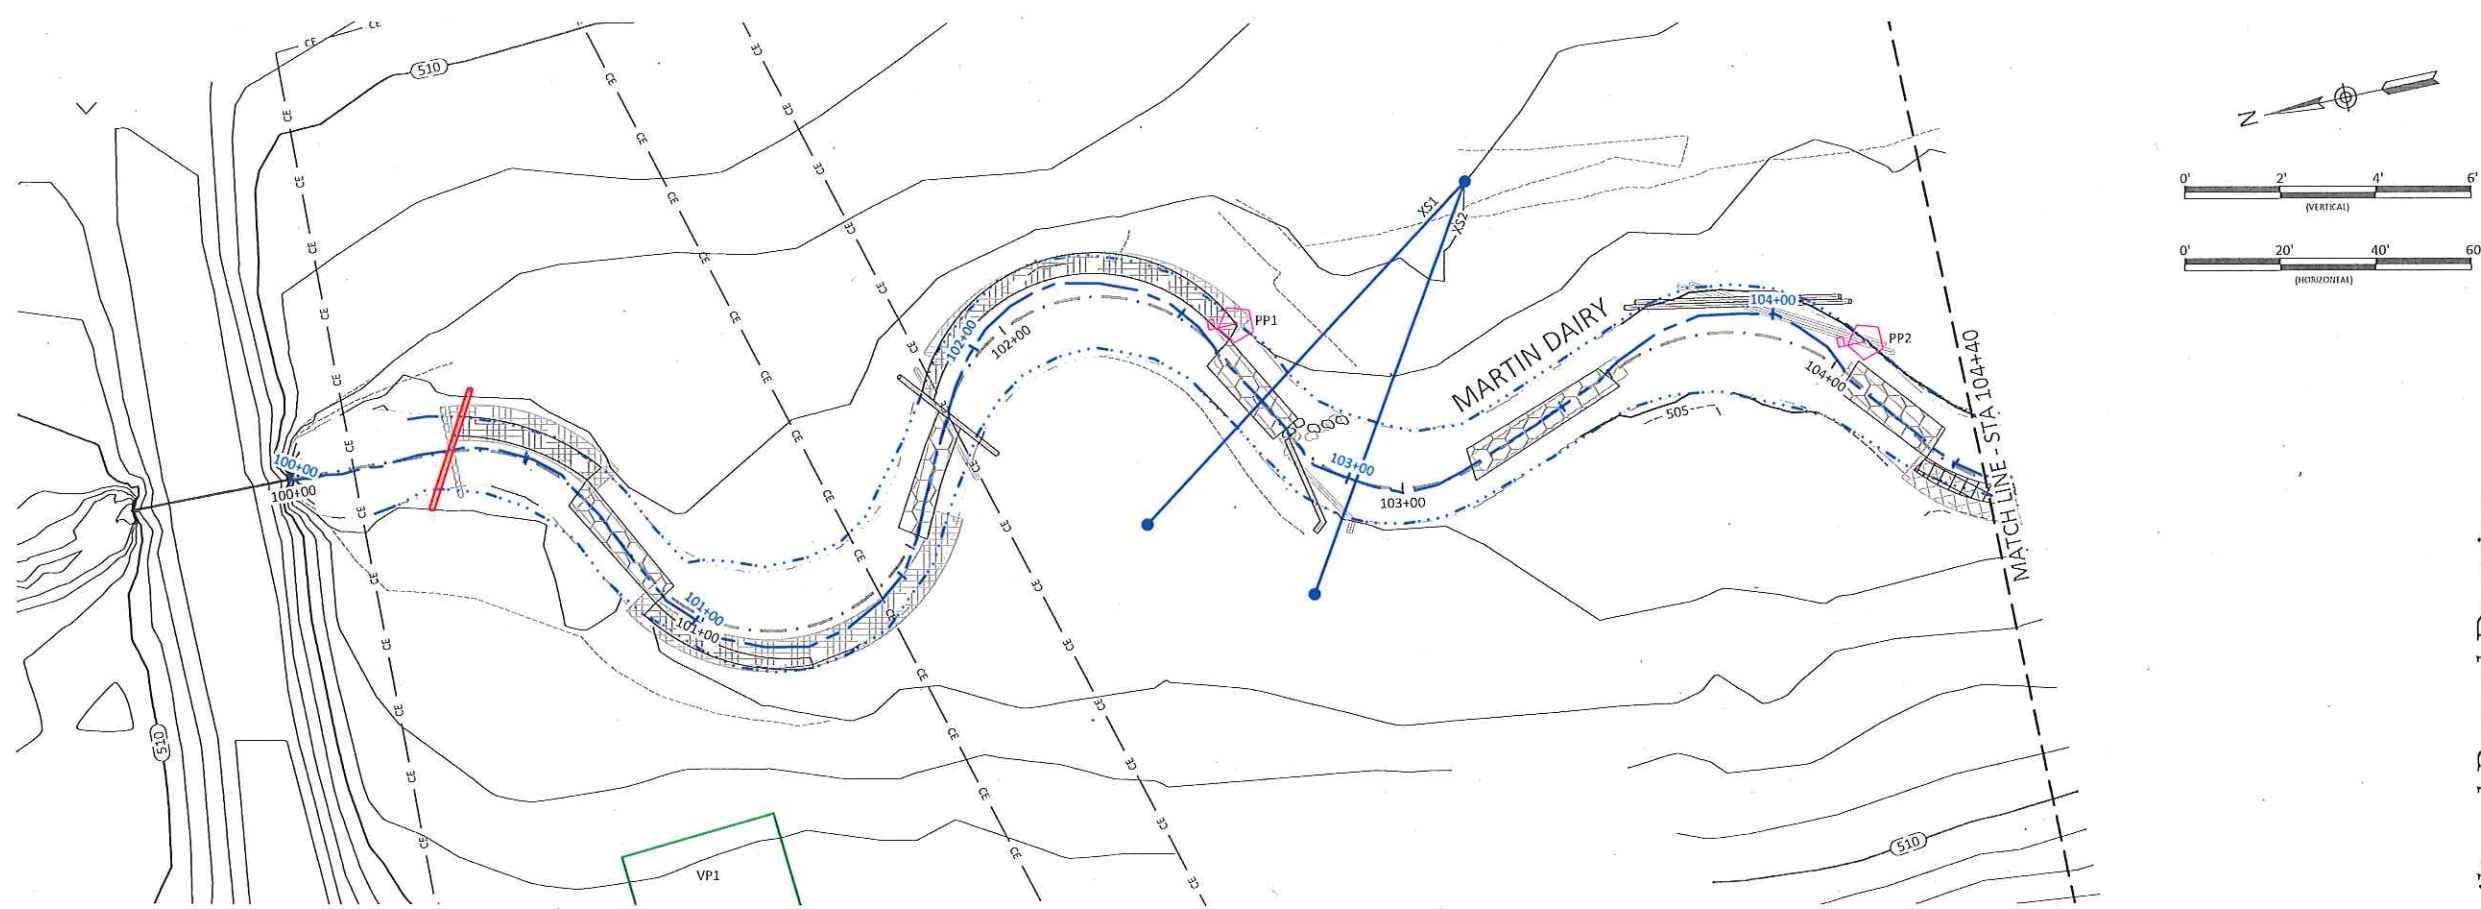
NOTE: AT MARTIN DAIRY STA. 100+34, BOULDER SILL WAS REPLACED WITH LOG SILL DUE TO FIELD CONDITIONS AND AVAILABILITY OF ONSITE MATERIAL.

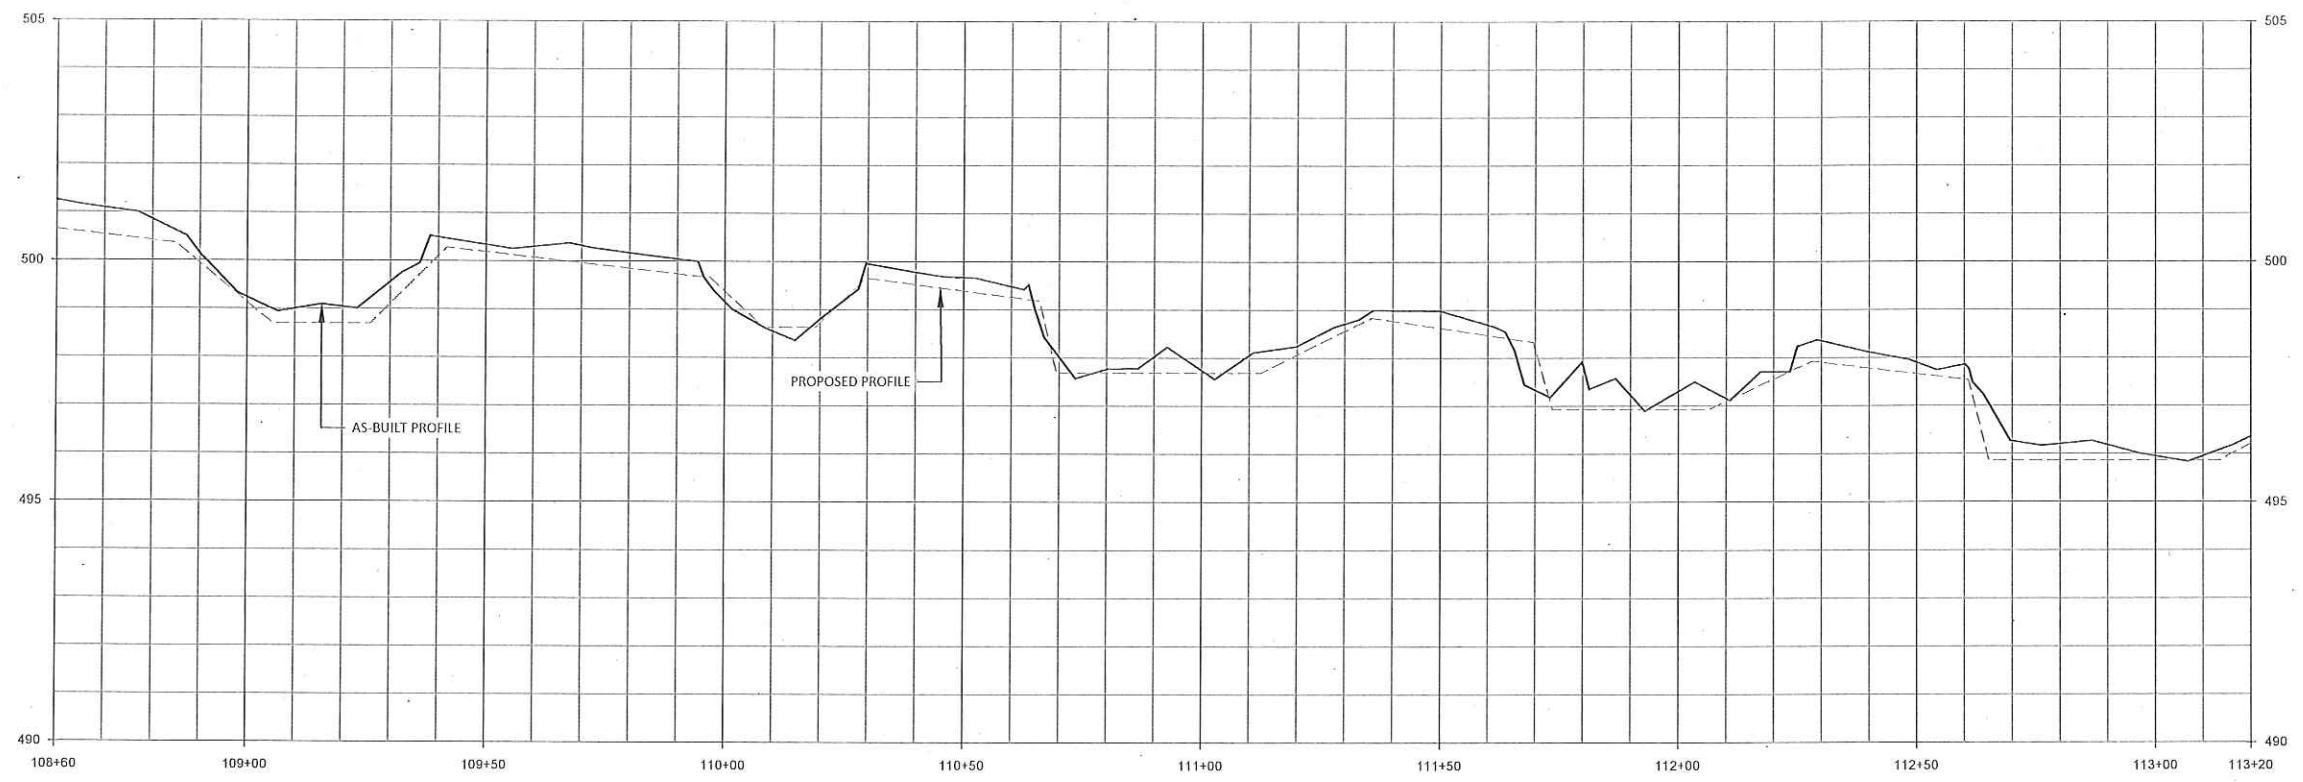
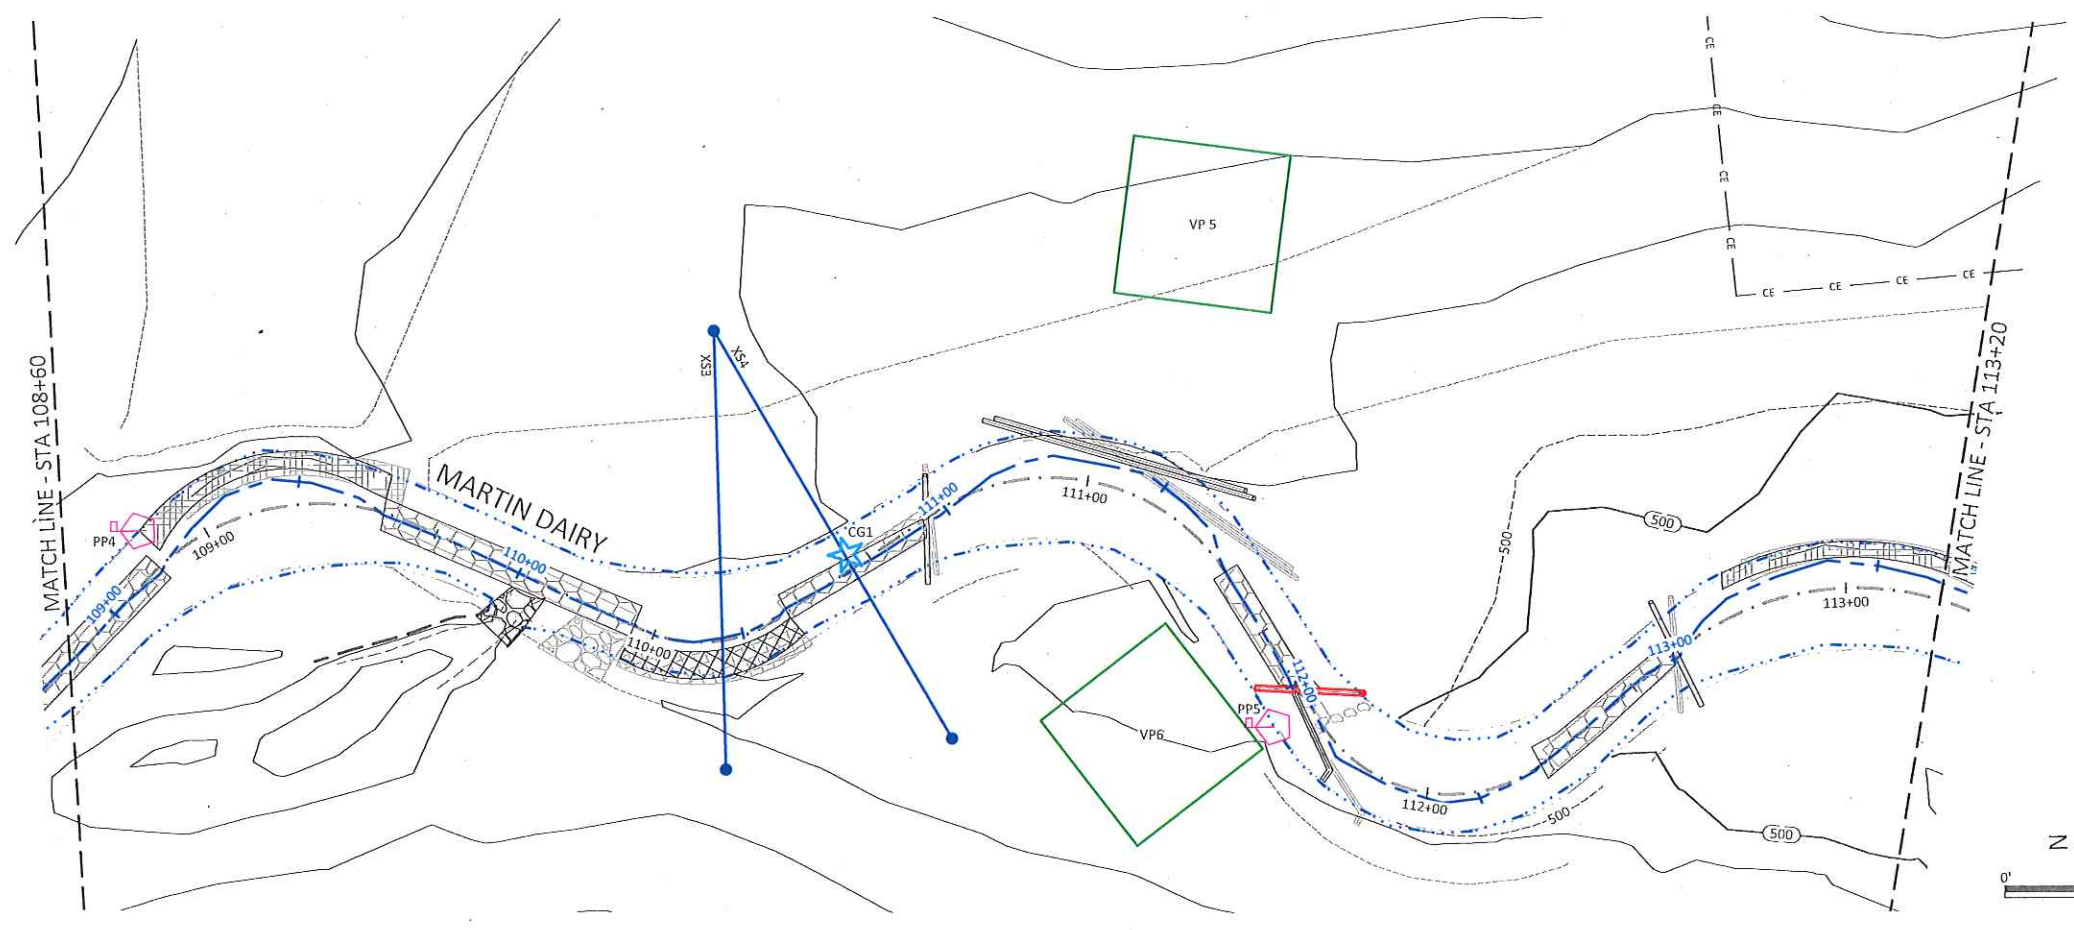
NOTE: AT MARTIN DAIRY STA. 112+01, BOULDER SILL WAS REPLACED WITH LOG SILL DUE TO FIELD CONDITIONS AND AVAILABILITY OF ONSITE MATERIAL.

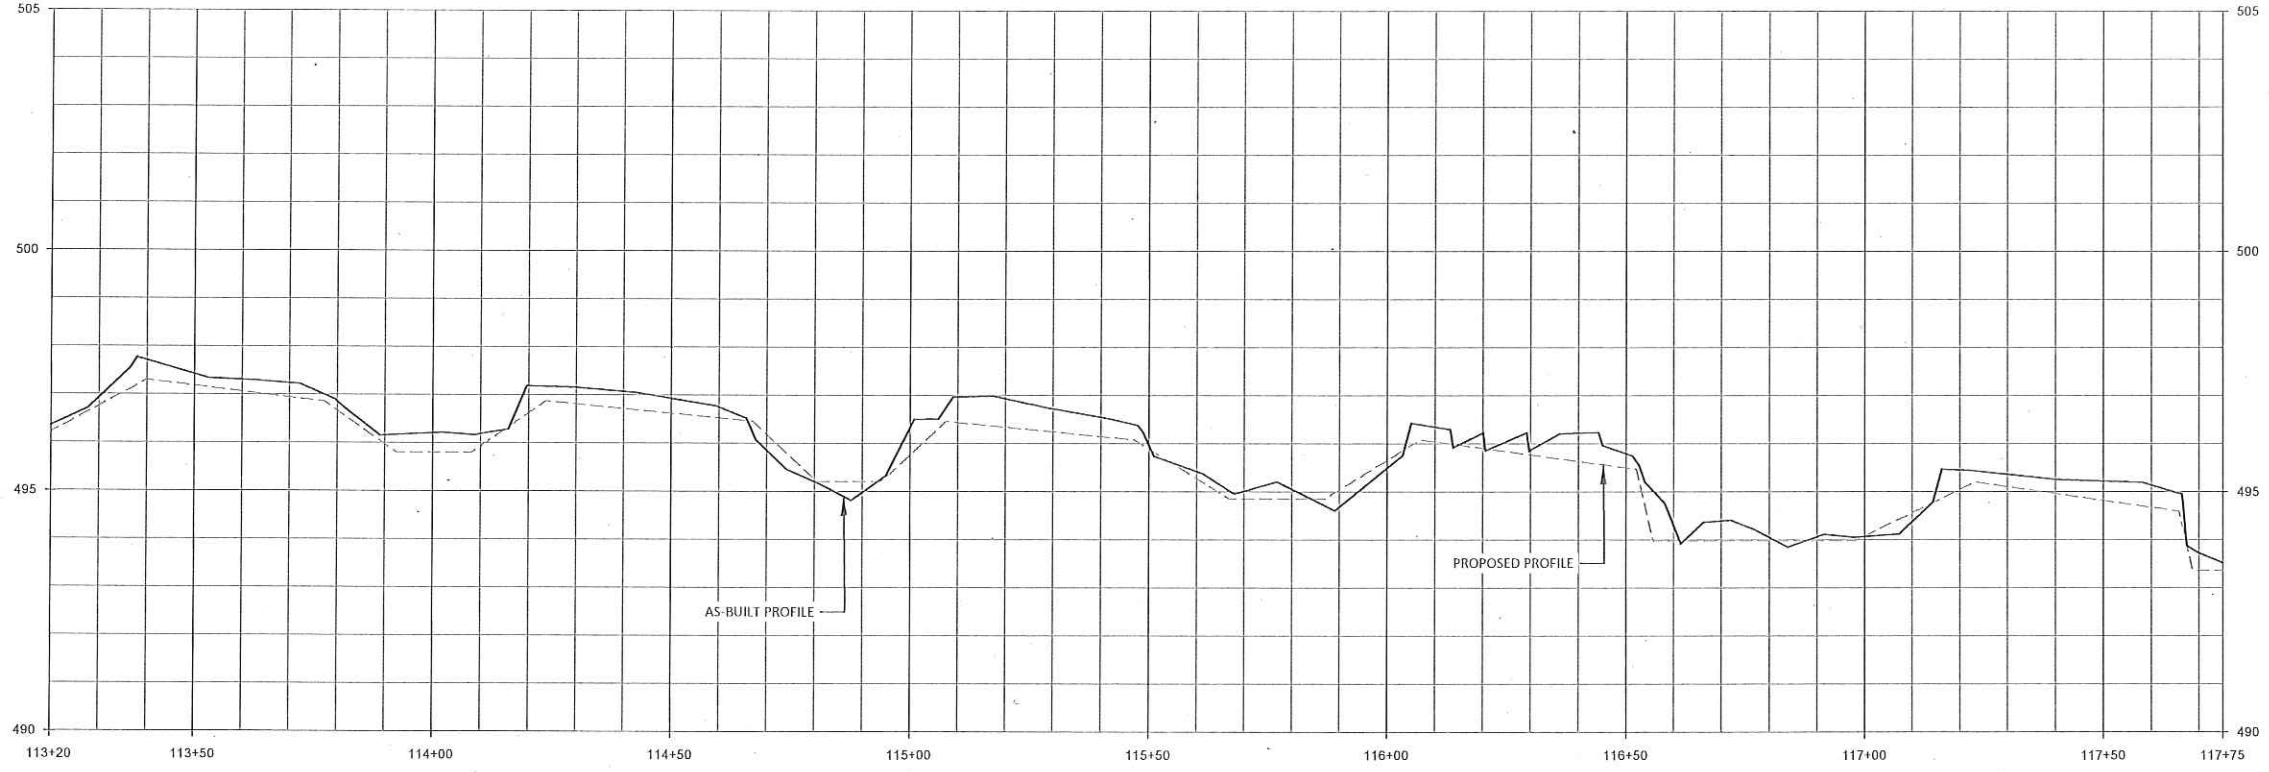
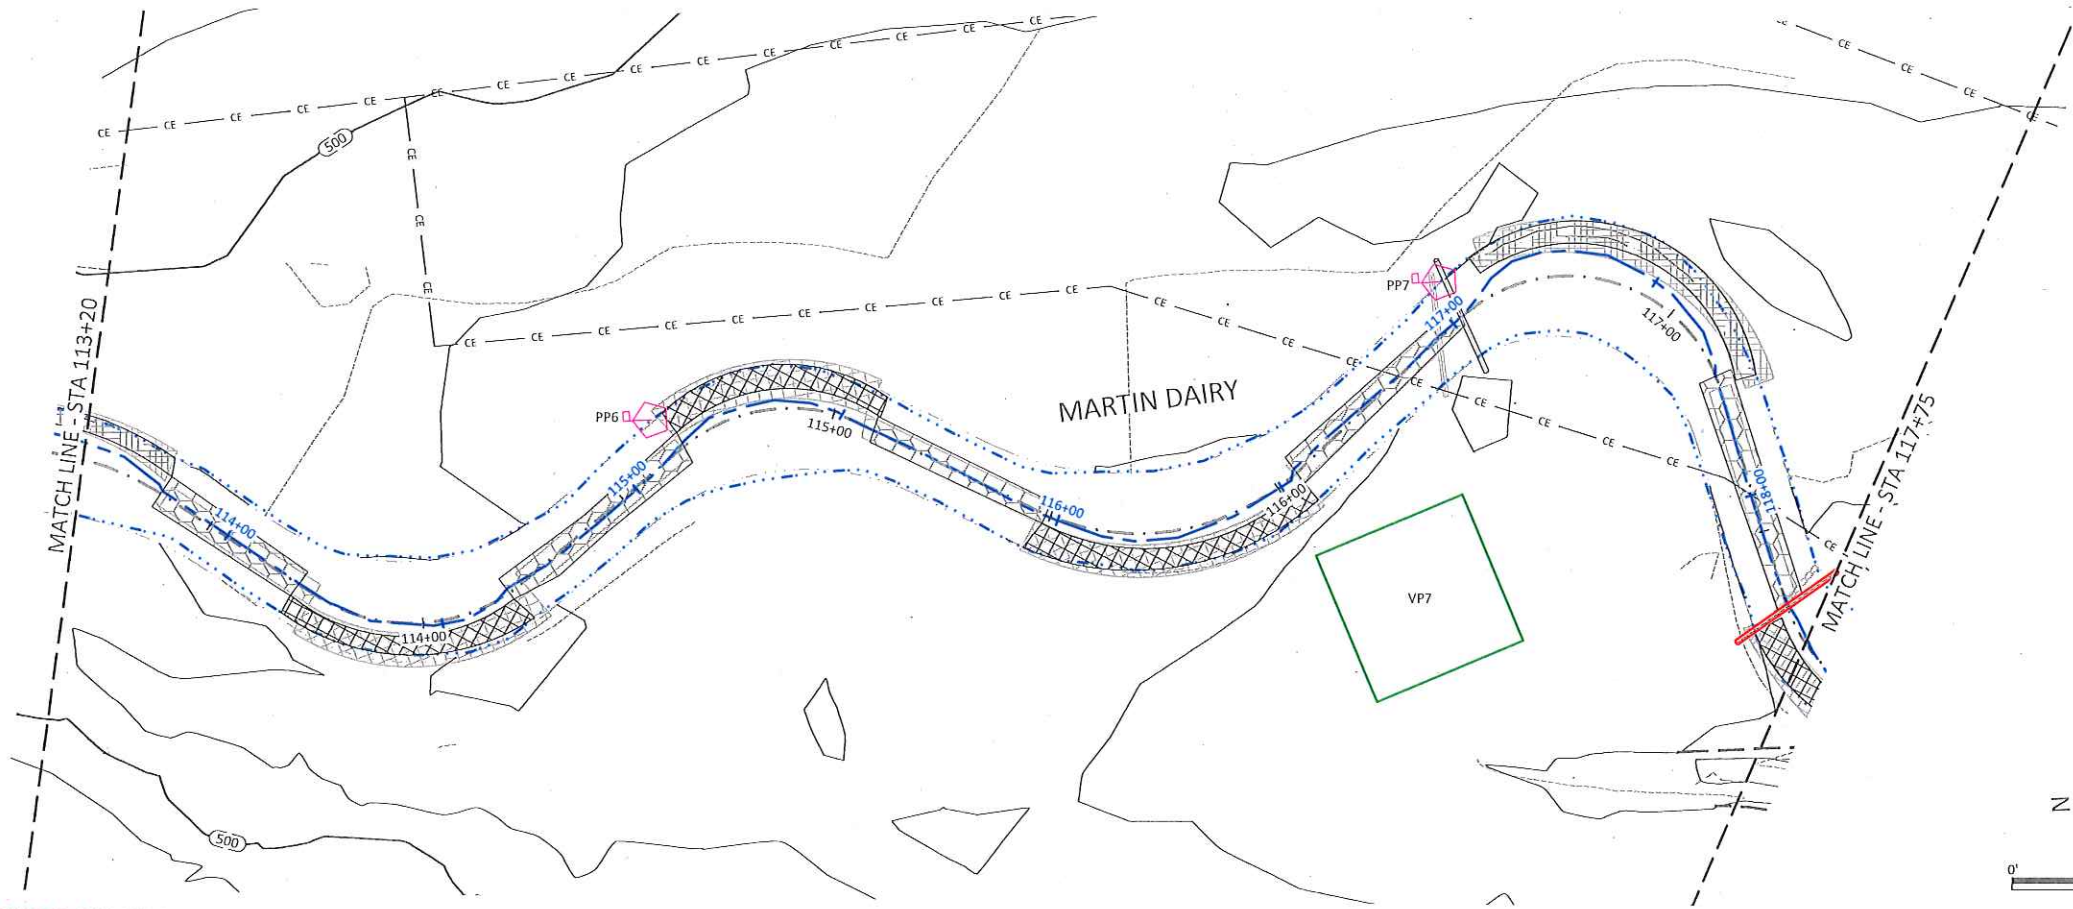
NOTE: AT MARTIN DAIRY STA. 118+24, BOULDER SILL WAS REPLACED WITH LOG SILL DUE TO FIELD CONDITIONS AND AVAILABILITY OF ONSITE MATERIAL.

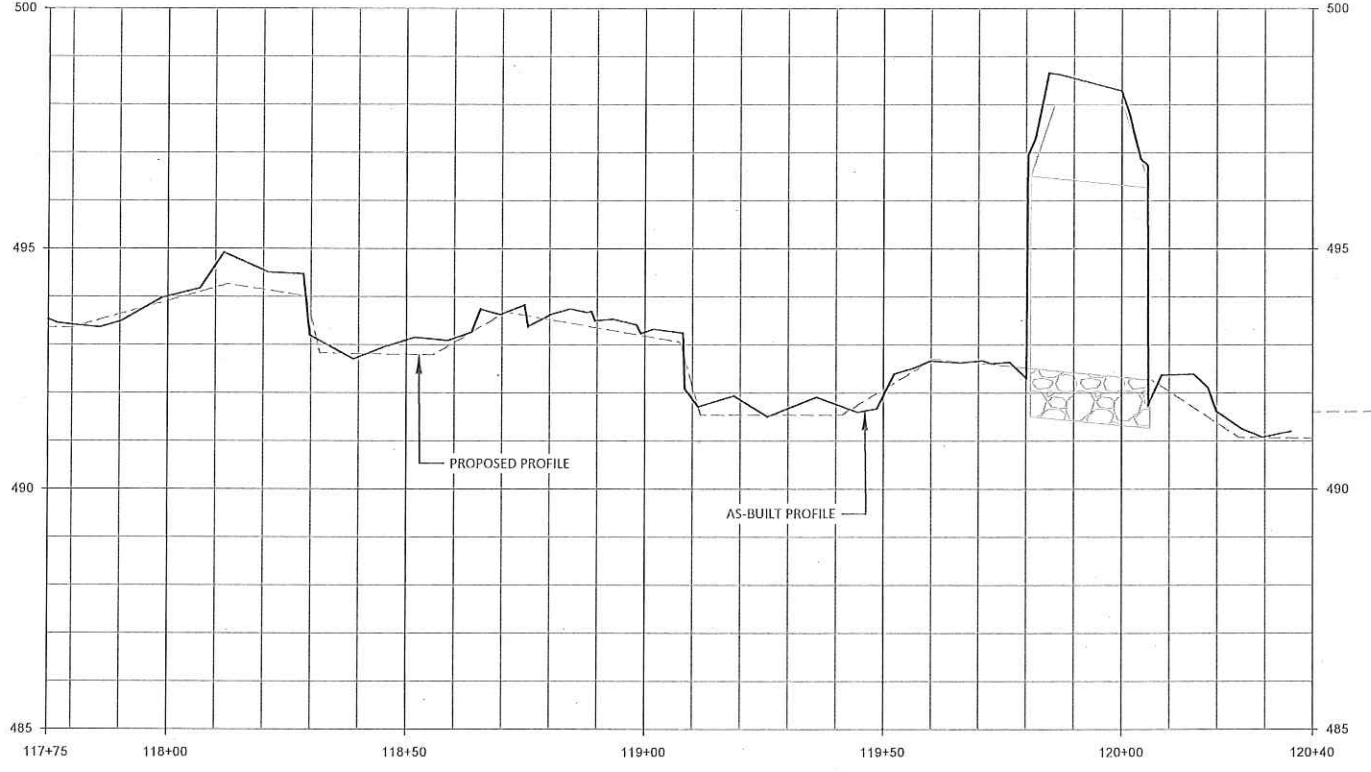
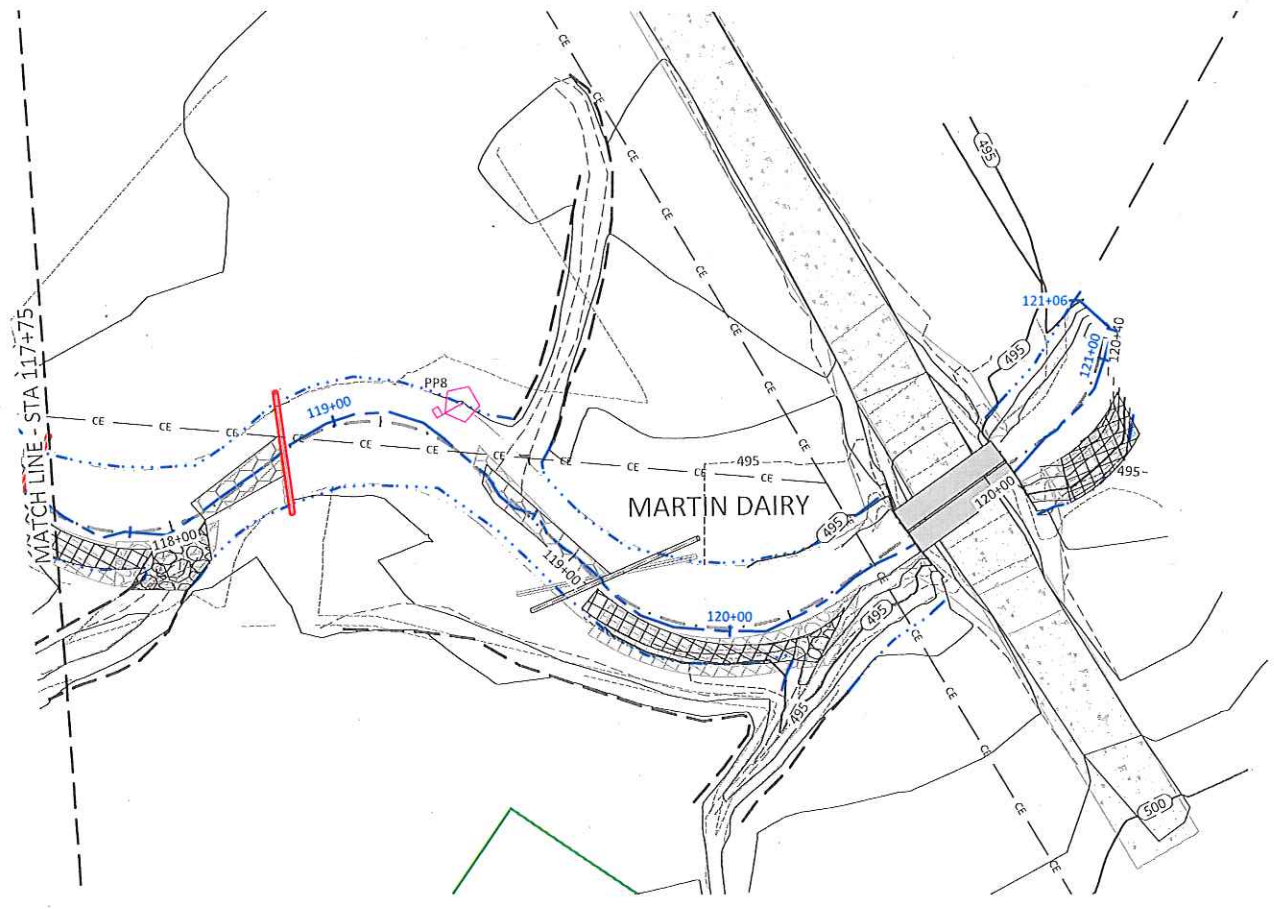
NOTE: AT MARTIN DAIRY STA. 118+88, BOULDER SILL WAS REPLACED WITH LOG SILL DUE TO FIELD CONDITIONS AND AVAILABILITY OF ONSITE MATERIAL.

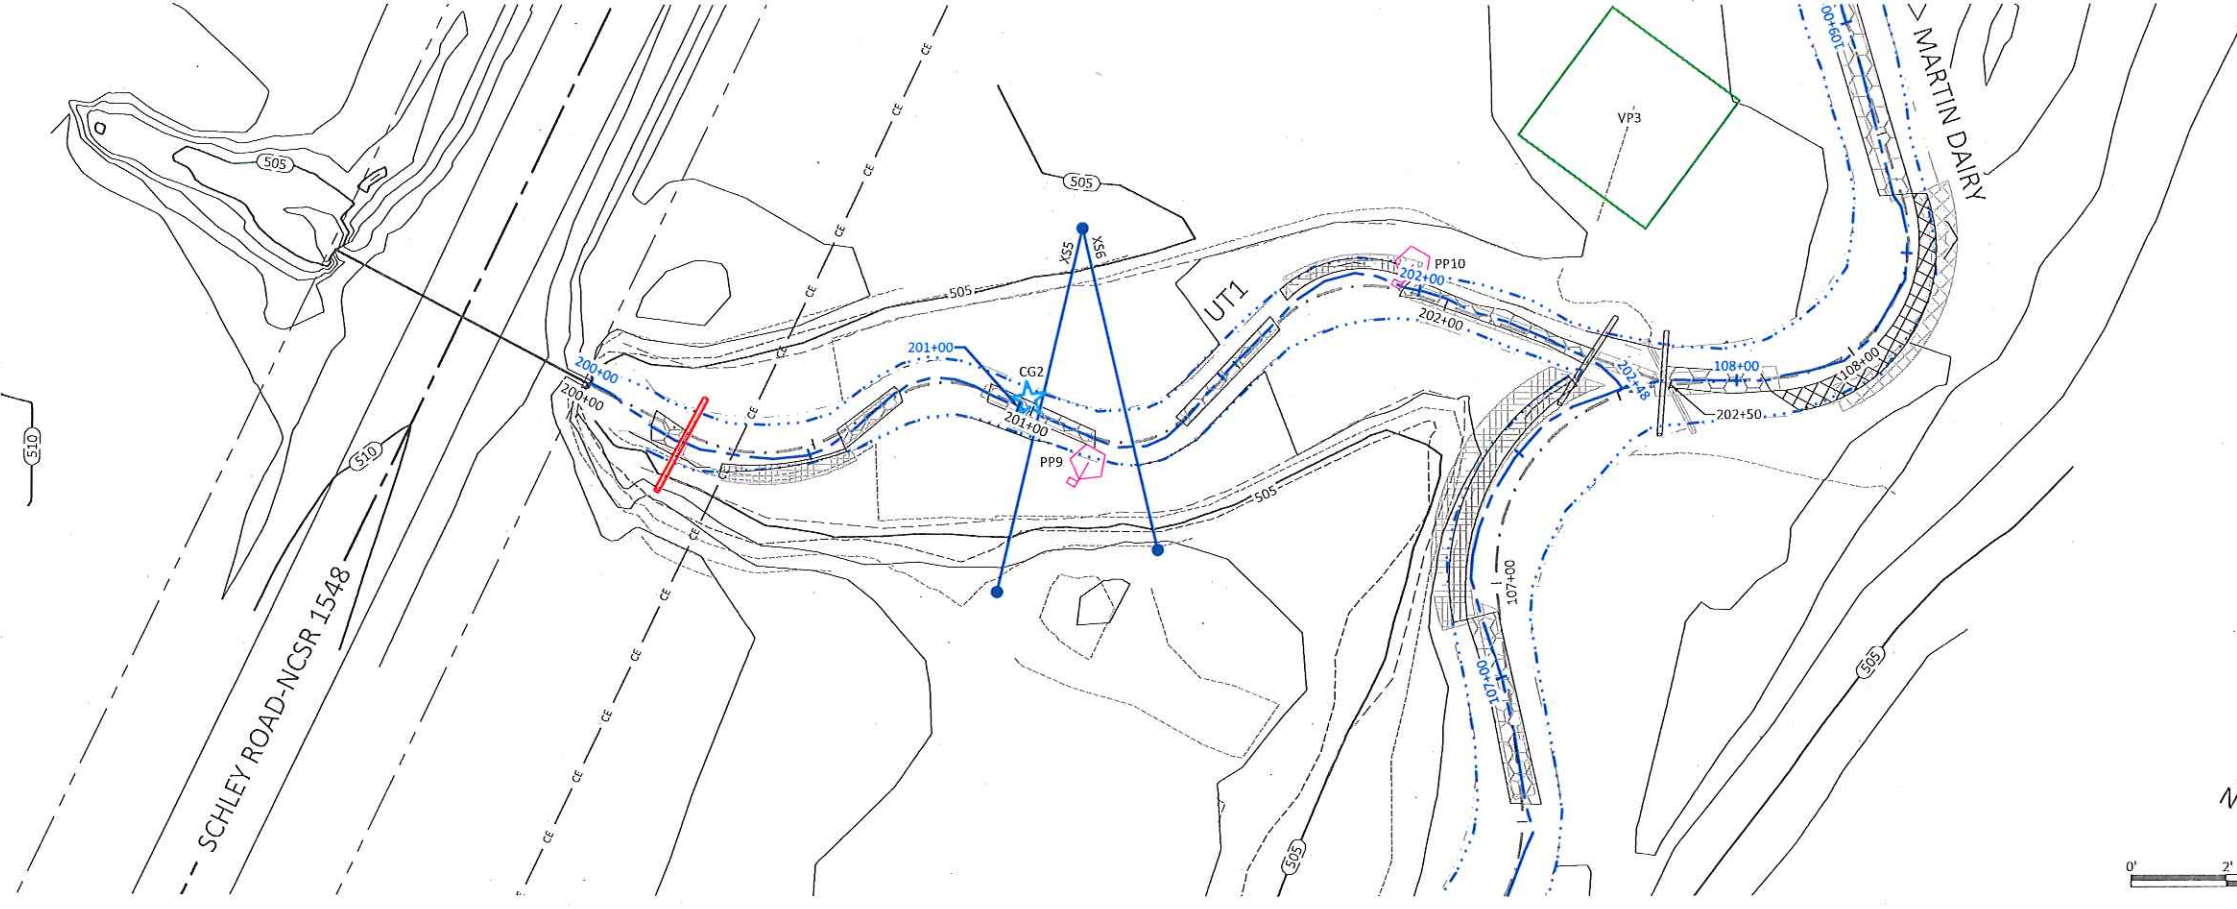
- Station 200+23 boulder sill was replaced with log sill due to field conditions and availability of onsite material.

NOTE: AT UT1 STA. 200+23, BOULDER SILL WAS REPLACED WITH LOG SILL DUE TO FIELD CONDITIONS AND AVAILABILITY OF ONSITE MATERIAL.
