MONITORING YEAR 2 ANNUAL REPORT

MARTIN DAIRY MITIGATION SITE

Orange County, NC

DMS Project Number 97087

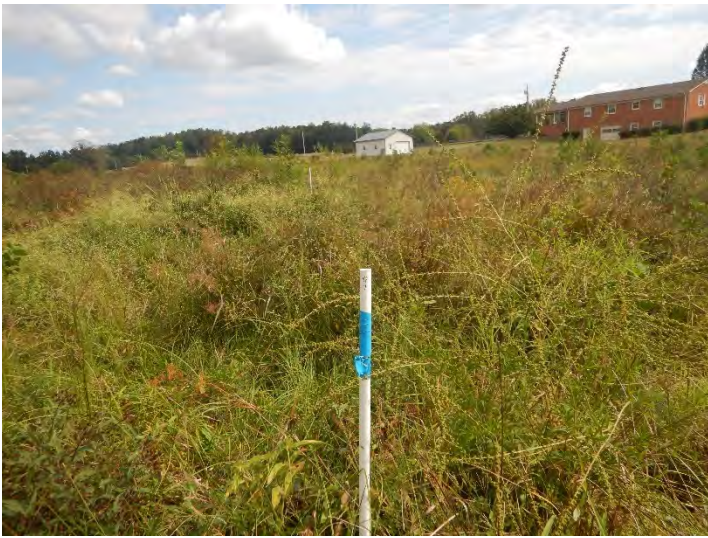
VEG PLOT 7 (09/18/2019)

3. Appendix 3, Table 9 – Vegetation Plot 7 planted stem density should be colored red as it is not on track to meet the interim success criteria for MY3 of 320 planted stems per acre.
