# **MONITORING YEAR 3 ANNUAL REPORT**

## **MARTIN DAIRY MITIGATION SITE**

Orange County, NC  
NCDEQ Contract No. 006831  
DMS Project No. 97087  
USACE Action ID No. 2016-00874  
NCDWR Project No. 2016-0366

Data Collection Period: January – October 2020  
Draft Submission Date: November 9, 2020  
Final Submission Date: December 14, 2020

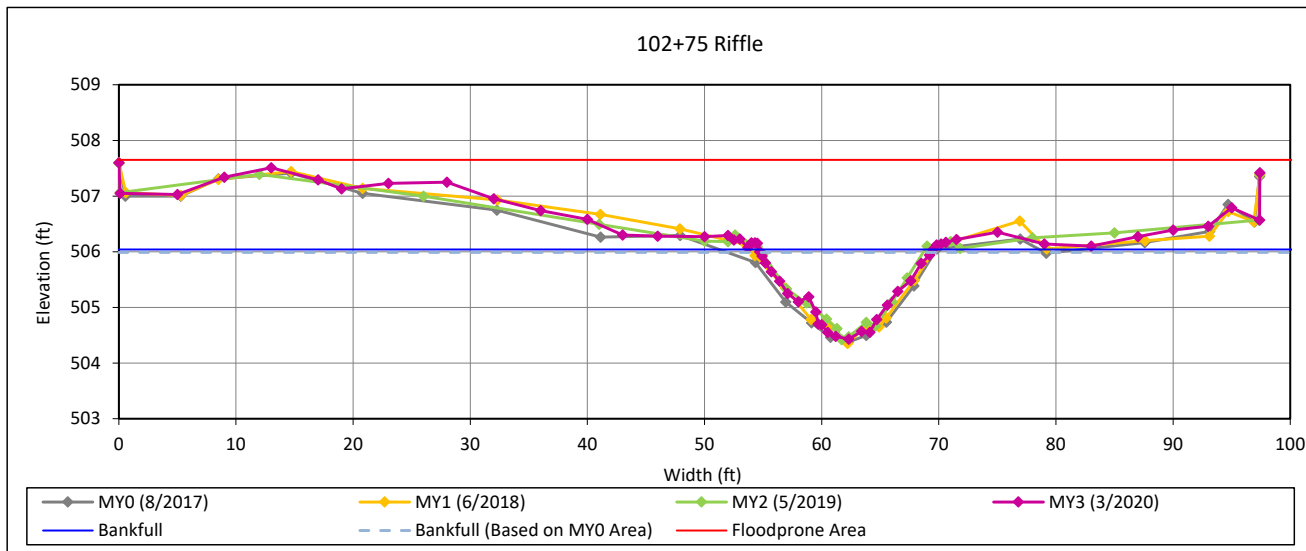
**Cross-Section 1 Martin Dairy Reach 1**

14.0	x-section area (ft.sq.)
14.9	width (ft)
0.9	mean depth (ft)
1.6	max depth (ft)
15.4	wetted perimeter (ft)
0.9	hydraulic radius (ft)
15.8	width-depth ratio
150.0	W flood prone area (ft)
10.1	entrenchment ratio
1.0	low bank height ratio

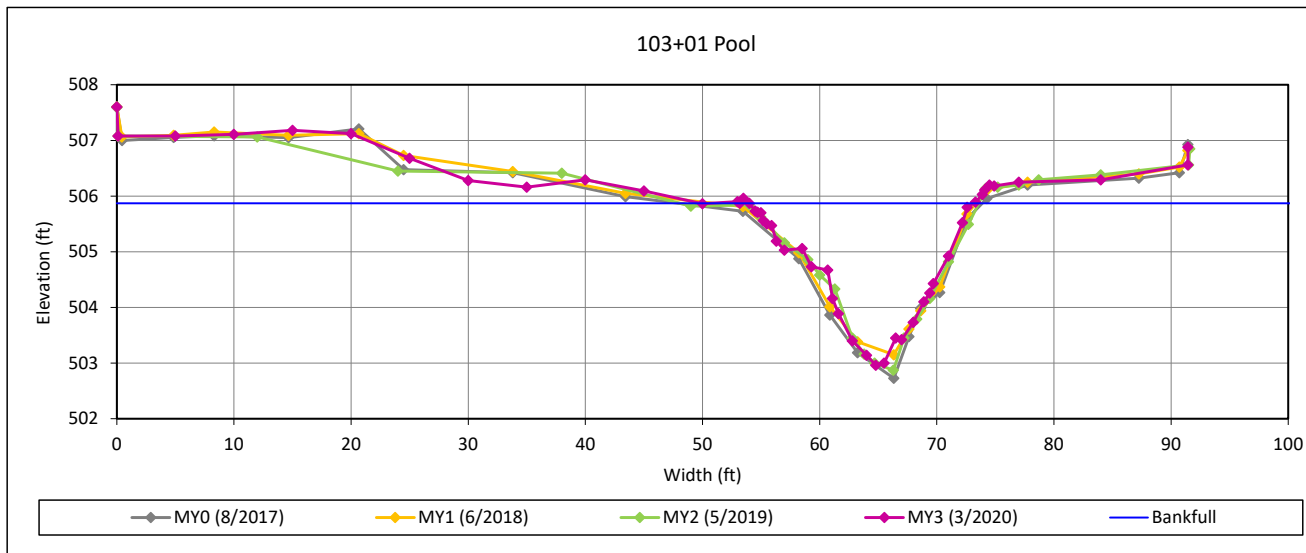
#### Cross-Section 2 Martin Dairy Reach 1

28.1	x-section area (ft.sq.)
19.1	width (ft)
1.5	mean depth (ft)
2.9	max depth (ft)
20.5	wetted perimeter (ft)
1.4	hydraulic radius (ft)
13.1	width-depth ratio

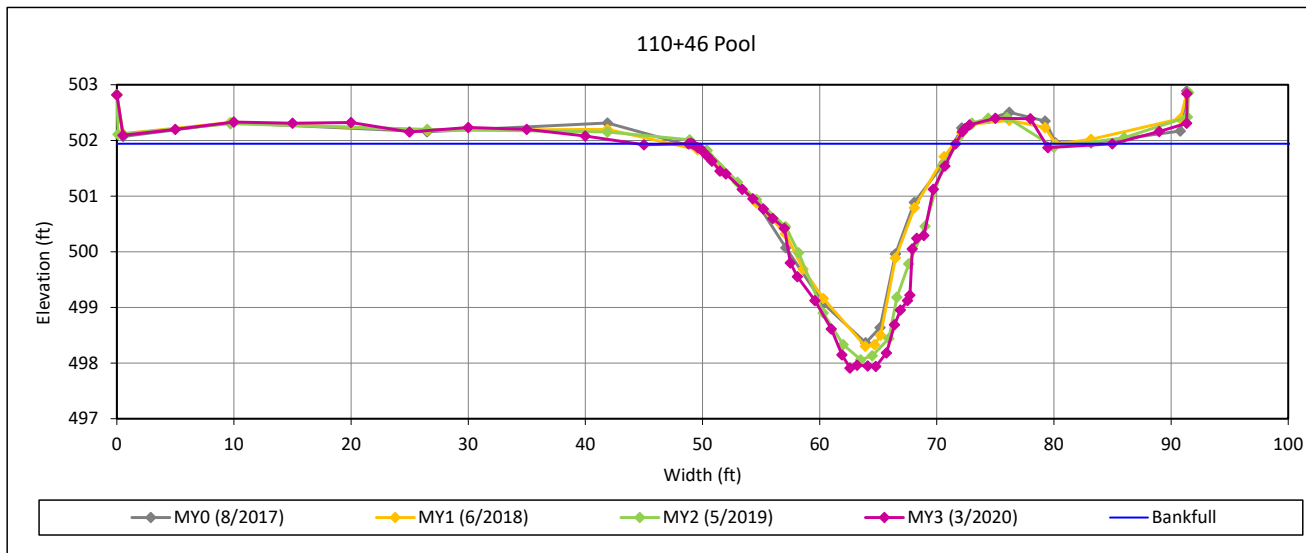
#### Cross-Section 3 Martin Dairy Reach 2

44.9	x-section area (ft.sq.)
22.5	width (ft)
2.0	mean depth (ft)
4.0	max depth (ft)
24.8	wetted perimeter (ft)
1.8	hydraulic radius (ft)
11.3	width-depth ratio

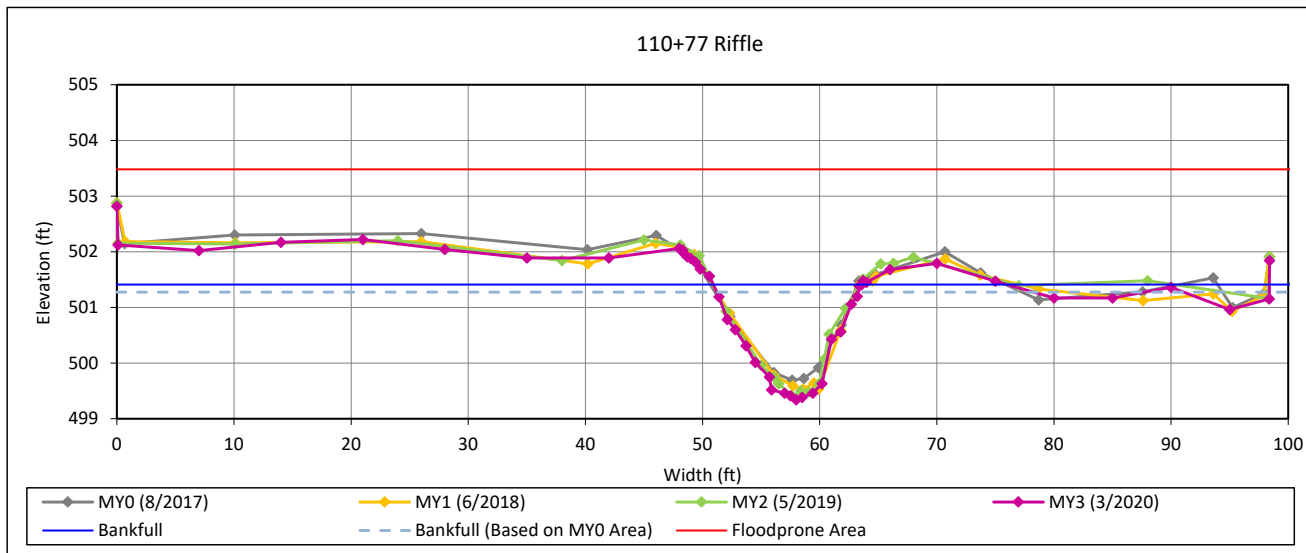
#### Cross-Section 4 Martin Dairy Reach 2

15.9	x-section area (ft.sq.)
12.7	width (ft)
1.3	mean depth (ft)
2.1	max depth (ft)
13.7	wetted perimeter (ft)
1.2	hydraulic radius (ft)
10.1	width-depth ratio
200.0	W flood prone area (ft)
15.8	entrenchment ratio
1.1	low bank height ratio

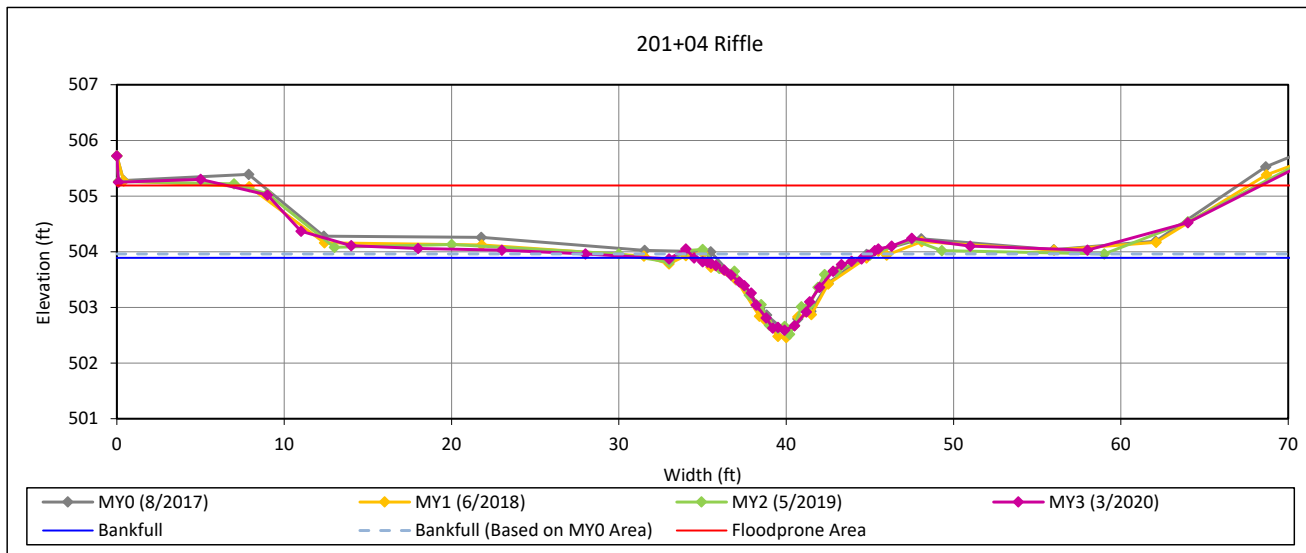
#### Cross-Section 5 UT1

5.6	x-section area (ft.sq.)
10.1	width (ft)
0.6	mean depth (ft)
1.3	max depth (ft)
10.6	wetted perimeter (ft)
0.5	hydraulic radius (ft)
18.4	width-depth ratio
65.0	W flood prone area (ft)
6.4	entrenchment ratio
< 1.0	low bank height ratio

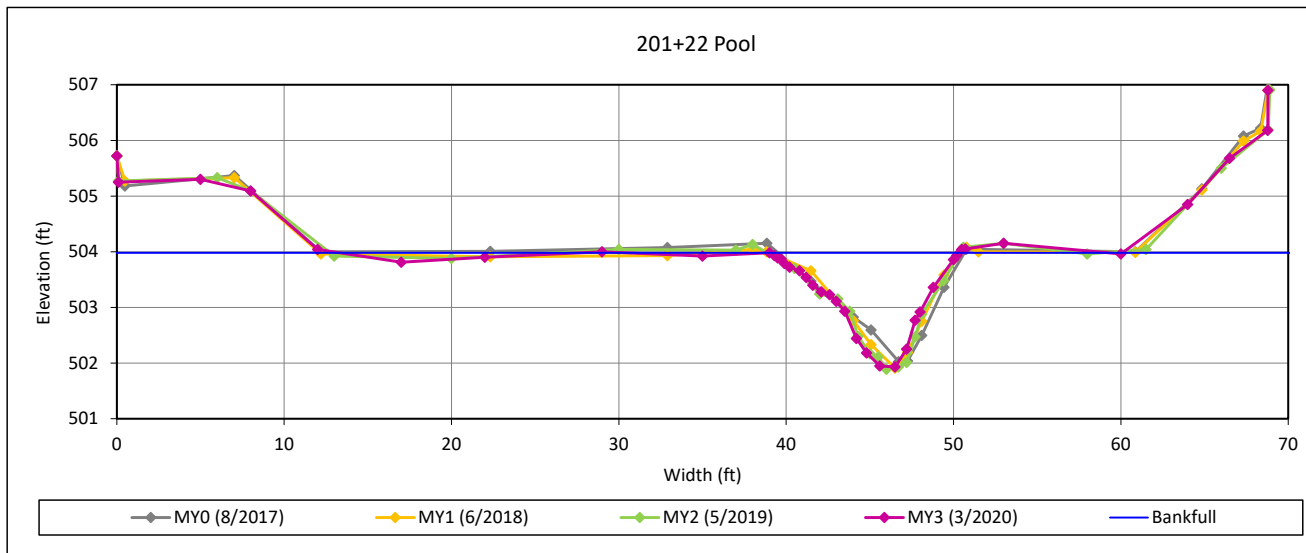
#### Cross-Section 6 UT1

11.0	x-section area (ft.sq.)
11.3	width (ft)
1.0	mean depth (ft)
2.1	max depth (ft)
12.3	wetted perimeter (ft)
0.9	hydraulic radius (ft)
11.7	width-depth ratio
