# **MONITORING YEAR 5 ANNUAL REPORT**

## **MARTIN DAIRY MITIGATION SITE**

DMS Project No. 97087

Data Collection Period: January – October 2022

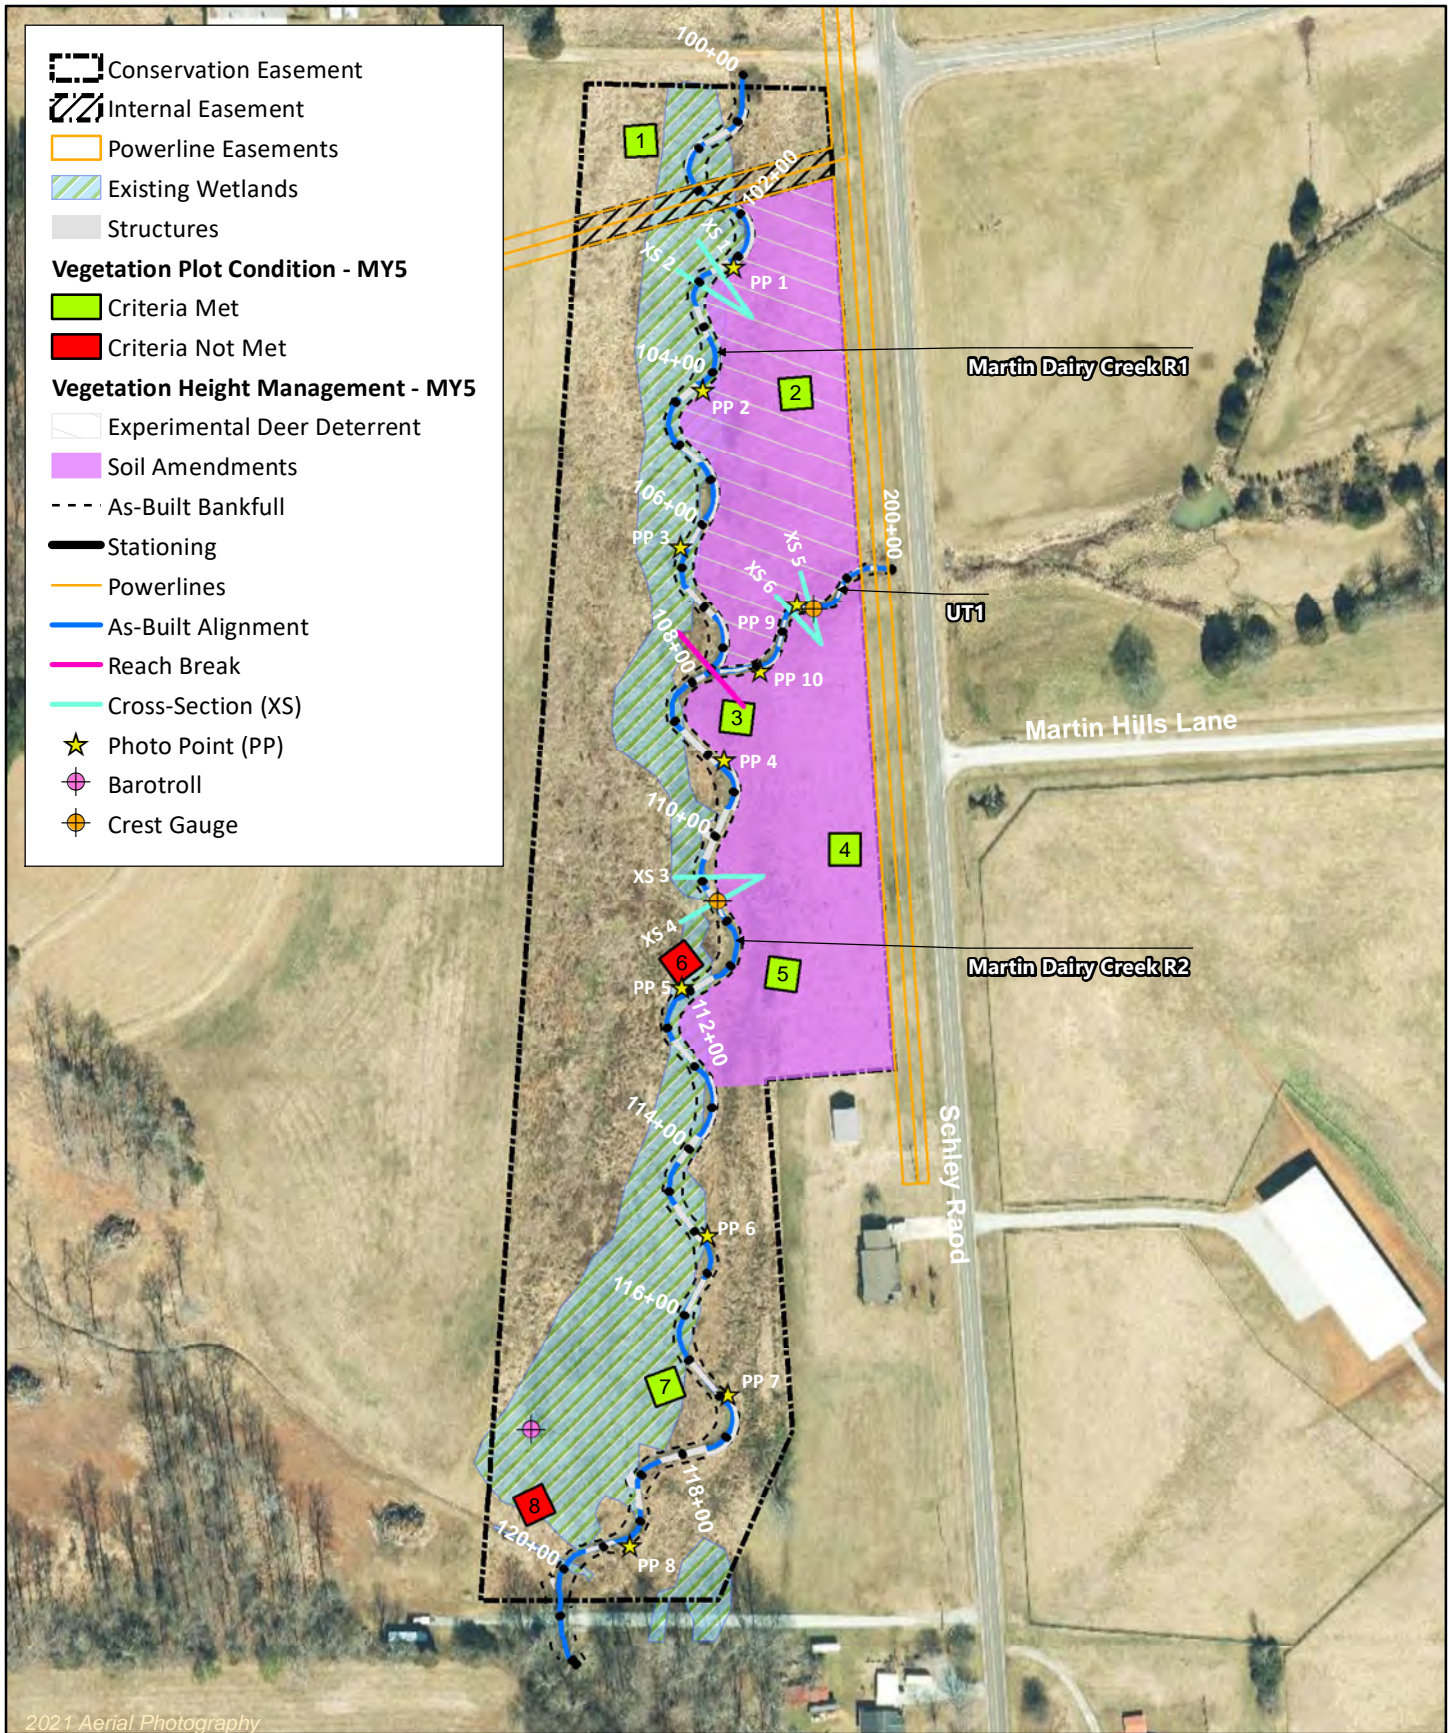
Figure 3. Intergrated Current Condition Plan View  
 Martin Dairy Mitigation Site  
 DMS Project No. 97087  
 Monitoring Year 5 - 2022  
 Orange County, NC

Due to excessive deer browsing, Wildlands experimented with capsaicin tablets as a deterrent around the base of each tree on the northeast side of the Site (Figure 3) in April 2022. Based off visual observations the results were mixed and ultimately found to not be an effective treatment on a large scale. Another effort to combat deer browsing was to add soil amendments at the base of each tree in an effort to get the top of the tree above deer browsing level. This was completed along east side of the Site in May 2022 (Figure 3).

Additional invasive removal of sporadic populations of Japanese honeysuckle (*Lonicera japonica*) is scheduled for winter 2022. Additional soil amendments are scheduled to be added throughout the Site in spring 2023 to continue to combat deer browsing.

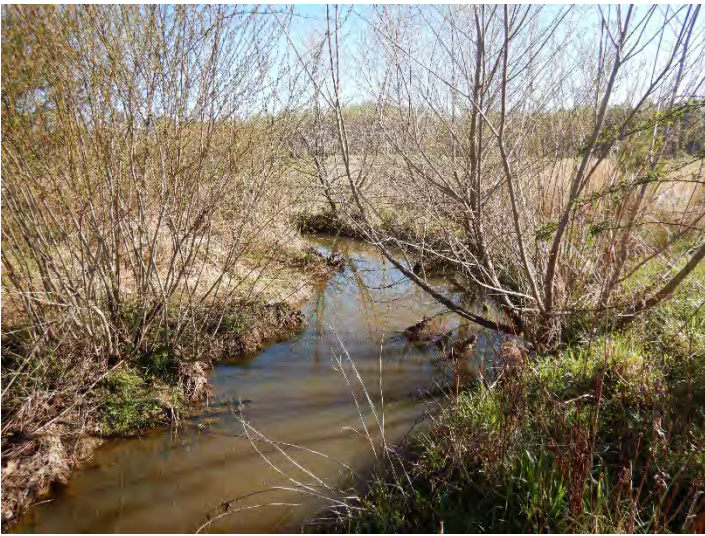
**PHOTO POINT 1 Martin Dairy R1 – upstream (4/6/2022)**

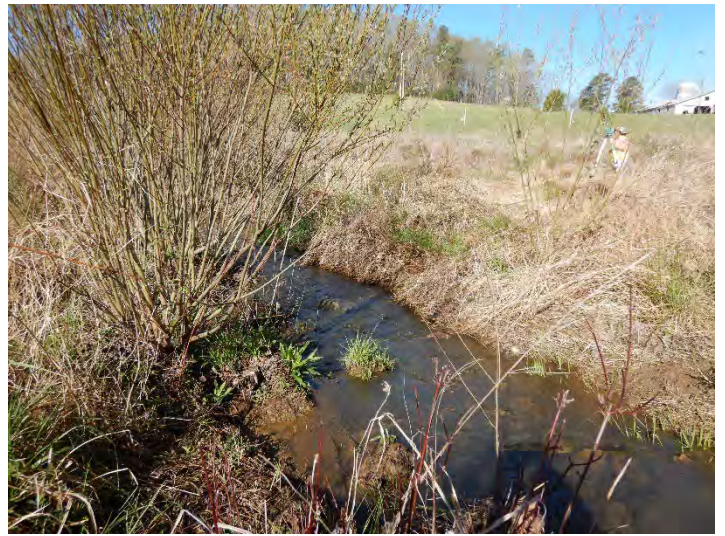
**PHOTO POINT 1 Martin Dairy R1 – downstream (4/6/2022)**

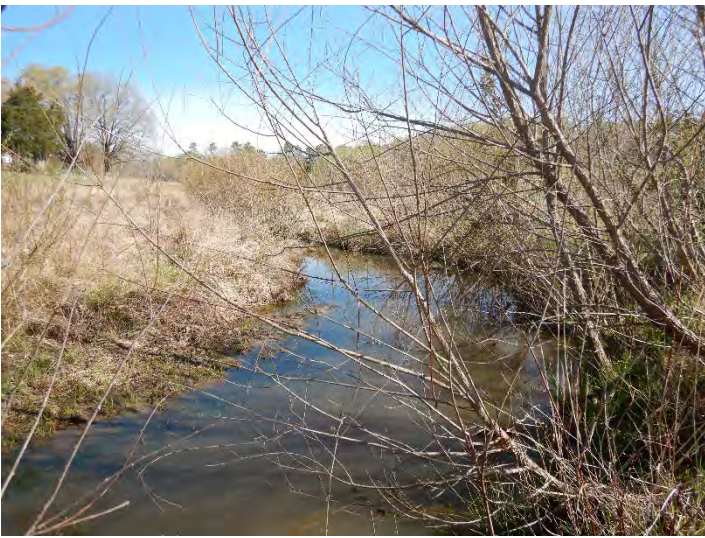
**PHOTO POINT 2 Martin Dairy R1 – upstream (4/6/2022)**

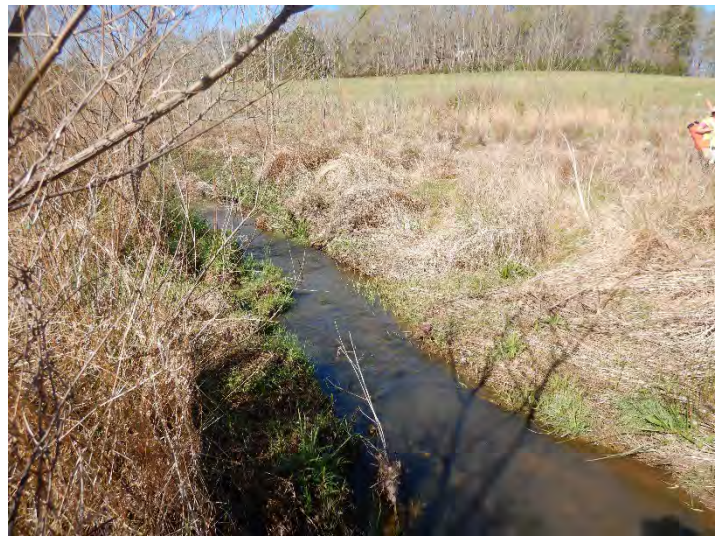
**PHOTO POINT 2 Martin Dairy R1 – downstream (4/6/2022)**

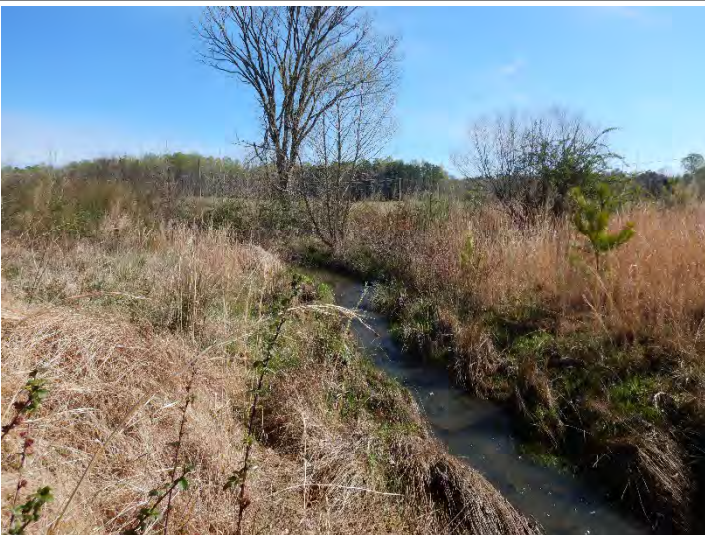
**PHOTO POINT 3 Martin Dairy R1 – upstream (4/6/2022)**

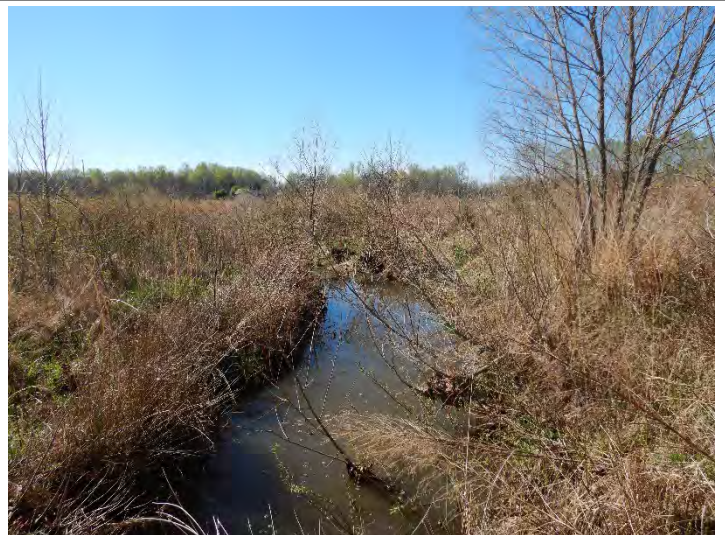
**PHOTO POINT 3 Martin Dairy R1 – downstream (4/6/2022)**

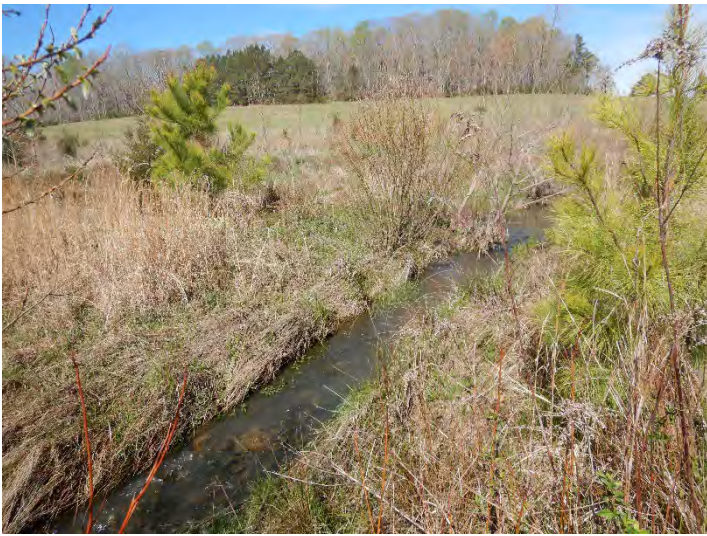
**PHOTO POINT 4 Martin Dairy R2 – upstream (4/6/2022)**

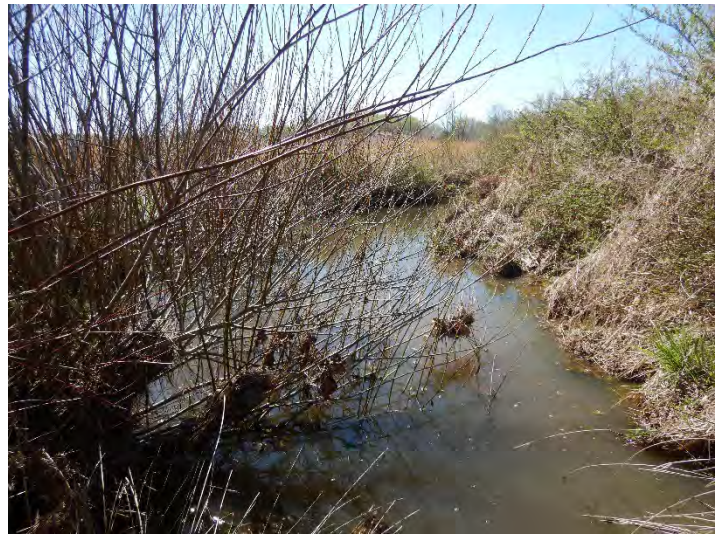
**PHOTO POINT 4 Martin Dairy R2 – downstream (4/6/2022)**

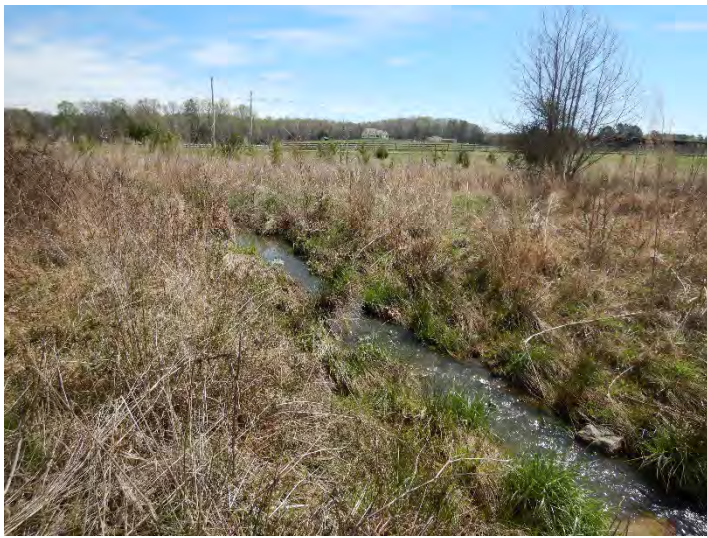
**PHOTO POINT 5 Martin Dairy R2 – upstream (4/6/2022)**

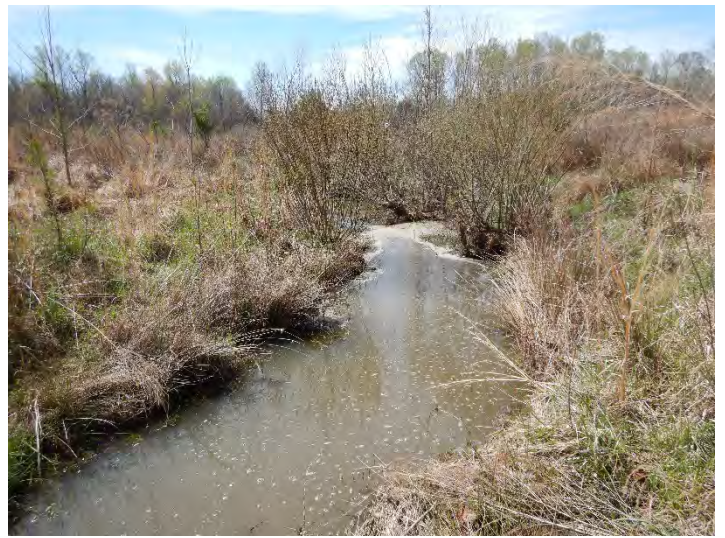
**PHOTO POINT 5 Martin Dairy R2 – downstream (4/6/2022)**

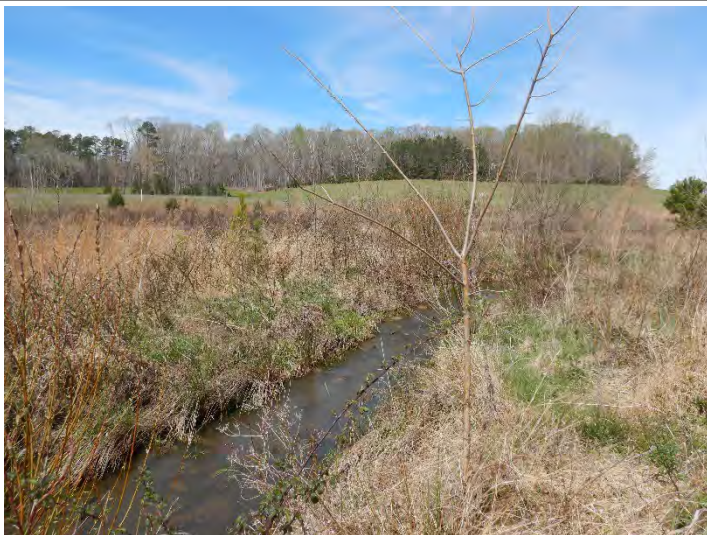
**PHOTO POINT 6 Martin Dairy R2 – upstream (4/6/2022)**

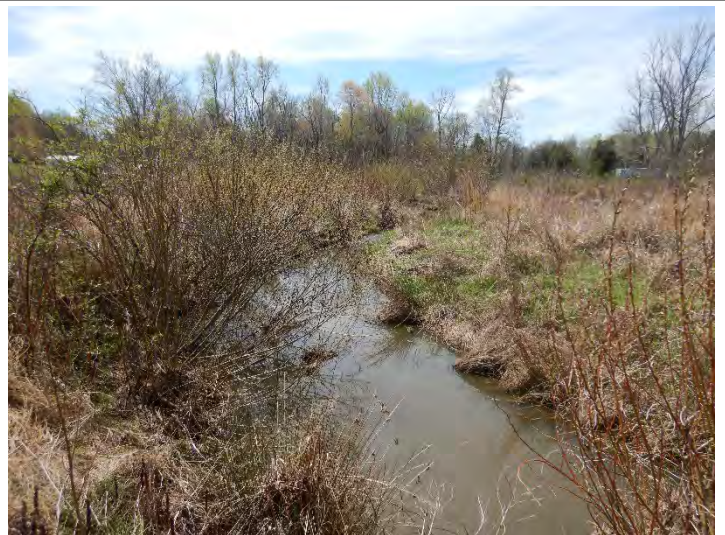
**PHOTO POINT 6 Martin Dairy R2 – downstream (4/6/2022)**

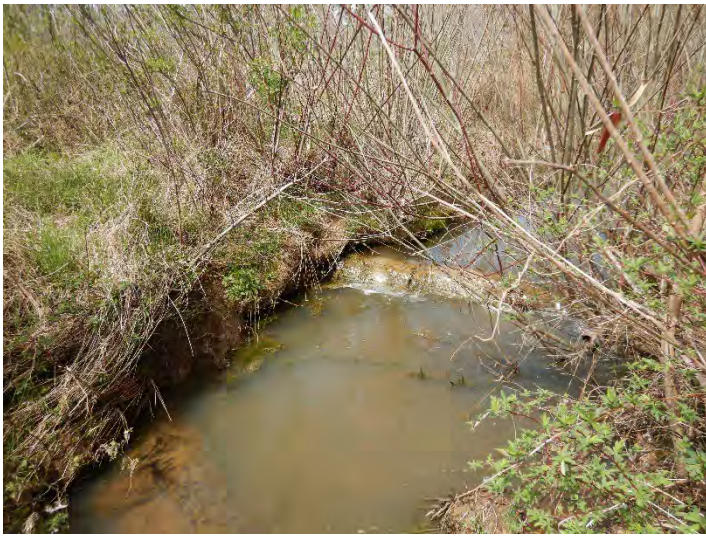
**PHOTO POINT 7 Martin Dairy R2 – upstream (4/6/2022)**

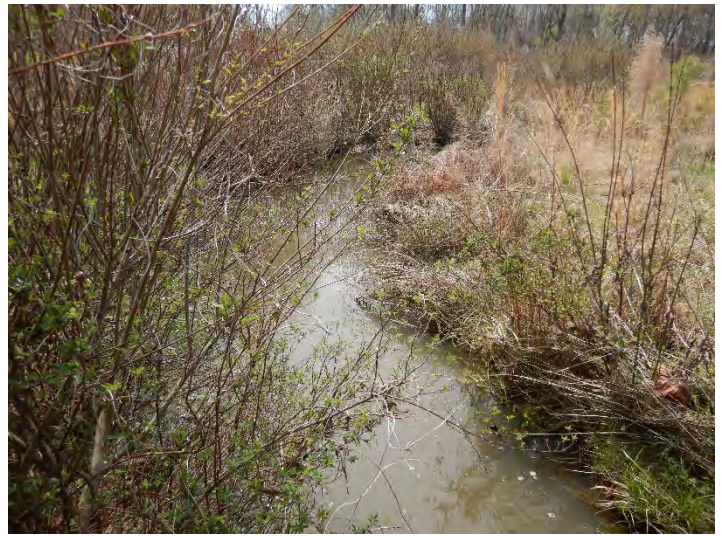
**PHOTO POINT 7 Martin Dairy R2 – downstream (4/6/2022)**

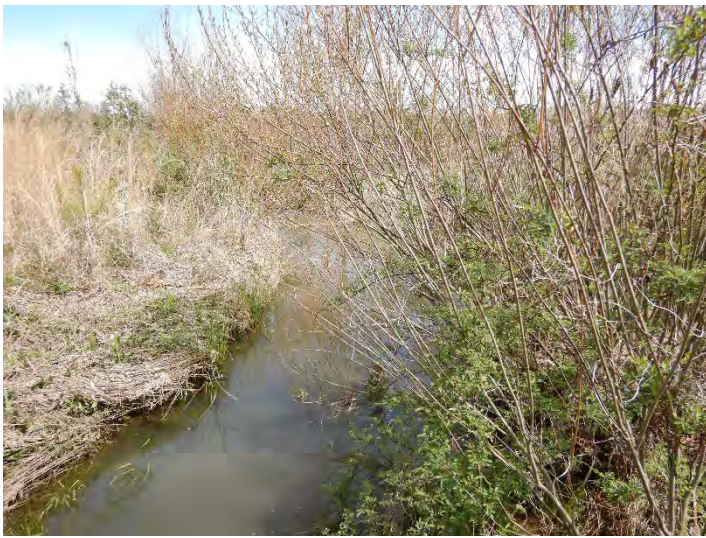
**PHOTO POINT 8 Martin Dairy R2 – upstream (4/6/2022)**

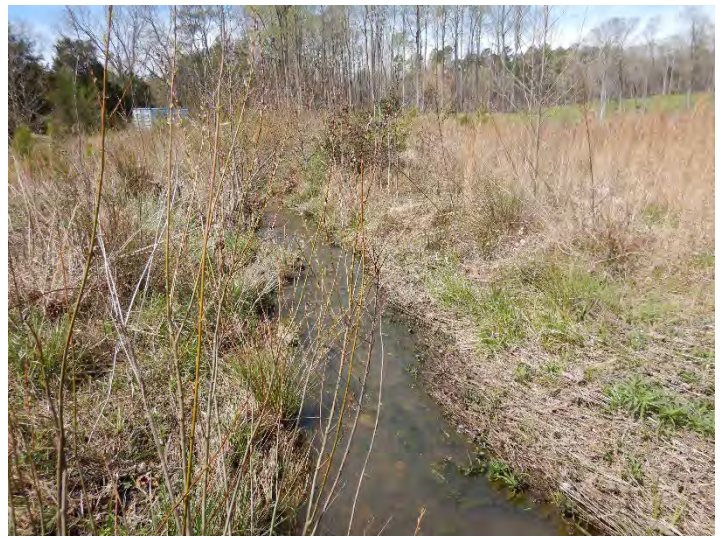
**PHOTO POINT 8 Martin Dairy R2 – downstream (4/6/2022)**

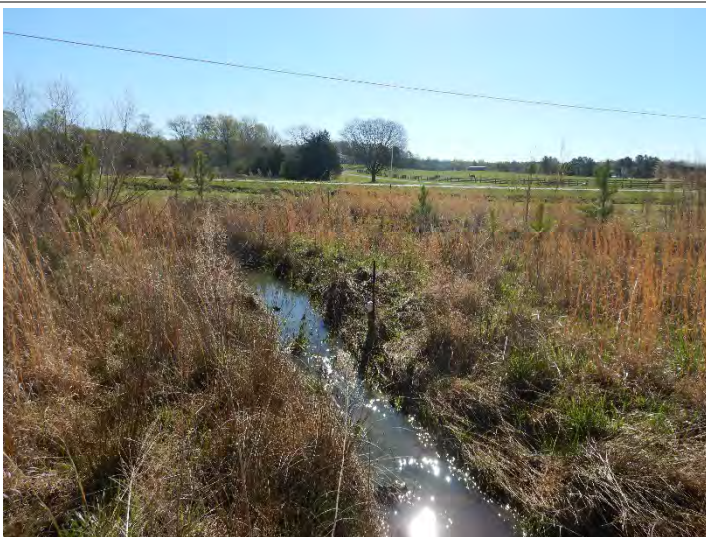
**PHOTO POINT 9 UT1 – upstream (4/6/2022)**

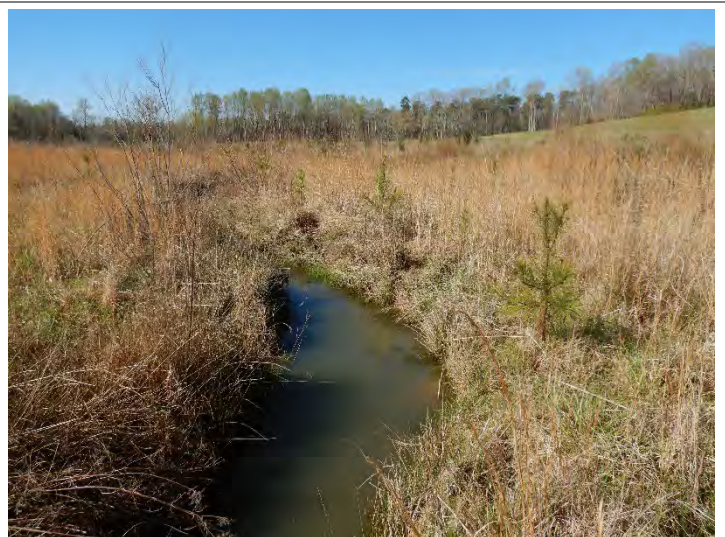
**PHOTO POINT 9 UT1 – downstream (4/6/2022)**

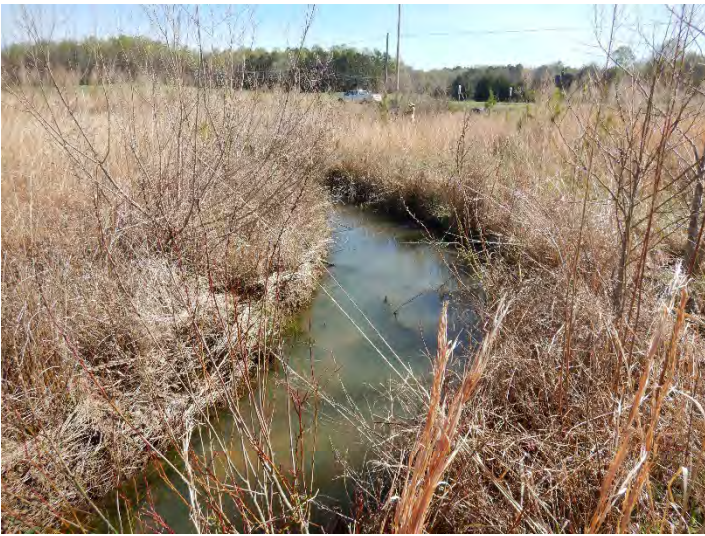
**PHOTO POINT 10 UT1 – upstream (4/6/2022)**

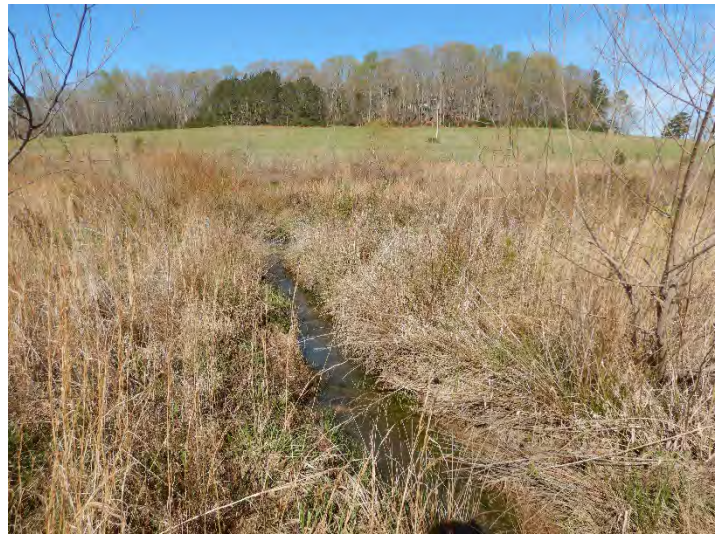
**PHOTO POINT 10 UT1 – downstream (4/6/2022)**
