MONITORING YEAR 6 ANNUAL REPORT

MARTIN DAIRY MITIGATION SITE

Orange County, NC
NCDEQ Contract No. 006831
DMS Project No. 97087
USACE Action ID No. 2016-00874
NCDWR Project No. 2016-0366

MARTIN DAIRY MITIGATION SITE
Monitoring Year 6 Annual Report

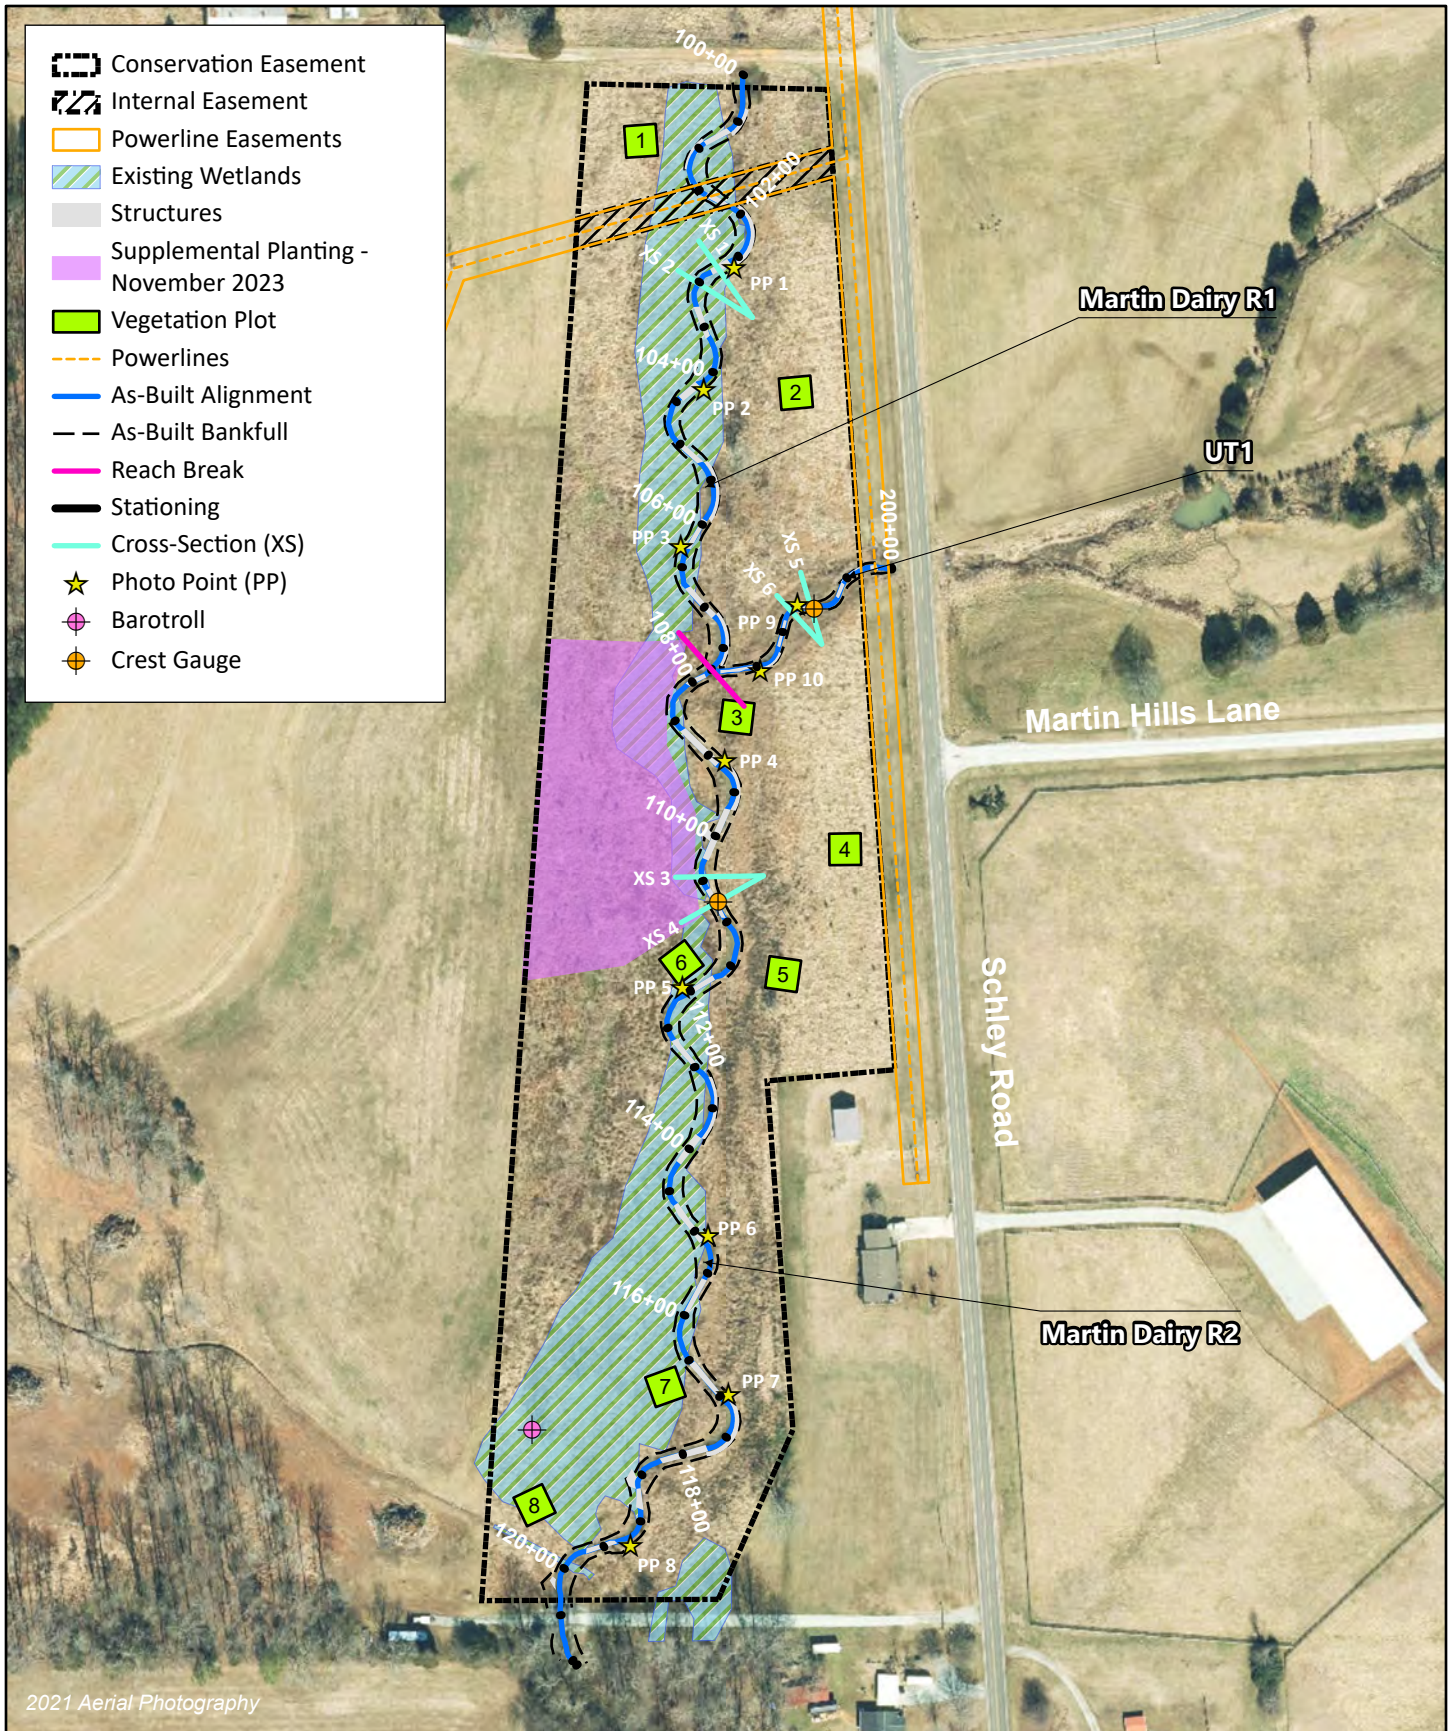
Figure 3. Intergraded Current Condition Plan View
 Martin Dairy Mitigation Site
 DMS Project No. 97087
 Monitoring Year 6 - 2023
 Orange County, NC

Visual assessment indicated that all stream reaches within the Site are geomorphically stable and functioning as designed. Vegetation is well established along the stream banks and desirable volunteer tree species continue to add to stem density and species diversity. Survival and growth of planted trees appear to be on track to surpass MY7 success criteria. On November 14th a supplemental planting of containerized trees occurred on approximately 1.25 acres along the right side of Martin Dairy near the confluence of UT1. This was recommended by DWR during a buffer closeout site walk on July 18th, 2023. Invasive vegetation treatment occurred across the Site to treat sporadic populations of invasive species. The Site will continue to receive follow-up invasive treatments as needed. In May and June, soil amendments were added to shorter trees to combat deer browsing and ensure tree height success. Multiple bankfull and geomorphically significant events were recorded on UT1, but none were recorded on Martin Dairy. The gauge on UT1 and the Barotroll malfunctioned around September 1st, and were replaced on November 1st. Overall, the Site is meeting its goals and is on track to meet final success criteria. No easement encroachments have been identified in MY6.

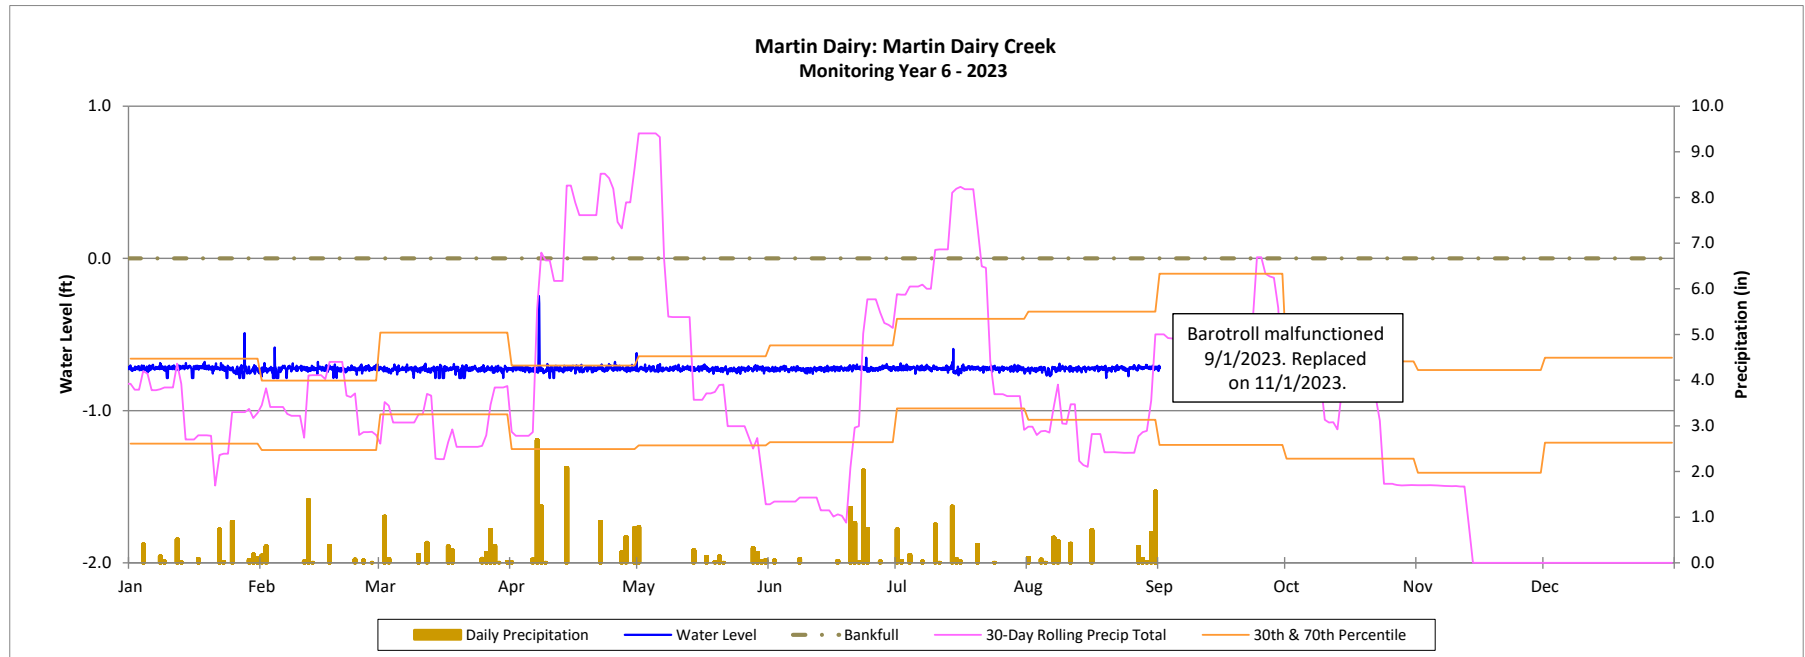
Recorded Bankfull Events Plot

While downloading gauges in October, it was discovered that the crest gauge on UT1 and the Barotroll (records atmospheric pressure) malfunctioned around September 1st. These two gauges were replaced on November 1st and will be checked again before the end of the year.

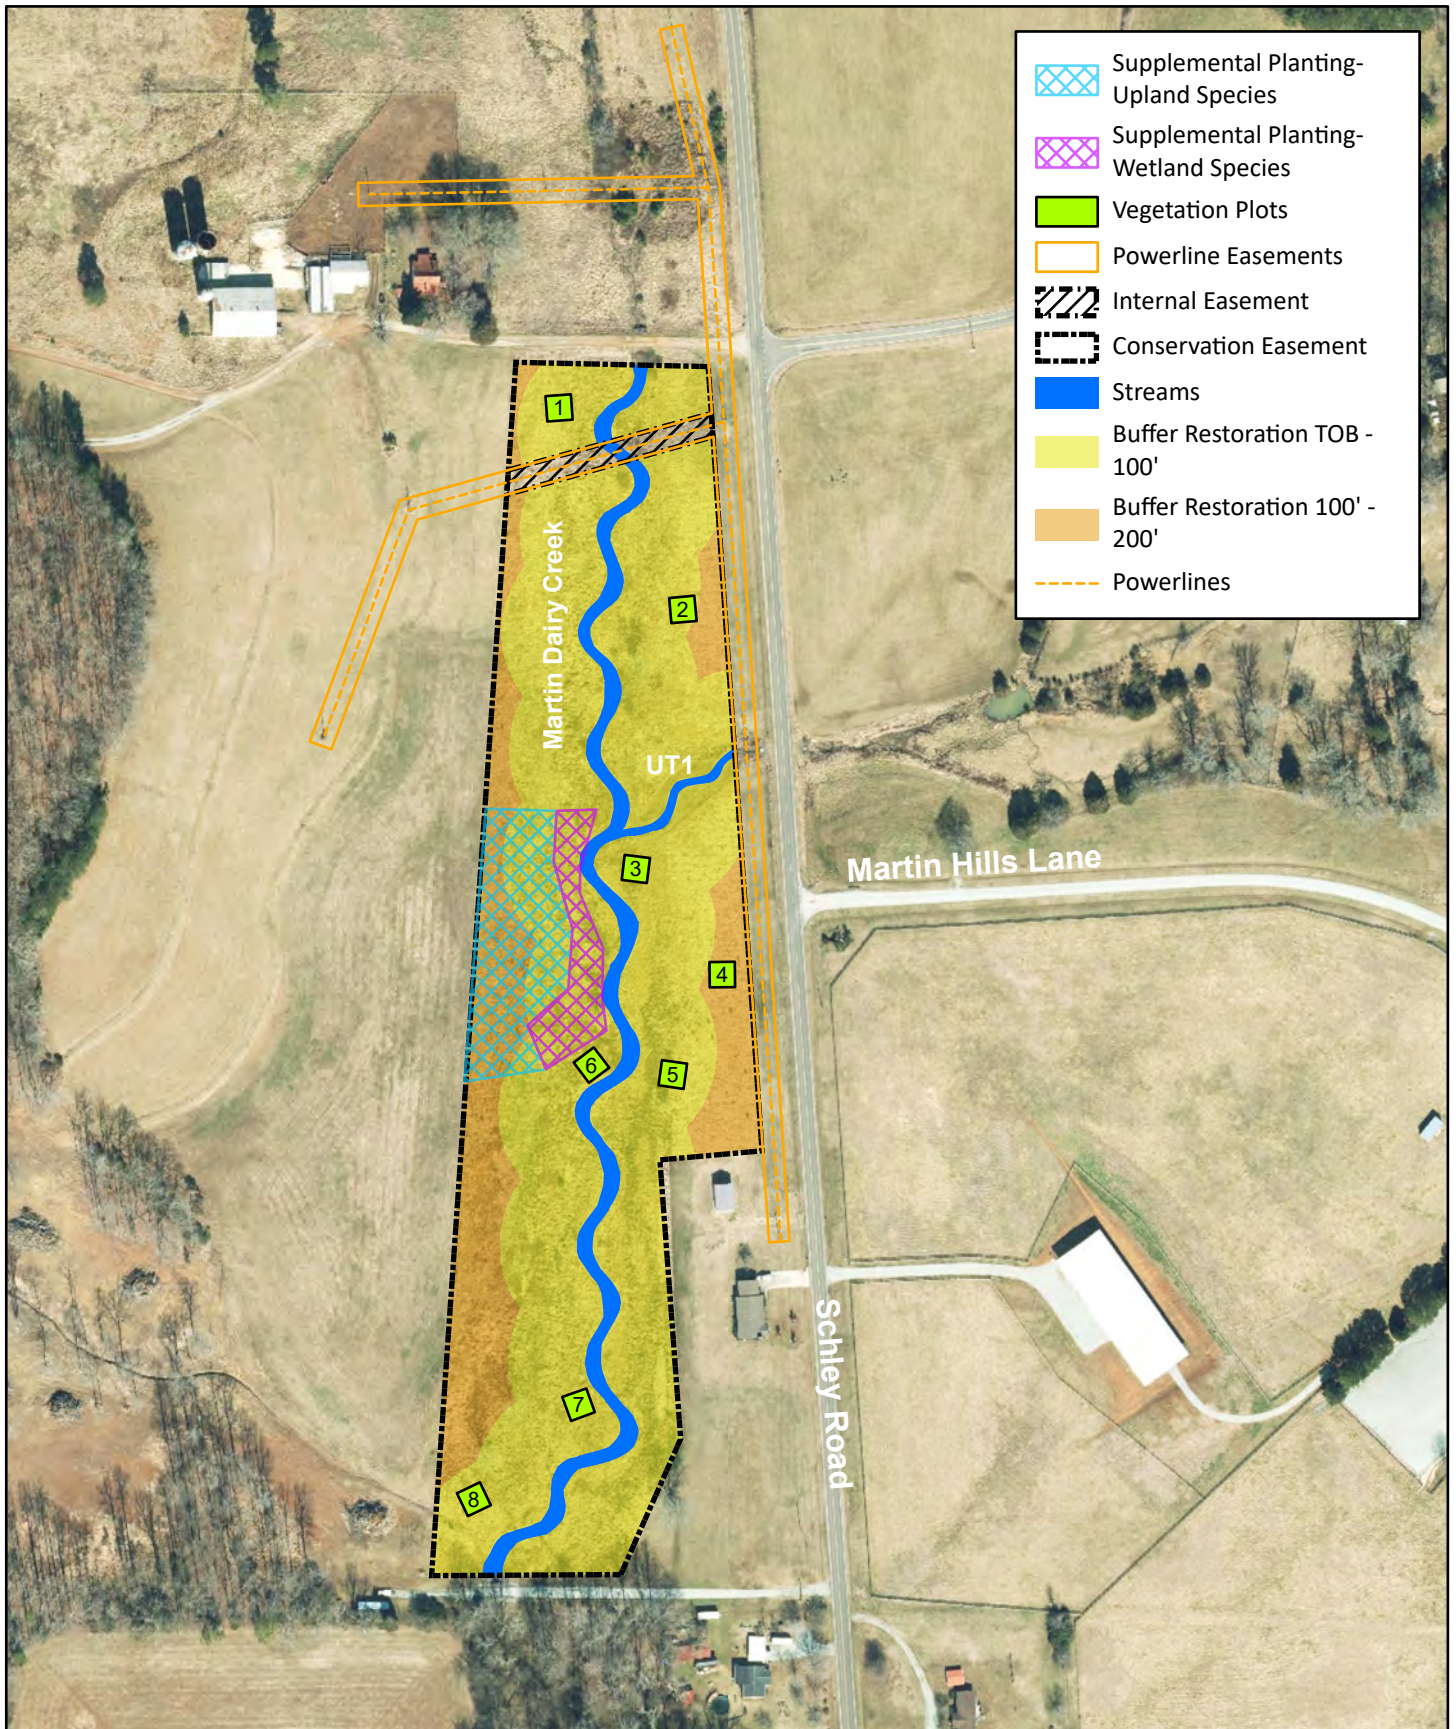
Updated Figure 1. Supplemental Planting Map

It is suspected that tree growth has been impacted by poor soil conditions from a rock harvest completed during construction. Constant deer browsing and wet floodplain conditions have likely played a role as well. Species selected for supplemental planting include some species originally approved by NCDWR in the Martin Dairy Buffer Mitigation Bank Parcel Development Package, as well as additional species deemed more likely to succeed at the Site. Table 1 below lists species selected along with their planted quantities and composition. Table 2 lists species that will be used for livestaking exclusively in the wetland area depicted in Figure 1.

A 1.25-acre supplemental planting will occur in the winter of 2023. The suspected cause of widespread planted stem fatality is likely due to lower quality soil conditions from rock harvesting during construction, and constant deer browsing activity. It is anticipated that new stems being treated with soil amendments will have a greater chance of survival.

The Division of Water Resources (DWR) closed the buffer portion of the Site on July 18th 2023 with the recommendation that supplemental planting be completed on a 1.25 acre area. On November 14th, 2023 this area was planted with approximately 190 containerized trees. The list of species and quantities has been approved by the NCIRT and is included in Appendix 6. Prior to supplemental planting, blackberry management was performed in September and October to reduce competition and increase likelihood of survival of the newly planted trees. These new stems will receive soil amendments along the base of the trees in the spring to aid in growth.
