FINAL
YEAR 2 (2015) ANNUAL MONITORING REPORT
MARTIN'S CREEK II MITIGATION PROJECT

Cherokee County, North Carolina
DMS Project No. 92633 (Contract No. 005717)
USACE Action ID No. SAW – 2009-00209/DWR Project No. 10-0952
SCO No. 08-07251-01

Data Collection – March-November 2015

December 2015

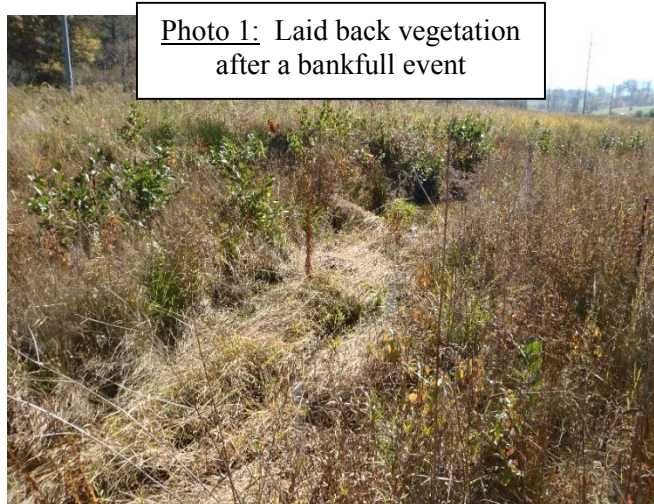
Photo 1: Laid back vegetation after a bankfull event
