FINAL
YEAR 3 (2016) ANNUAL MONITORING REPORT
MARTIN'S CREEK II MITIGATION PROJECT

Cherokee County, North Carolina
DMS Project No. 92633 (Contract No. 005717)
USACE Action ID No. SAW – 2009-00209/DWR Project No. 10-0952
SCO No. 08-07251-01

Data Collection – March-November 2016

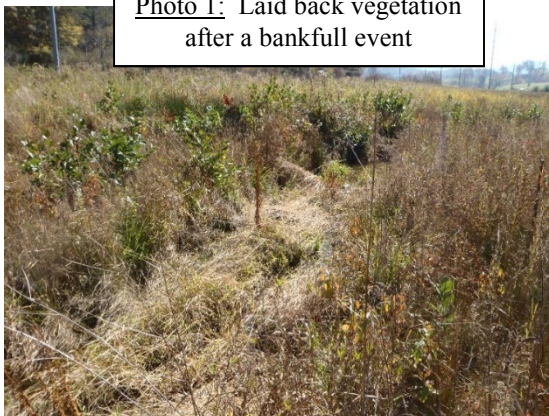
August 22, 2016	June 5, 2016	Crest gauge data, floodplain scour, and laid back vegetation indicate a bankfull event after approximately 2.28 inches of rain was documented over two days at an onsite rain gauge.	2

Photo 1: Laid back vegetation after a bankfull event

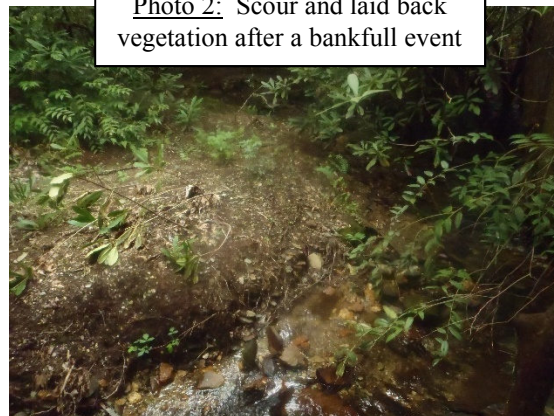
Photo 2: Scour and laid back vegetation after a bankfull event
