FINAL
YEAR 4 (2017) ANNUAL MONITORING REPORT
MARTIN'S CREEK II MITIGATION PROJECT

Cherokee County, North Carolina
DMS Project No. 92633 (Contract No. 005717)
USACE Action ID No. SAW – 2009-00209/DWR Project No. 10-0952
SCO No. 08-07251-01

RE: Martin's Creek II Monitoring (DMS Project # 92633, Contract # 005717)
Final MY4 (2017) Annual Monitoring Report

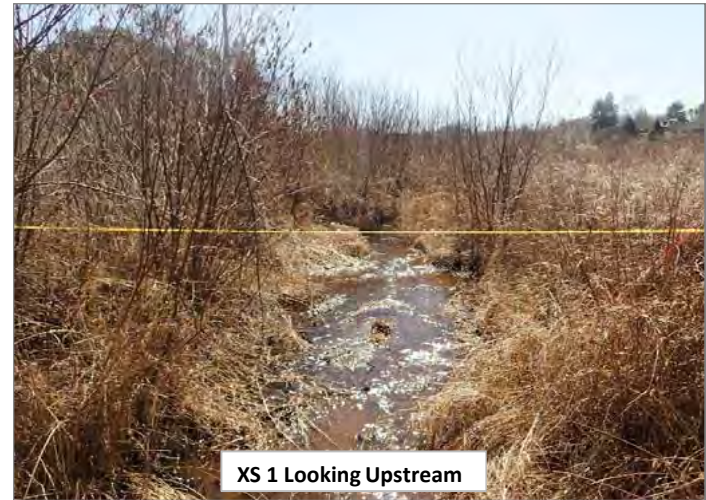
XS 1 Looking Upstream

SUMMARY DATA	
Bankfull Elevation:	95.2
Bankfull Cross-Sectional Area:	8.1
Bankfull Width:	11.2
Flood Prone Area Elevation:	96.2
Flood Prone Width:	100.0
Max Depth at Bankfull:	1.0
Mean Depth at Bankfull:	0.7
W / D Ratio:	15.5
Entrenchment Ratio:	8.9
Bank Height Ratio:	1.0

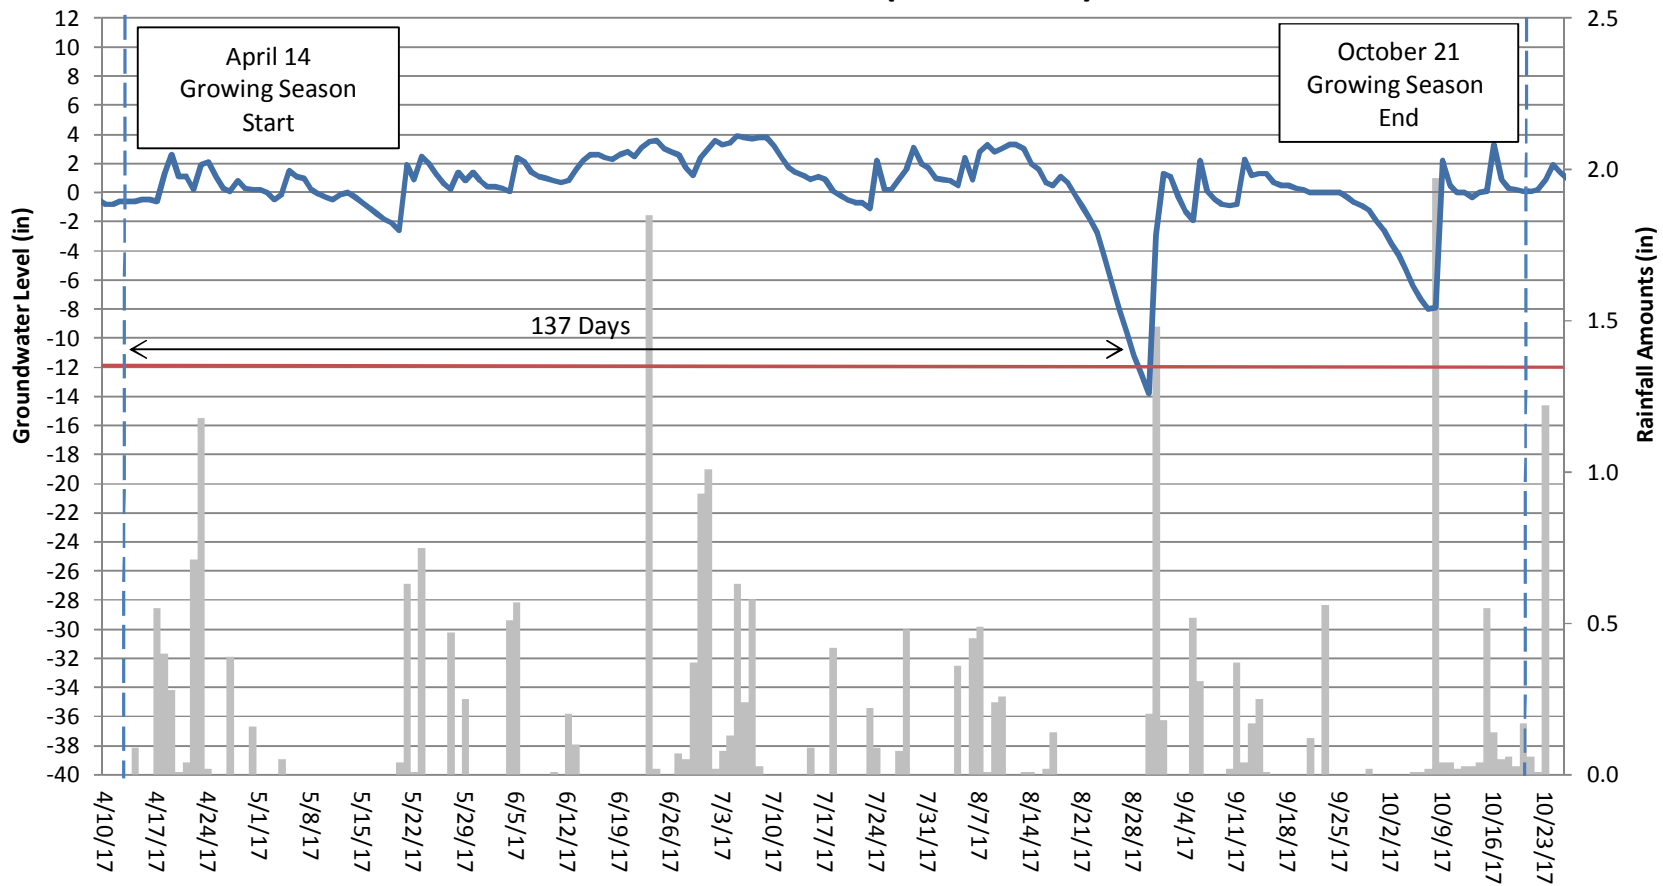
Martins Creek II Groundwater Gauge 2 Year 4 (2017 Data)

The following was added to the wetland hydrology discussion: "Gauge 2 malfunctioned on July 1, 2017 and was replaced on August 30, 2017. The new gauge collected data for just 6 days before malfunctioning again for the remainder of the growing season; however, it was saturated/inundated for 42 days prior to its malfunction. Gauge 11 malfunctioned on August 29, 2017 resulting in loss of data for the remainder of the growing season. The gauge had not met success criteria prior to its malfunction, and it is not expected to have met success criteria during the period of its malfunction. Both gauges were replaced with functioning gauges, and, as of November 8, 2017, were functioning properly." Axiom keeps several DMS-owned gauges in stock and brings them to every site visit in anticipation of gauge malfunction. We will request additional replacement gauges from DMS if the need arises.

*This gauge malfunctioned on July 1, 2017 and was replaced on August 30, 2017. The new gauge collected data for just 6 days before malfunctioning again for the remainder of the growing season; however, it was saturated/inundated for 42 days prior to its malfunction.
