FINAL
YEAR 5 (2018) ANNUAL MONITORING REPORT
MARTIN'S CREEK II MITIGATION PROJECT

Cherokee County, North Carolina
DMS Project No. 92633 (Contract No. 005717)
USACE Action ID No. SAW – 2009-00209/DWR Project No. 10-0952
SCO No. 08-07251-01

December 2018

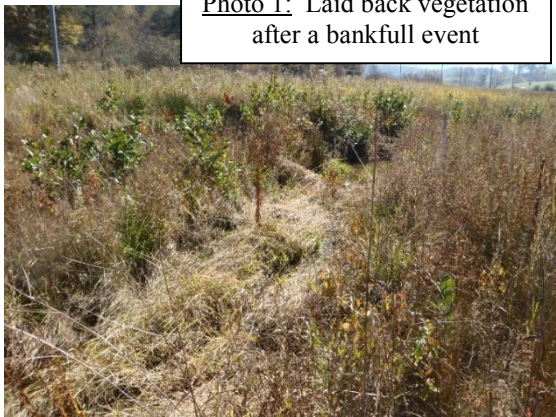
Photo 1: Laid back vegetation after a bankfull event

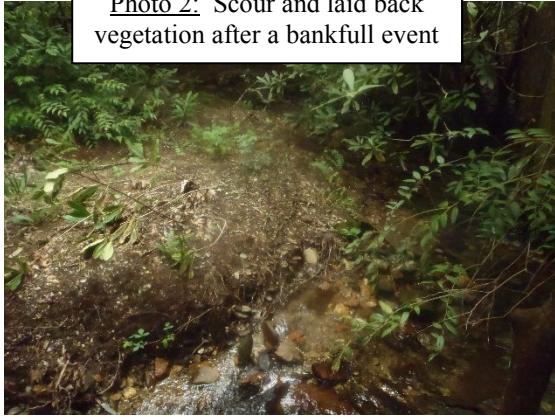
Photo 2: Scour and laid back vegetation after a bankfull event
