Mason Property Wetland Mitigation Project

Hyde County, NC

2008 Annual Monitoring Report
Year 1, Baseline

NCEEP Project Number D06001
Tar-Pamlico River Basin

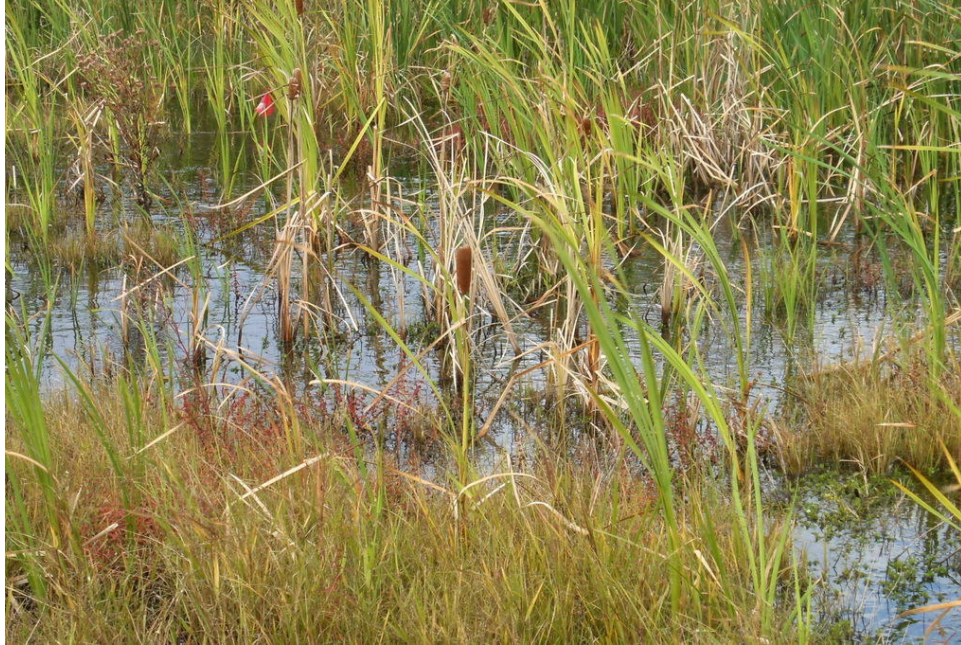
Table 6. Vegetation Problem Areas			
Feature/Issue	Plot	Probable Cause	Photo #
Poor Survival	3, 4	Excessivley Wet	VPA 1
Poor Health and Growth	All	Excessively Wet	VPA 2, VPA 3

VPA 1
Excessively wet conditions
Sept. 08

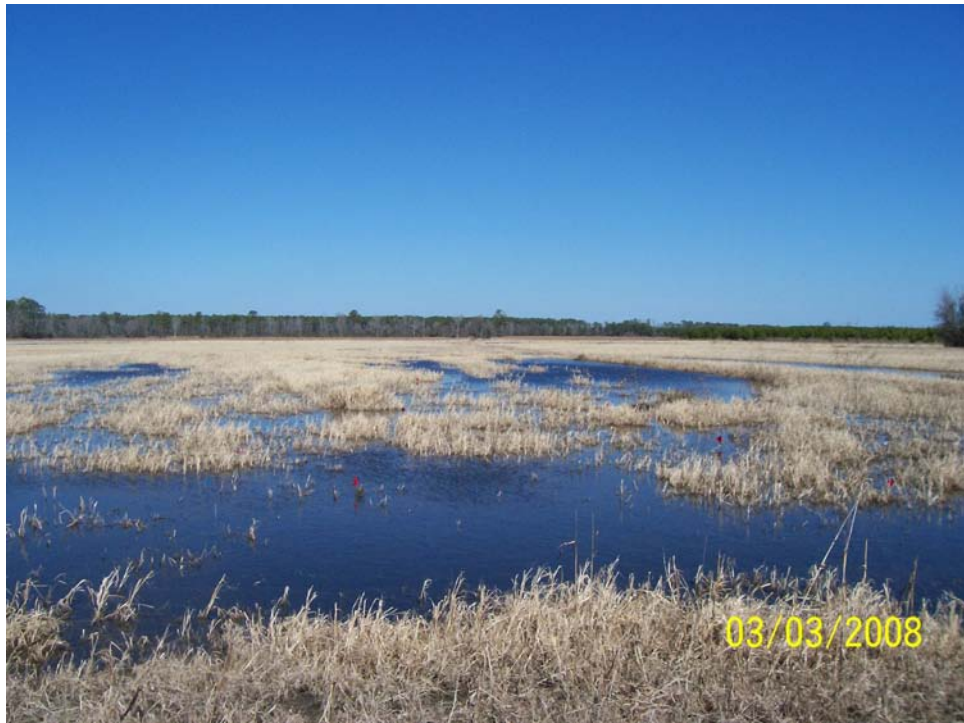
VPA 2
Excessively wet conditions during planting
March 08

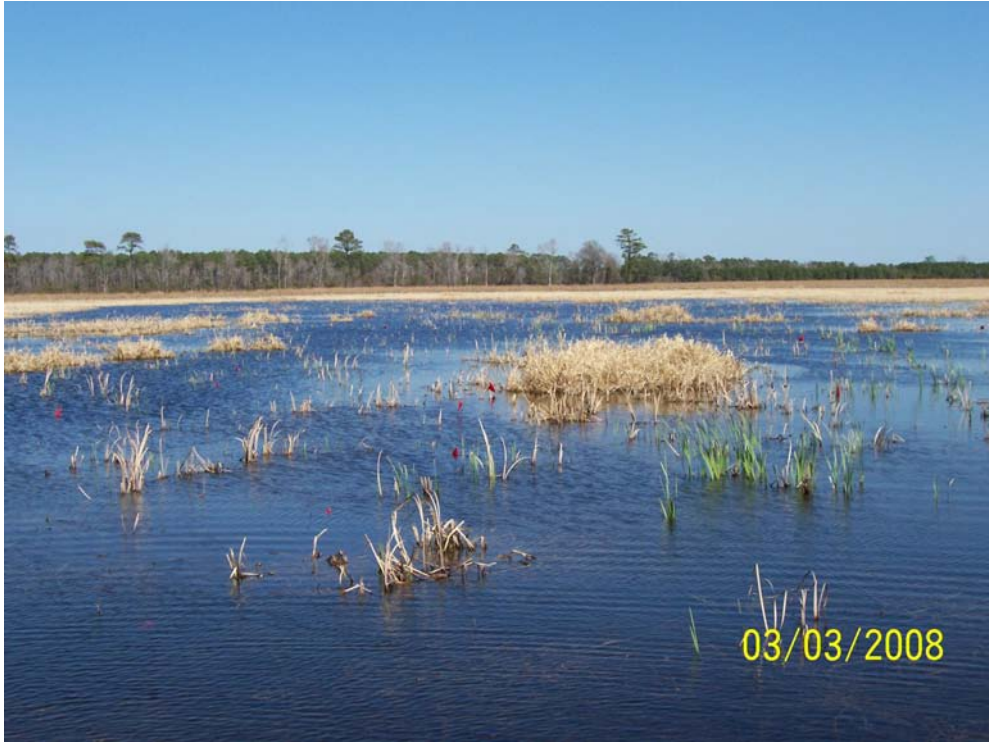
VPA 3
Excessively wet conditions during planting
March 08

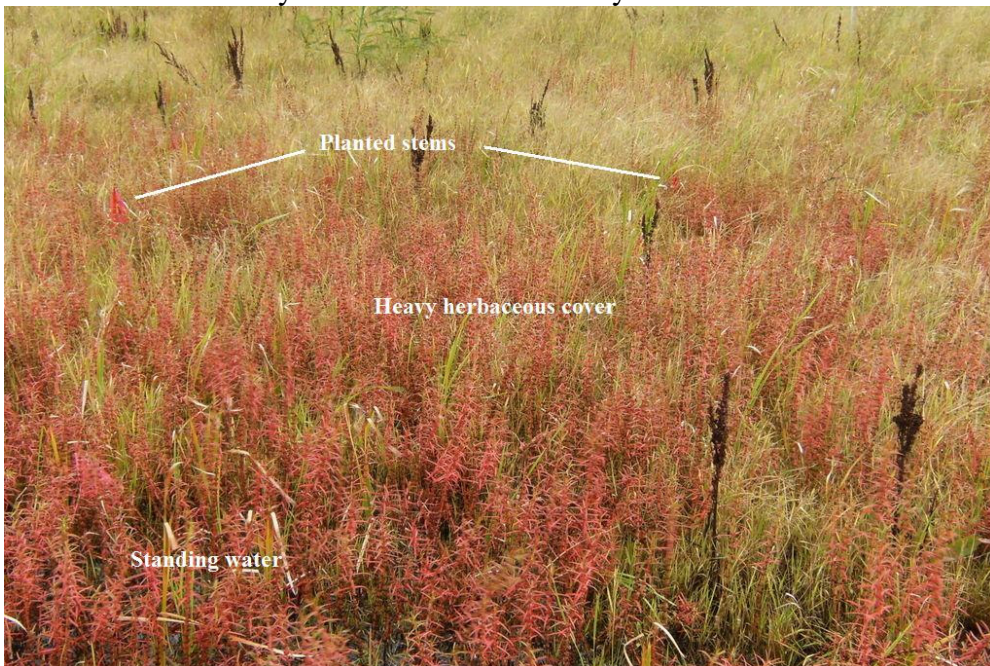
VPA 4
Excessively wet conditions and heavy herbaceous cover

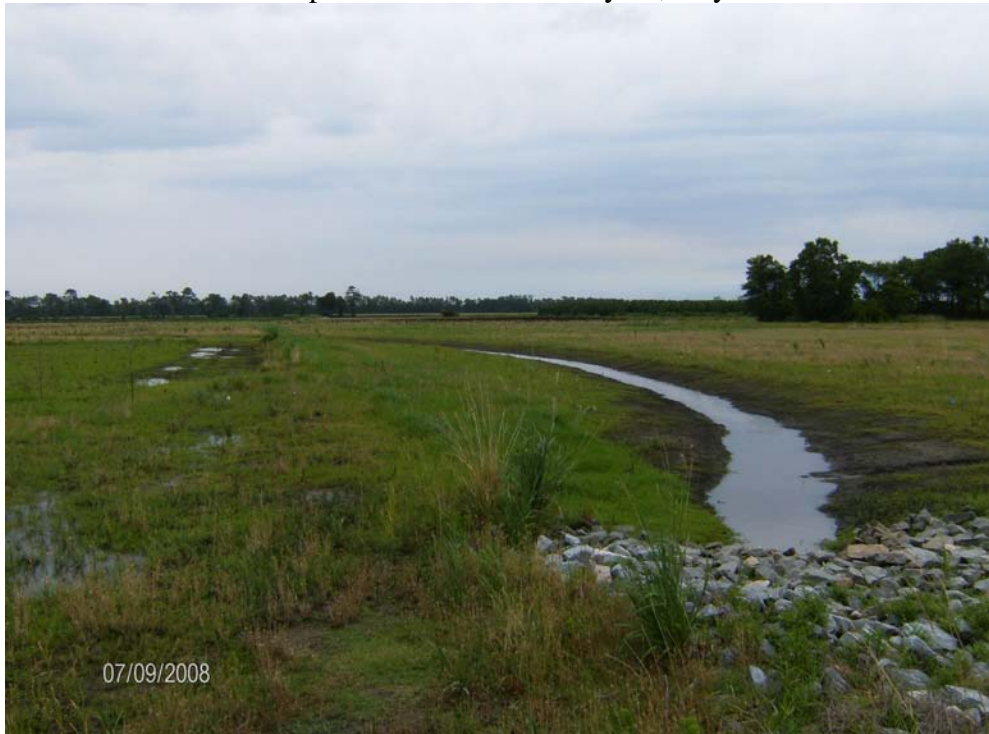
Swamp Run at driest time of year, July 08

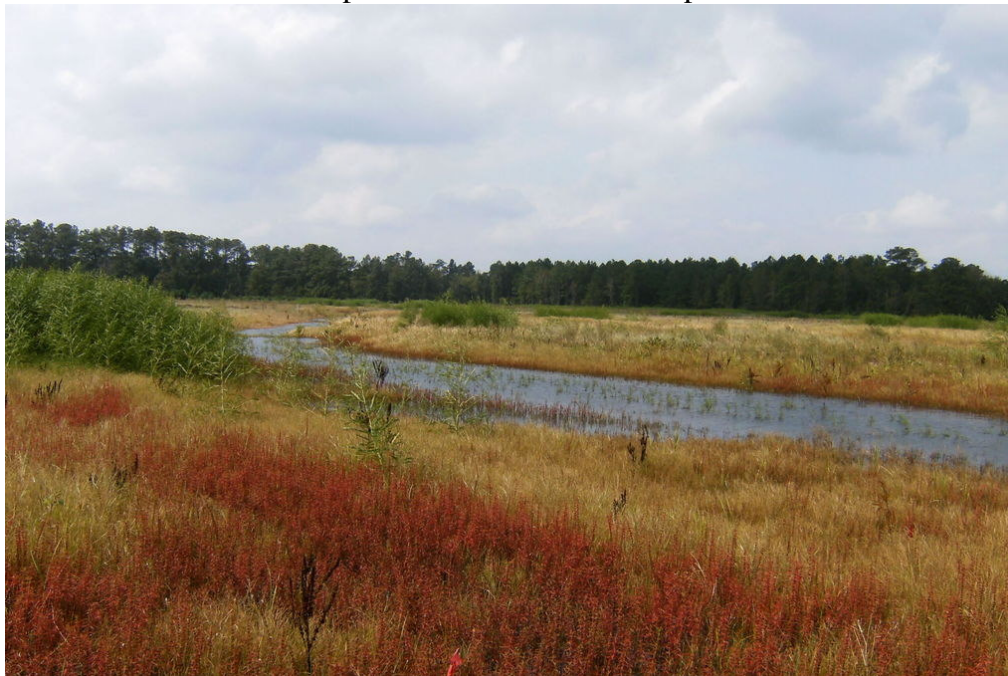
Swamp Run 2 months later in Sept. 08

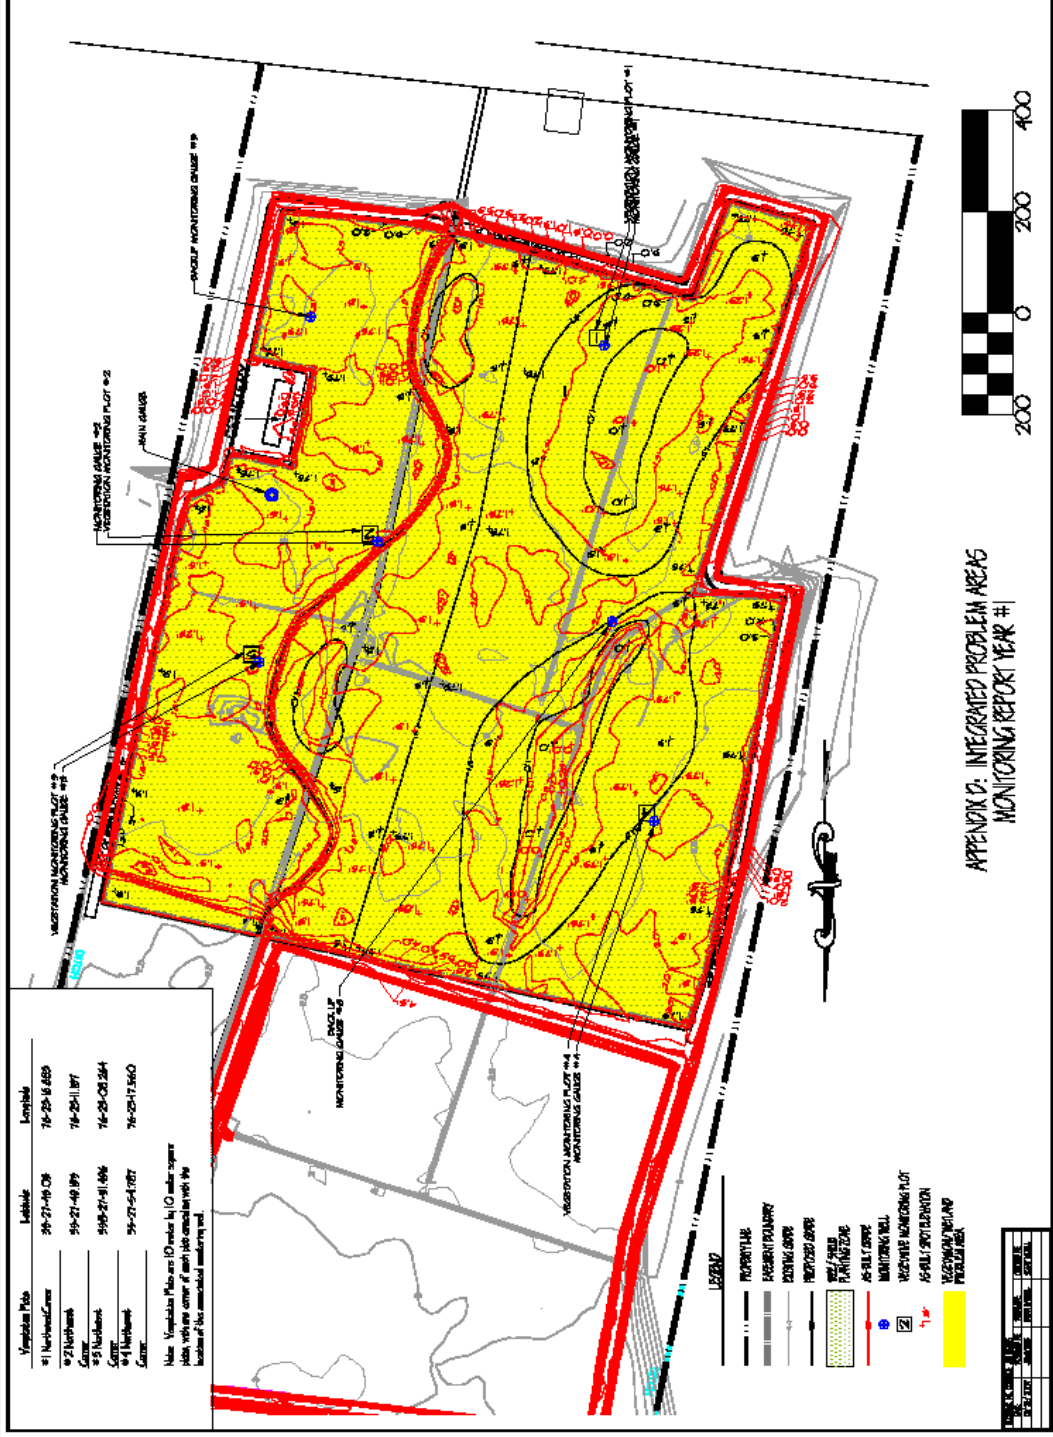
Problem Areas Plan View (Integrated)

Figure 4 in Appendix D illustrates the general inadequate survival of planted stock due to standing water during the planting and growing season.

As illustrated in figure 4, Appendix D, the site remained very wet for almost the entire growing season. While this is important for successful hydrology, it creates problems in establishing woody vegetation. There were no micro-scale problems.
