Mason Property Wetland Mitigation Project

Hyde County, NC

2009 Annual Monitoring Report
Year 2

NCEEP Project Number D06001
Tar-Pamlico River Basin

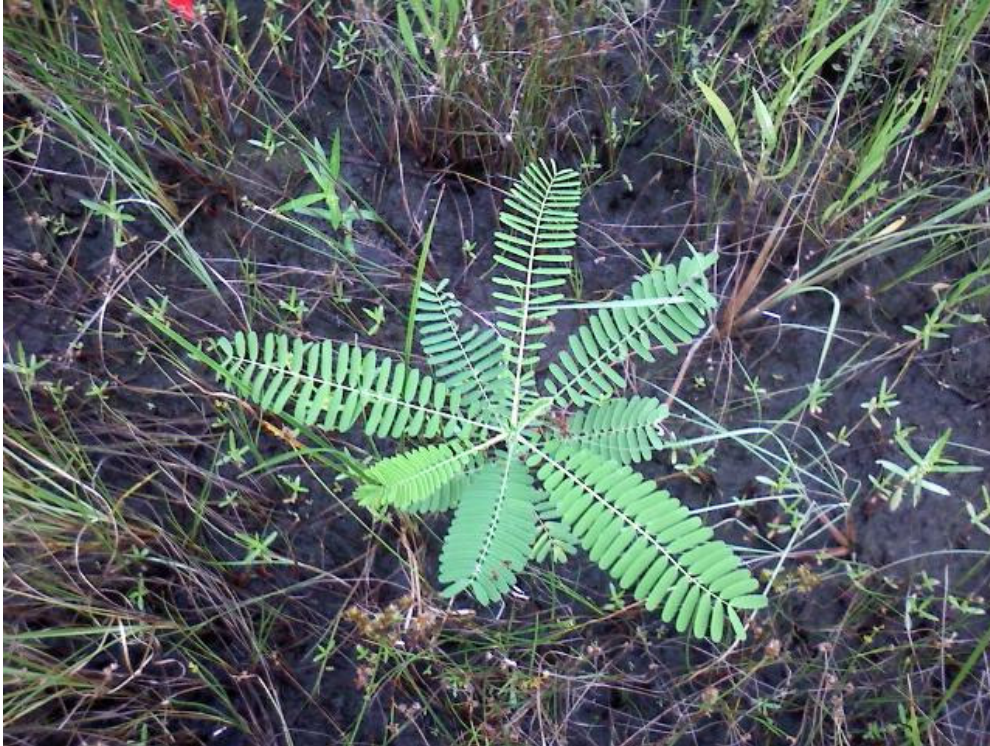
Feature/Issue	Plot	Probable Cause	Photo #
Site Colonization by Coffeeweed (<i>Sesbania herbacea</i>)	Entire Site	Plant is considered a noxious and/or invasive species on cropland	VPA 1 through 5

Immature specimen of Coffeeweed (*Sesbania herbacea*)

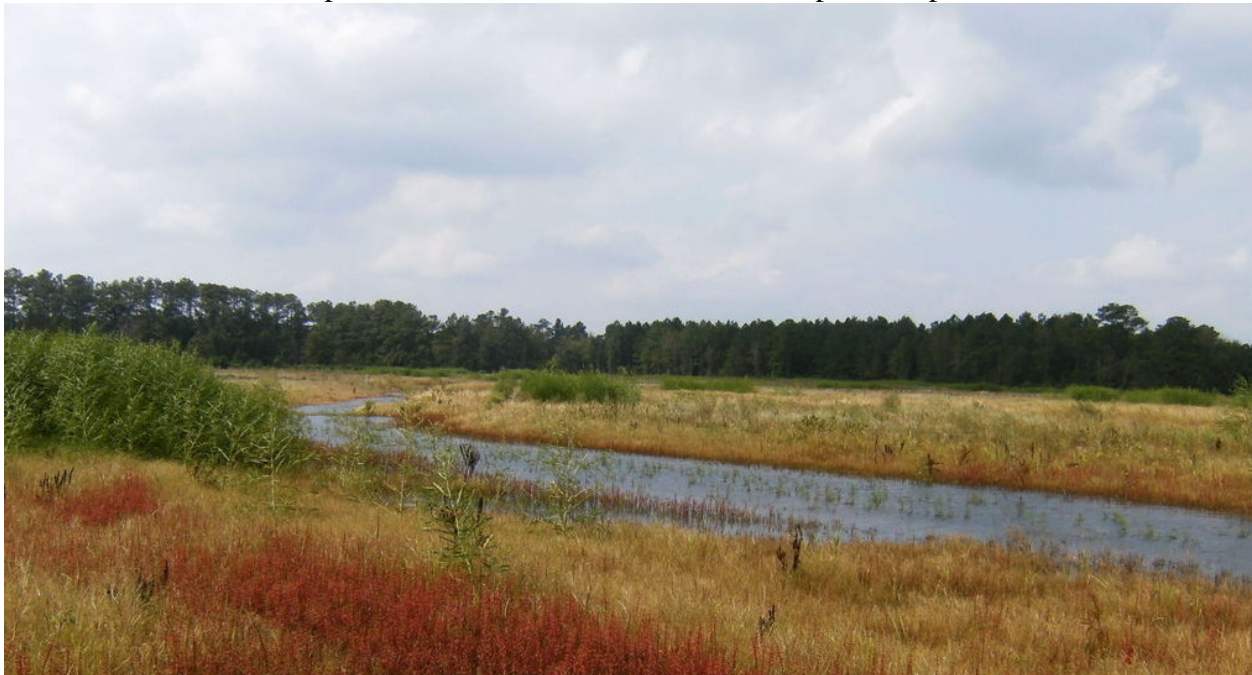
VPA 2

Clumps of Coffeeweed can be seen from Sept. 2008 photo

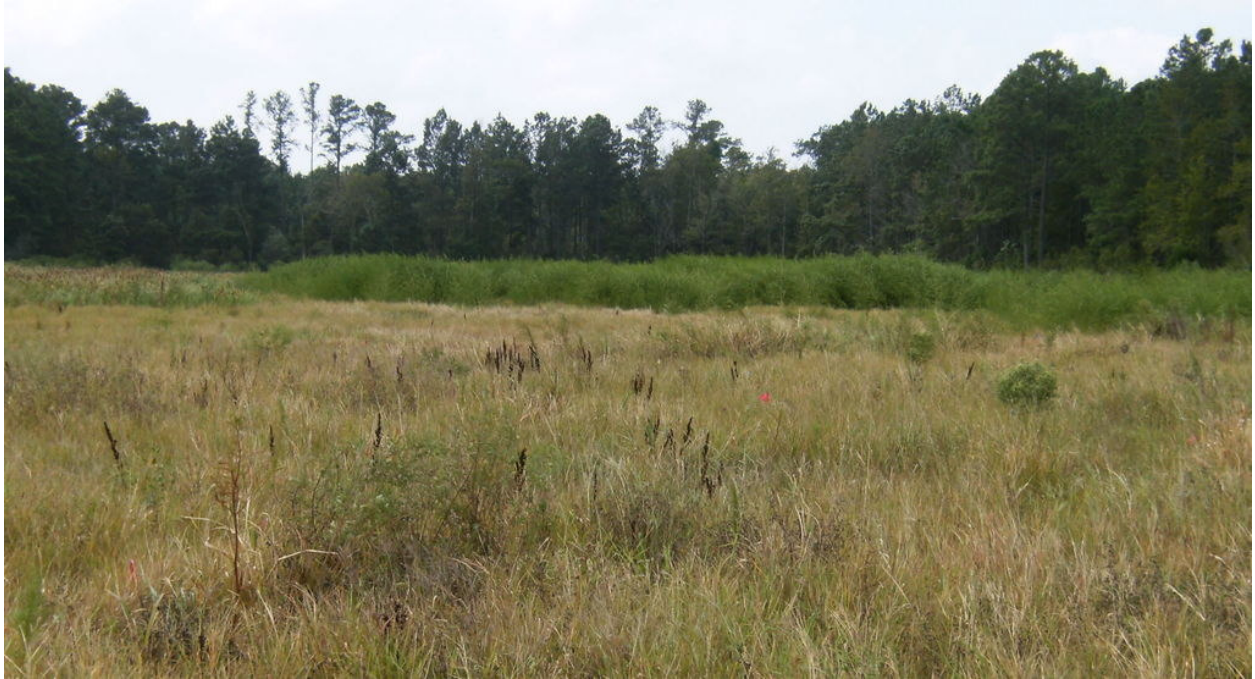
VPA 3

More extensive stands of Coffeeweed from Sept. 2008 photo

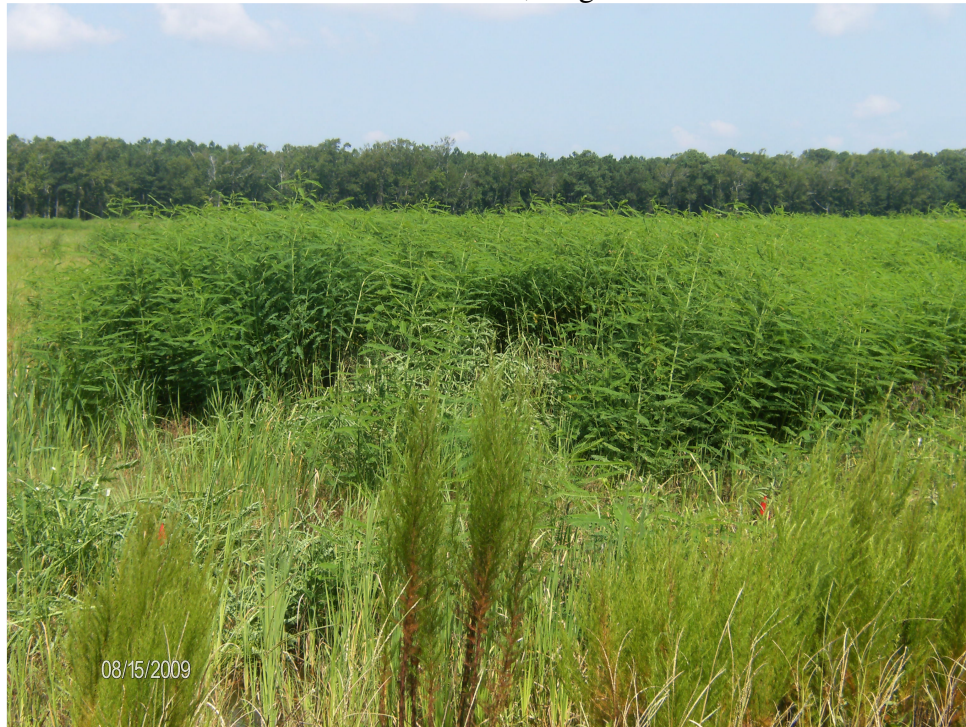
VPA 4

hydric species for replanting appears to be the best approach to maintaining the required stocking levels. The site was under an average of 6 inches of water when planting was done in 2009. In 2008, dense clumps of coffeeweed (*Sesbania herbacia*) began to appear on site. By mid-summer 2009, approximately 40% of the site had been colonized by very dense and apparently rapidly spreading stands of this invasive legume. Manual removal by hand chopping was deemed the only viable option and it was timed after flowering but prior to seed set to maximize the effects of control. Hopefully in 2010 the problem will be minor and maintenance will be a simple issue of hand chopping again before seed set. The vegetation problem area photos show the plant and its spread in 2008 and 2009.

Coffeeweed on site, August 2009

As mentioned, the result of this constant inundation continues to cause problems with seedling mortality, especially in three distinct areas (see Appendix D). The replacement planting done early this year appears to have stabilized stocking levels. As such, the coffeeweed was removed as a measure to give the planted trees every chance for survival and growth.

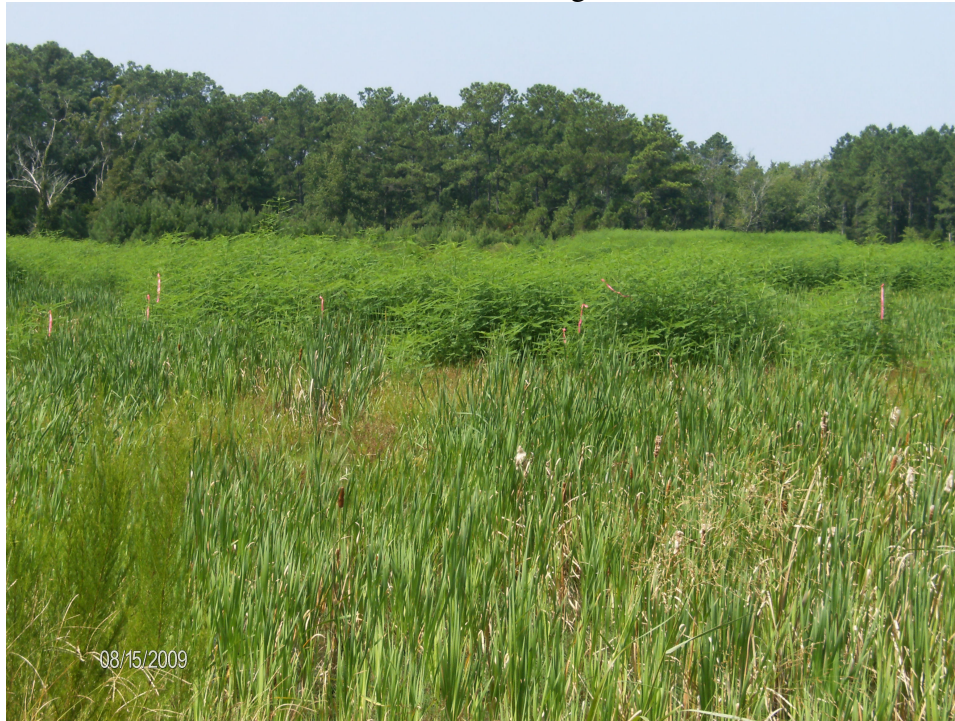
VPA 5
Coffeeweed on site, August 2009

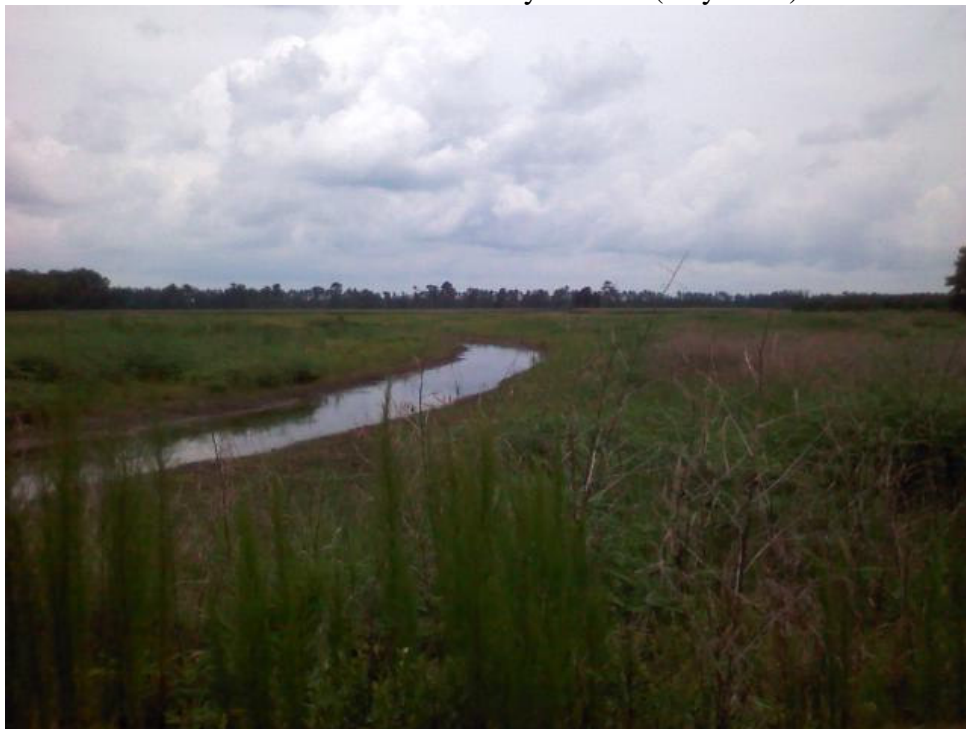
Run full but site not entirely flooded (July 2009)

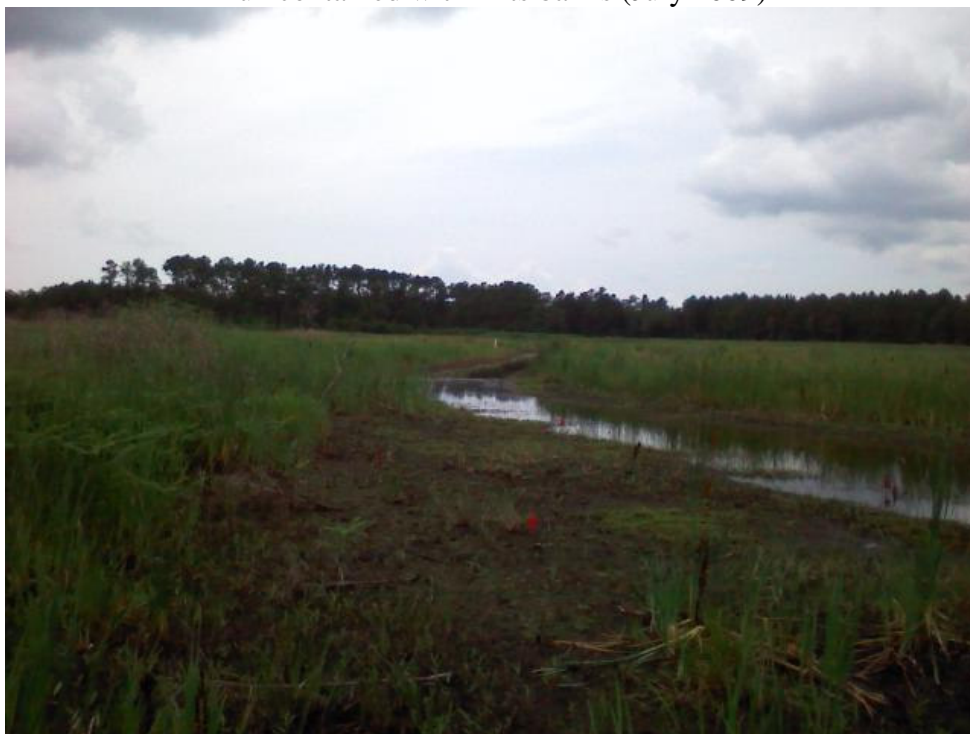
Run contained within its banks (July 2009)

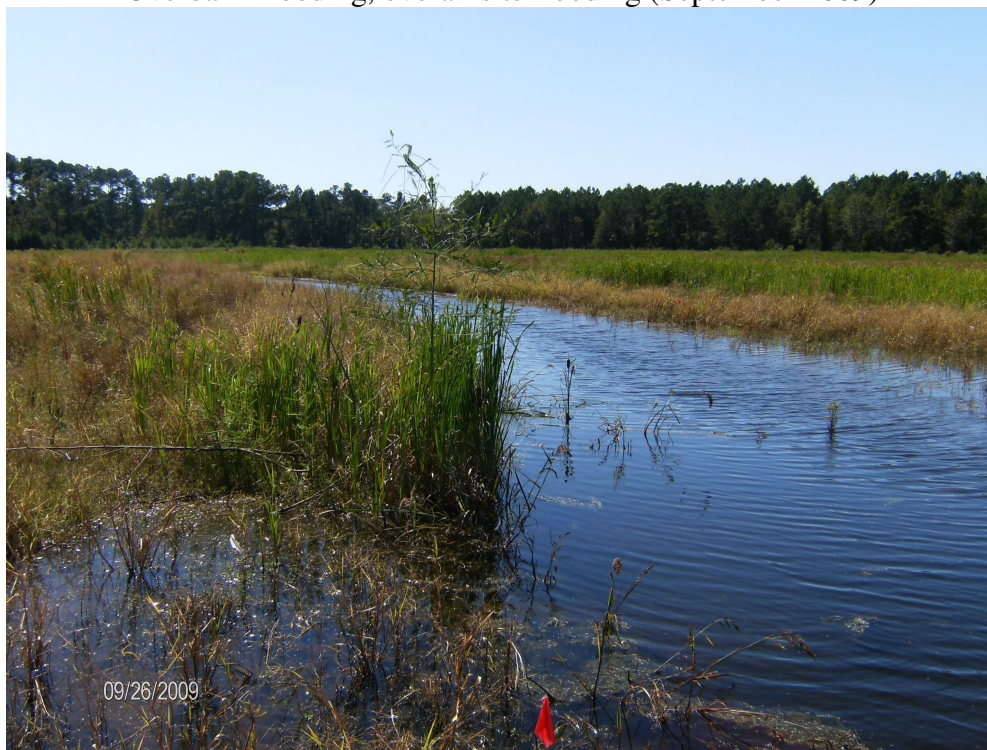
Overbank flooding, overall site flooding (September 2009)

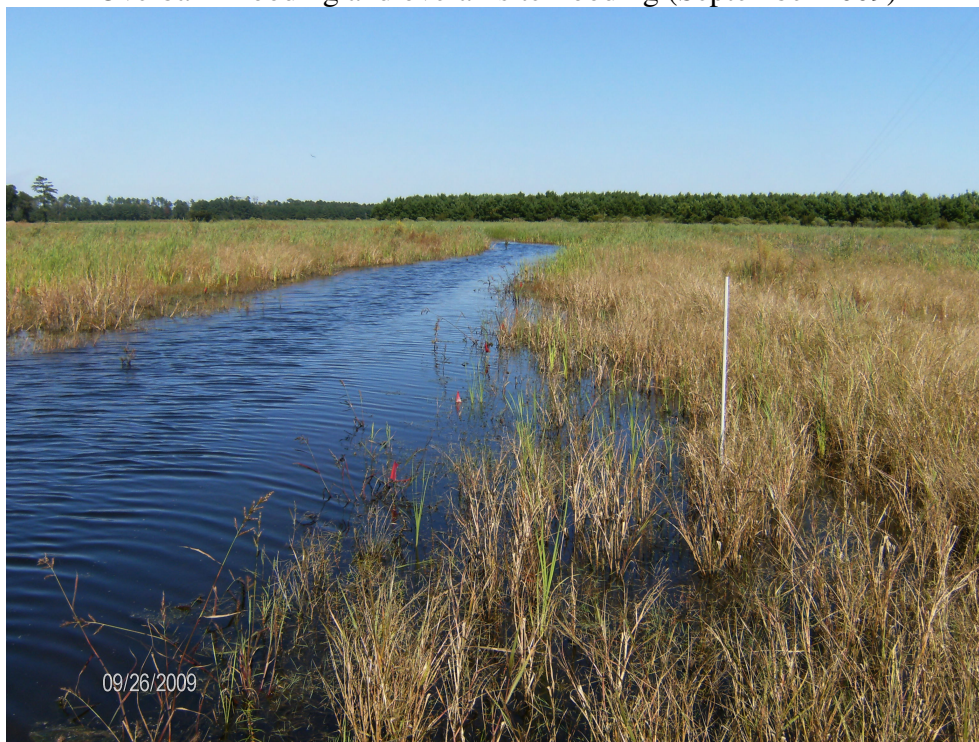
Overbank flooding and overall site flooding (September 2009)

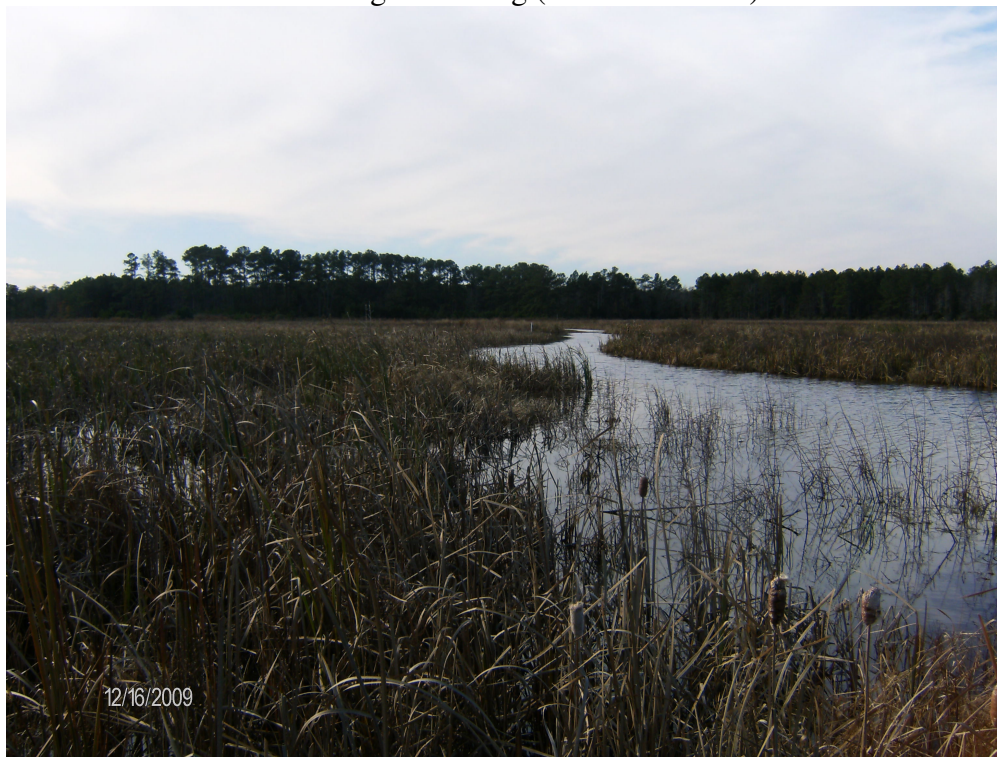
A coastal storm in November dropped over eight inches of rain on the site and strong northeast winds not only kept the site from draining, but likely pushed additional water onto the site for nearly a week. The photos in Appendix A from the last site visit in December of 2009 show the severe flooding on site. Water levels were between six and twelve inches across the site.

Severe sight flooding (December 2009)

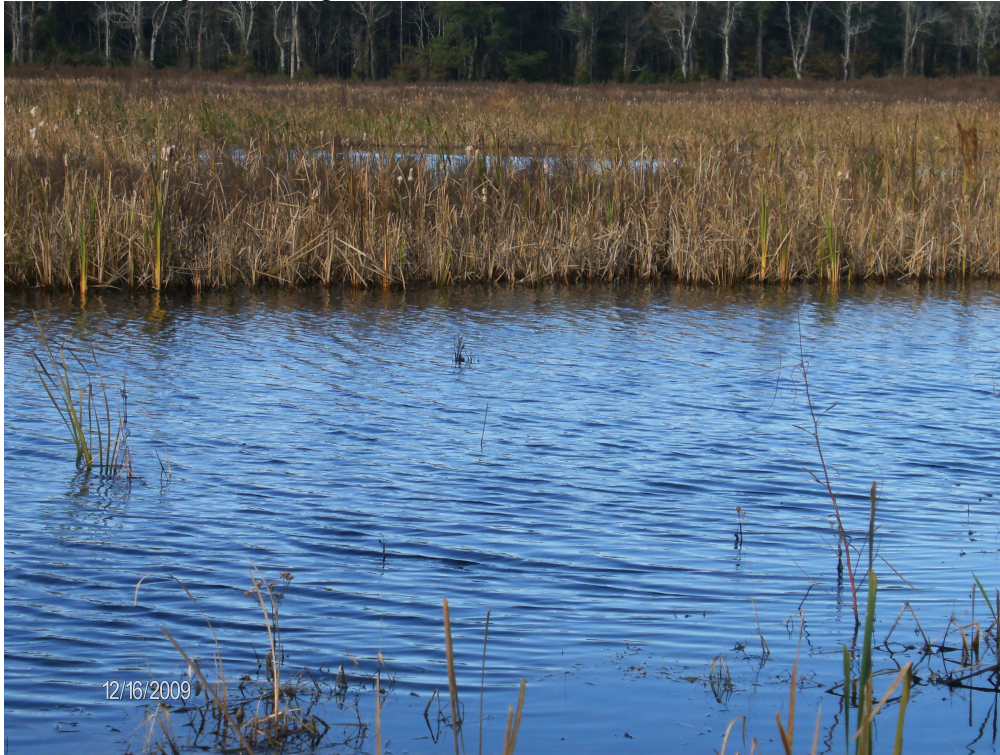
Severe sight flooding can be seen west of main run (December 2009)

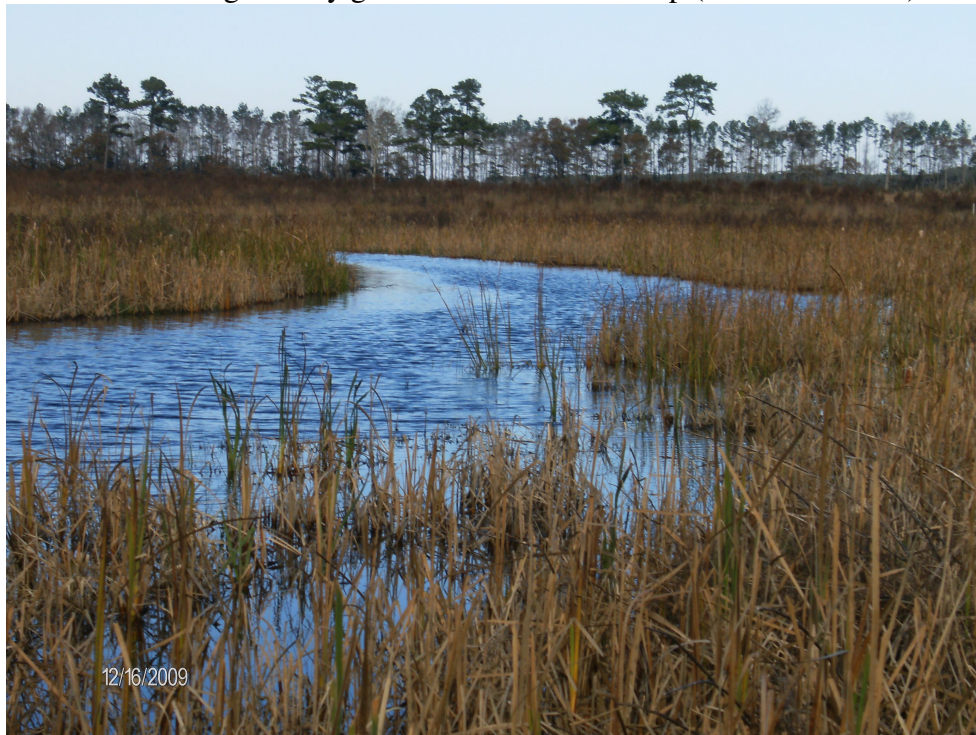
Main run looking north. Water levels outside the run and across the site are generally greater than one foot deep (December 2009)
