Mason Property Wetland Mitigation Project

Hyde County, NC

2010 Annual Monitoring Report
Year 3

NCEEP Project Number D06001
Tar-Pamlico River Basin

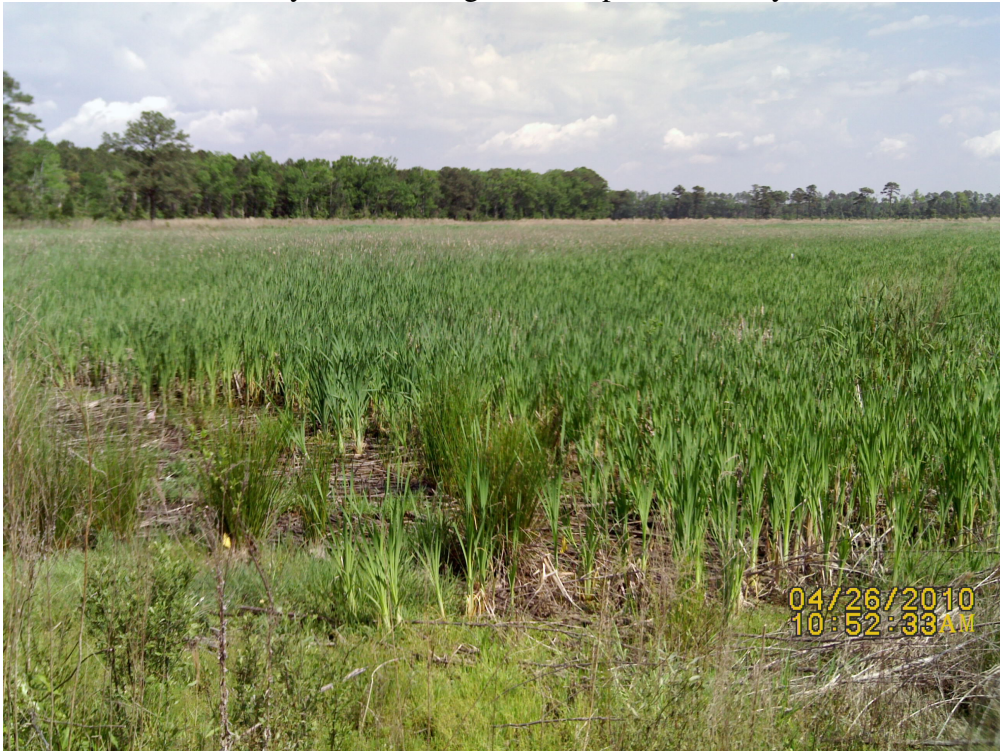
VPA 1

Table 6. Vegetation Problem Areas			
Feature/Issue	Plot	Probable Cause	Photo #
Mortality/poor growth caused by soil salinity	1,2,3	Saltwater intrusion during very high tides	Refer to video on accompanying CD
Heavy herbaceous competition	All	Cattails/Coffeeweed	VPA 1-3

Heavy cattail emergence in April, site is dry

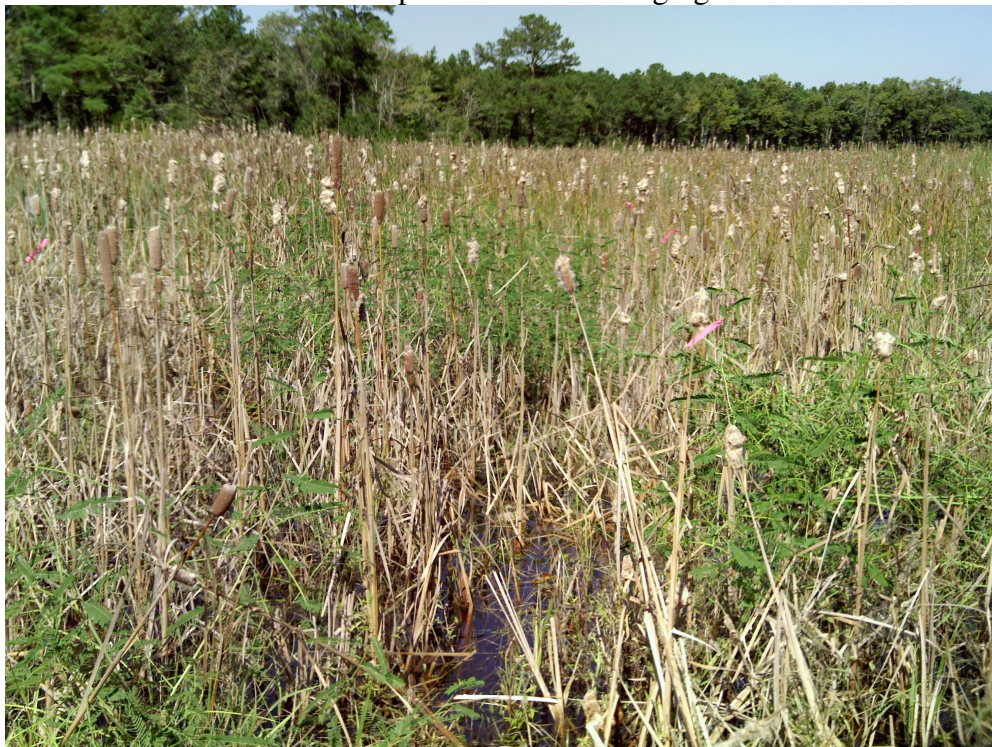
VPA 2

Water oak (*Q. phellos*), buttonbush (*C. occidentalis*) and bald cypress (*T. distichum*) proved to be the hardiest species as they are all obligate wetland species. During March of 2009, an additional 8,000 stems of water oak and bald cypress were planted to once again bring the density up to approximately 450 stems per acre. The containerized stock that was added in March of 2010 was bald cypress (*T. distichum*) and buttonbush (*C. occidentalis*) as they have been noted to exhibit some tolerance to salinity, were on the original planting schedule for this project, and have survived the site so far. Due to the site's robust wetland hydrology and long periods of inundation, there are few options for site maintenance beyond manual herbaceous competition control to improve tree survival. Herbaceous competition is thought to be a problem secondary to the length of constant inundation and soil salinity levels. Once again in 2010, coffeeweed (*Sesbania herbacia*) began to appear on site and was manually chopped for control, but was still present at the time of vegetation sampling as can be seen in the photos.

Coffeeweed is still present and re-emerging in October

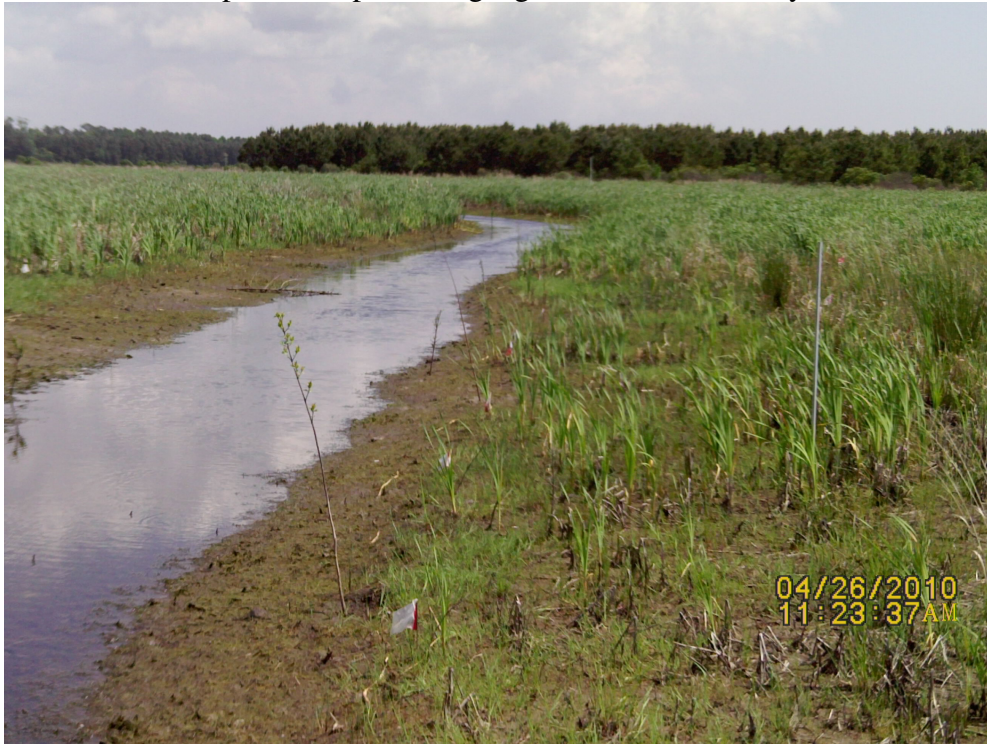
VPA 3

The swamp run in April near gauge 3, low water, heavy cattails

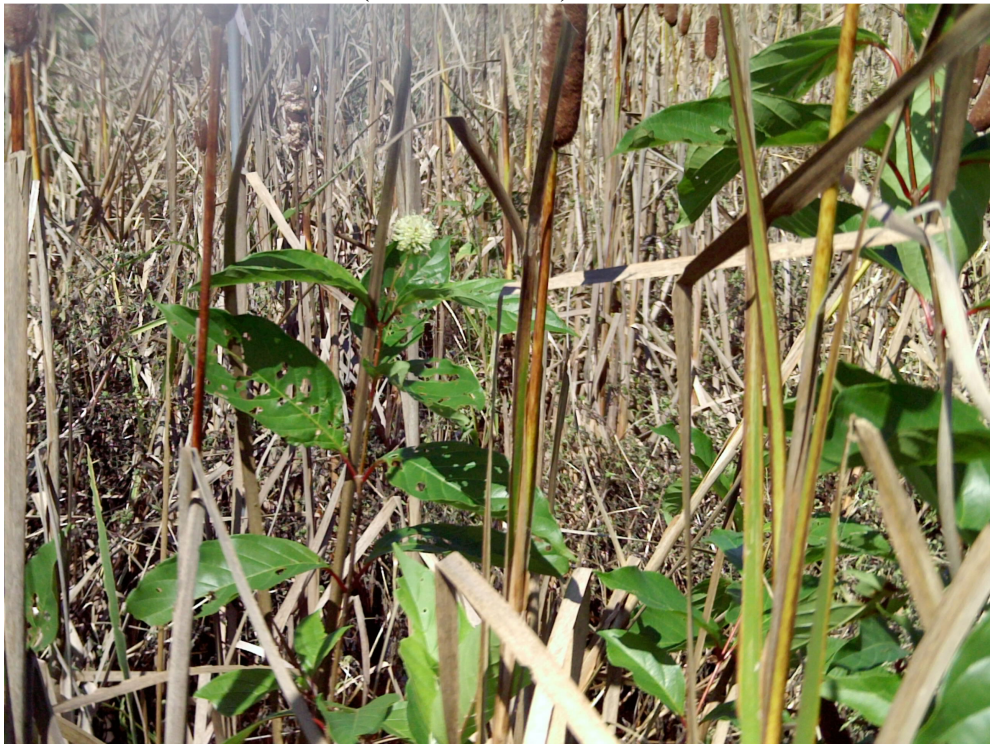
Buttonbush (*C. occidentalis*) is able to survive

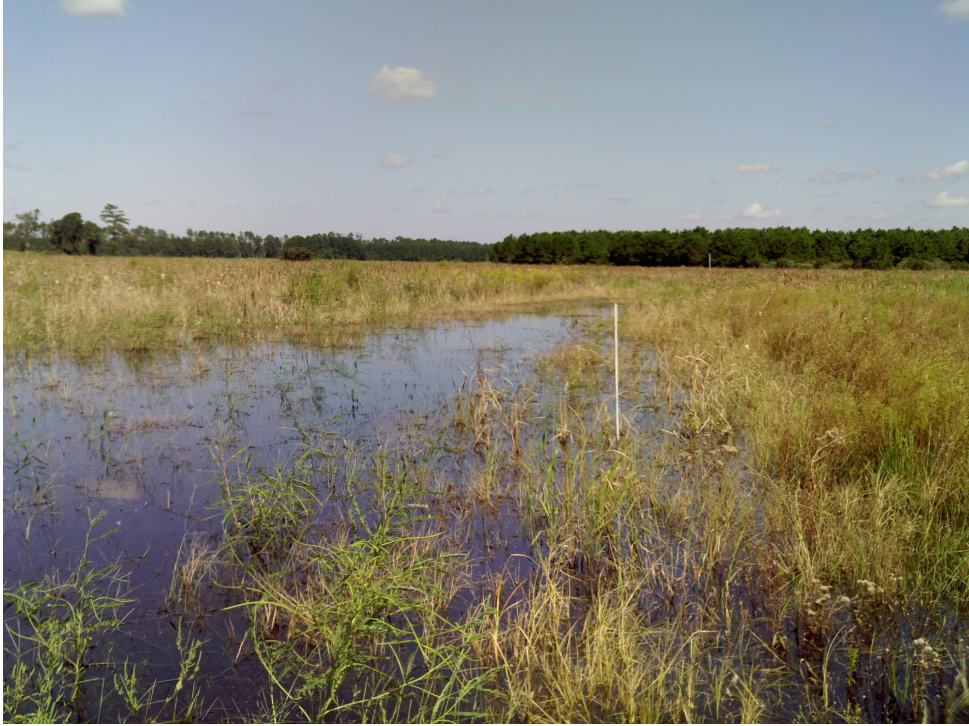
The remnants of the tropical storm in September provided evidence of tidal flows entering the site from the ditch that leads from the site to Rose Bay Creek. Considering the site’s close proximity to Rose Bay, wind driven tidal intrusions into the Mason wetland site are expected and are common occurrences in adjacent existing wetland systems in the Rose Bay watershed.

Main run near gauge 3 in October after Tropical Storm Nicole
Water beyond limits of the run is approximately 12" deep

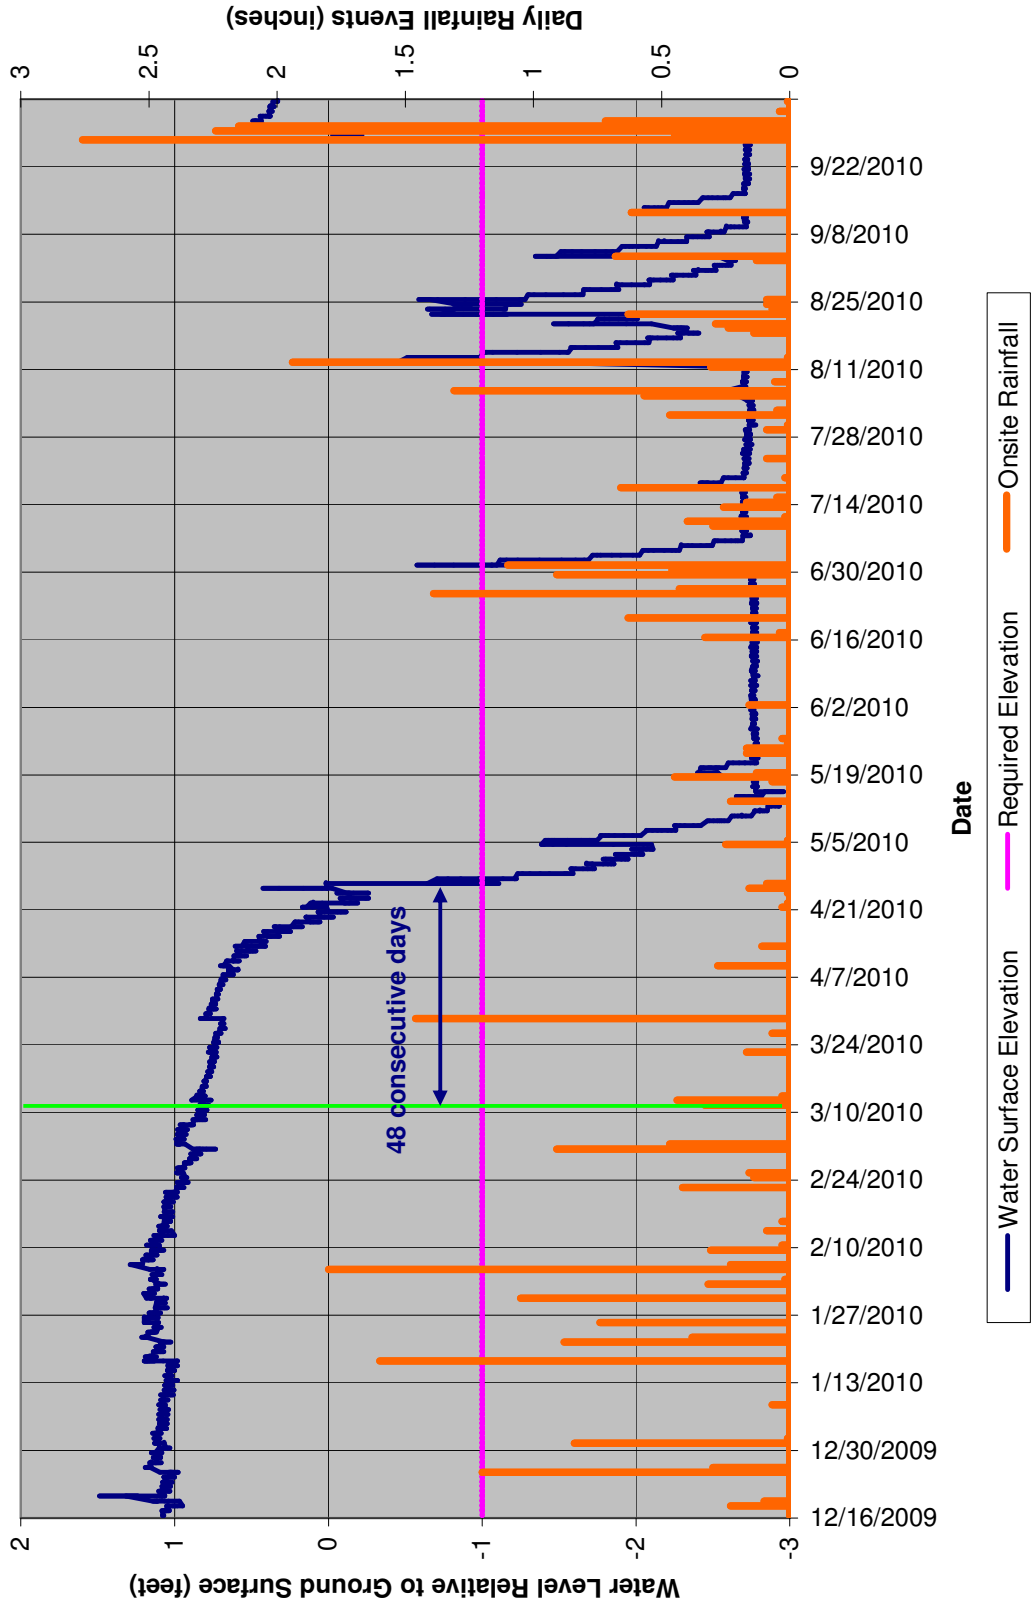
Mason Monitoring Gauge #4 (1126652)

Further evidence of these effects can be seen by comparing the hydrographs in Appendix C. Gauge 4 does not show the same sensitivity to periodic minor rainfall events as the other gauges, including gauges 5 and 6 (gauge 6 is on the borderline between the two vegetative cover types). During the period from the end of April, when rainfall lessened considerably, until the end of September when Tropical Storm Nicole produced very heavy rainfall, gauge 4 shows less peaks and a generally less sensitive water table than the other five gauges on the project.

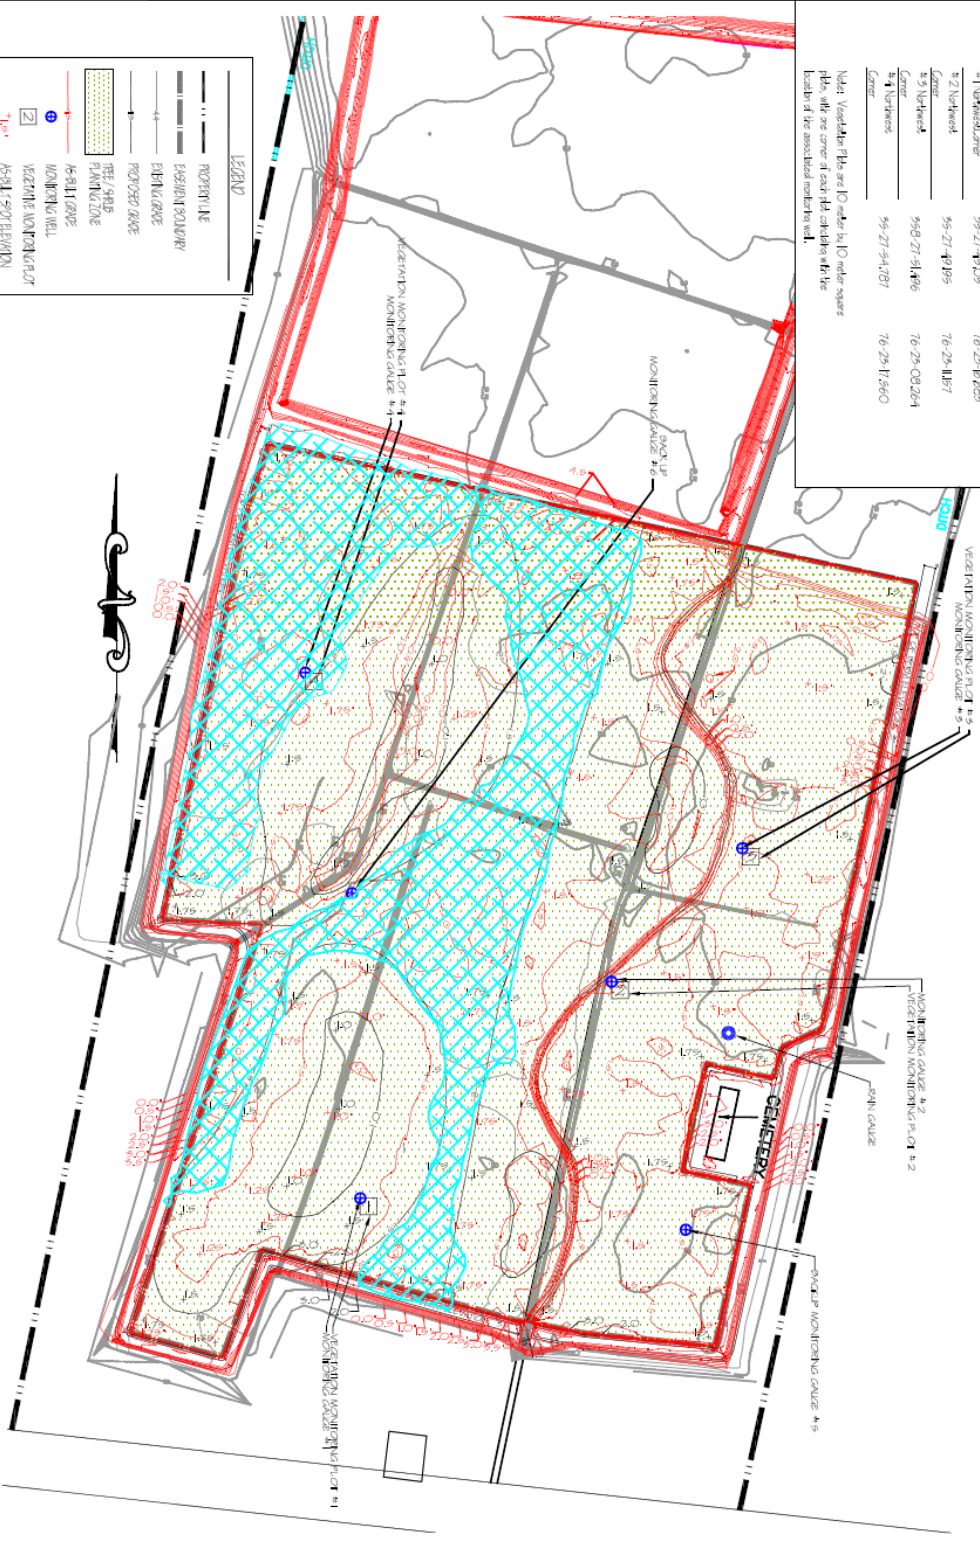
PROBLEM AREAS
DECEMBER 2010

Figure 4 in Appendix D illustrates the development of cover types caused by suspected effects of depth and length of inundation and salinity. Refer to **3.0 Project Success Discussion** for further discussion of developing cover types.

The site topography is such that the area around gauge/plot 4 is less subject to minor flooding, though still subject to total inundation during very wet periods and probably less subject to saltwater intrusion. The area shown on Figure 4 in Appendix D (identified by blue cross-hatching) identifies a large portion of the site where this appears to be the case, based on tree growth, species mix and herbaceous cover. There are other smaller pockets, inclusions and ridges that share the same vegetative features, but this area is the largest contiguous acreage of this cover type. This distinction is not made to delineate wetland types, but to assess the

development of the vegetative cover. Saltwater intrusion has been documented (though the extent is unknown) and length of inundation between the two vegetative cover types can vary depending on rainfall patterns. The depth of standing water, the length of time it stands and its salinity levels and combinations of these factors has had an effect on the development of these two distinct cover types.
