# **Mason Property Wetland Mitigation Project**

**2011 Annual Monitoring Report**  
**Year 4**

**NCEEP Project Number D06001**  
**Tar-Pamlico River Basin**

Date: September, 2011

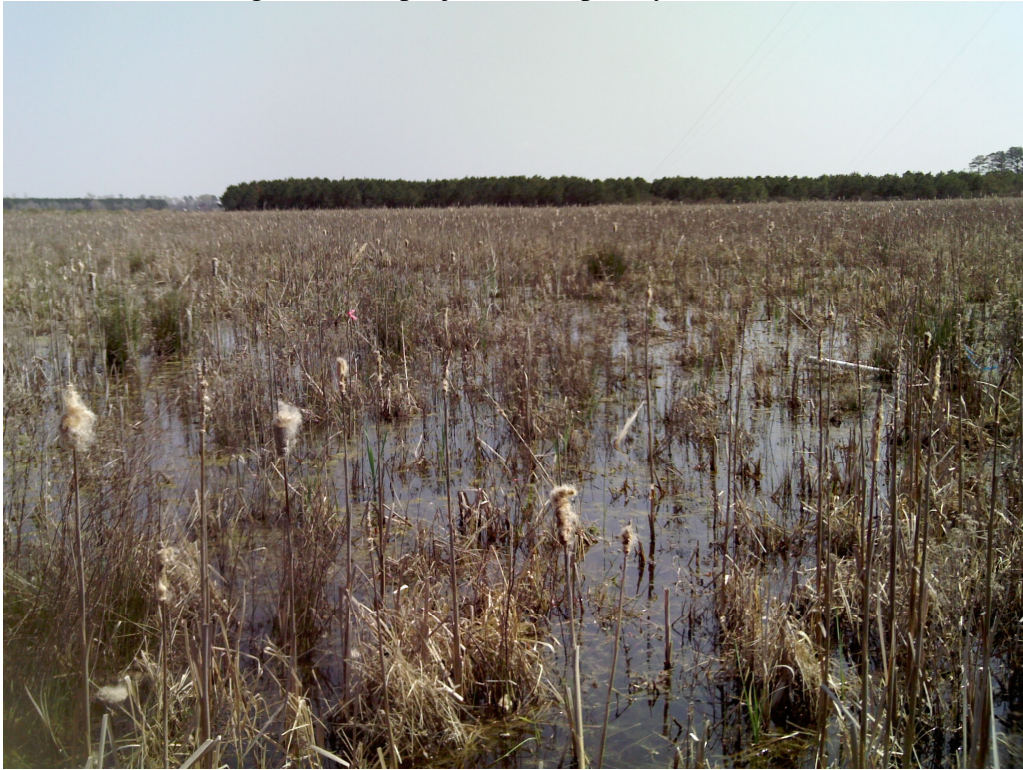
View from Gauge 1 shows project is completely flooded in March 2011.

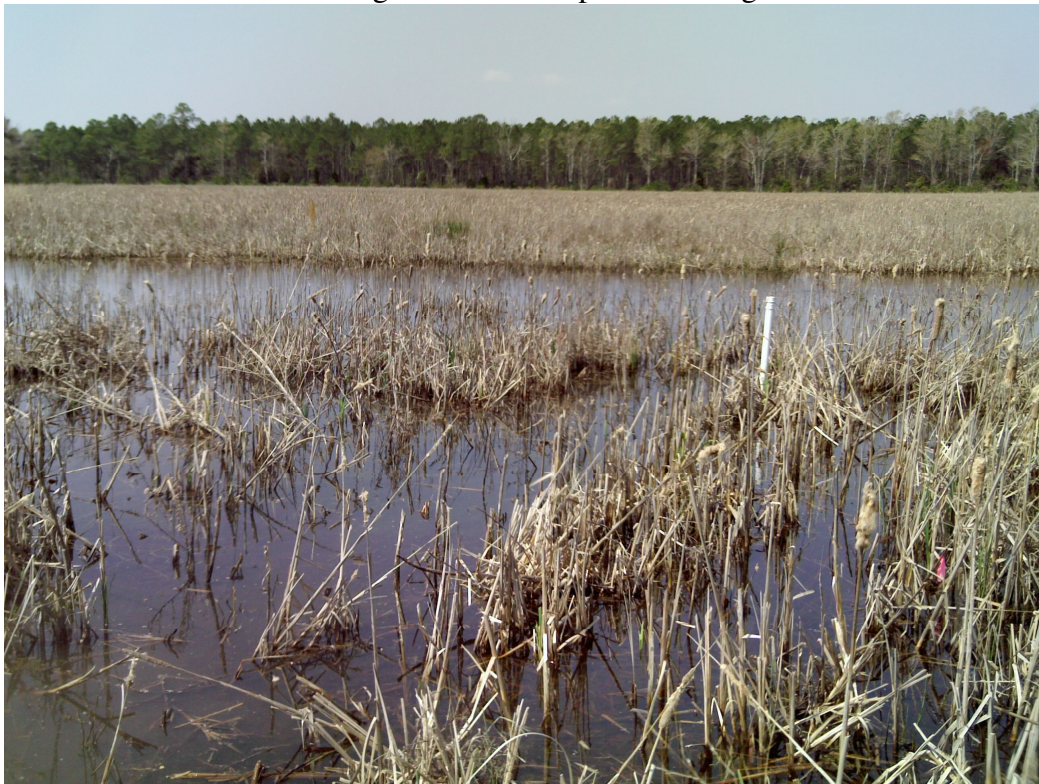
View of run from Gauge 3 shows complete flooding in March 2011.

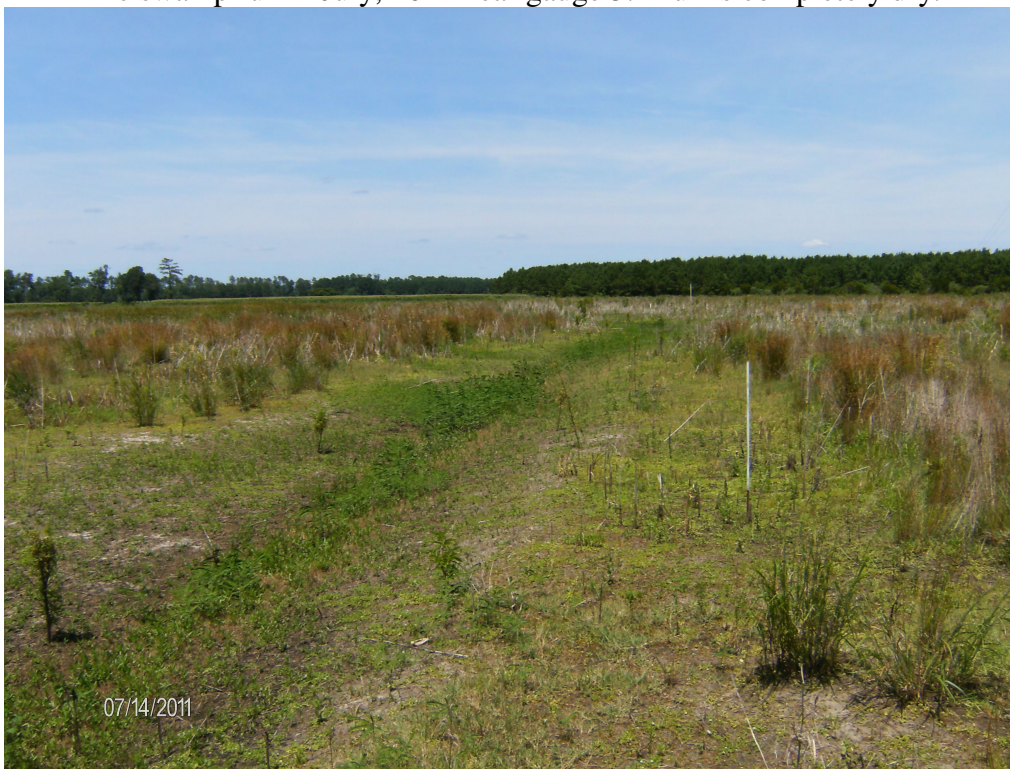
The swamp run in July, 2011 near gauge 3. Run is completely dry.

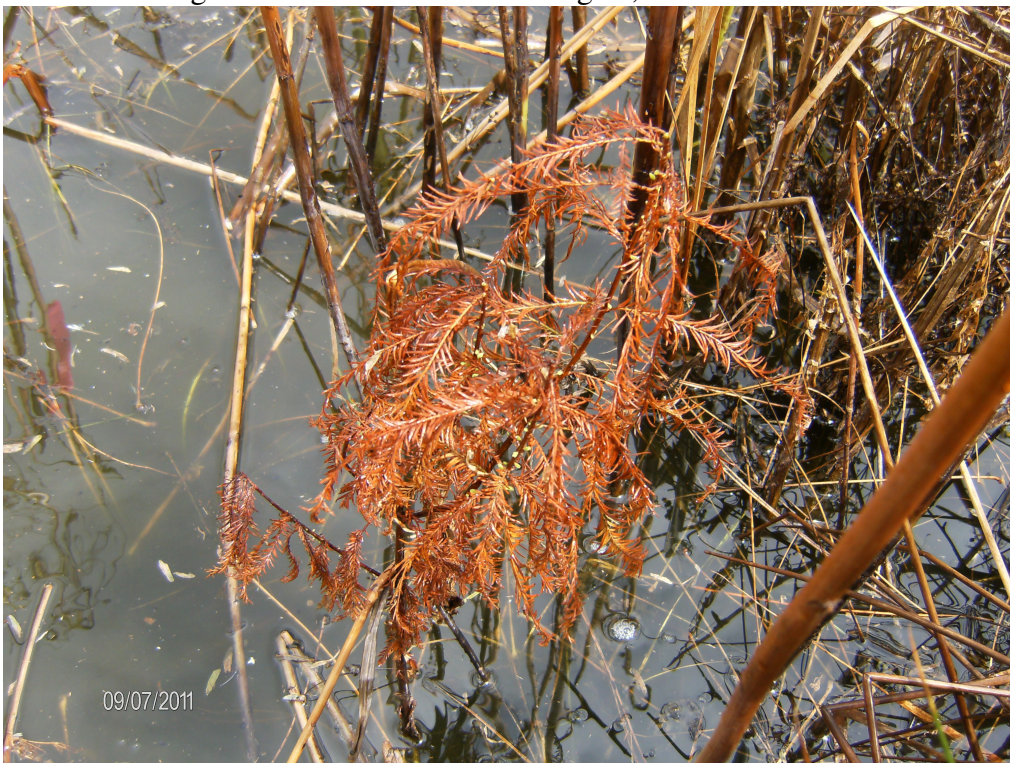
### VPA 1

During the vegetation assessment which was completed in September, 2011, approximately two weeks after the storm related flooding, many of the cypress trees appeared to have viable leaf buds, which indicate they may survive the salt intrusion. Factors affecting the survival of all

planted stems include the depth of salt penetration into the trees' root zone, the relative salinity levels and whether or not the leaf buds break open in the fall of 2011. Late bud break could deplete root carbohydrate stocks which may adversely affect spring leaf-out in 2012. Live buds were less obvious on buttonbush and willow oak, though many of these stems are tall enough that their uppermost buds may have escaped serious damage.

Table 6. Vegetation Problem Areas			
Feature/Issue	Plot	Probable Cause	Photo #
Possible mortality caused by saltwater intrusion	Entire project area	Saltwater intrusion during Hurricane Irene	VPA 1, 2, 3

Salt water damage after Hurricane Irene in August, 2011. Note live buds on stem.

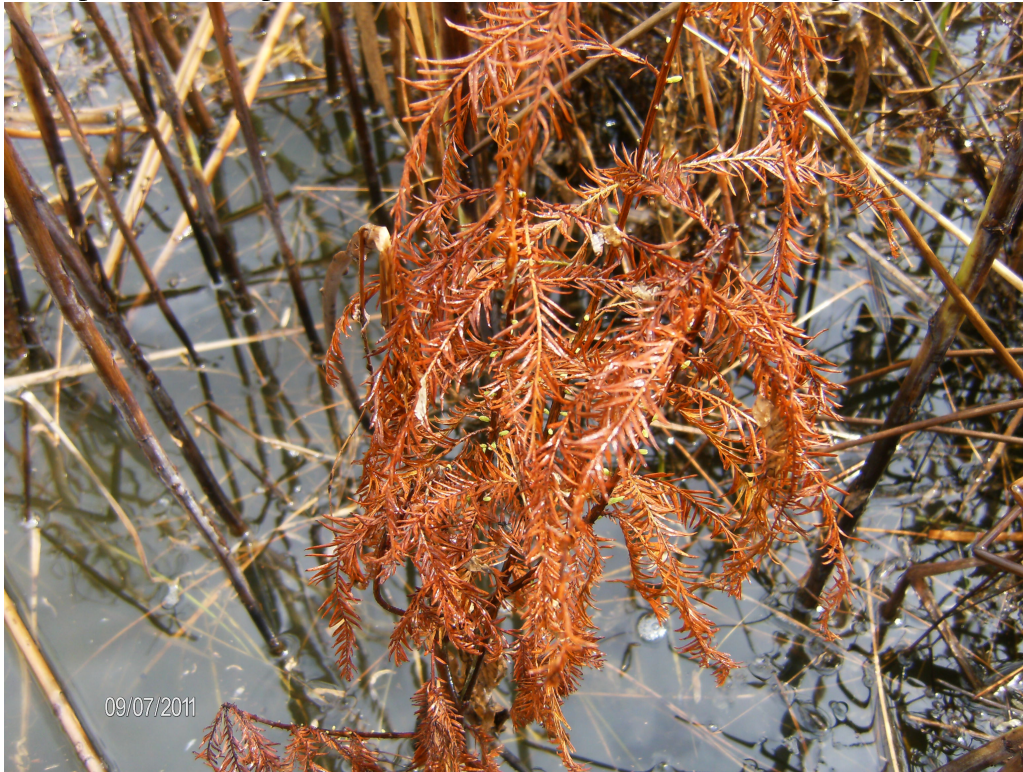
### VPA 2

Similar photo from September, 2011 shows live buds on salt damaged cypress stem.

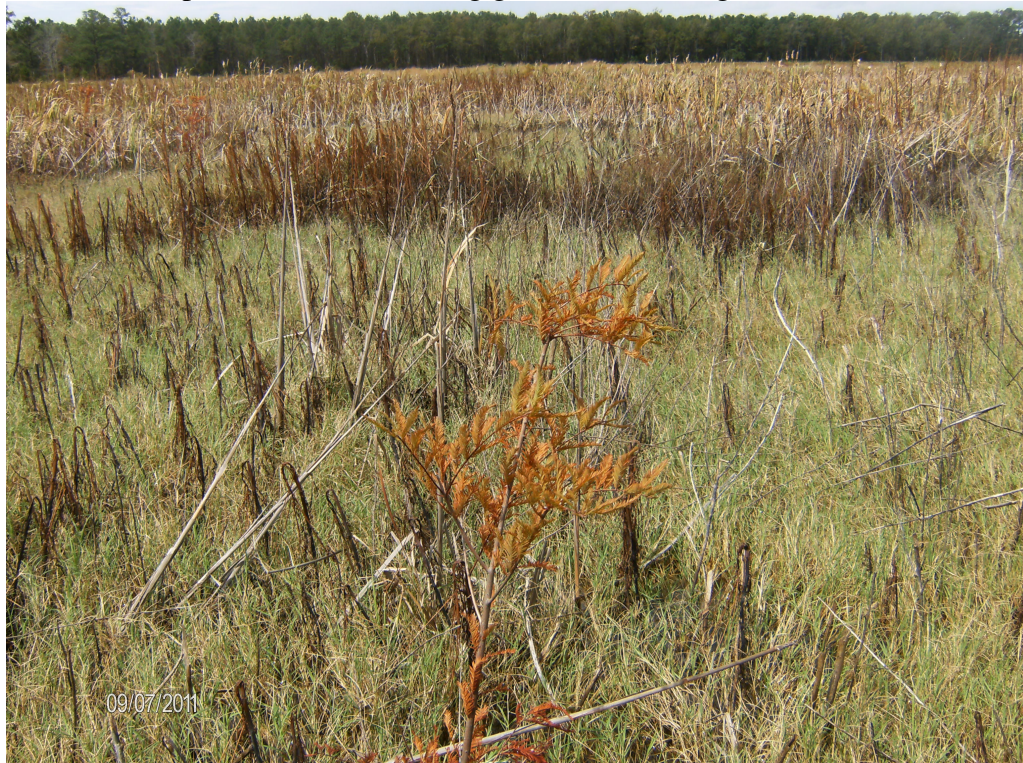
### VPA 3

Photo from September, 2011 showing general salt damage from Hurricane Irene.

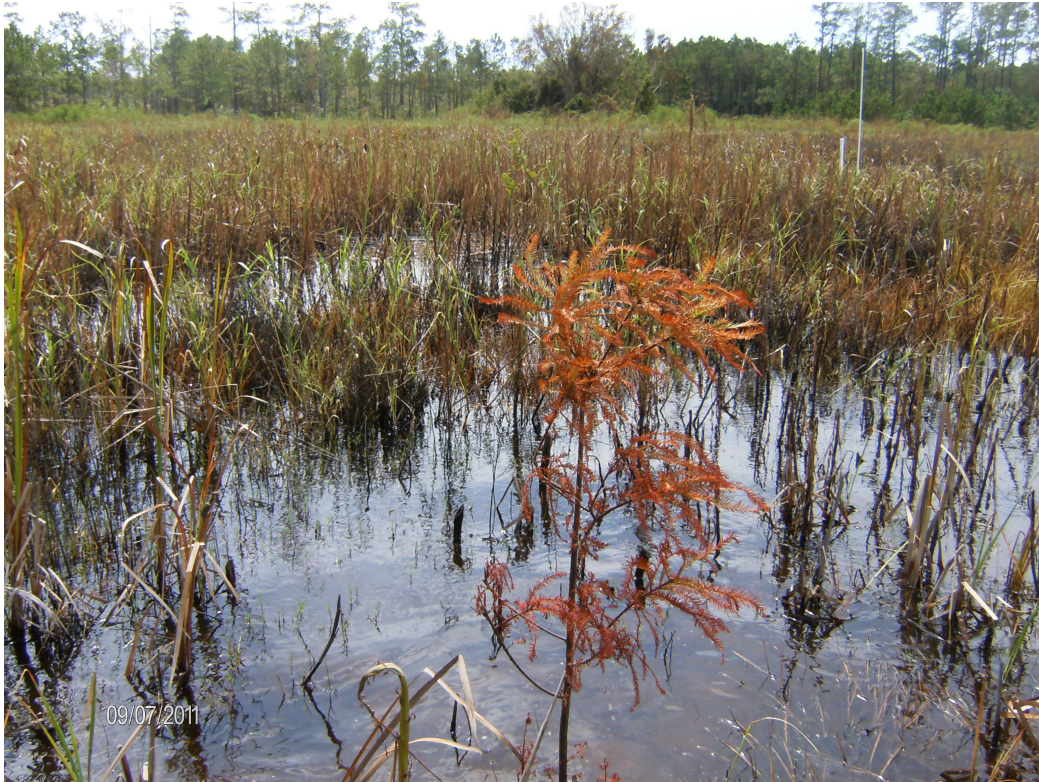
**In lieu of an integrated map, some photos are offered as evidence of the potential damage caused by Hurricane Irene in late August of 2011. Vegetation across the project site shows stress and premature leaf browning or leaf drop due to salt water intrusion during the storm. The long-term effects of this salt damage are unknown at this point.**

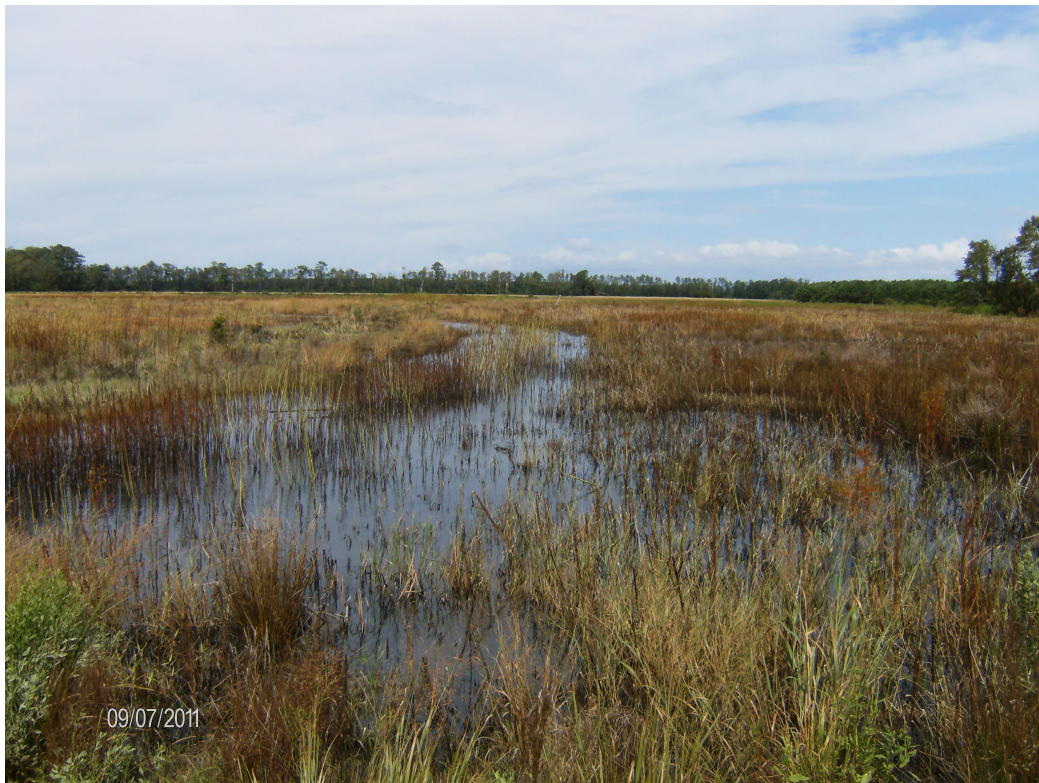
**Typical example of damage from salt water flooding post Irene.**

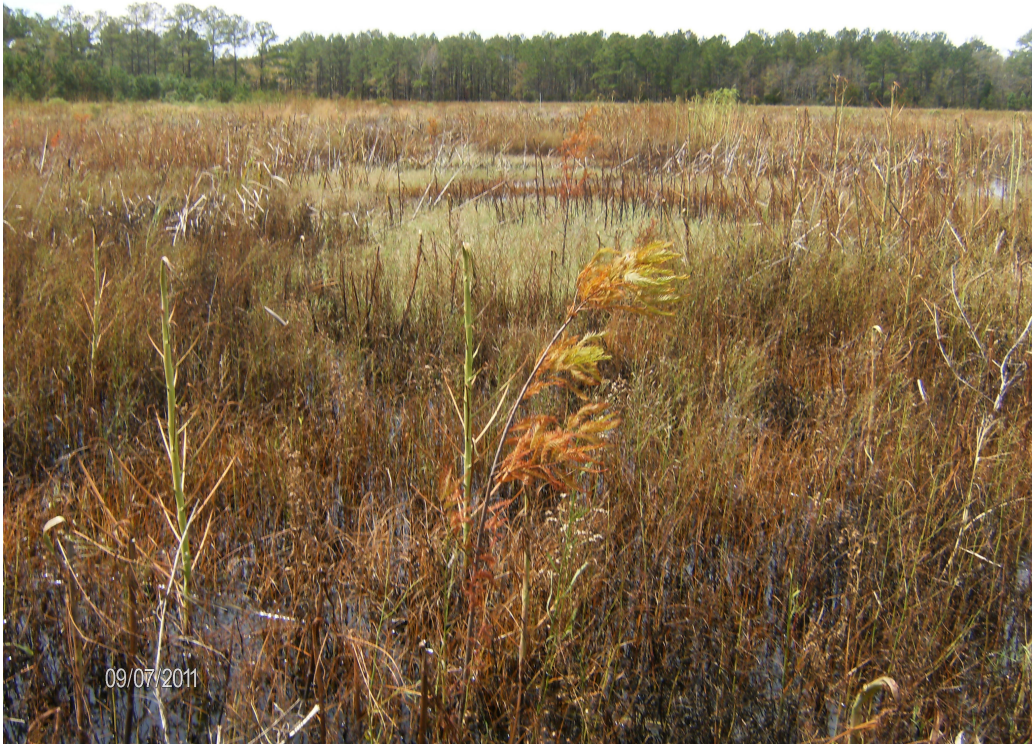
**Entire project site was inundated with salt water causing widespread browning of vegetation.**

**Typical browning of the vegetation on the project site. Some live leaf material above the 4.0' high water mark appears to have survived.**
