Mason Property Wetland Mitigation Project
EEP ID (IMS# 92328)
FDP Contract Number D06001
USACE Action ID # SAW-2007-59-148

Monitoring Year 5 (2012)

WETLAND

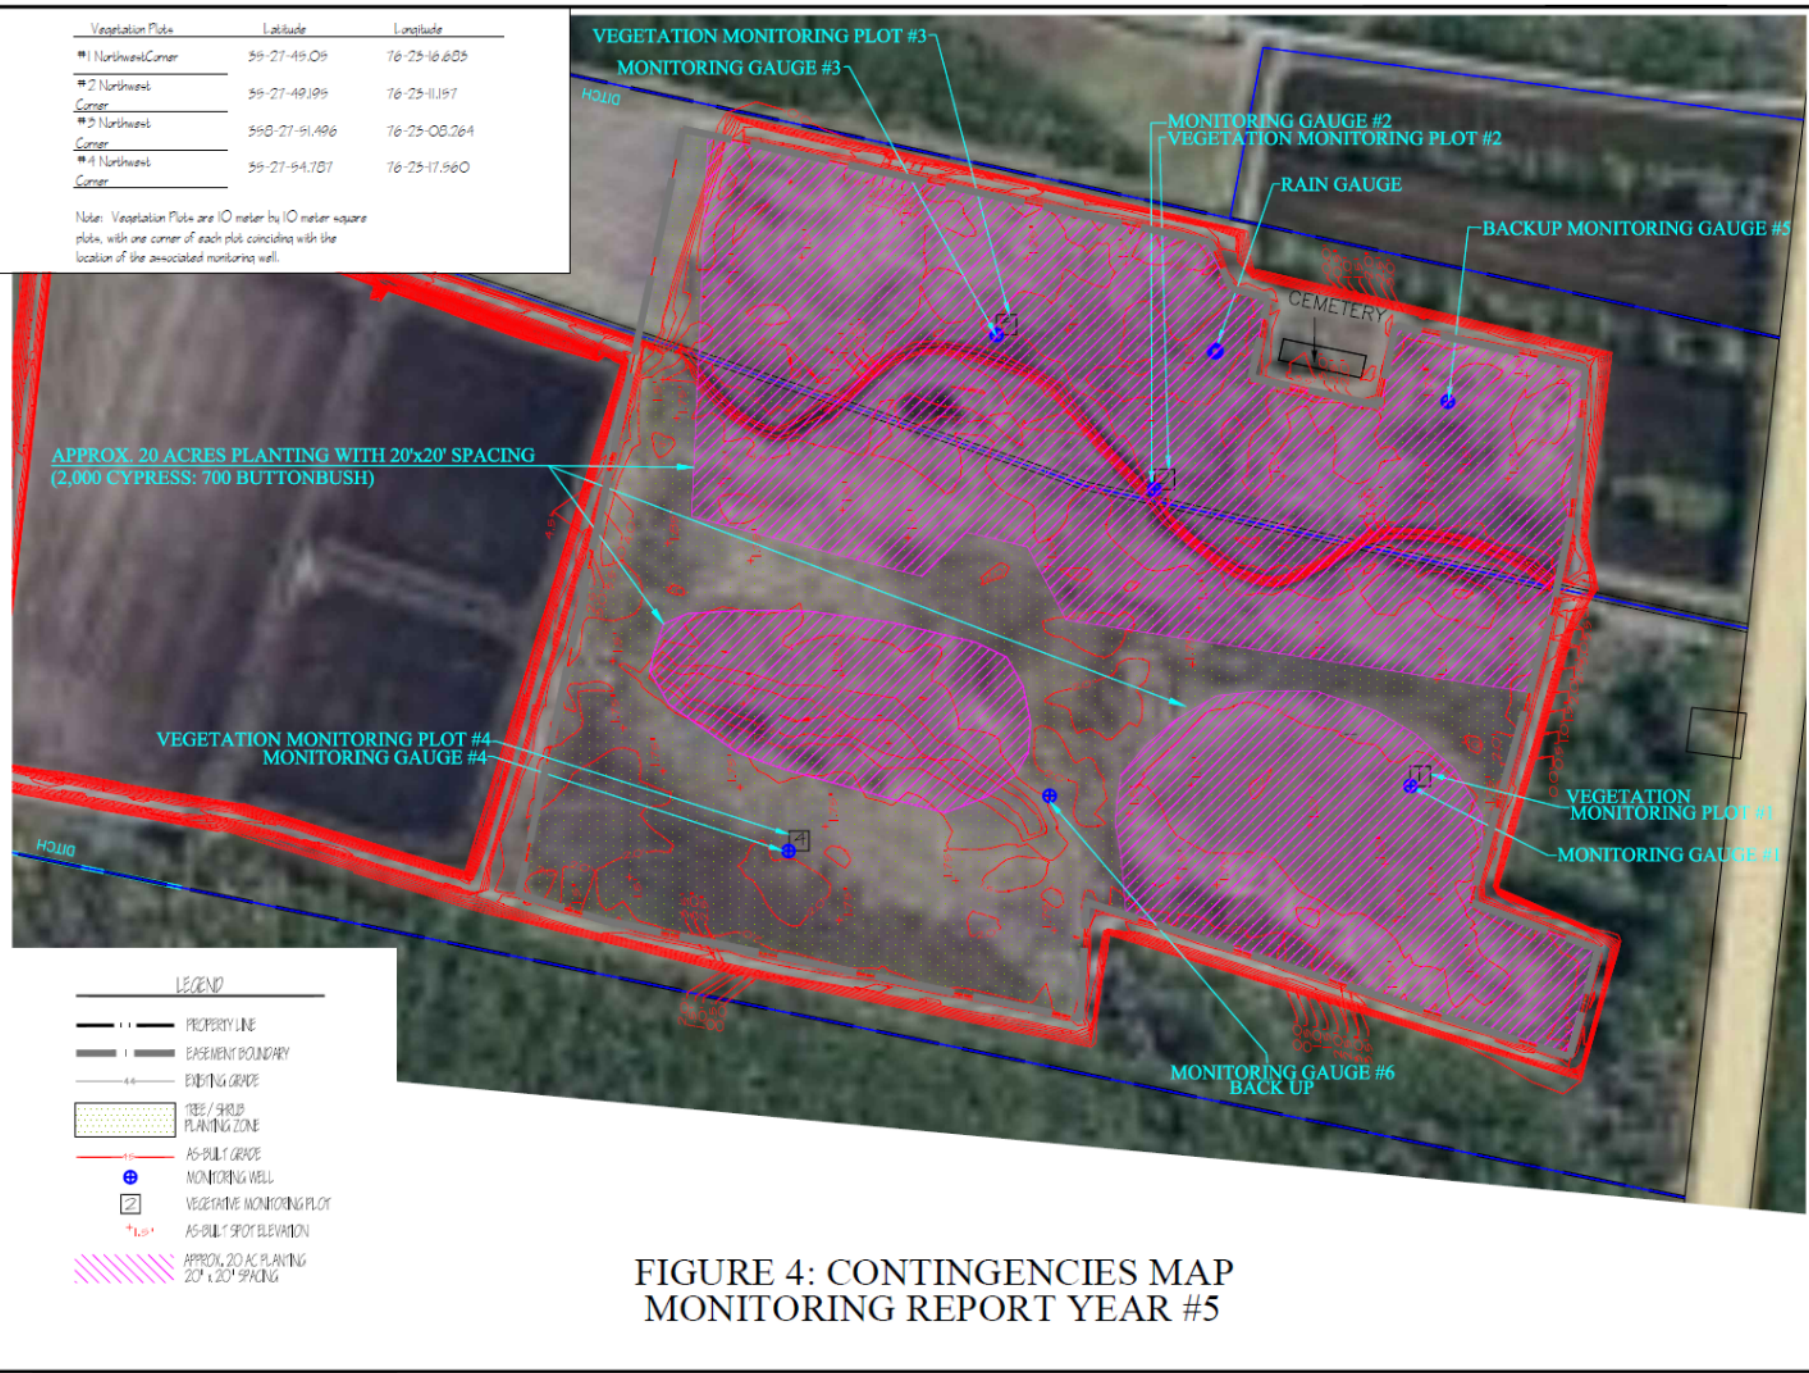
FIGURE 4: CONTINGENCIES MAP
MONITORING REPORT YEAR #5

MASON PROPERTY
ERREVE MEAS AND MITIGATION AS-BUILT
16.0 ACRES
MONITORING MEAS AND MITIGATION AS-BUILT
700 CYPRESS
400 BUTTONBUSH
FOR CONTACT: M. B. BOGGS

APPROX. 20 ACRES PLANTING WITH 20'x20' SPACING
(2,000 CYPRESS; 700 BUTTONBUSH)
