# **Mason Property Wetland Mitigation Project**

**Hyde County, NC**

**2014 Supplemental Monitoring Report – Post Closeout  
Year 7**

**NCEEP Project Number D06001**  
**Tar-Pamlico River Basin CU: 03020105**

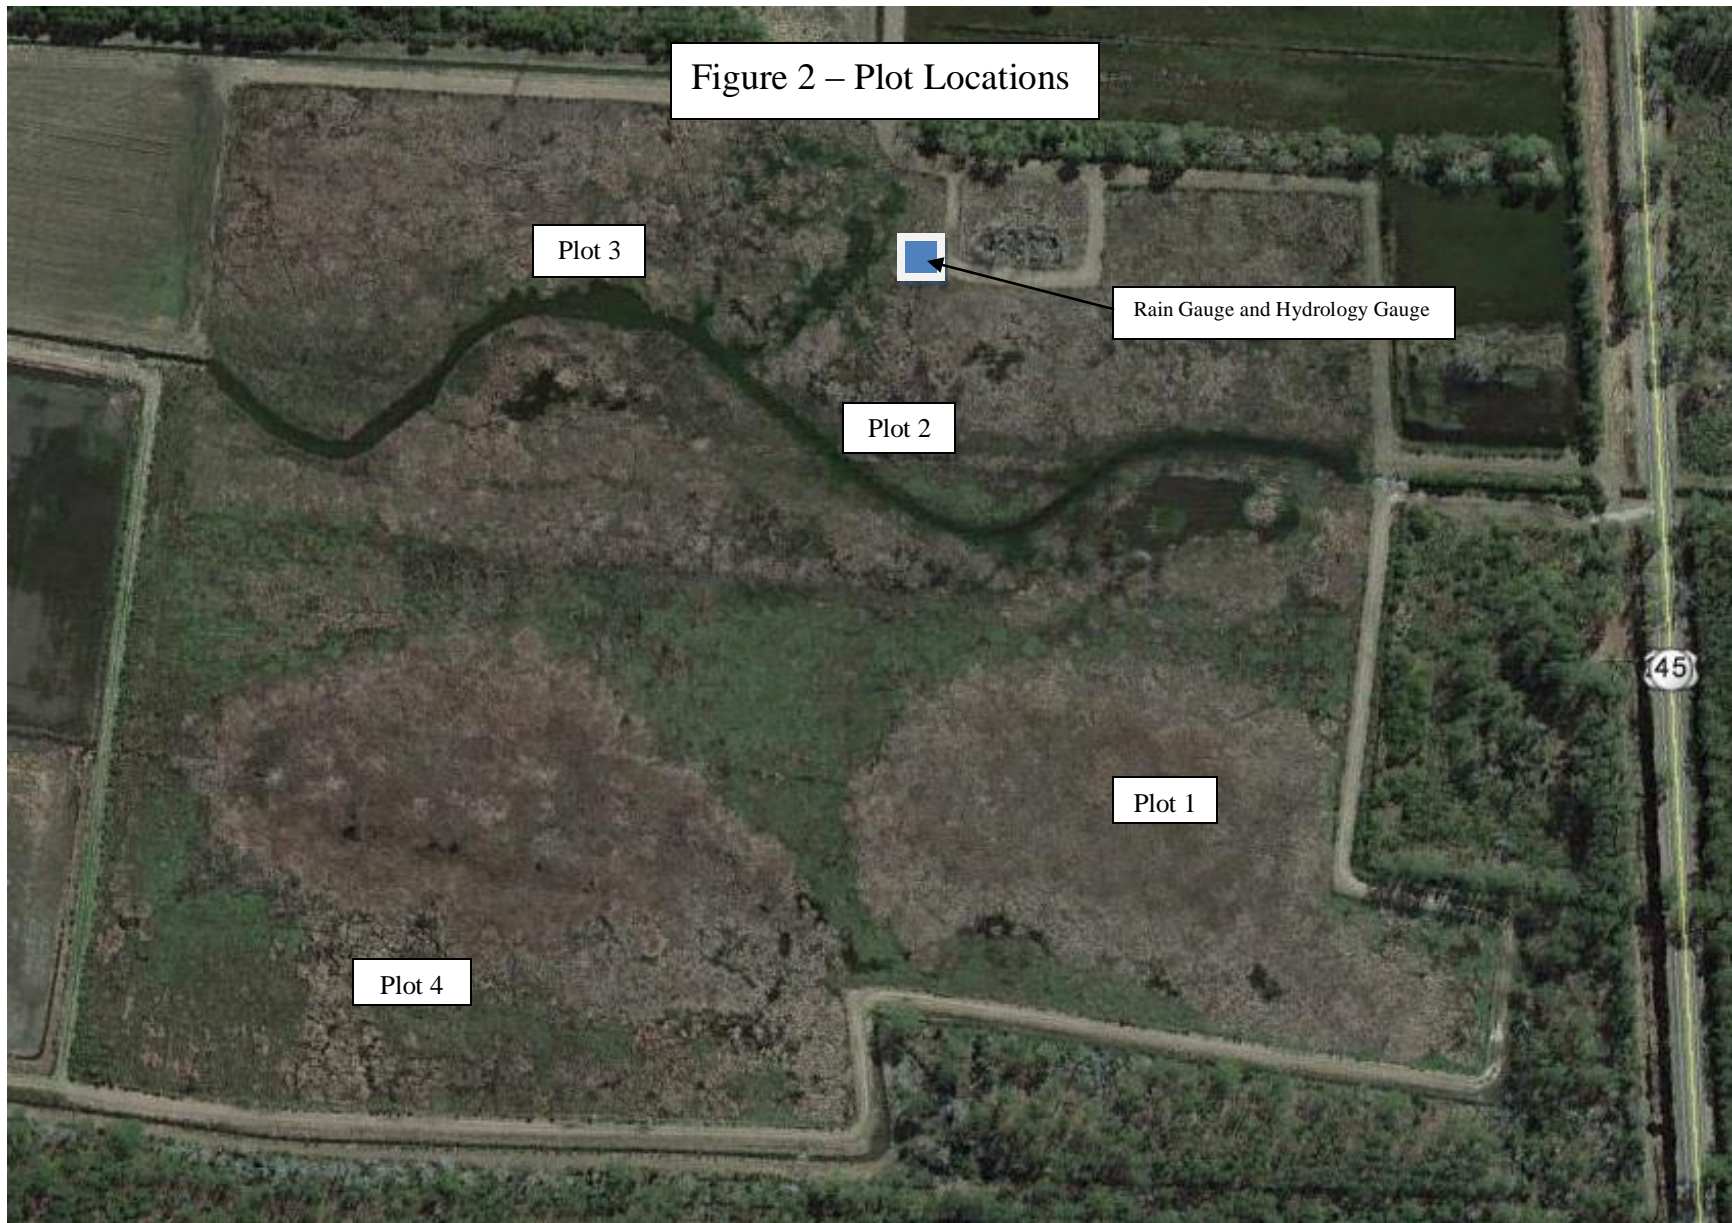
Figure 2 – Plot Locations

Figure 2 provides a plan view of the site showing the location of the four vegetation monitoring plots and the location of the rain gauge and single hydrologic gauge.

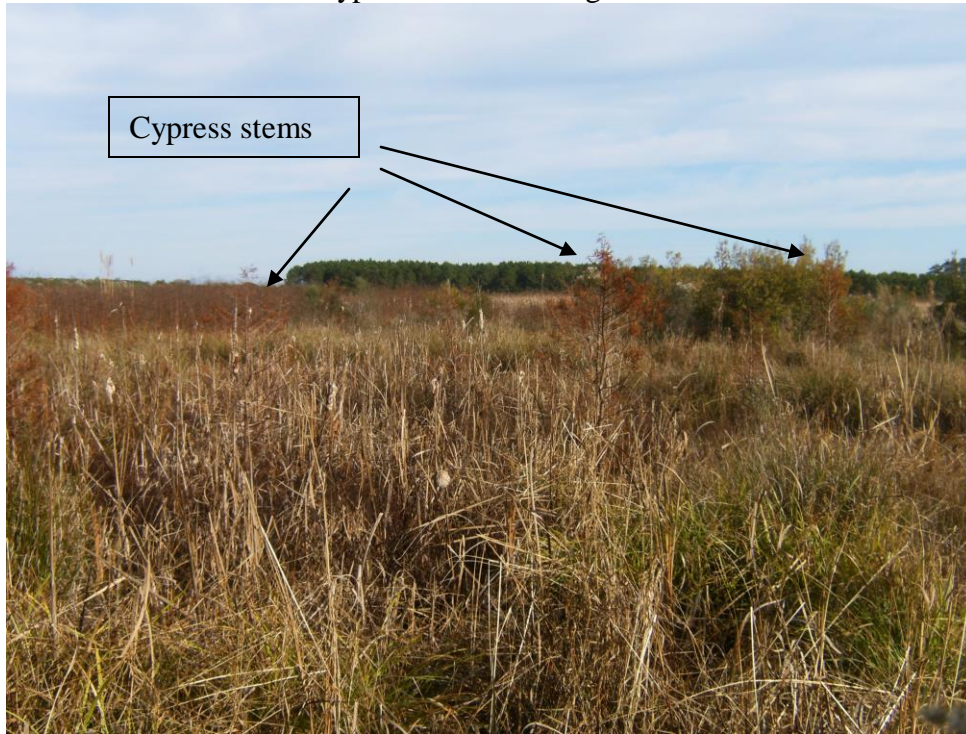
Cypress are still doing well

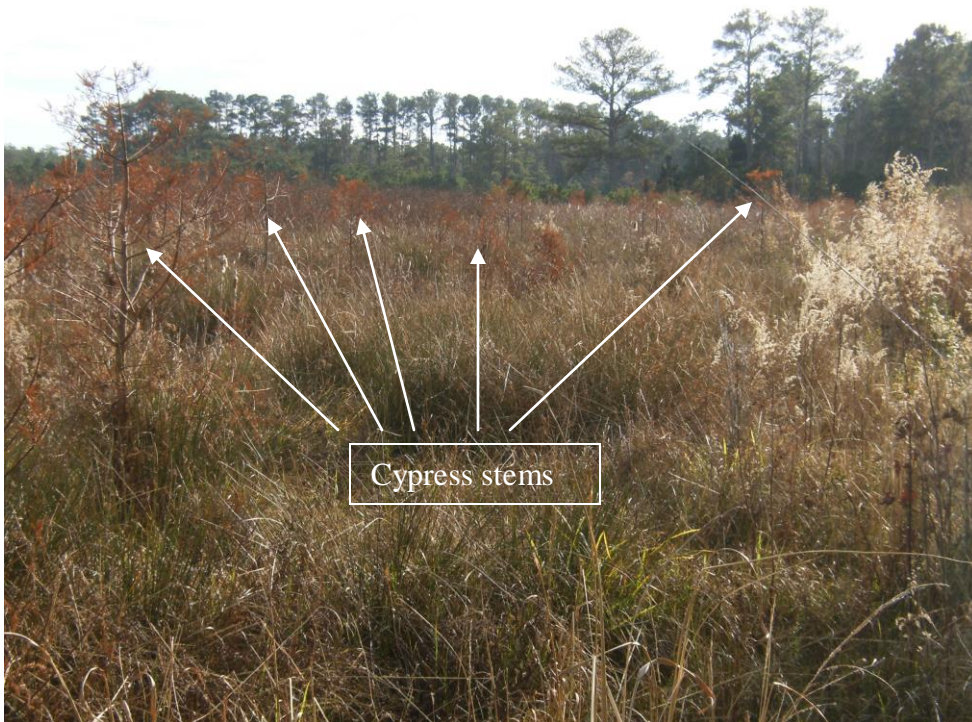
Another photo of cypress growth.

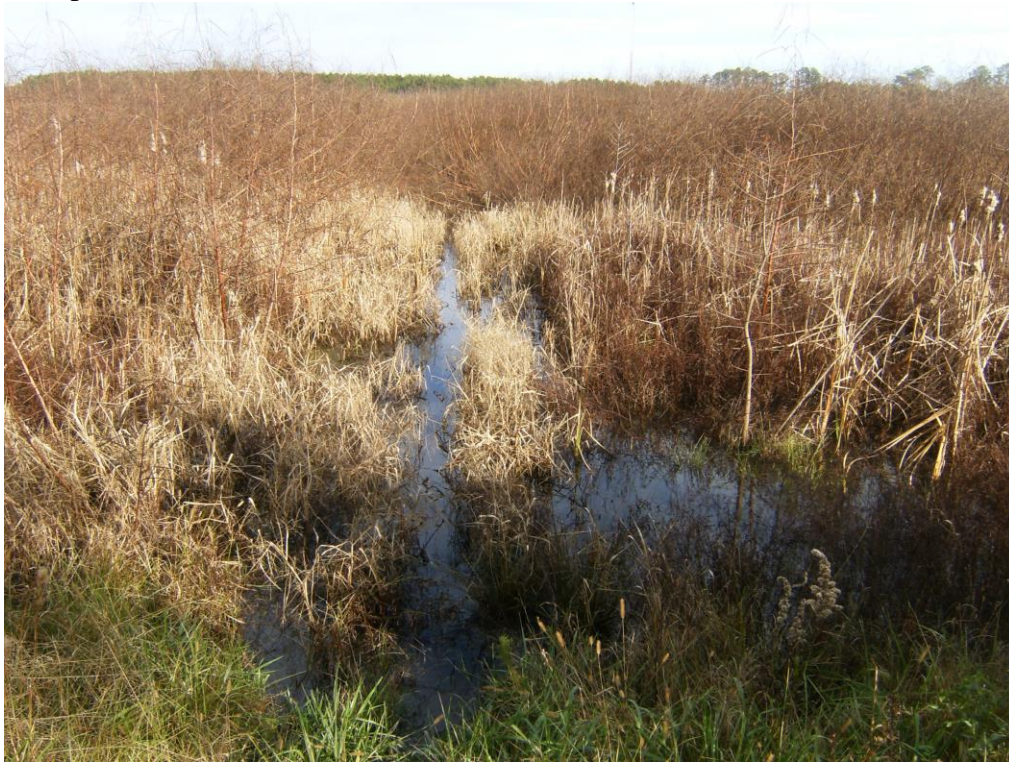
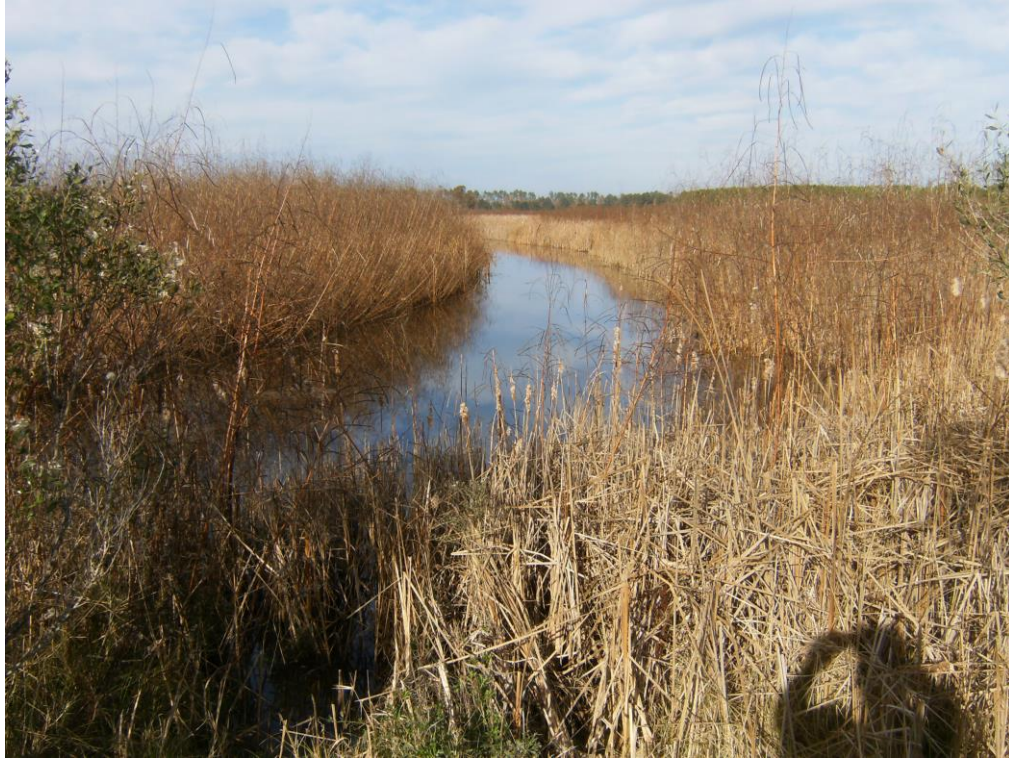
A hydrology gauge was left on site but malfunctioned sometime during the monitoring season and its data had not been recovered as of the submission of this report. As can be seen from the photos at the end of this report, hydrology as not changed and the site continues to be very wet.

These two photos taken in December 2014, show that the hydrology has not been altered by the site prep and has not changed over time. The site is still extremely wet and standing water throughout the year is still common. Top photo is on the west side of the project. Bottom photo is of the swamp run at the outfall.
