# **Mason Property Wetland Mitigation Project**

**2015 Supplemental Monitoring Report – Post Closeout  
Year 8**

**NCEEP Project Number D06001**  
**Tar-Pamlico River Basin CU: 03020105**

Monitoring:  
**Albemarle Restorations, LLC**  
P. O. Box 176  
Fairfield, NC 27826

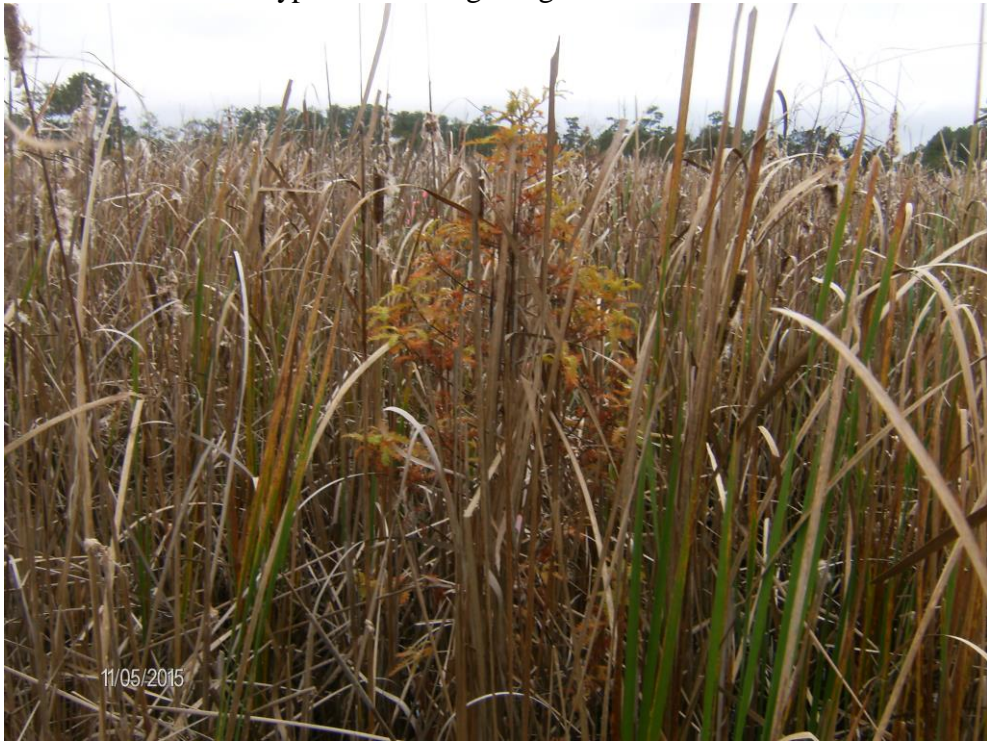
Cypress crowns getting above cattails

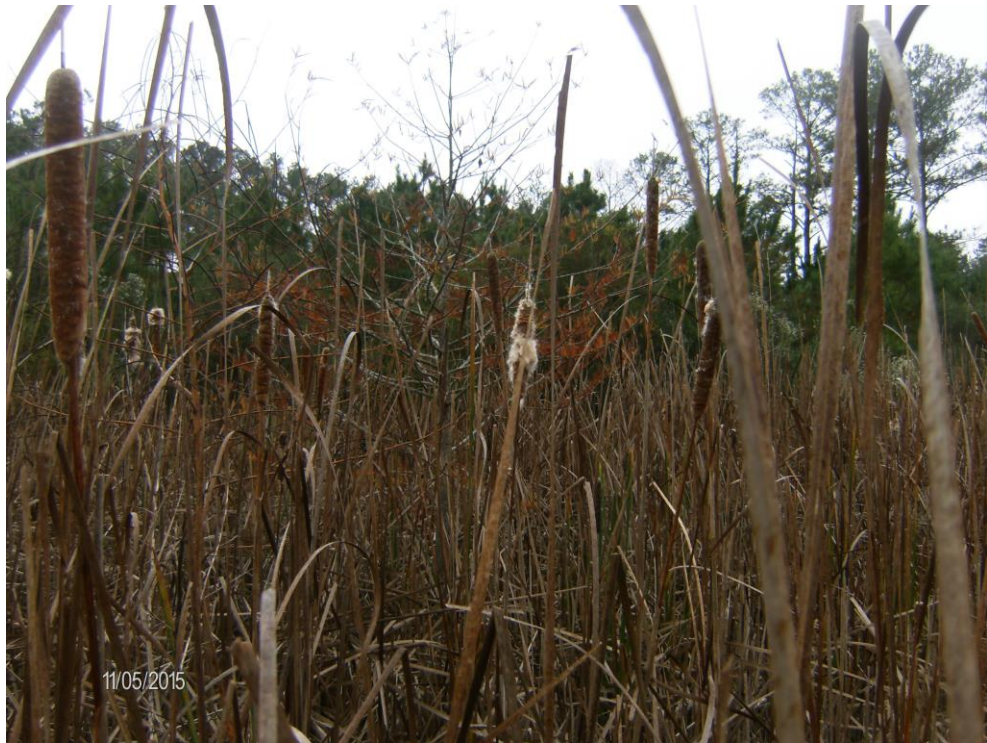
Crown of an older tree well above cattails.

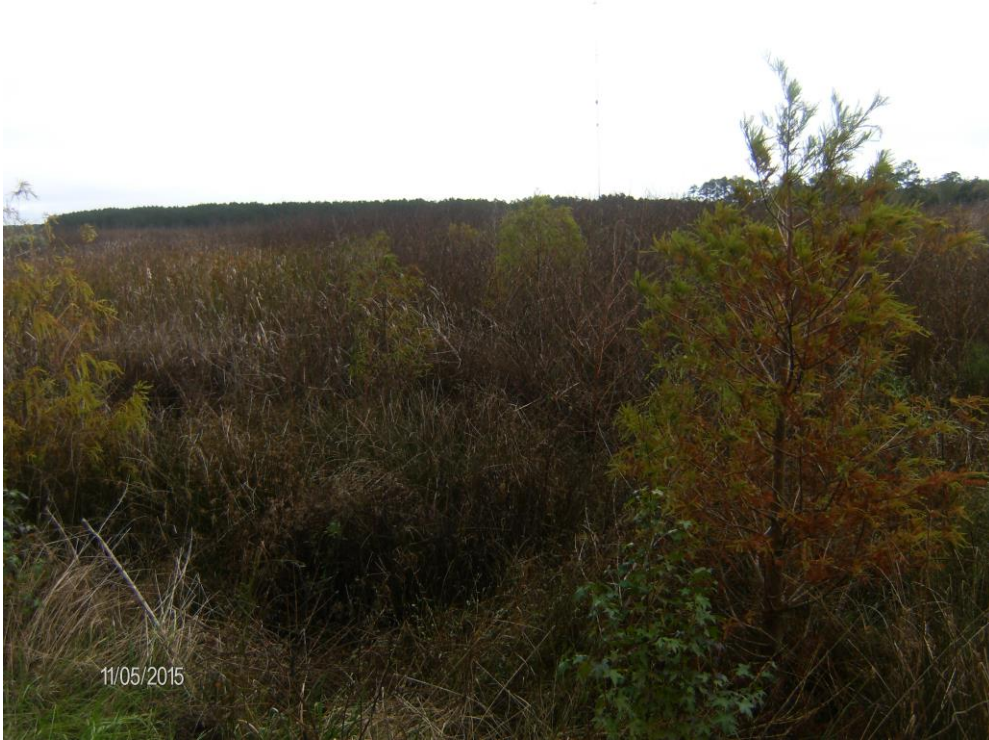
Good stocking and growth.

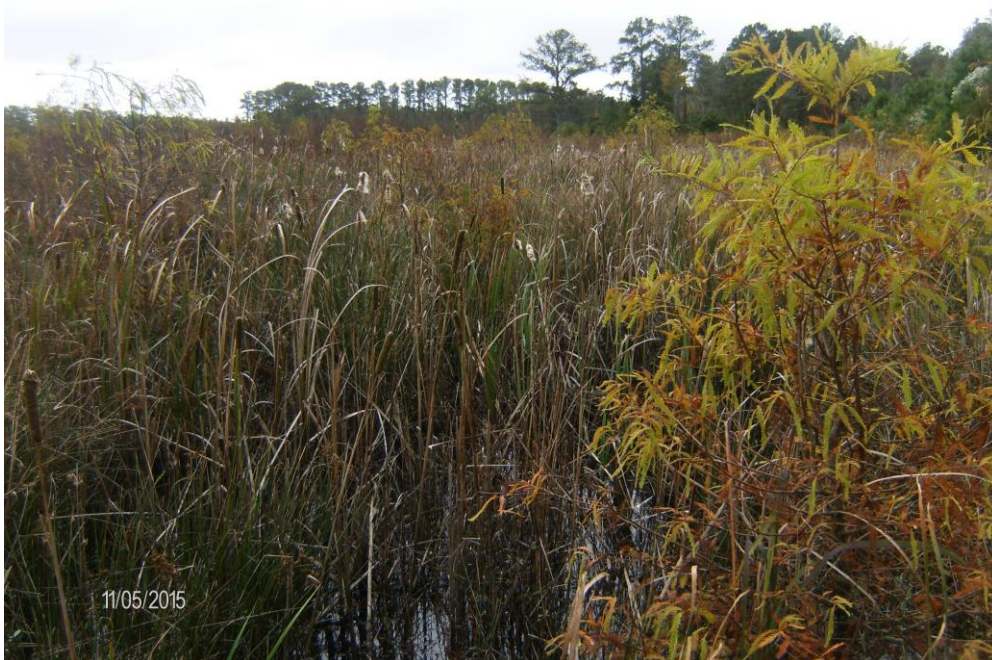
Standing water in November, crowns getting above cattails.
