As-Built Baseline Monitoring Report

MATTHEW SITE

NCDMS Project #100043 (Contract #7419)

June 2021

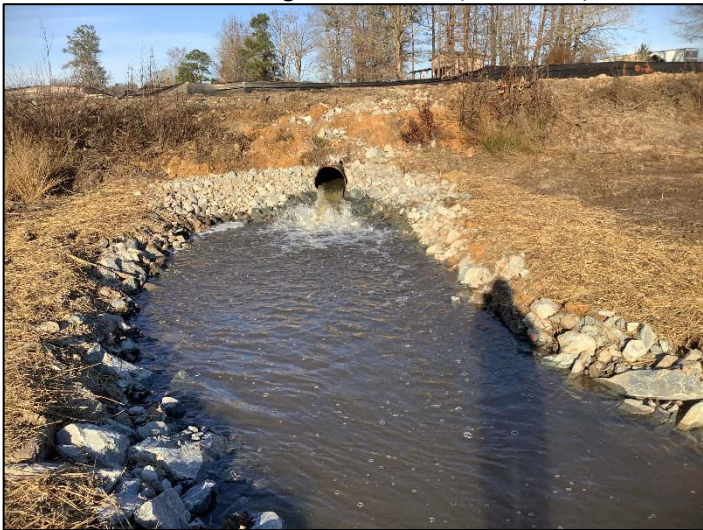
Plunge pool at the top of RL2 (12/15/2020)

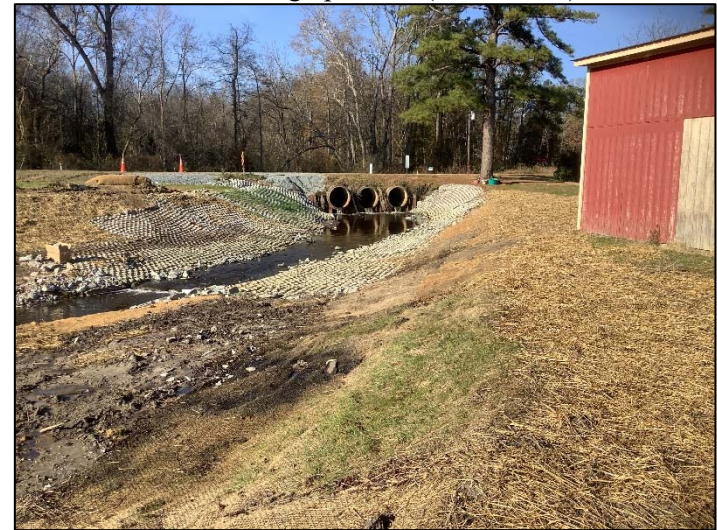
Plunge pool and boulder toe protection below NC-96 culvert on RL1-A (12/15/2020)

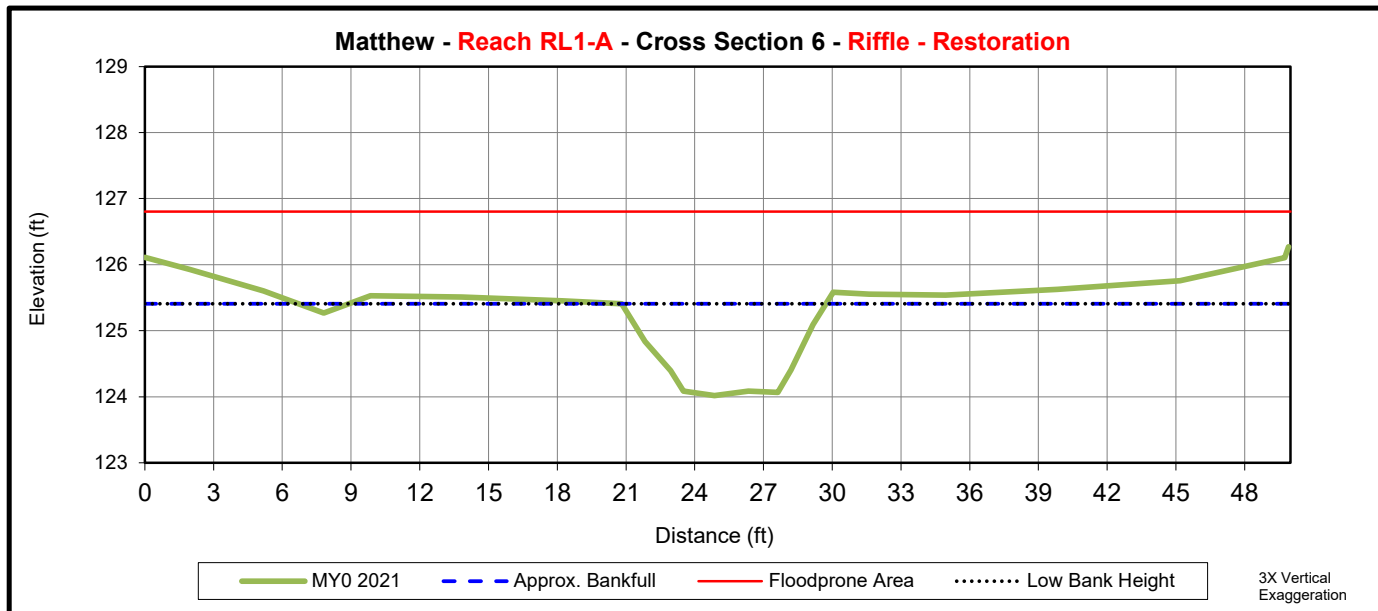
14. Please review the cross section data and ensure that all points outside of the main channel with elevations less than the Low Bank Height are excluded from the cross section area calculation (e.g. XS 6).
XS 6 has been corrected and all cross section data has been reviewed and no other errors were found.
