Year 2 Monitoring Report

MATTHEW SITE

NCDMS Project #100043 (Contract #7419)
USACE Action ID: SAW-2017-00055
DWR Project #2017-0624

January 2023

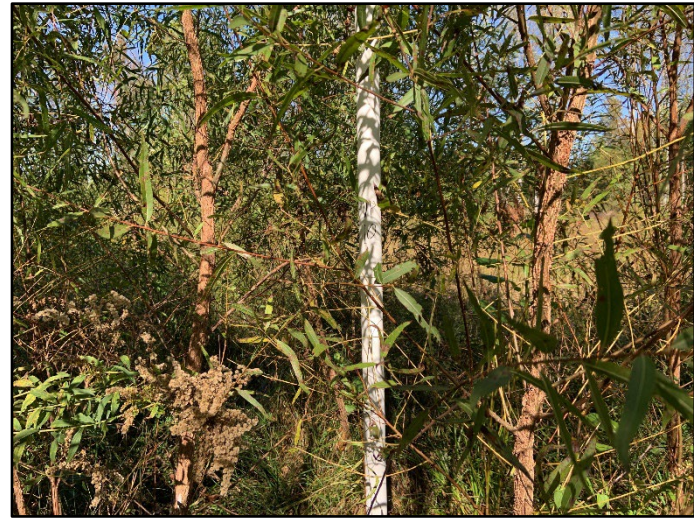
Vegetation Plot 10 (10/20/2022)

3. VP10 has a high number of loblolly volunteers. Please check if this is isolated to that VP and reminder that those should not be counted for success. As a note, in some later-stage wetland projects, IRT has indicated that pines may be dewatering wetlands. Consider this when evaluating treatment of young pines.

For now, the pines are localized to the immediate area around VP10. RES also recorded that all those volunteer pines within that plot were still between 50-100cm tall. Therefore, it is not an immediate concern considering the success of the planted trees and the overall vegetative diversity in that area. However, RES plans to assess the pine situation again during MY3 monitoring and will determine if treatment is necessary.

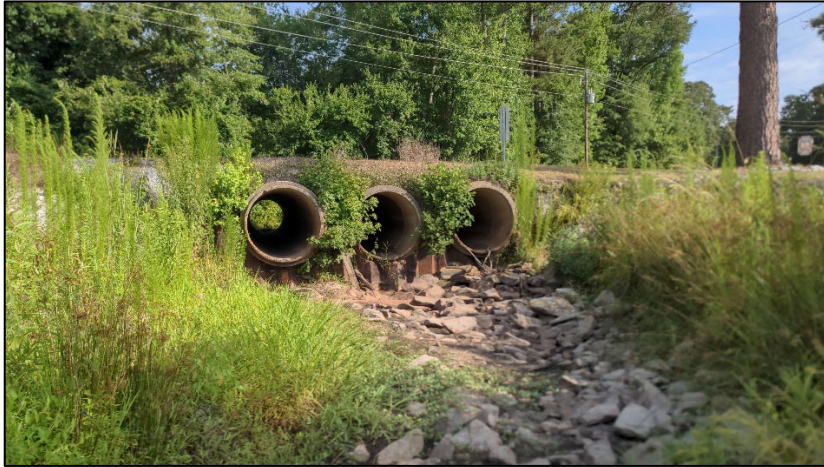
Plunge pool and boulder toe protection below NC-96 culvert on RL1-A (06/28/2022)

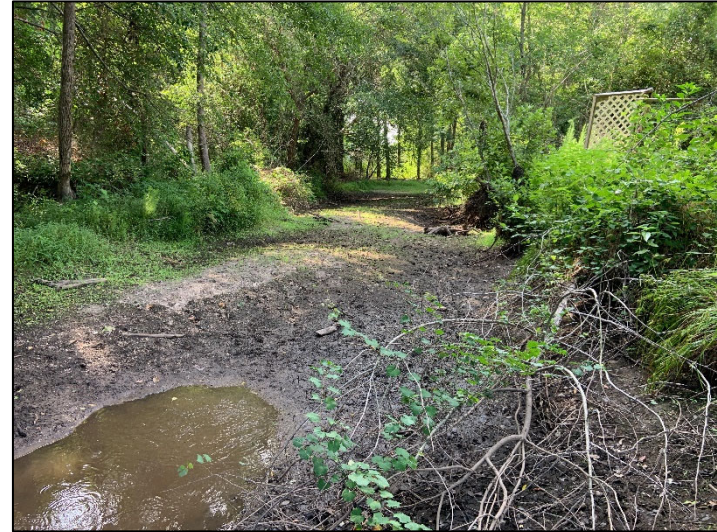
Preservation area dry (06/28/2022)

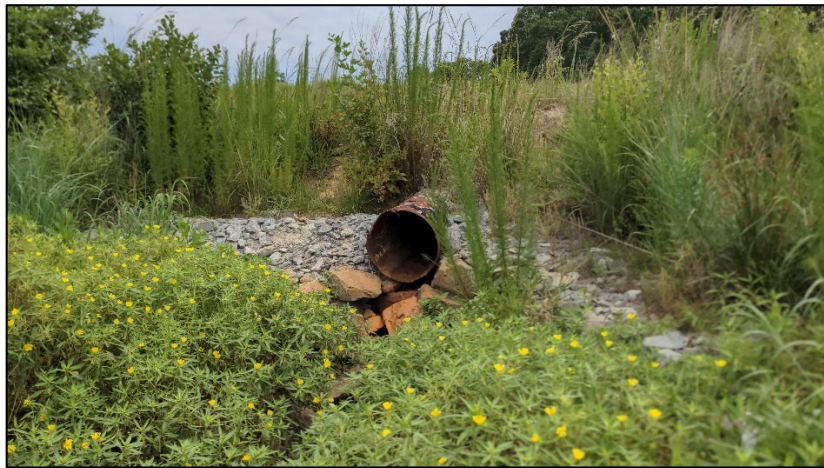
Plunge Pool at the top of RL2 (6/28/2022)

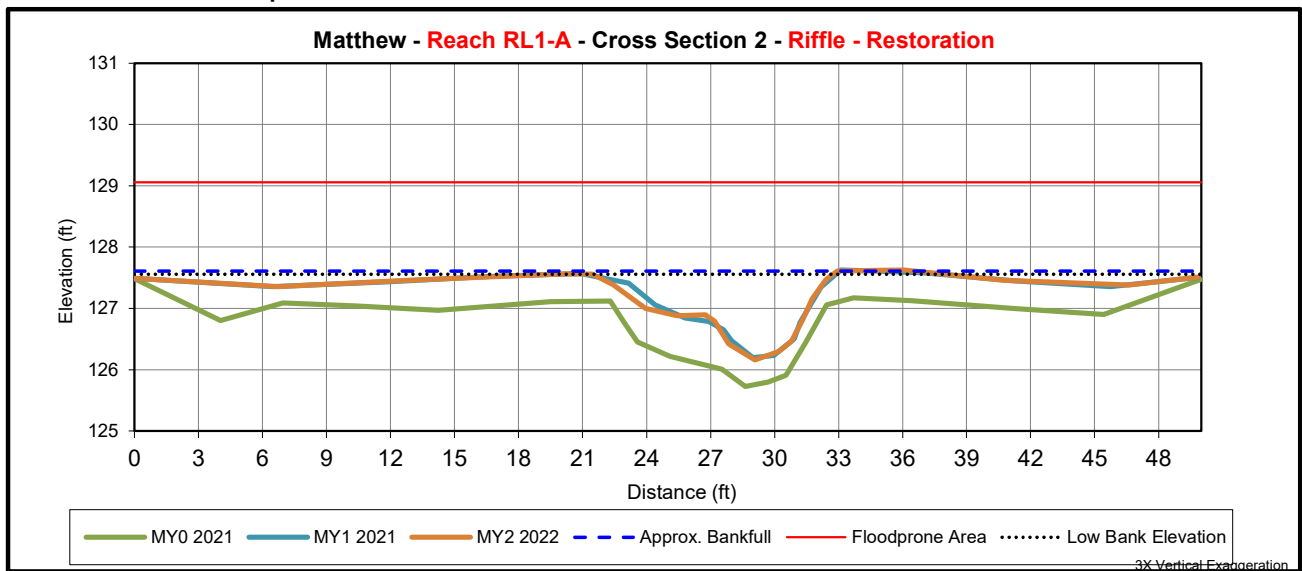
1. Please QA/QC cross section data for accuracy. For example, XS 2 shows a greater than 25% reduction in cross sectional area between AB and MY1, then an increase in cross sectional area (6.1 to 8.0) between MY1 And MY2. Are these estimates in error or do they reflect a large change in cross sectional area?

The reduction in cross sectional area between MY0 and MY1 was legitimate and was due to some aggradation of sediment coming into the top of the Project. However, the actual channel dimension remained stable and almost identical between MY1 and MY2, but the “top-of-bank calls” (which is where we set Low TOB and BF Stage elevations for the sake of calculating cross sectional area) appears somewhat subjective and not perfectly consistent between MY1 and MY2 even though the channel was virtually unchanged. Sometimes there is discrepancy in such calls simply due to surveyor subjectivity and/or a physical “obstacle” in the field while surveying, such as a thick clump of juncus on the TOB or even minor bank sluffing due to the surveyor’s boot walking up the bank. In reality, these are not substantial changes in the channel dimension but can appear to skew the calculated cross sectional area and is especially exaggerated for smaller channels.

Cross Section 2 (Riffle)						
	Base	MY1	MY2	MY3	MY5	MY7	MY+
Bankfull Elevation (ft) - Based on AB-XSA¹	127.1	127.7	127.6				
Bankfull Width (ft) ¹	10.0	9.9	11.5				
Floodprone Width (ft) ¹	>49.9	>49.9	>49.9				
Bankfull Max Depth (ft) ²	1.3	1.2	1.4				
Low Bank Elevation (ft)	127.1	127.4	127.6				
Bankfull Cross Sectional Area (ft ²) ²	8.6	6.1	8.0				
Bankfull Entrenchment Ratio ¹	>5.0	>5.0	>4.4				
Bankfull Bank Height Ratio ¹	1.0	0.8	1.0

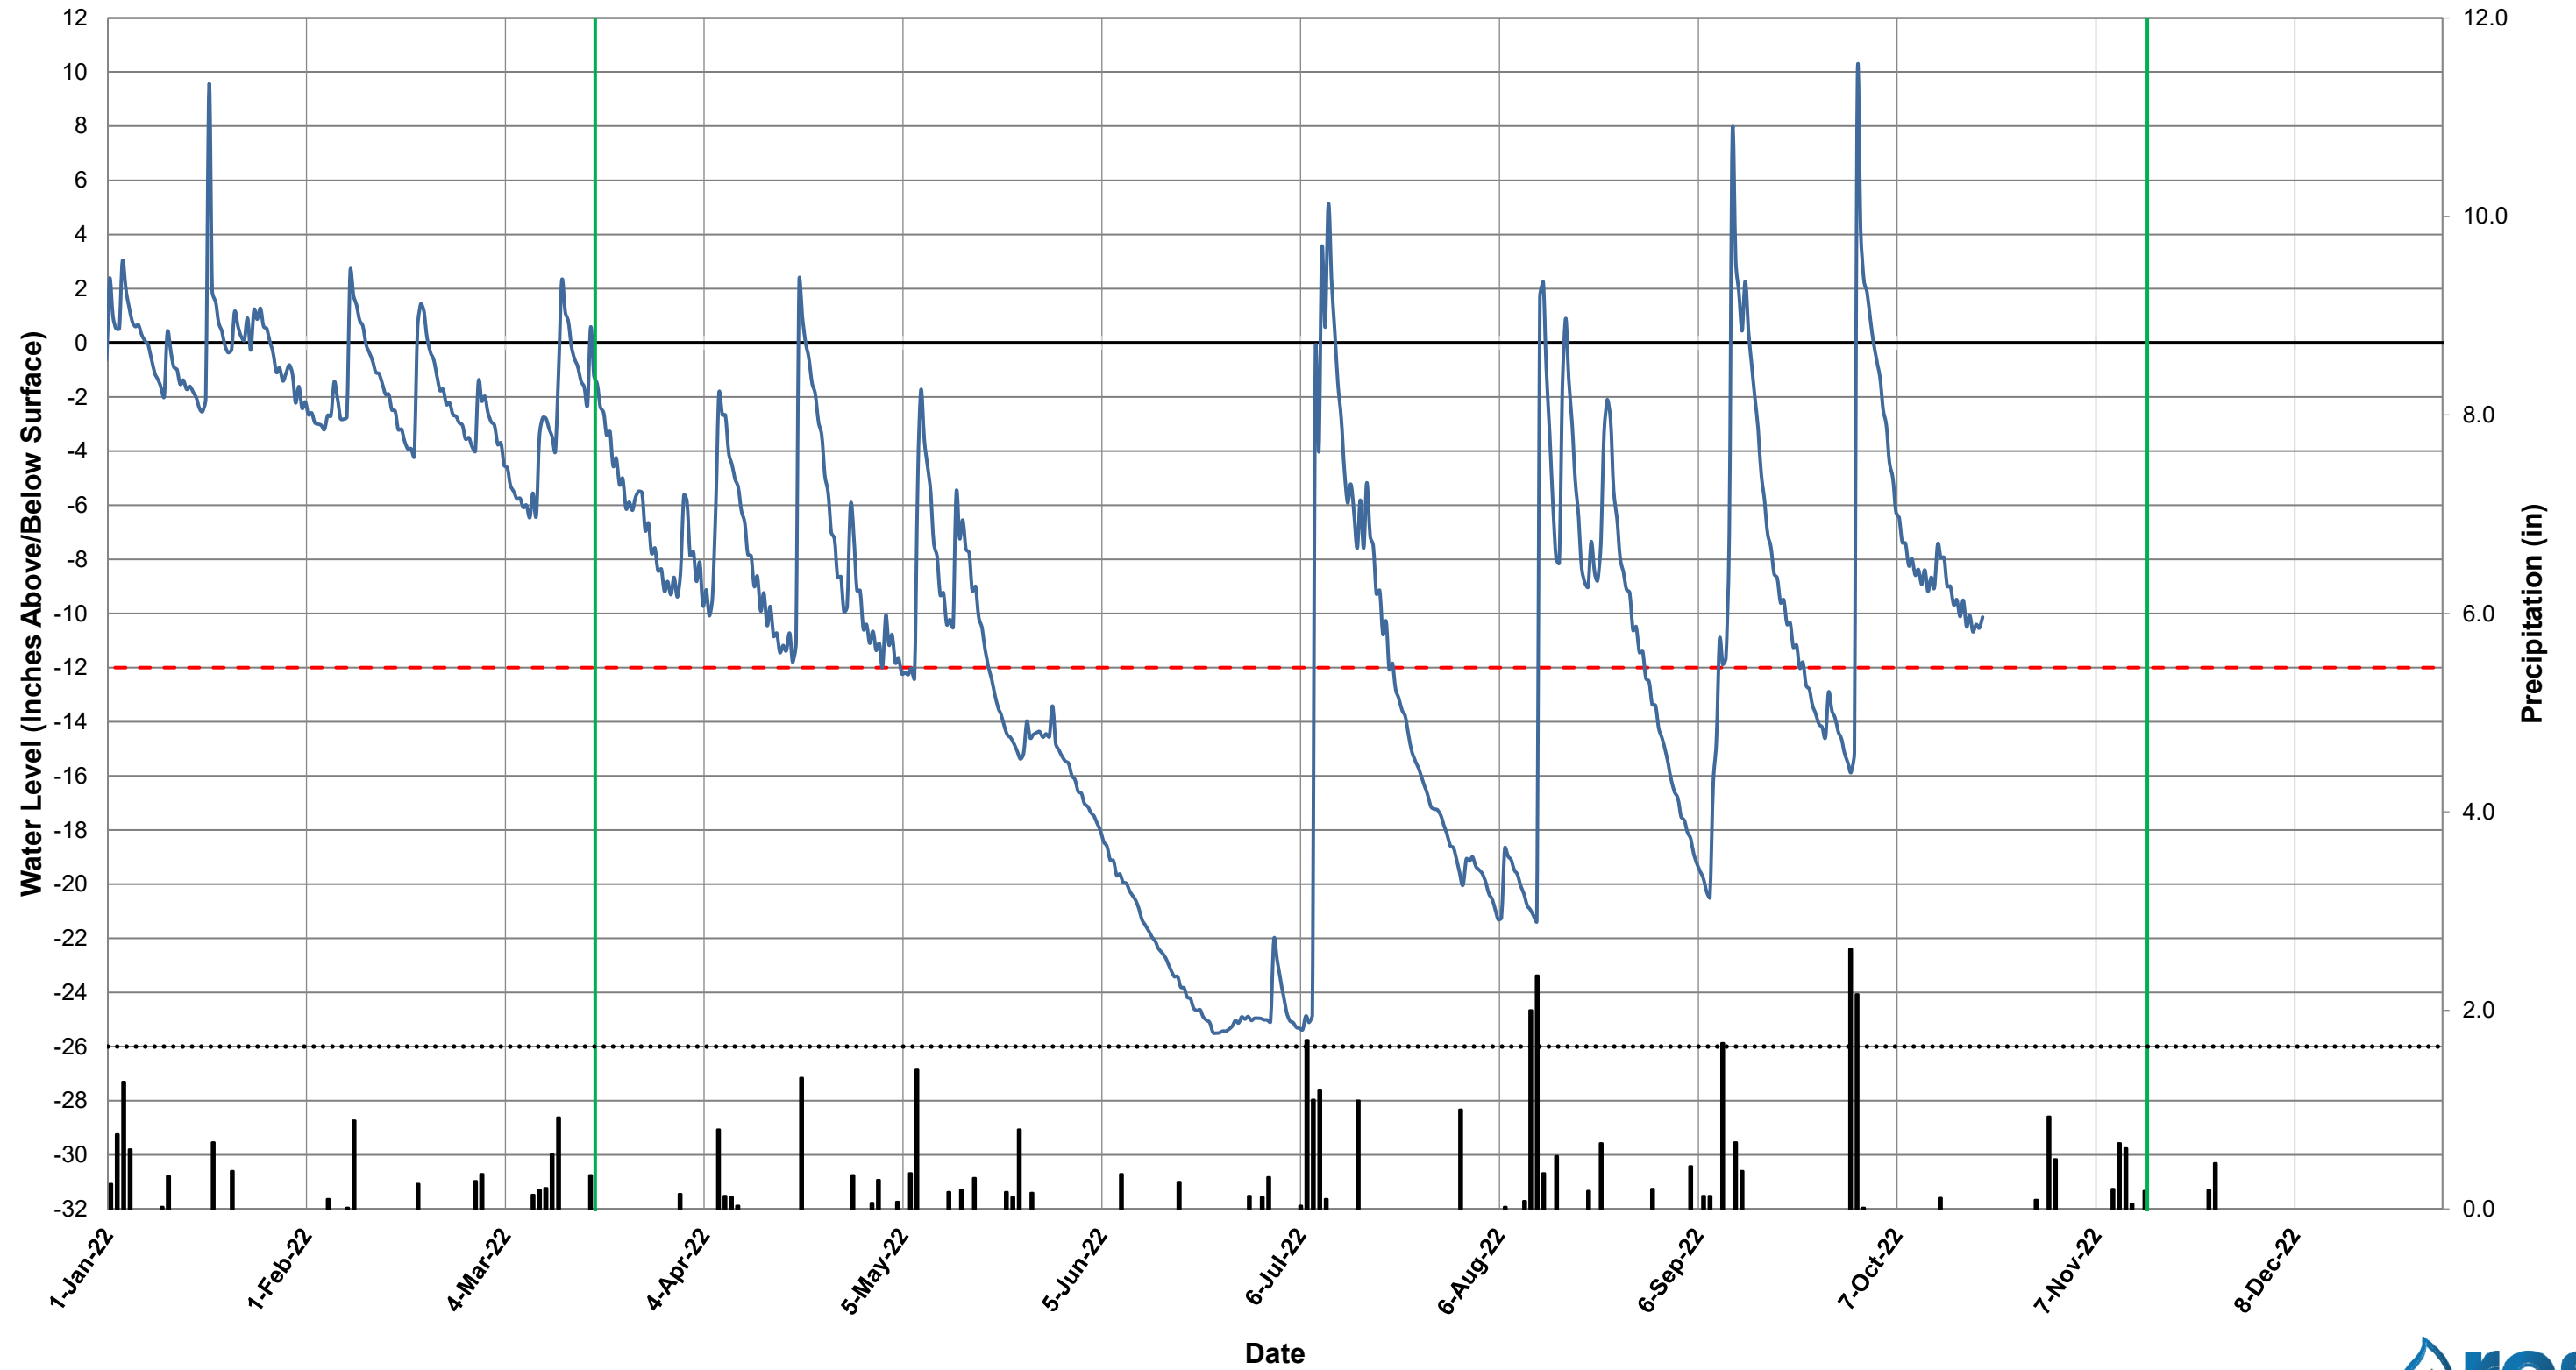
2022 Matthew GW1

47 Consecutive Days of Hydrology
03/18/2022 - 05/03/2022

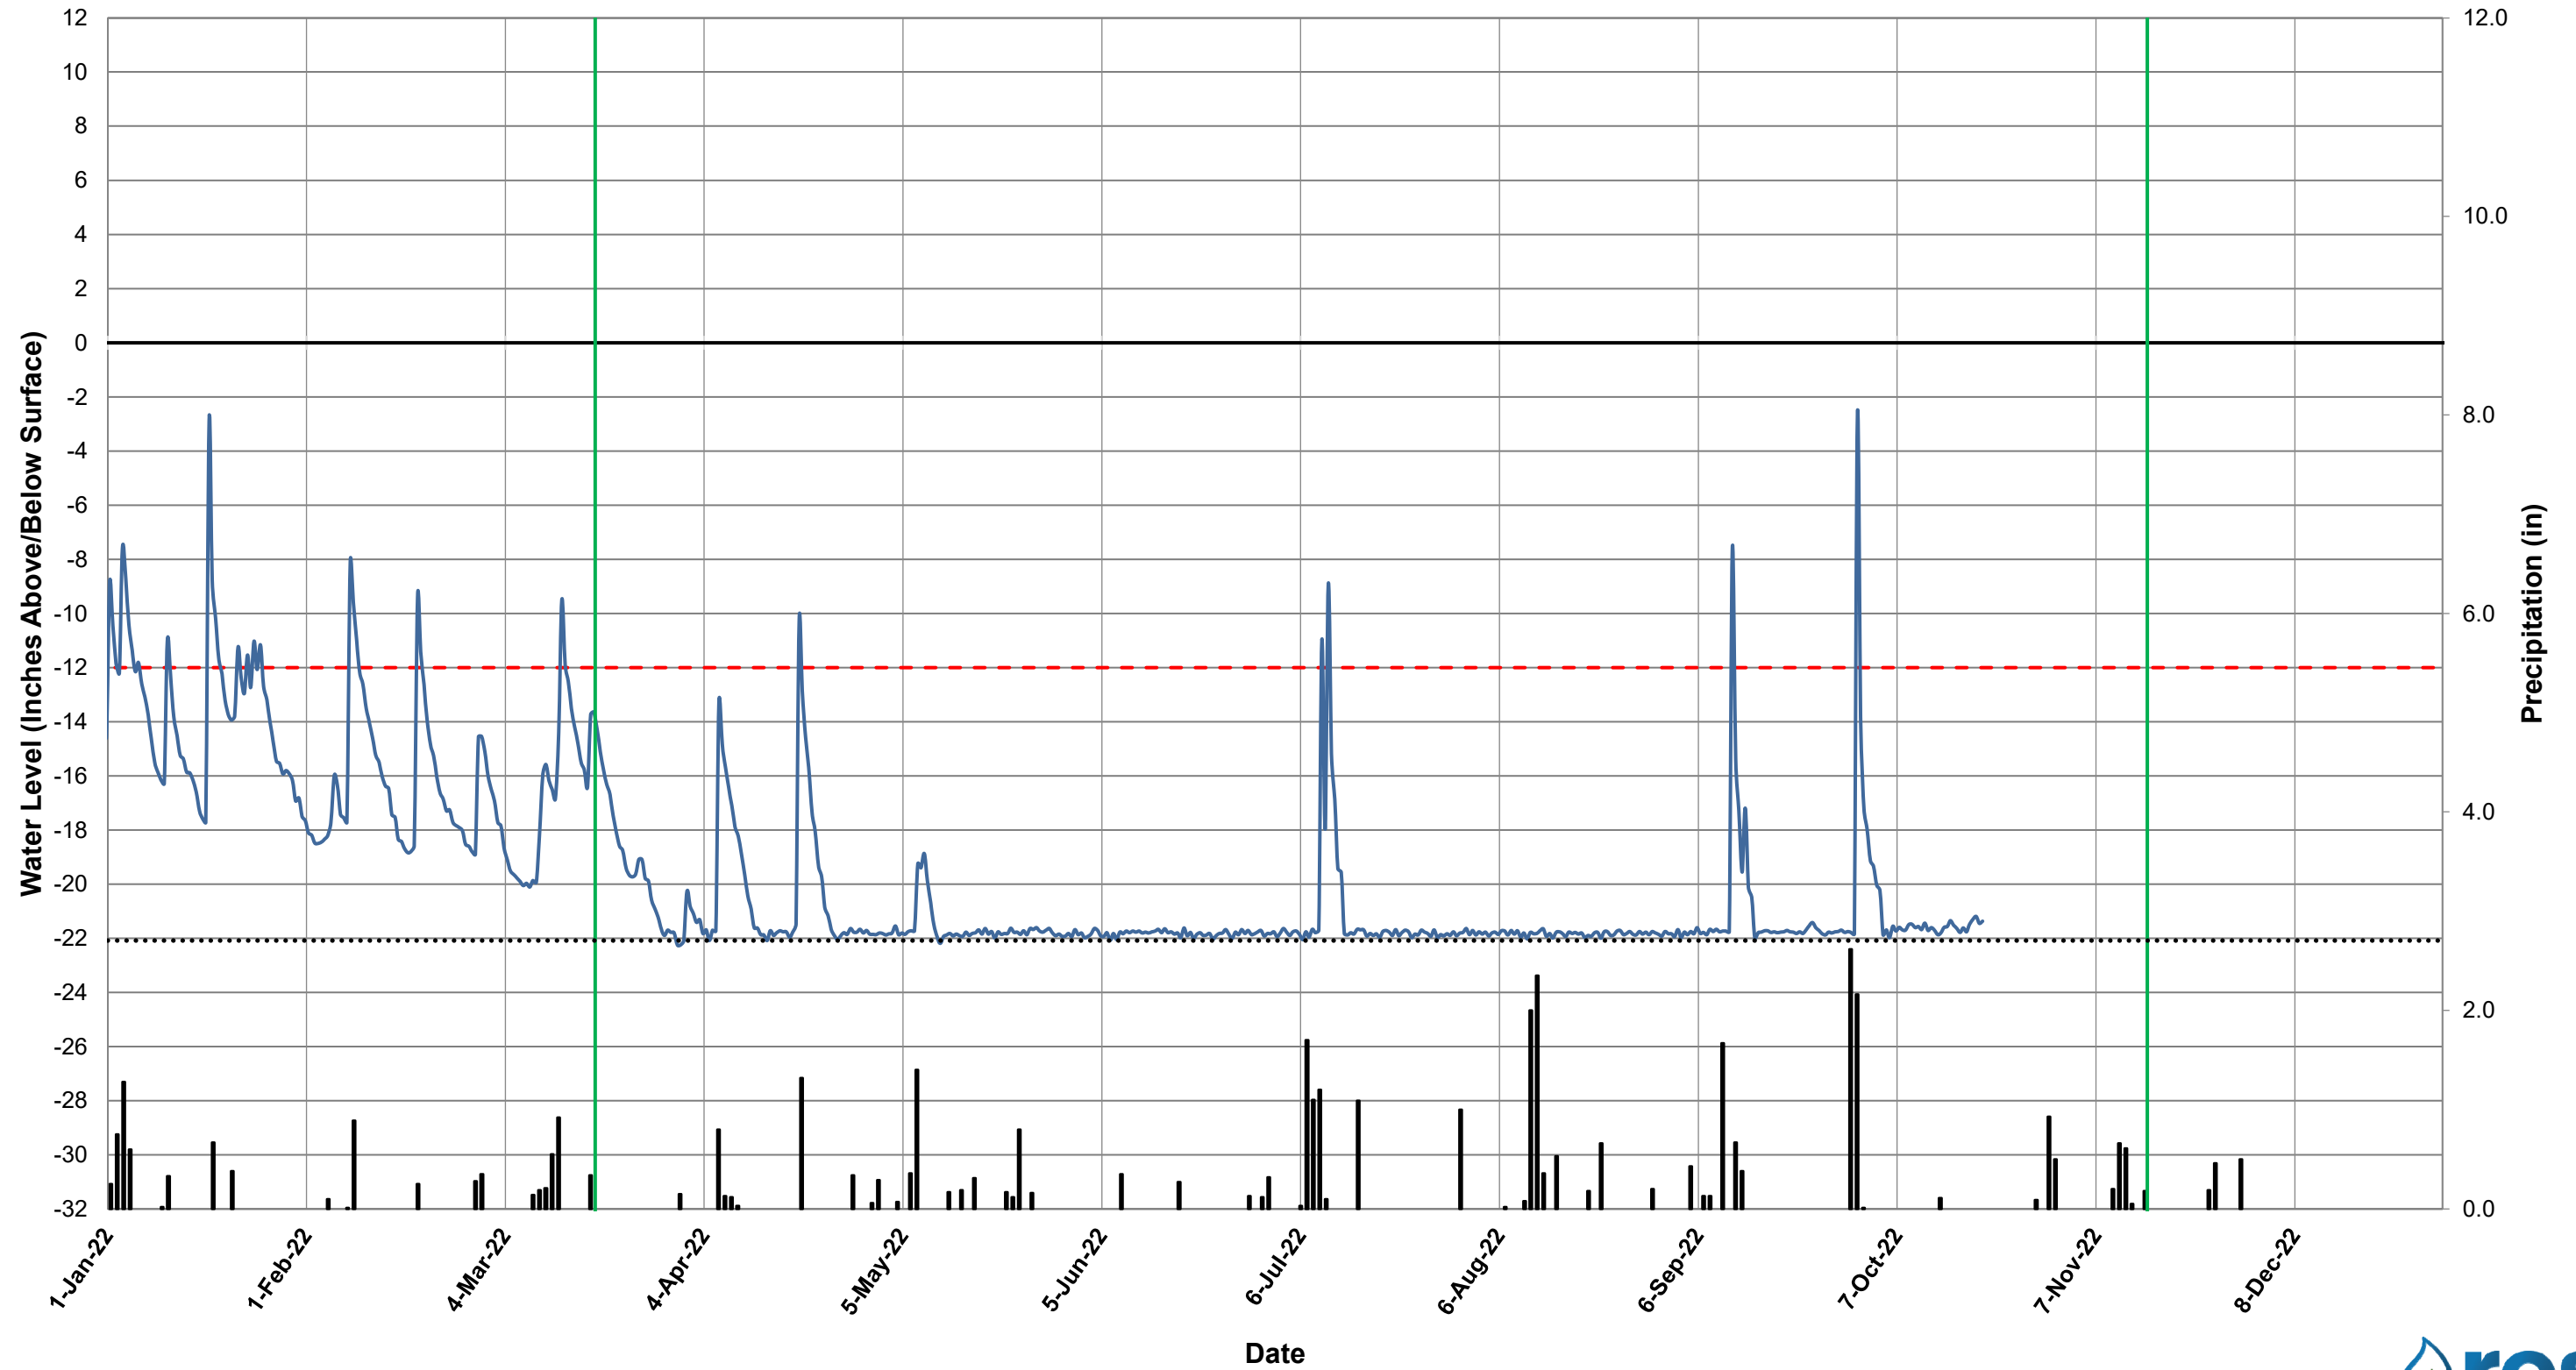
2022 Matthew GW2

0 Consecutive Days of Hydrology

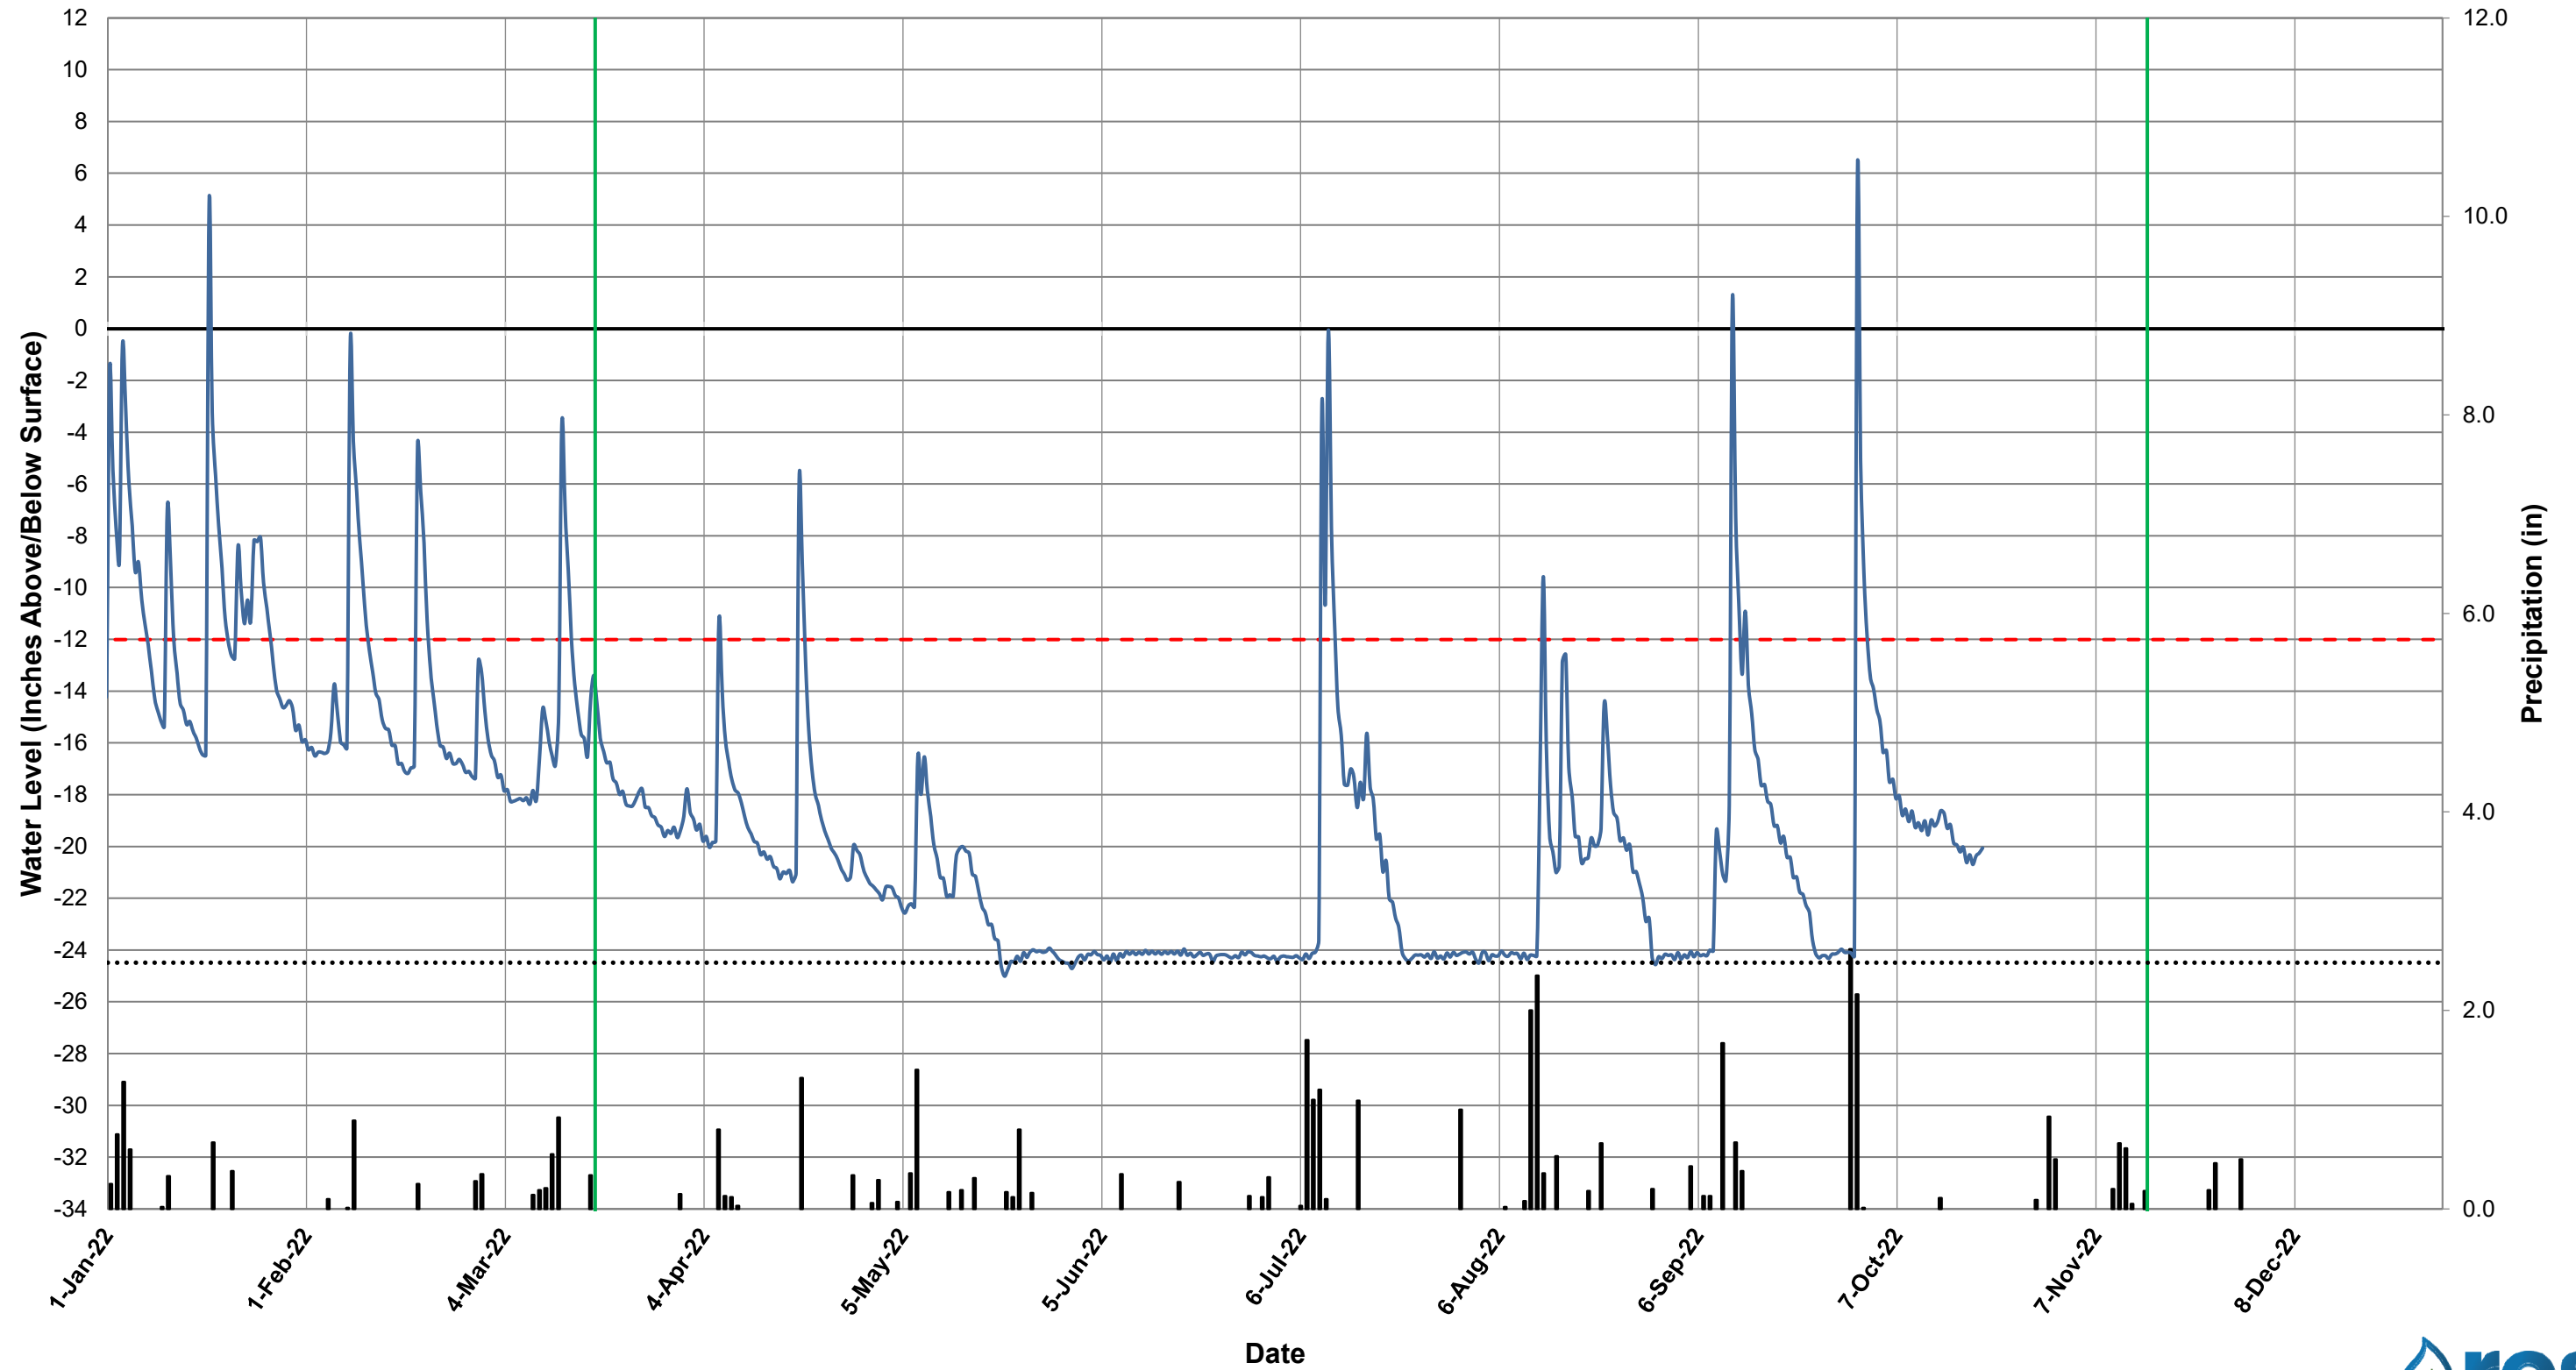
2022 Matthew GW3

2 Consecutive Days of Hydrology
07/09/2022 - 07/10/2022

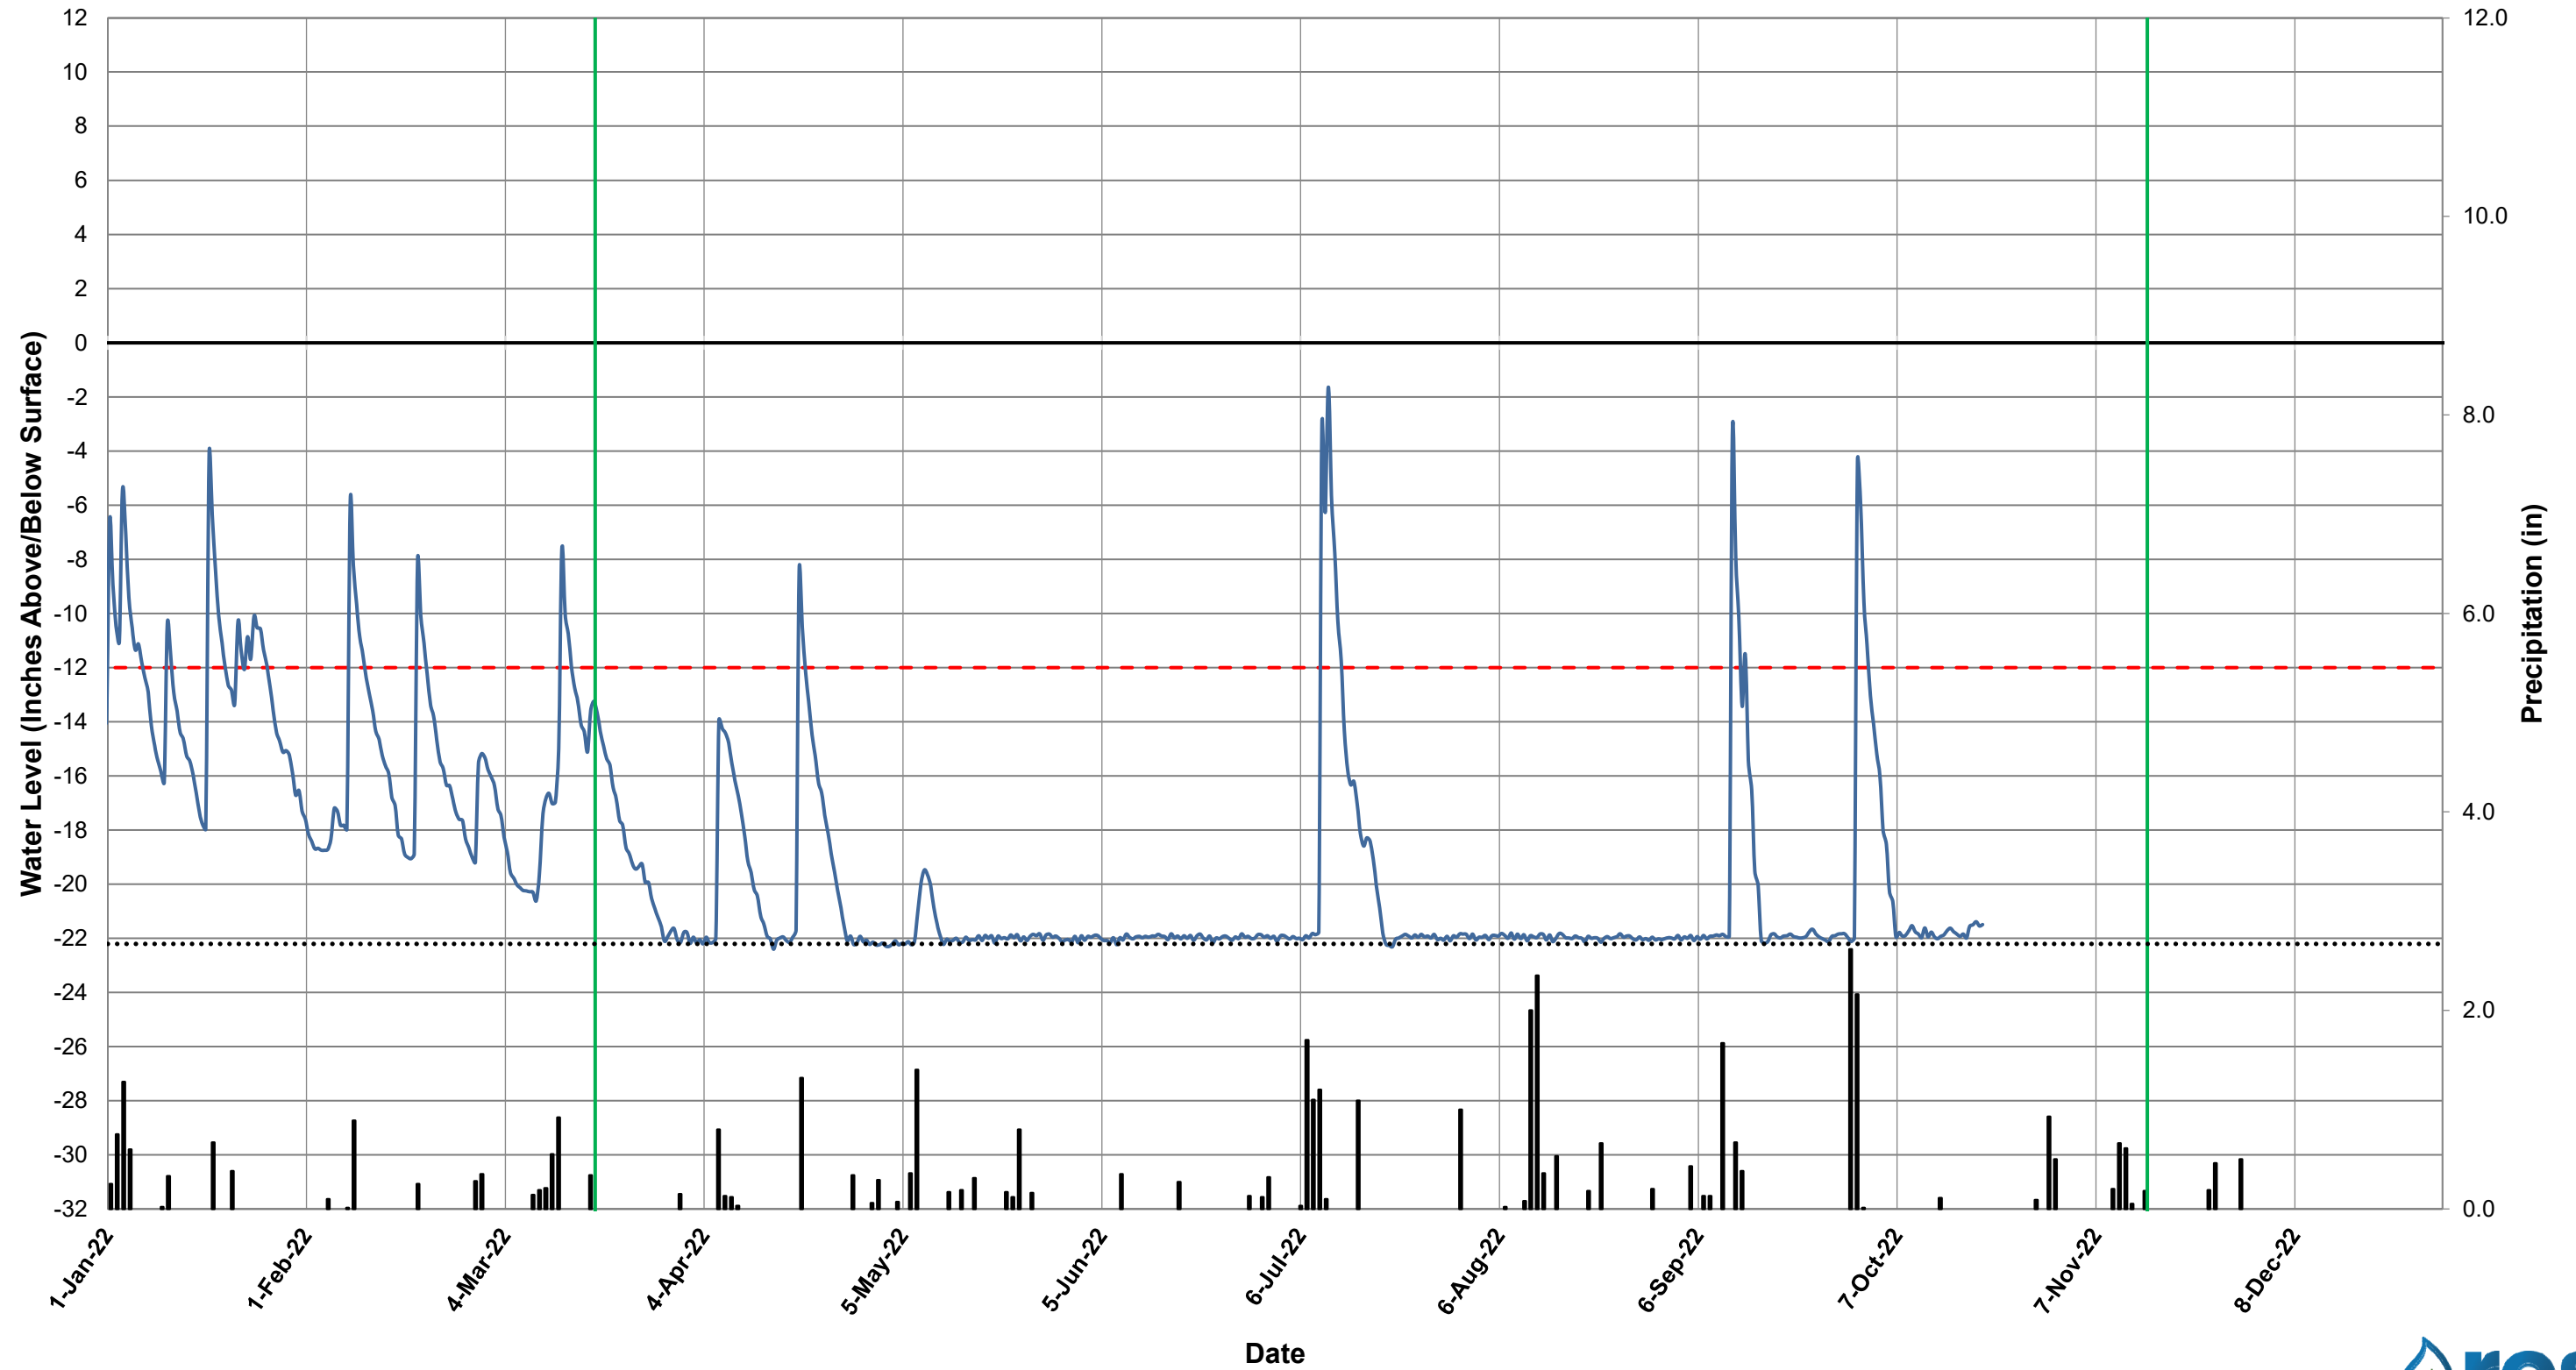
2022 Matthew GW4

3 Consecutive Days of Hydrology
07/09/2022 - 07/11/2022

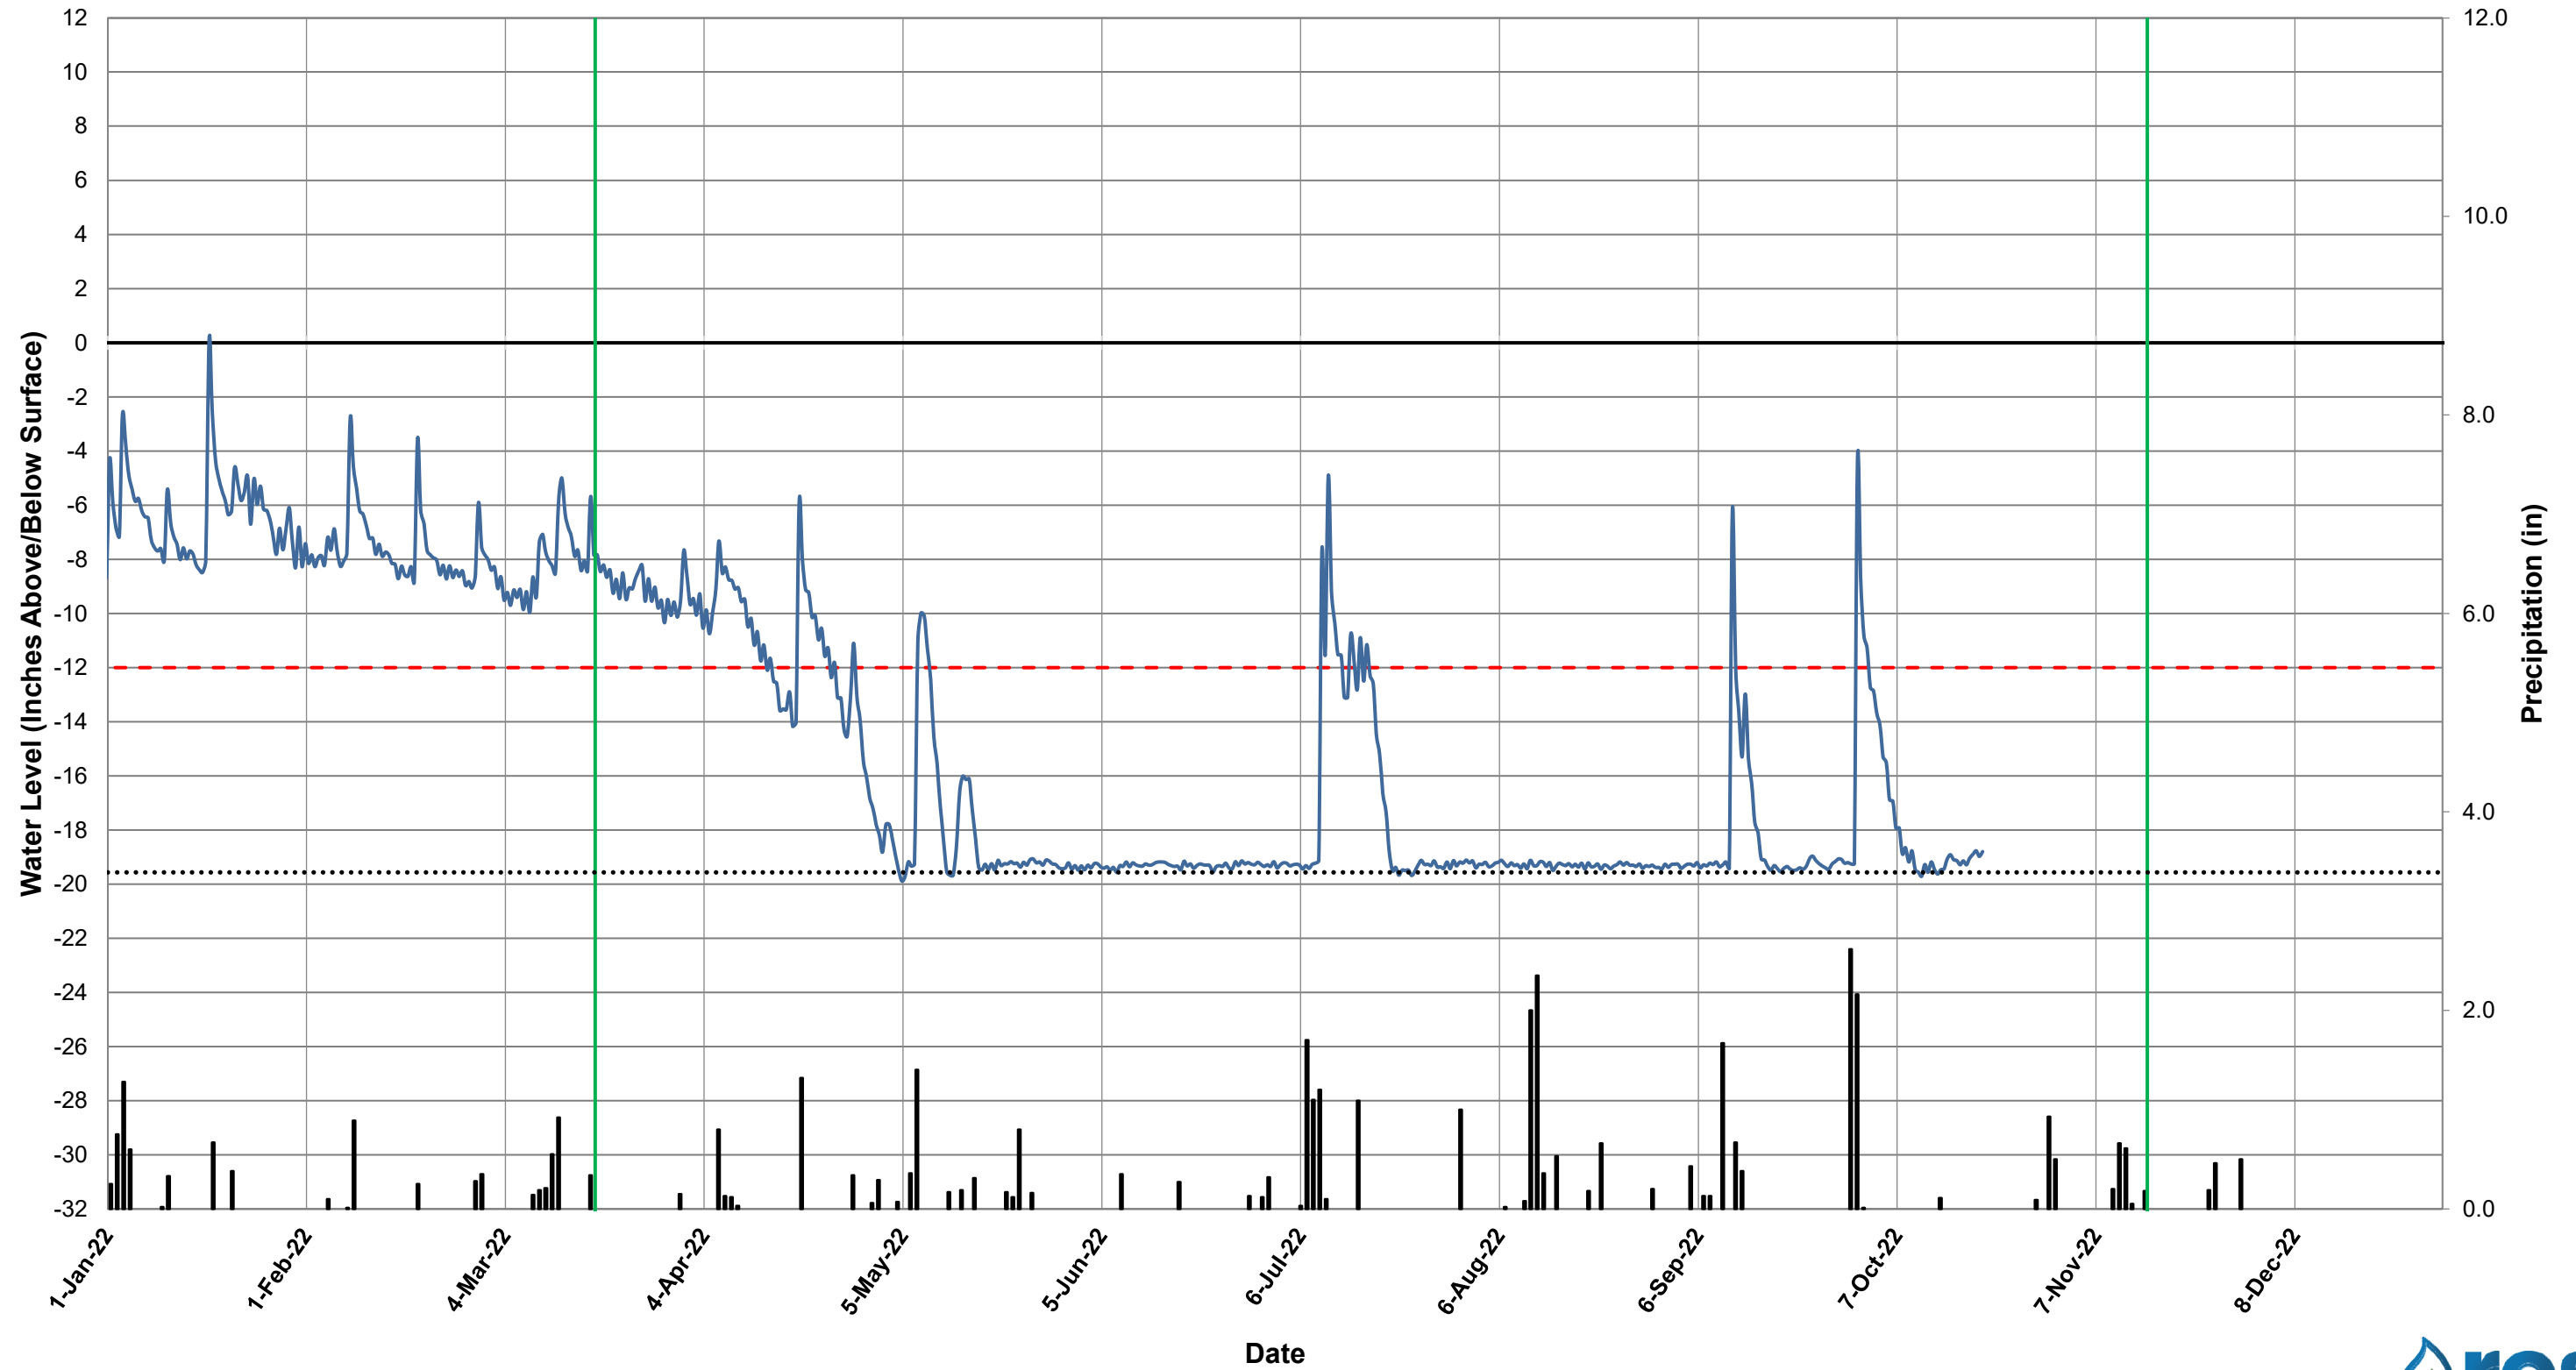
2022 Matthew GW5

27 Consecutive Days of Hydrology
03/18/2022 - 04/13/2022
