Year 2 Monitoring Report

MATTHEW SITE

NCDMS Project #100043 (Contract #7419)
USACE Action ID: SAW-2017-00055
DWR Project #2017-0624

January 2023

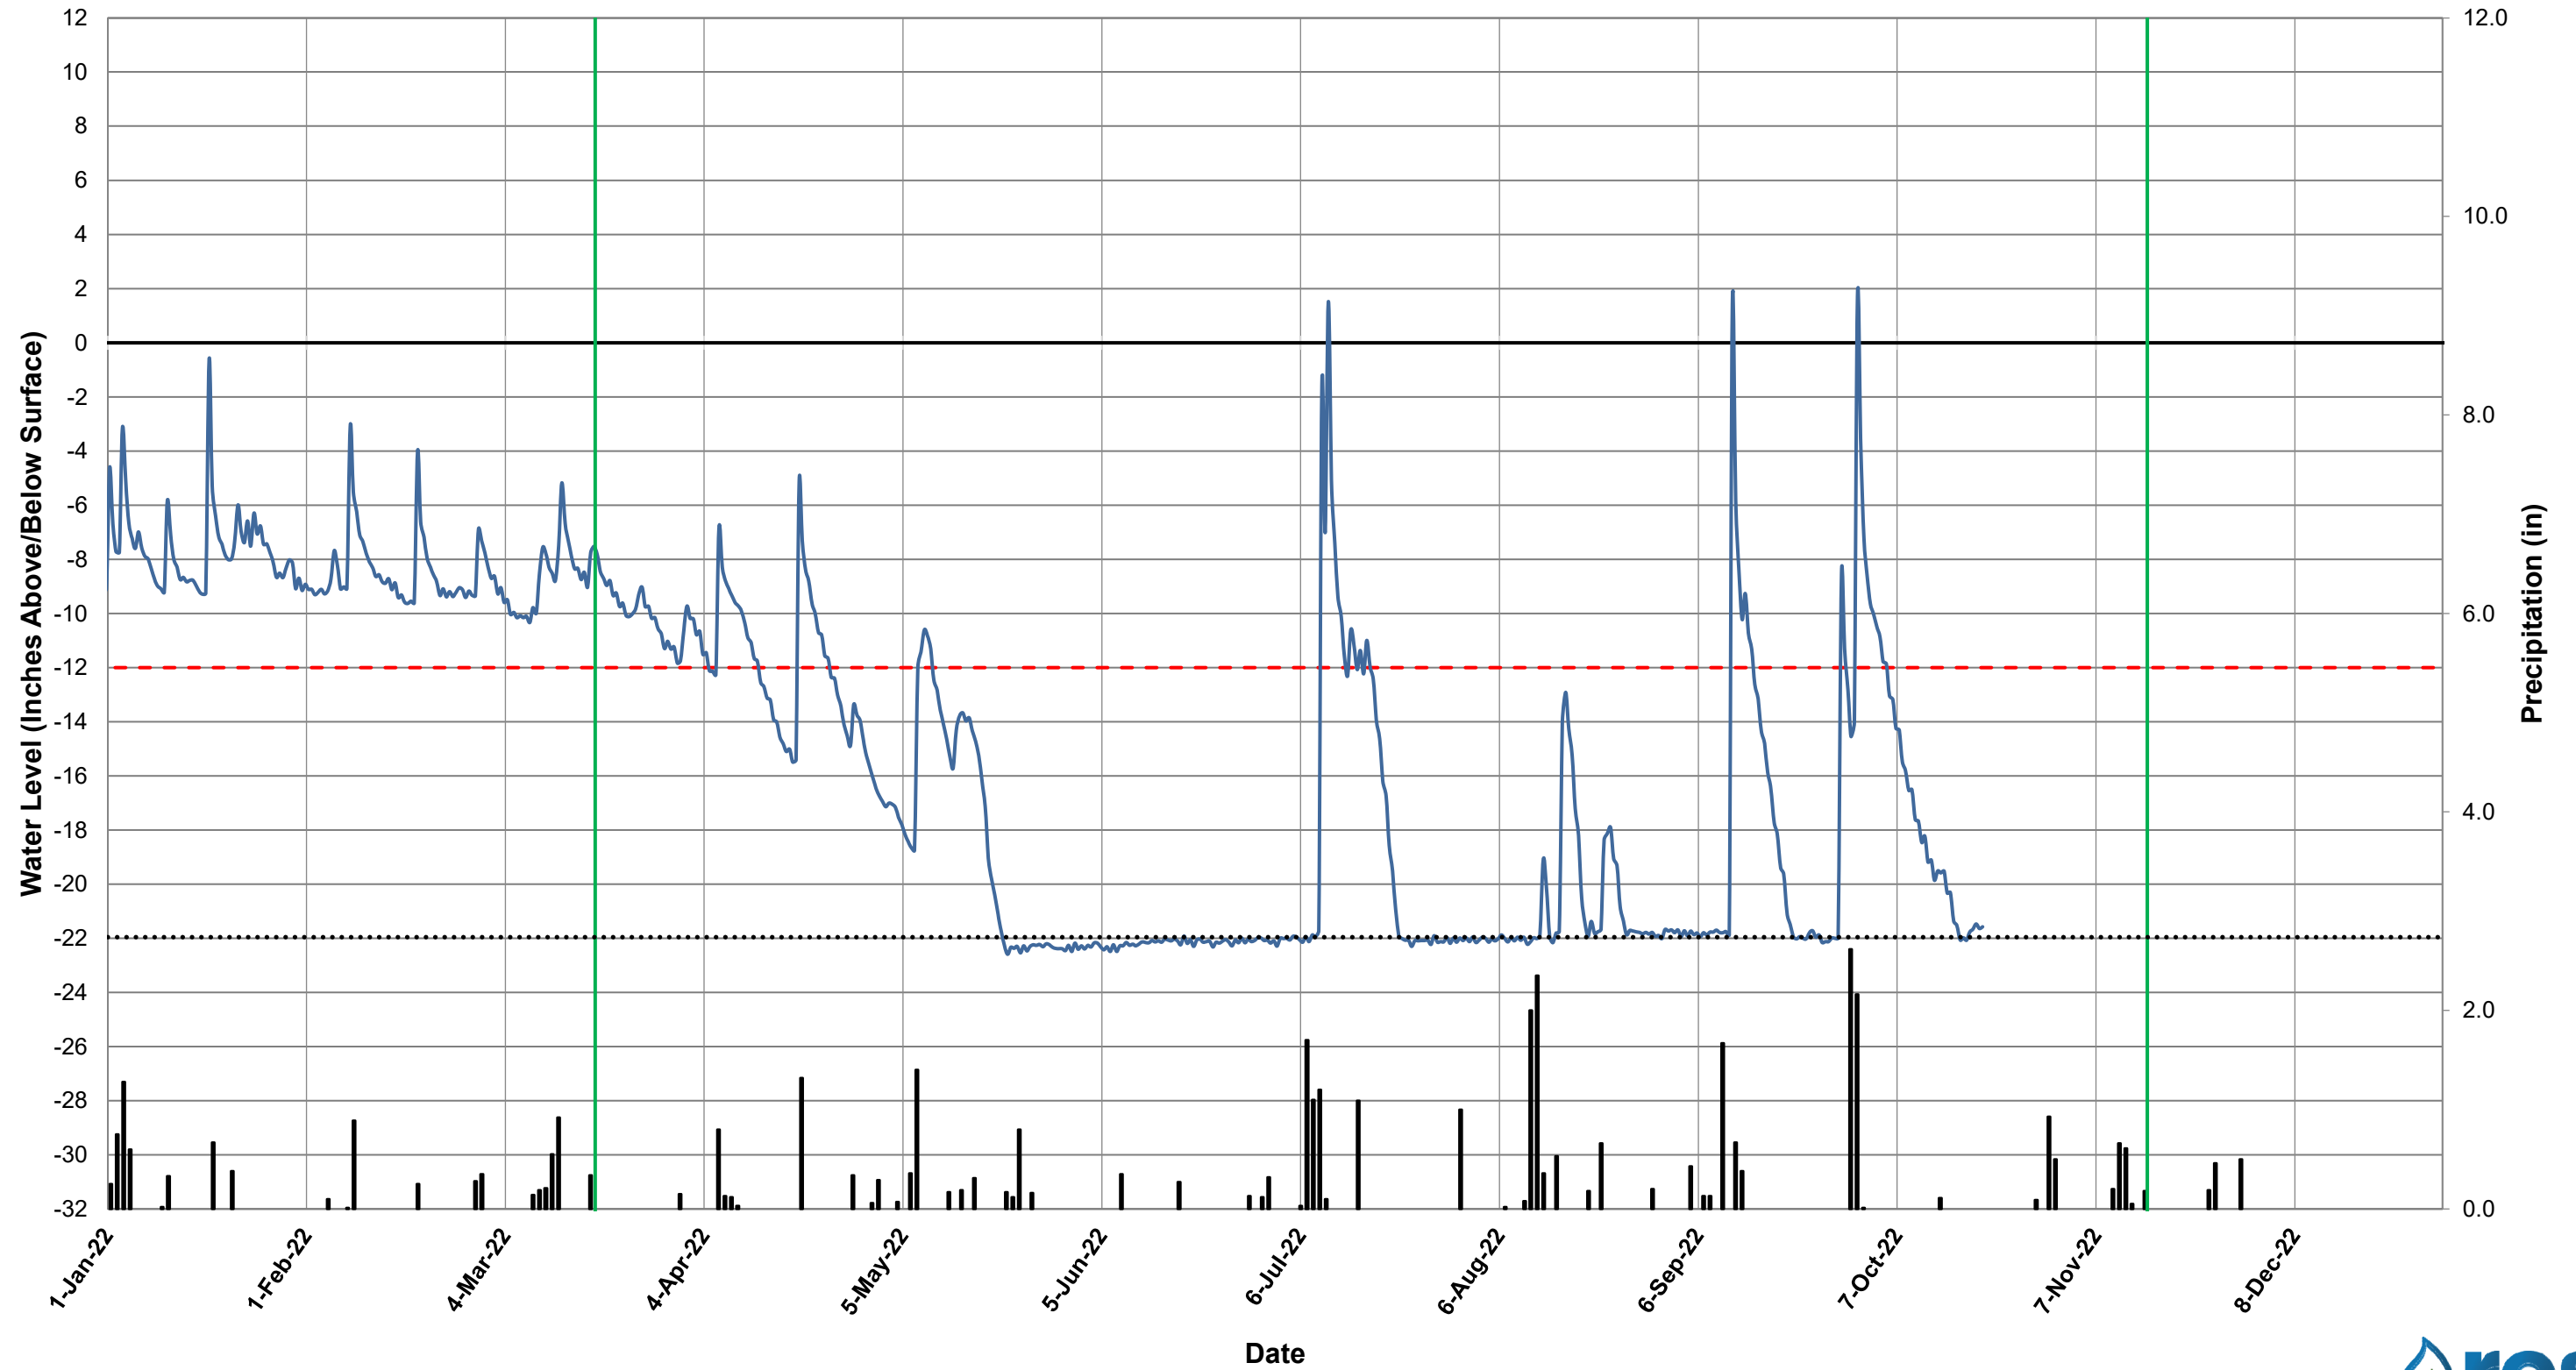
2022 Matthew GW6

17 Consecutive Days of Hydrology
03/18/2022 - 04/03/2022

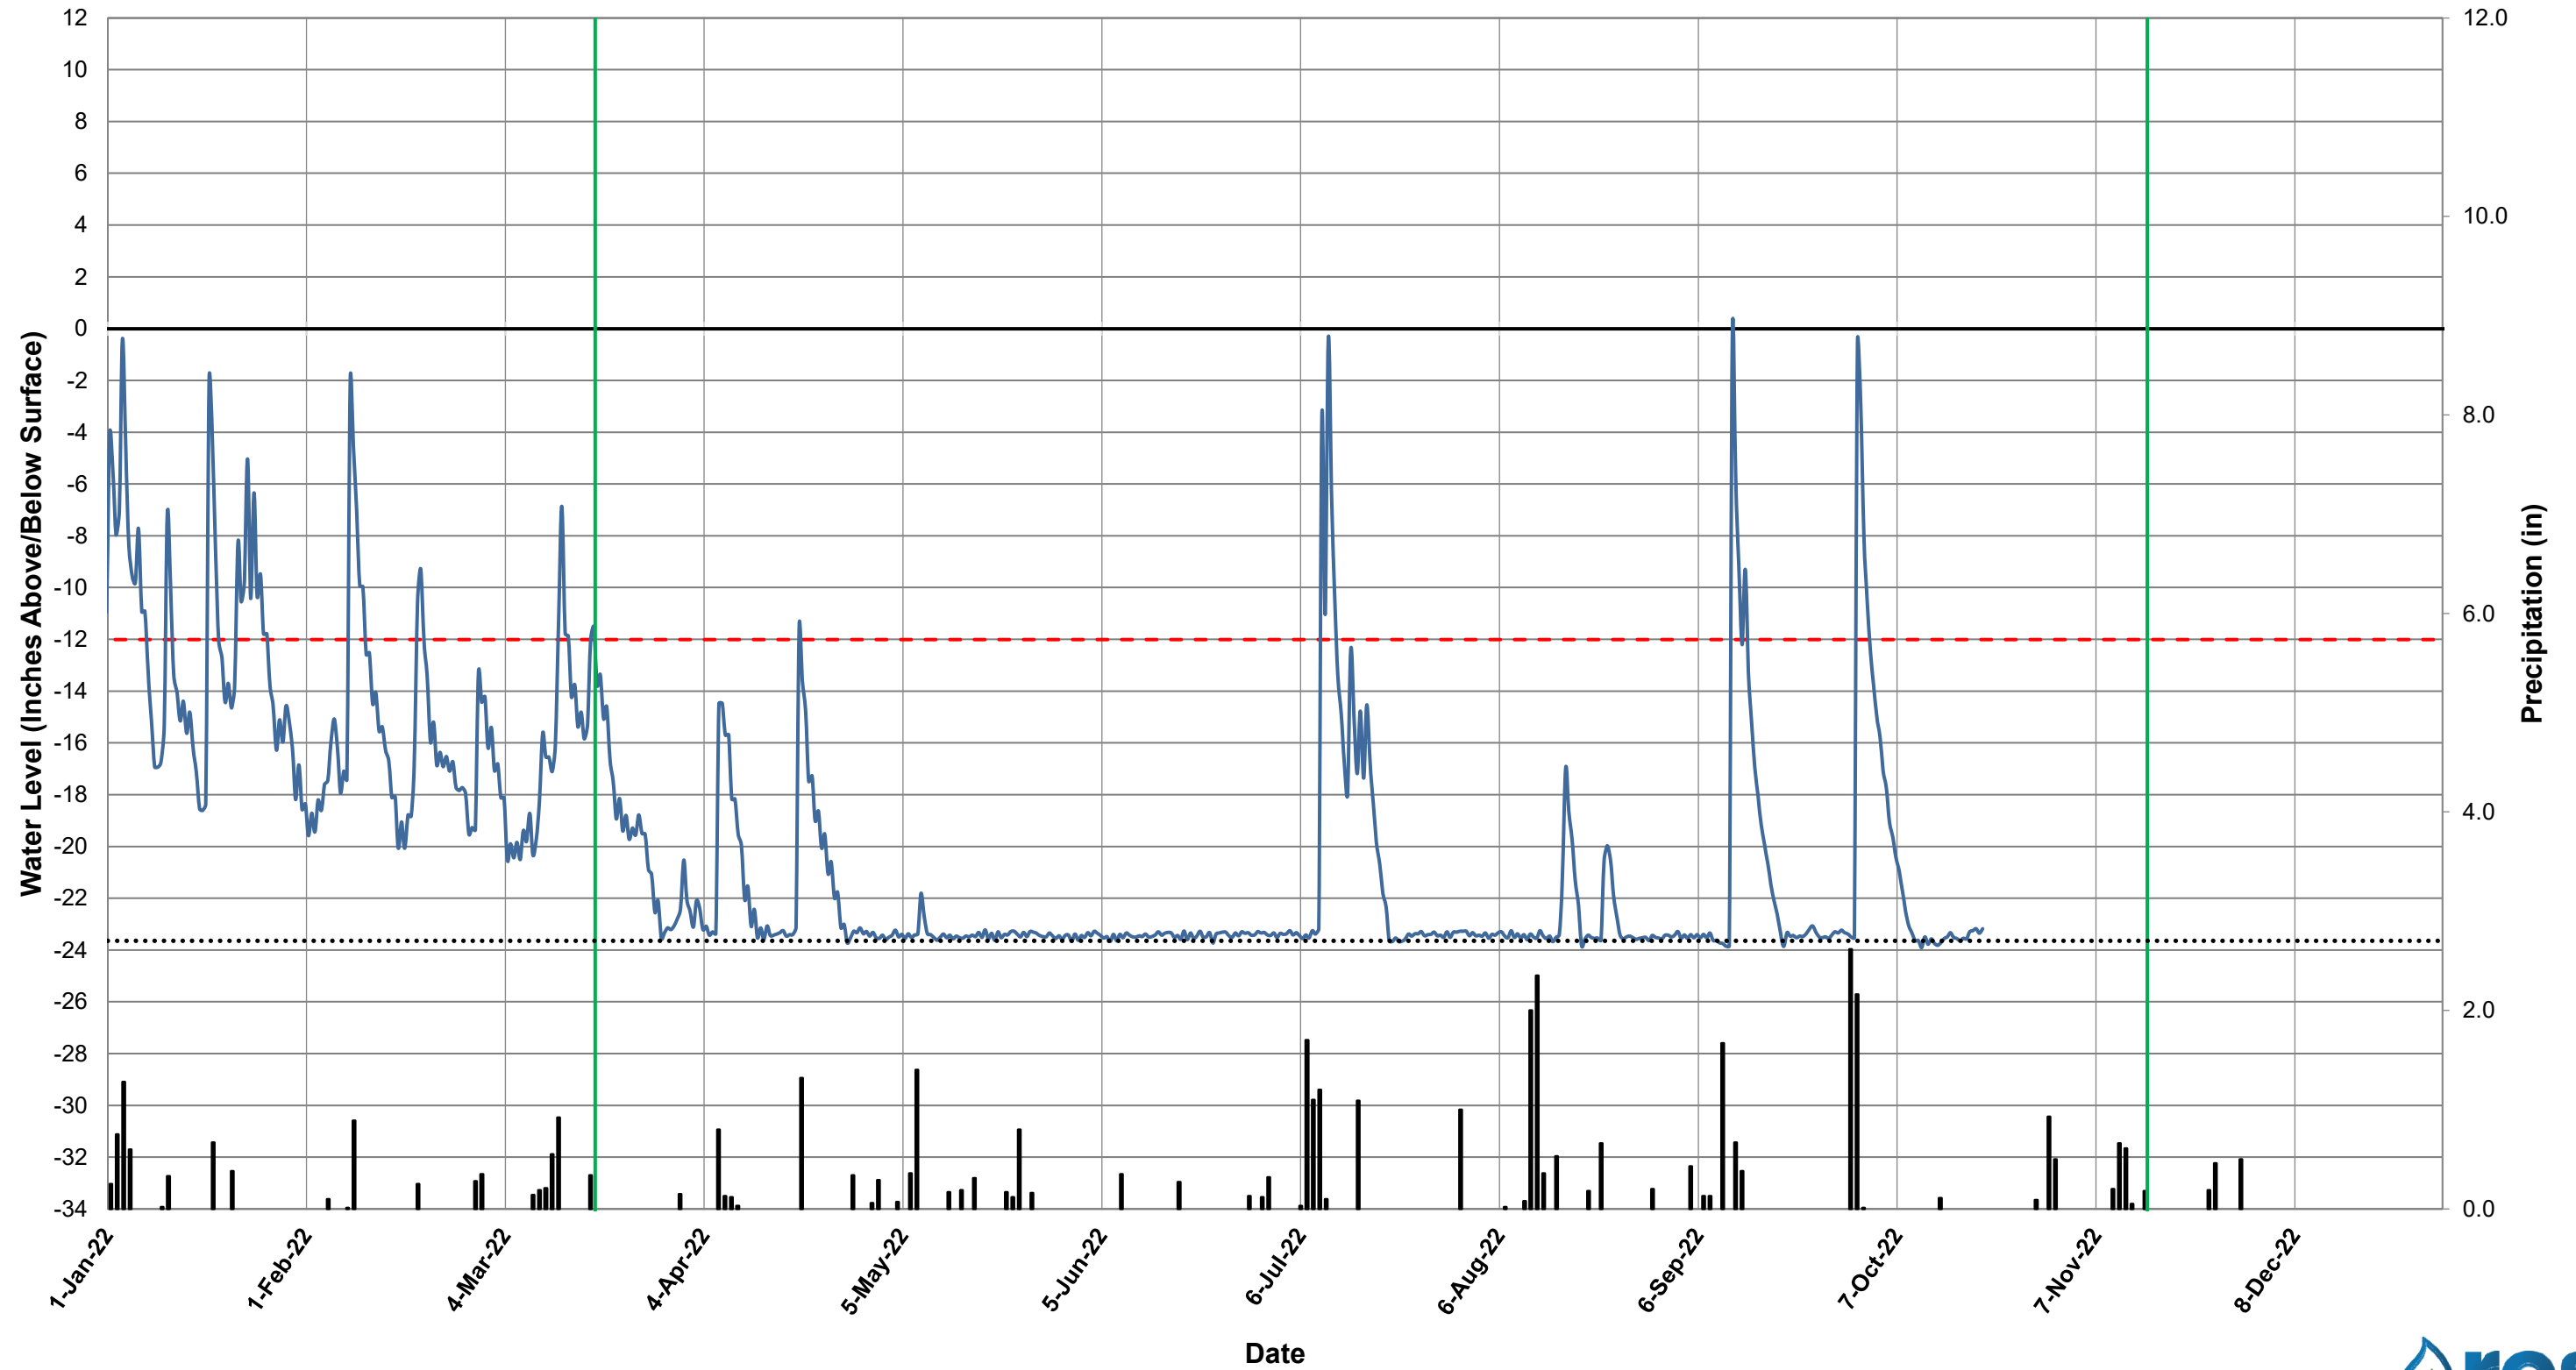
2022 Matthew GW7

2 Consecutive Days of Hydrology
07/09/2022 - 07/10/2022

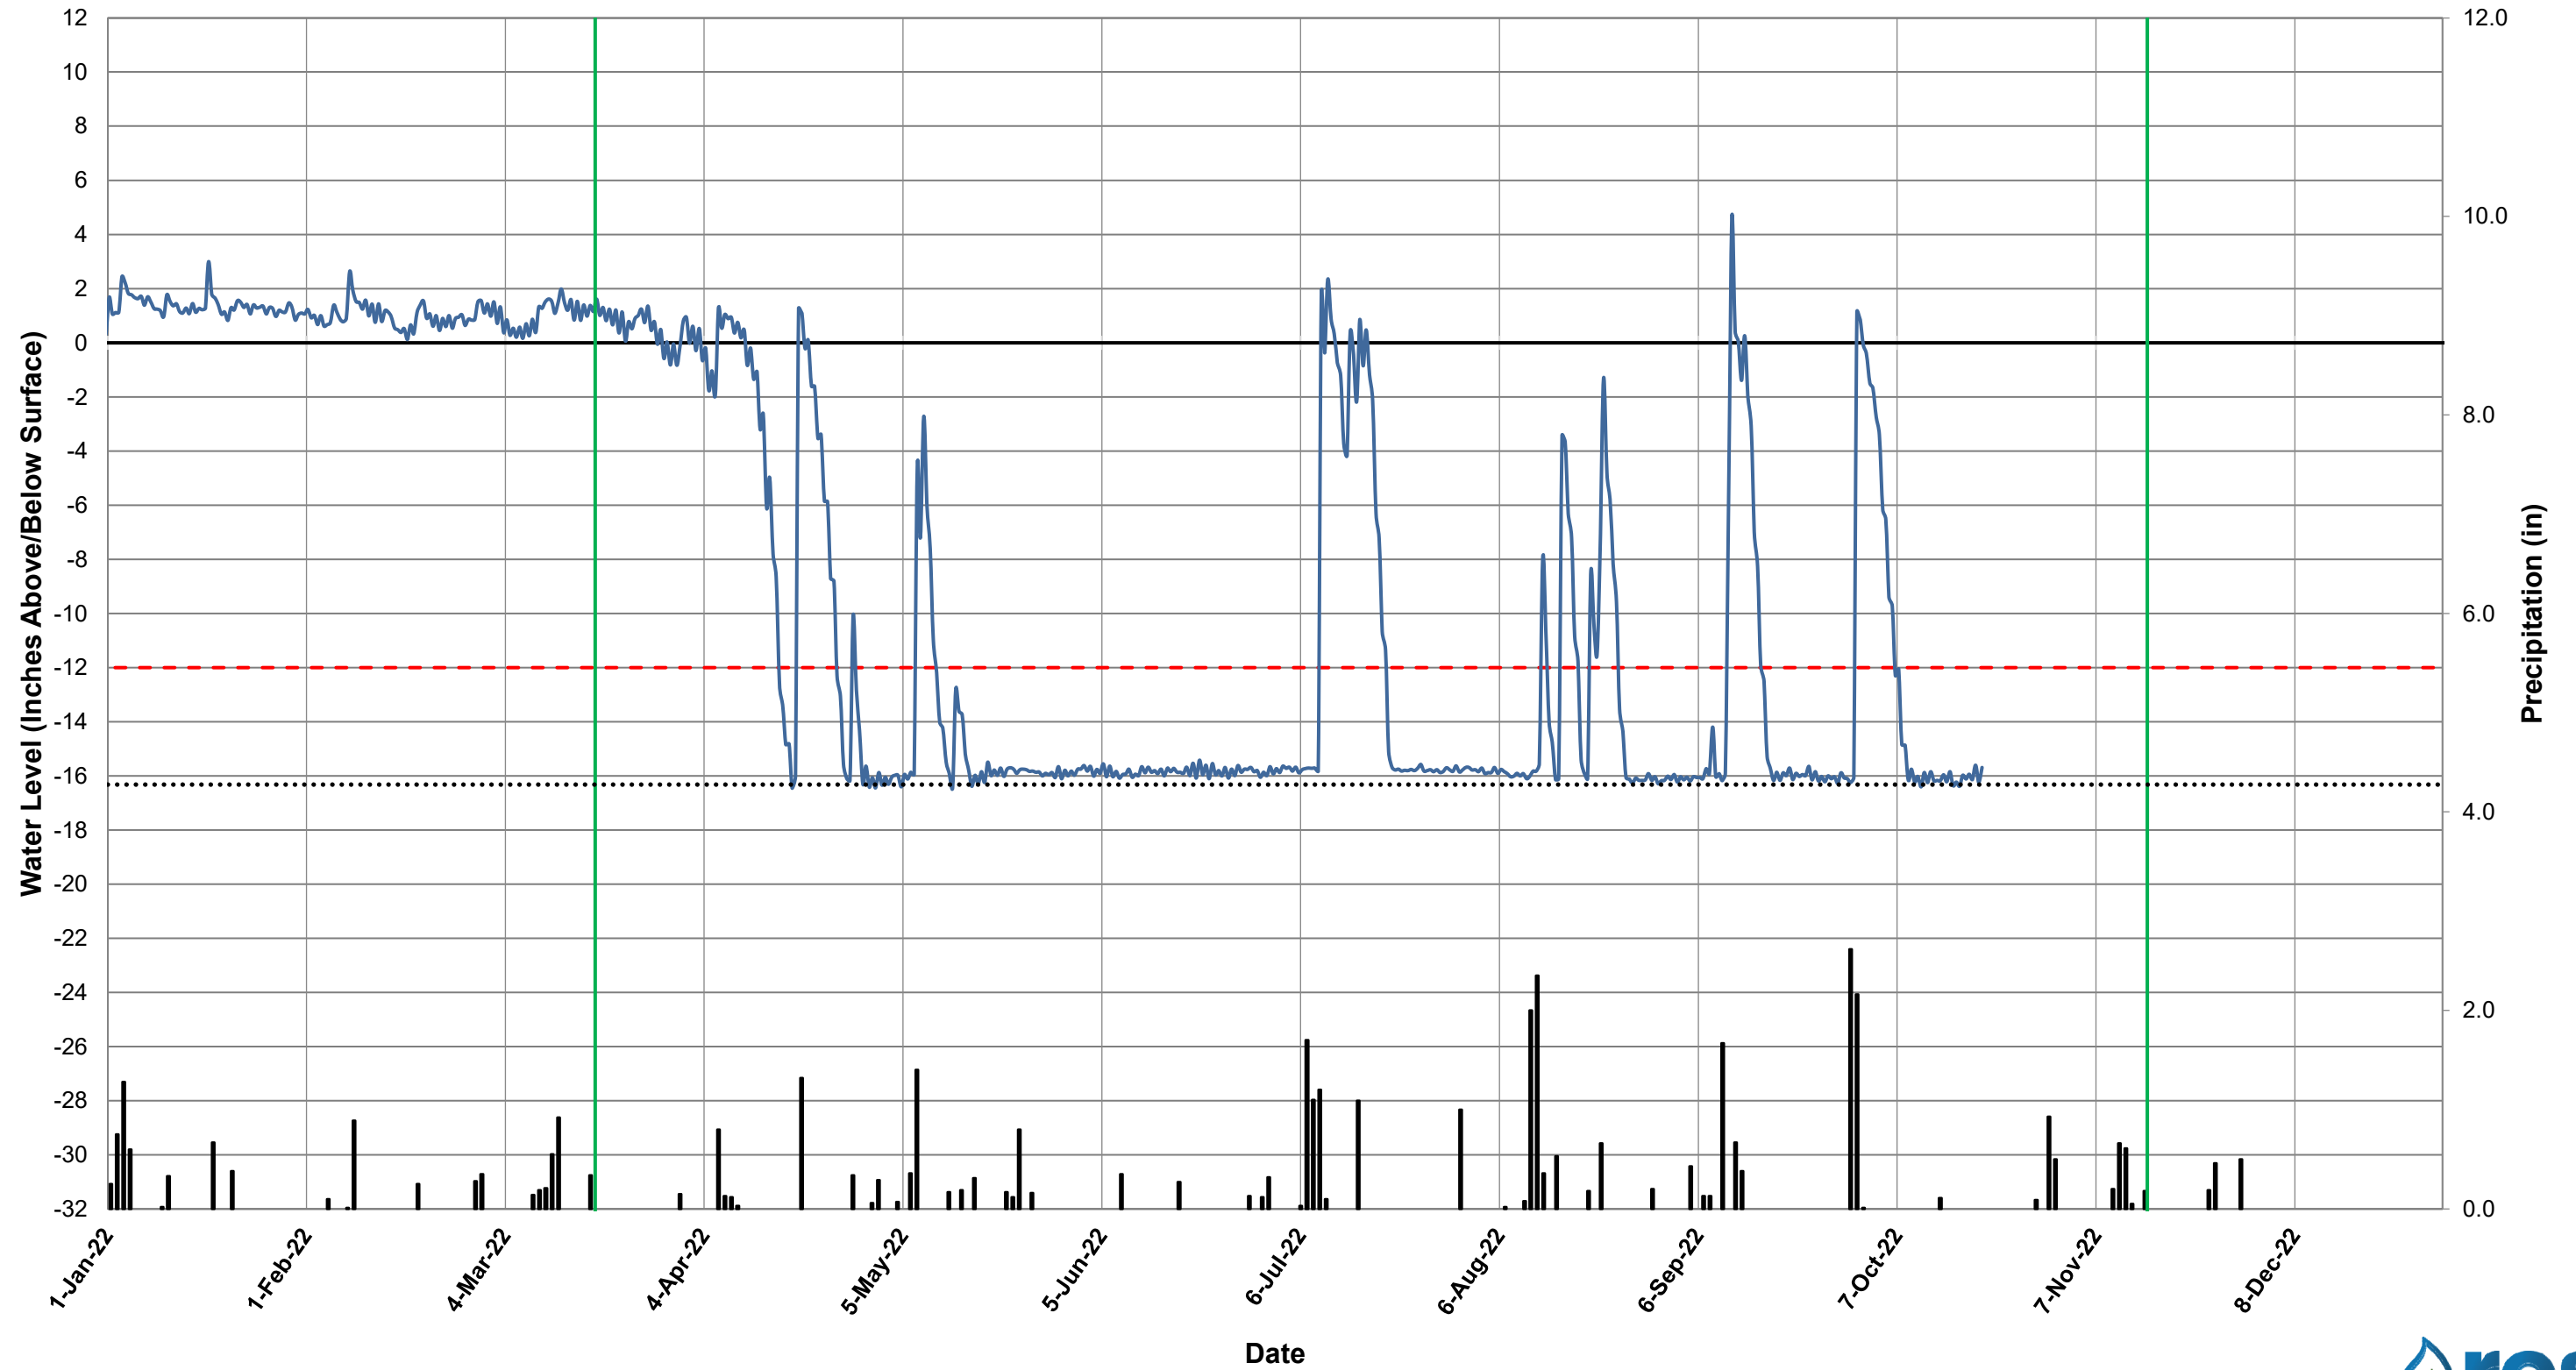
2022 Matthew GW8

28 Consecutive Days of Hydrology
03/18/2022 - 04/14/2022

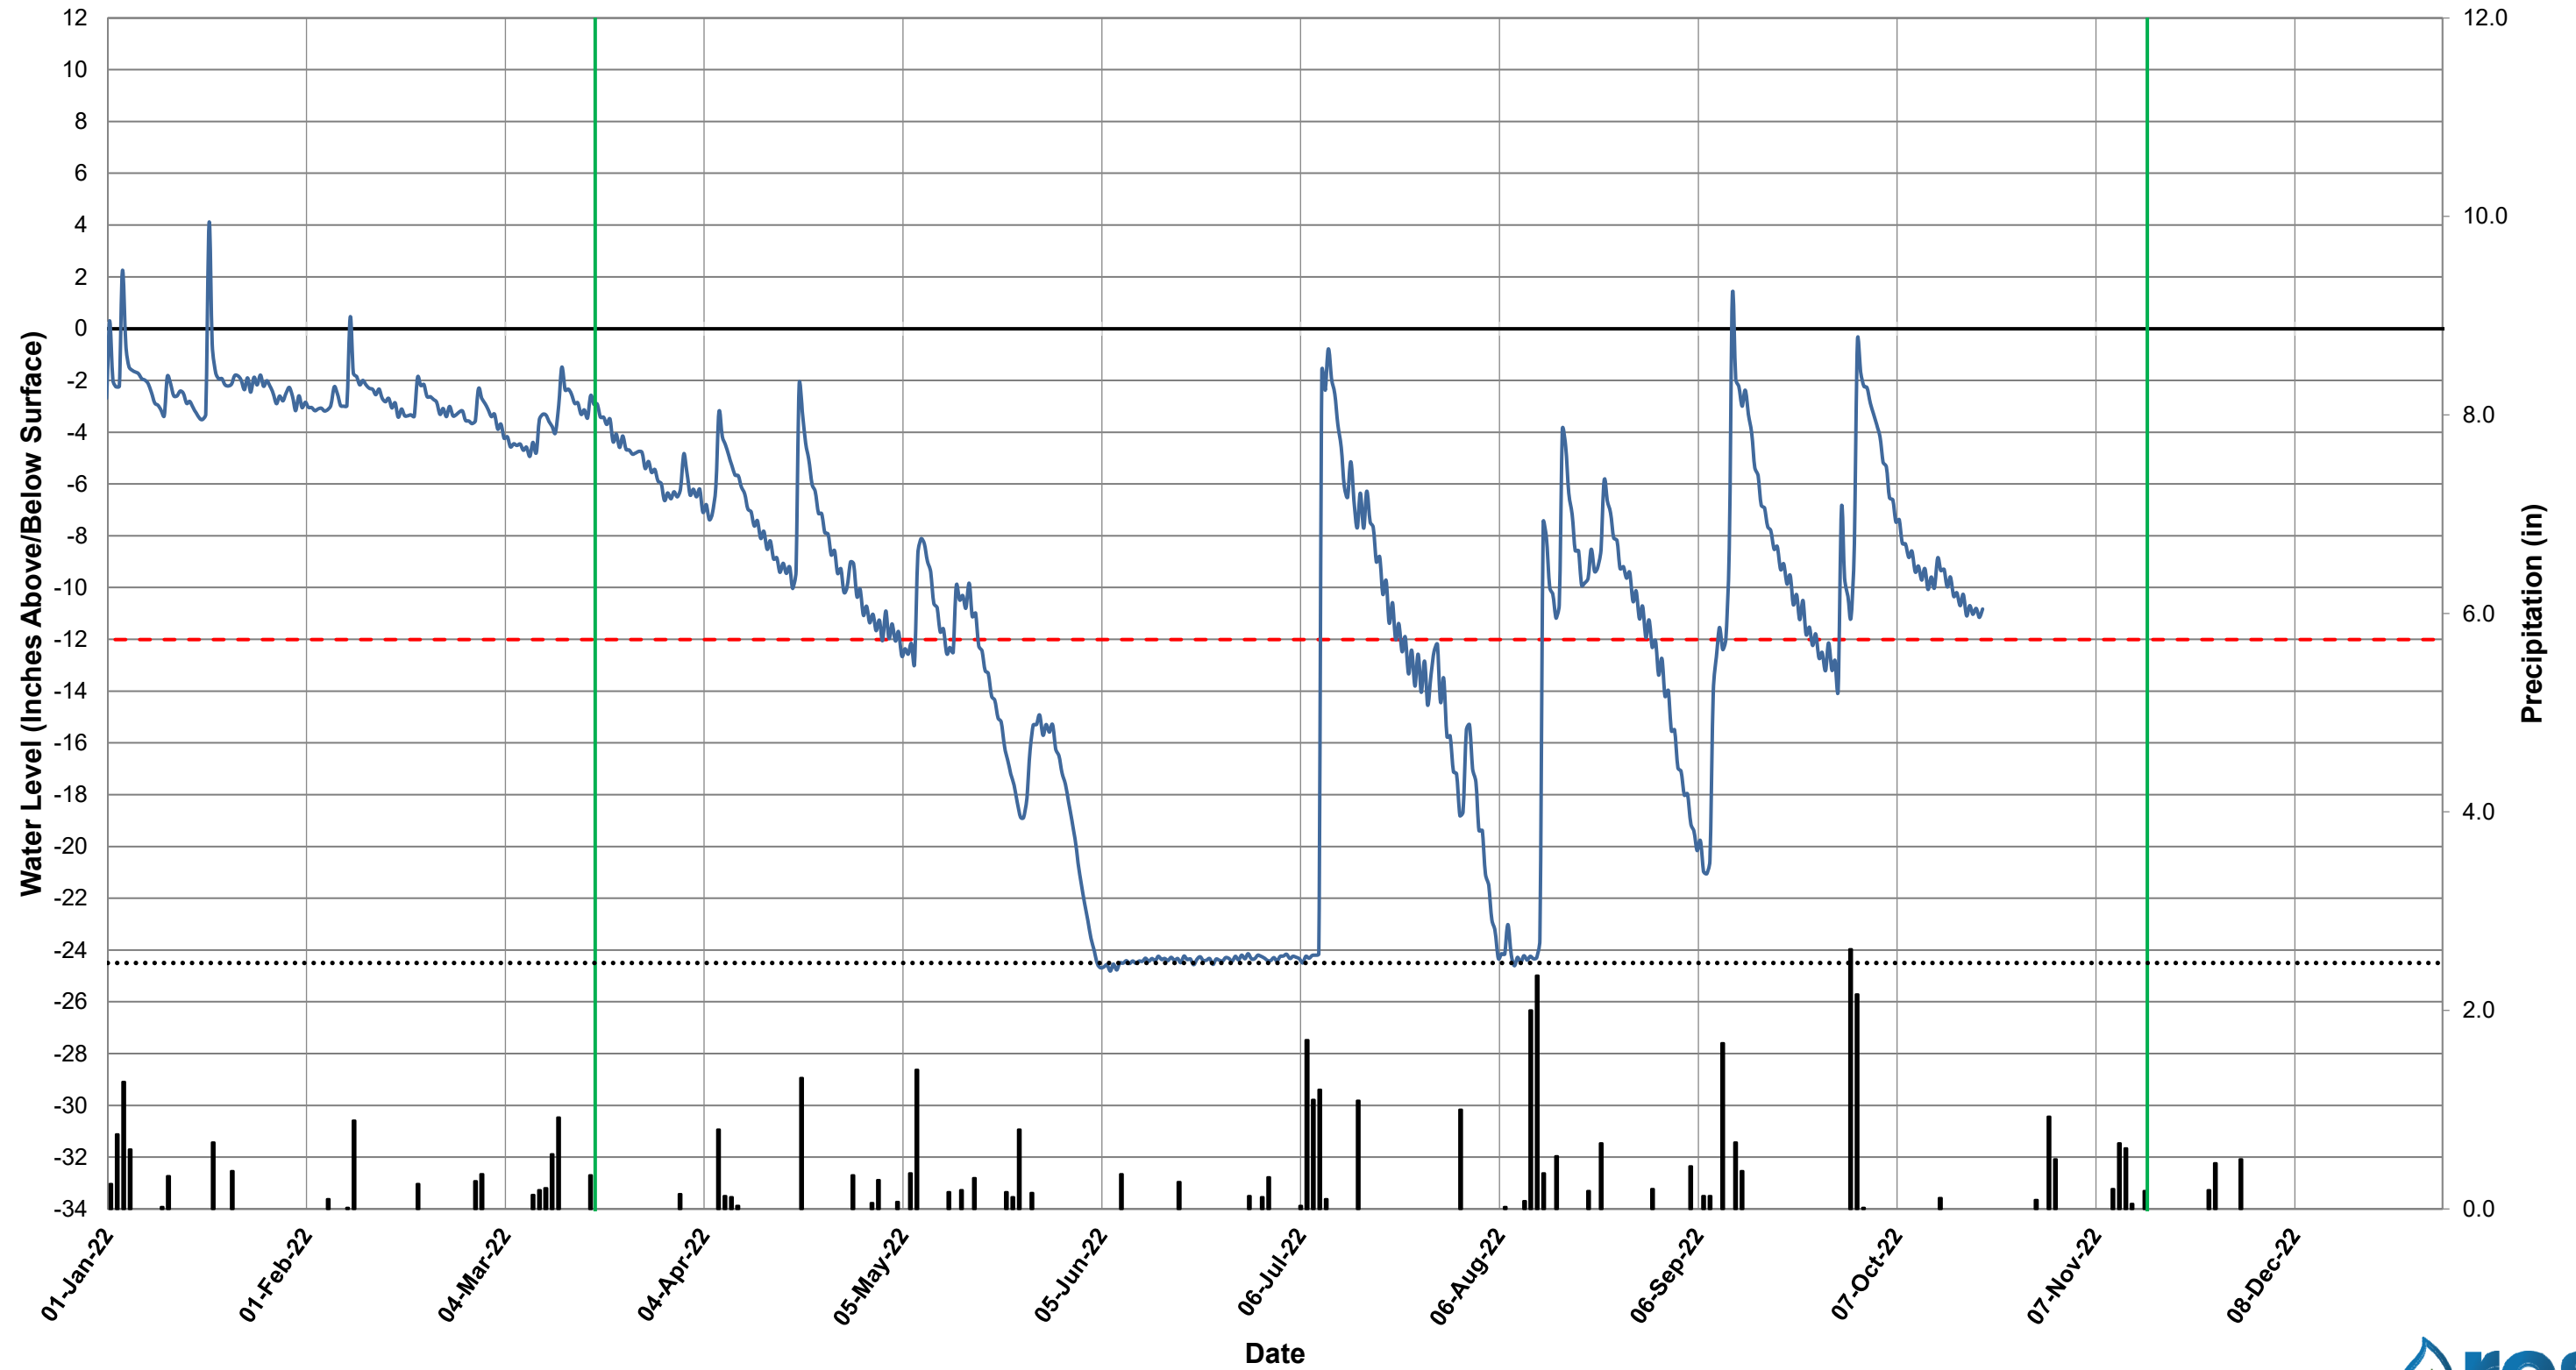
2022 Matthew REF GW1

47 Consecutive Days of Hydrology
03/18/2022 - 05/04/2022

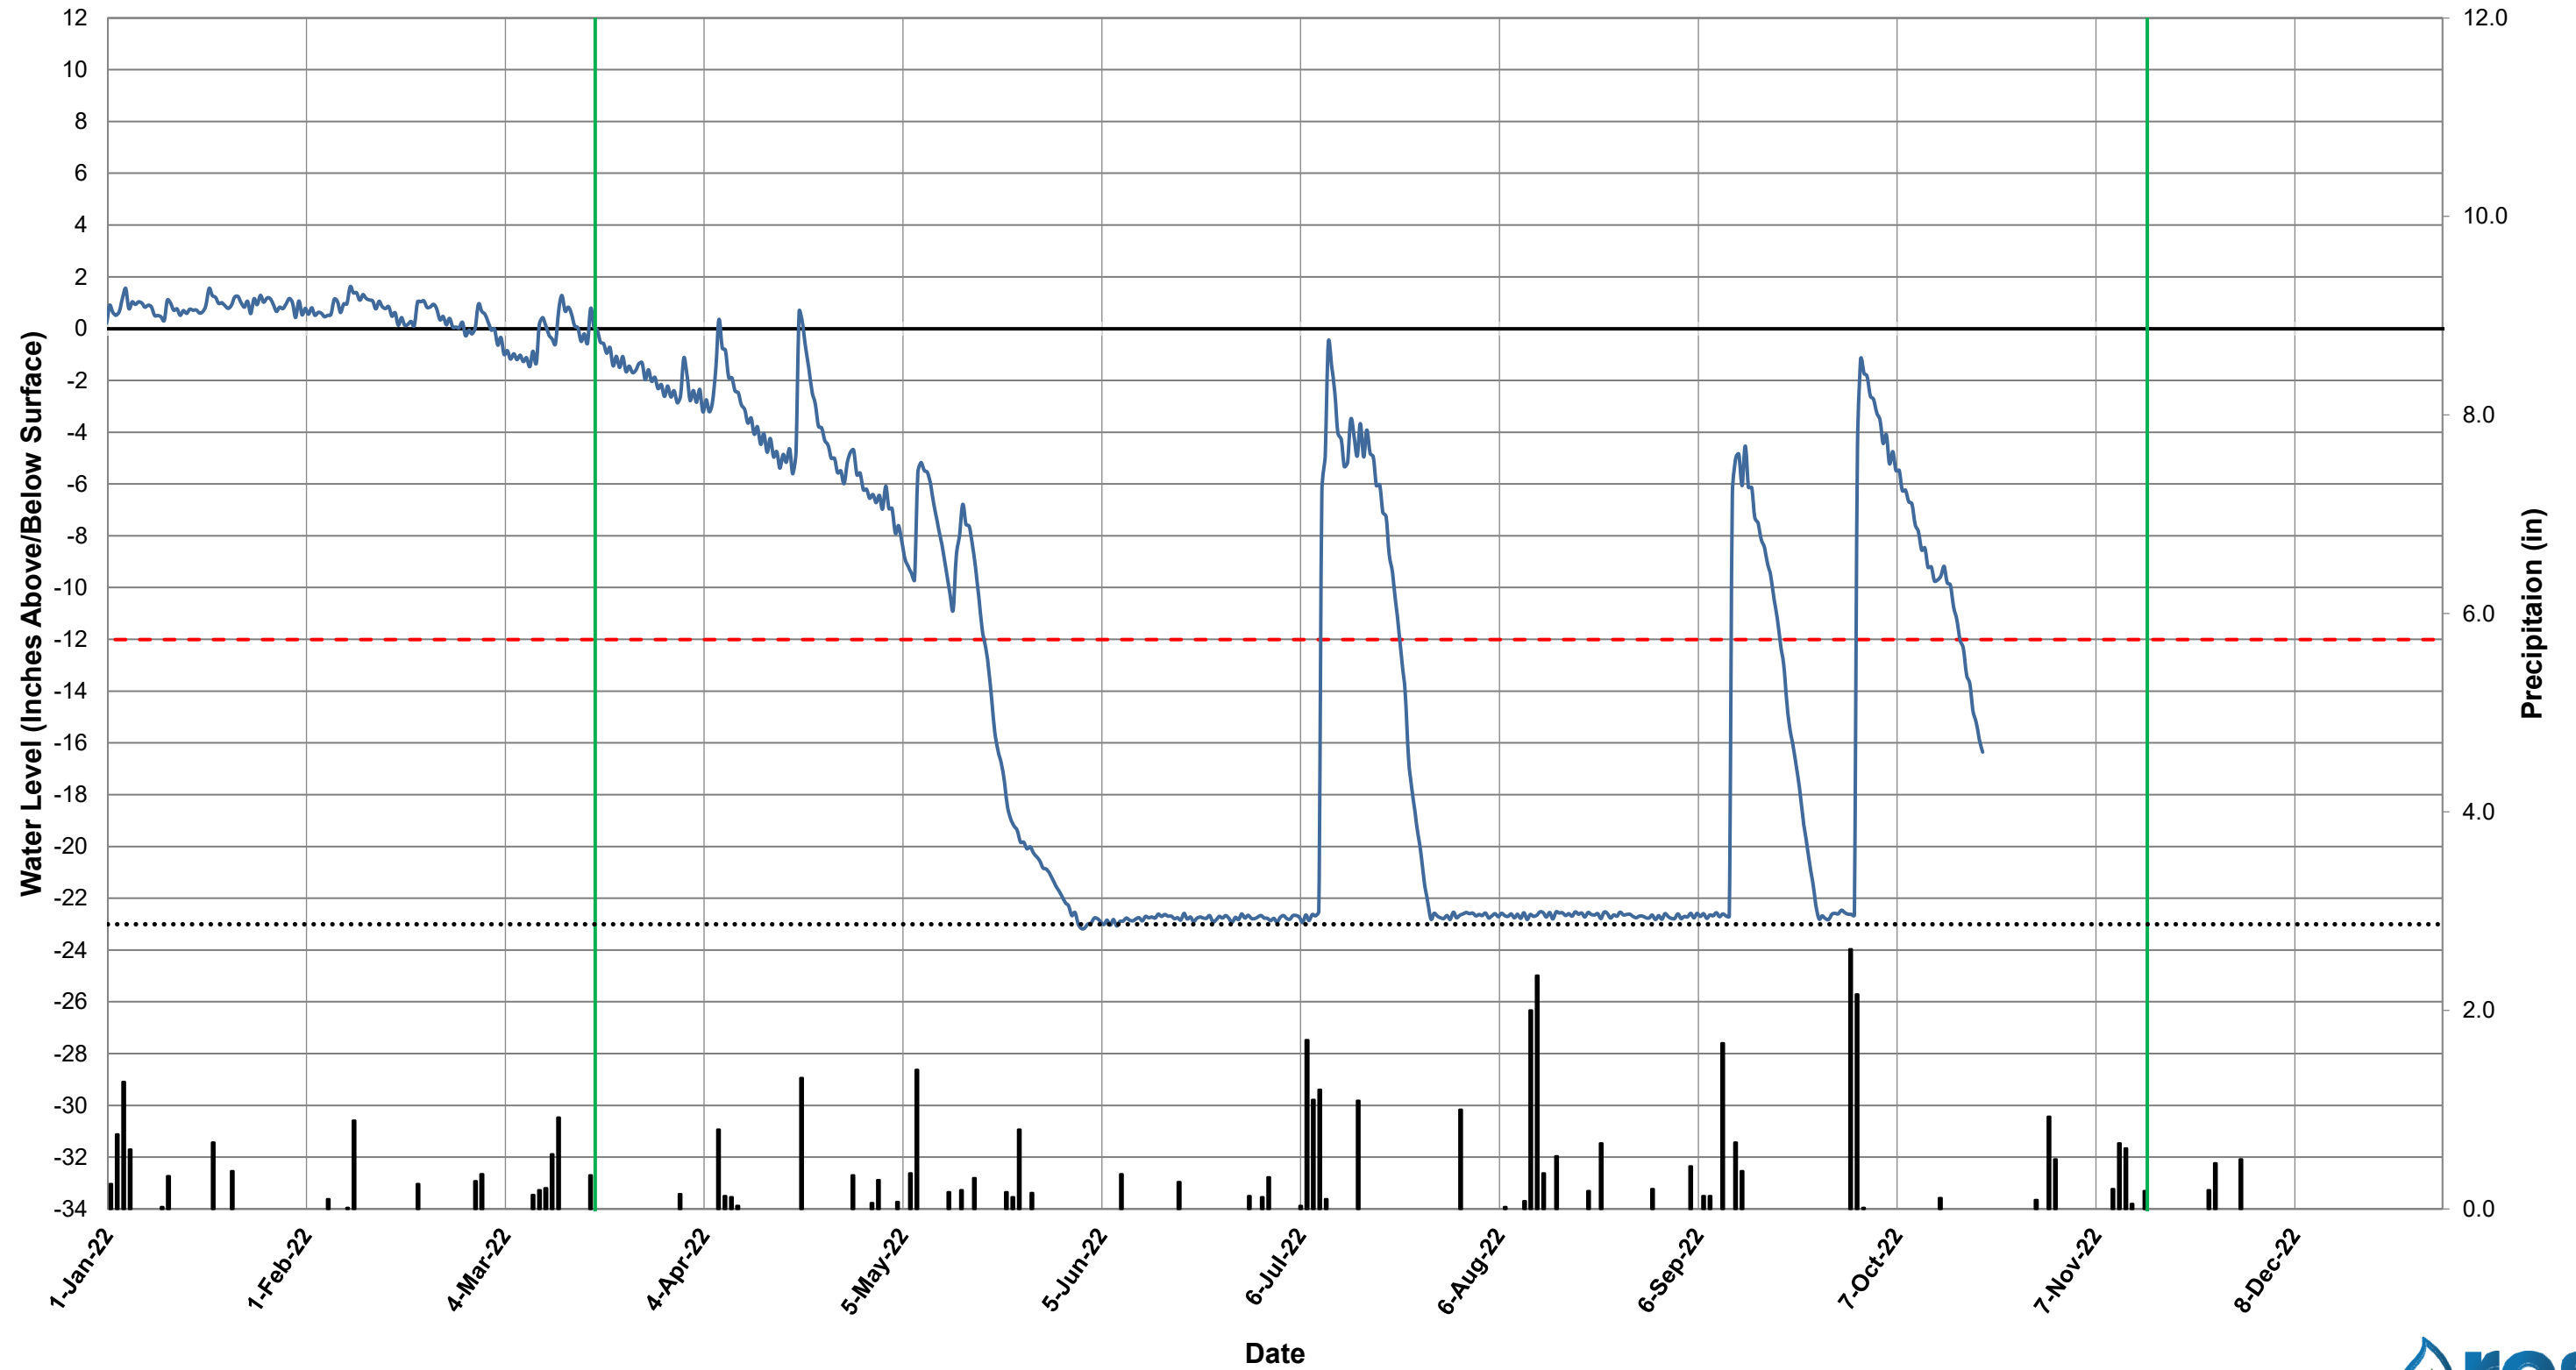
2022 Matthew REF GW2

60 Consecutive Days of Hydrology
03/18/2022 - 05/16/2022
