Subject: DMS Comments on the MY3 2023 Draft Report  
Matthews Project ID # 100043, DMS Contract # 7419

**Year 3 Final Monitoring Report**

**MATTHEW SITE**

NCDMS Project #100043 (Contract #7419)

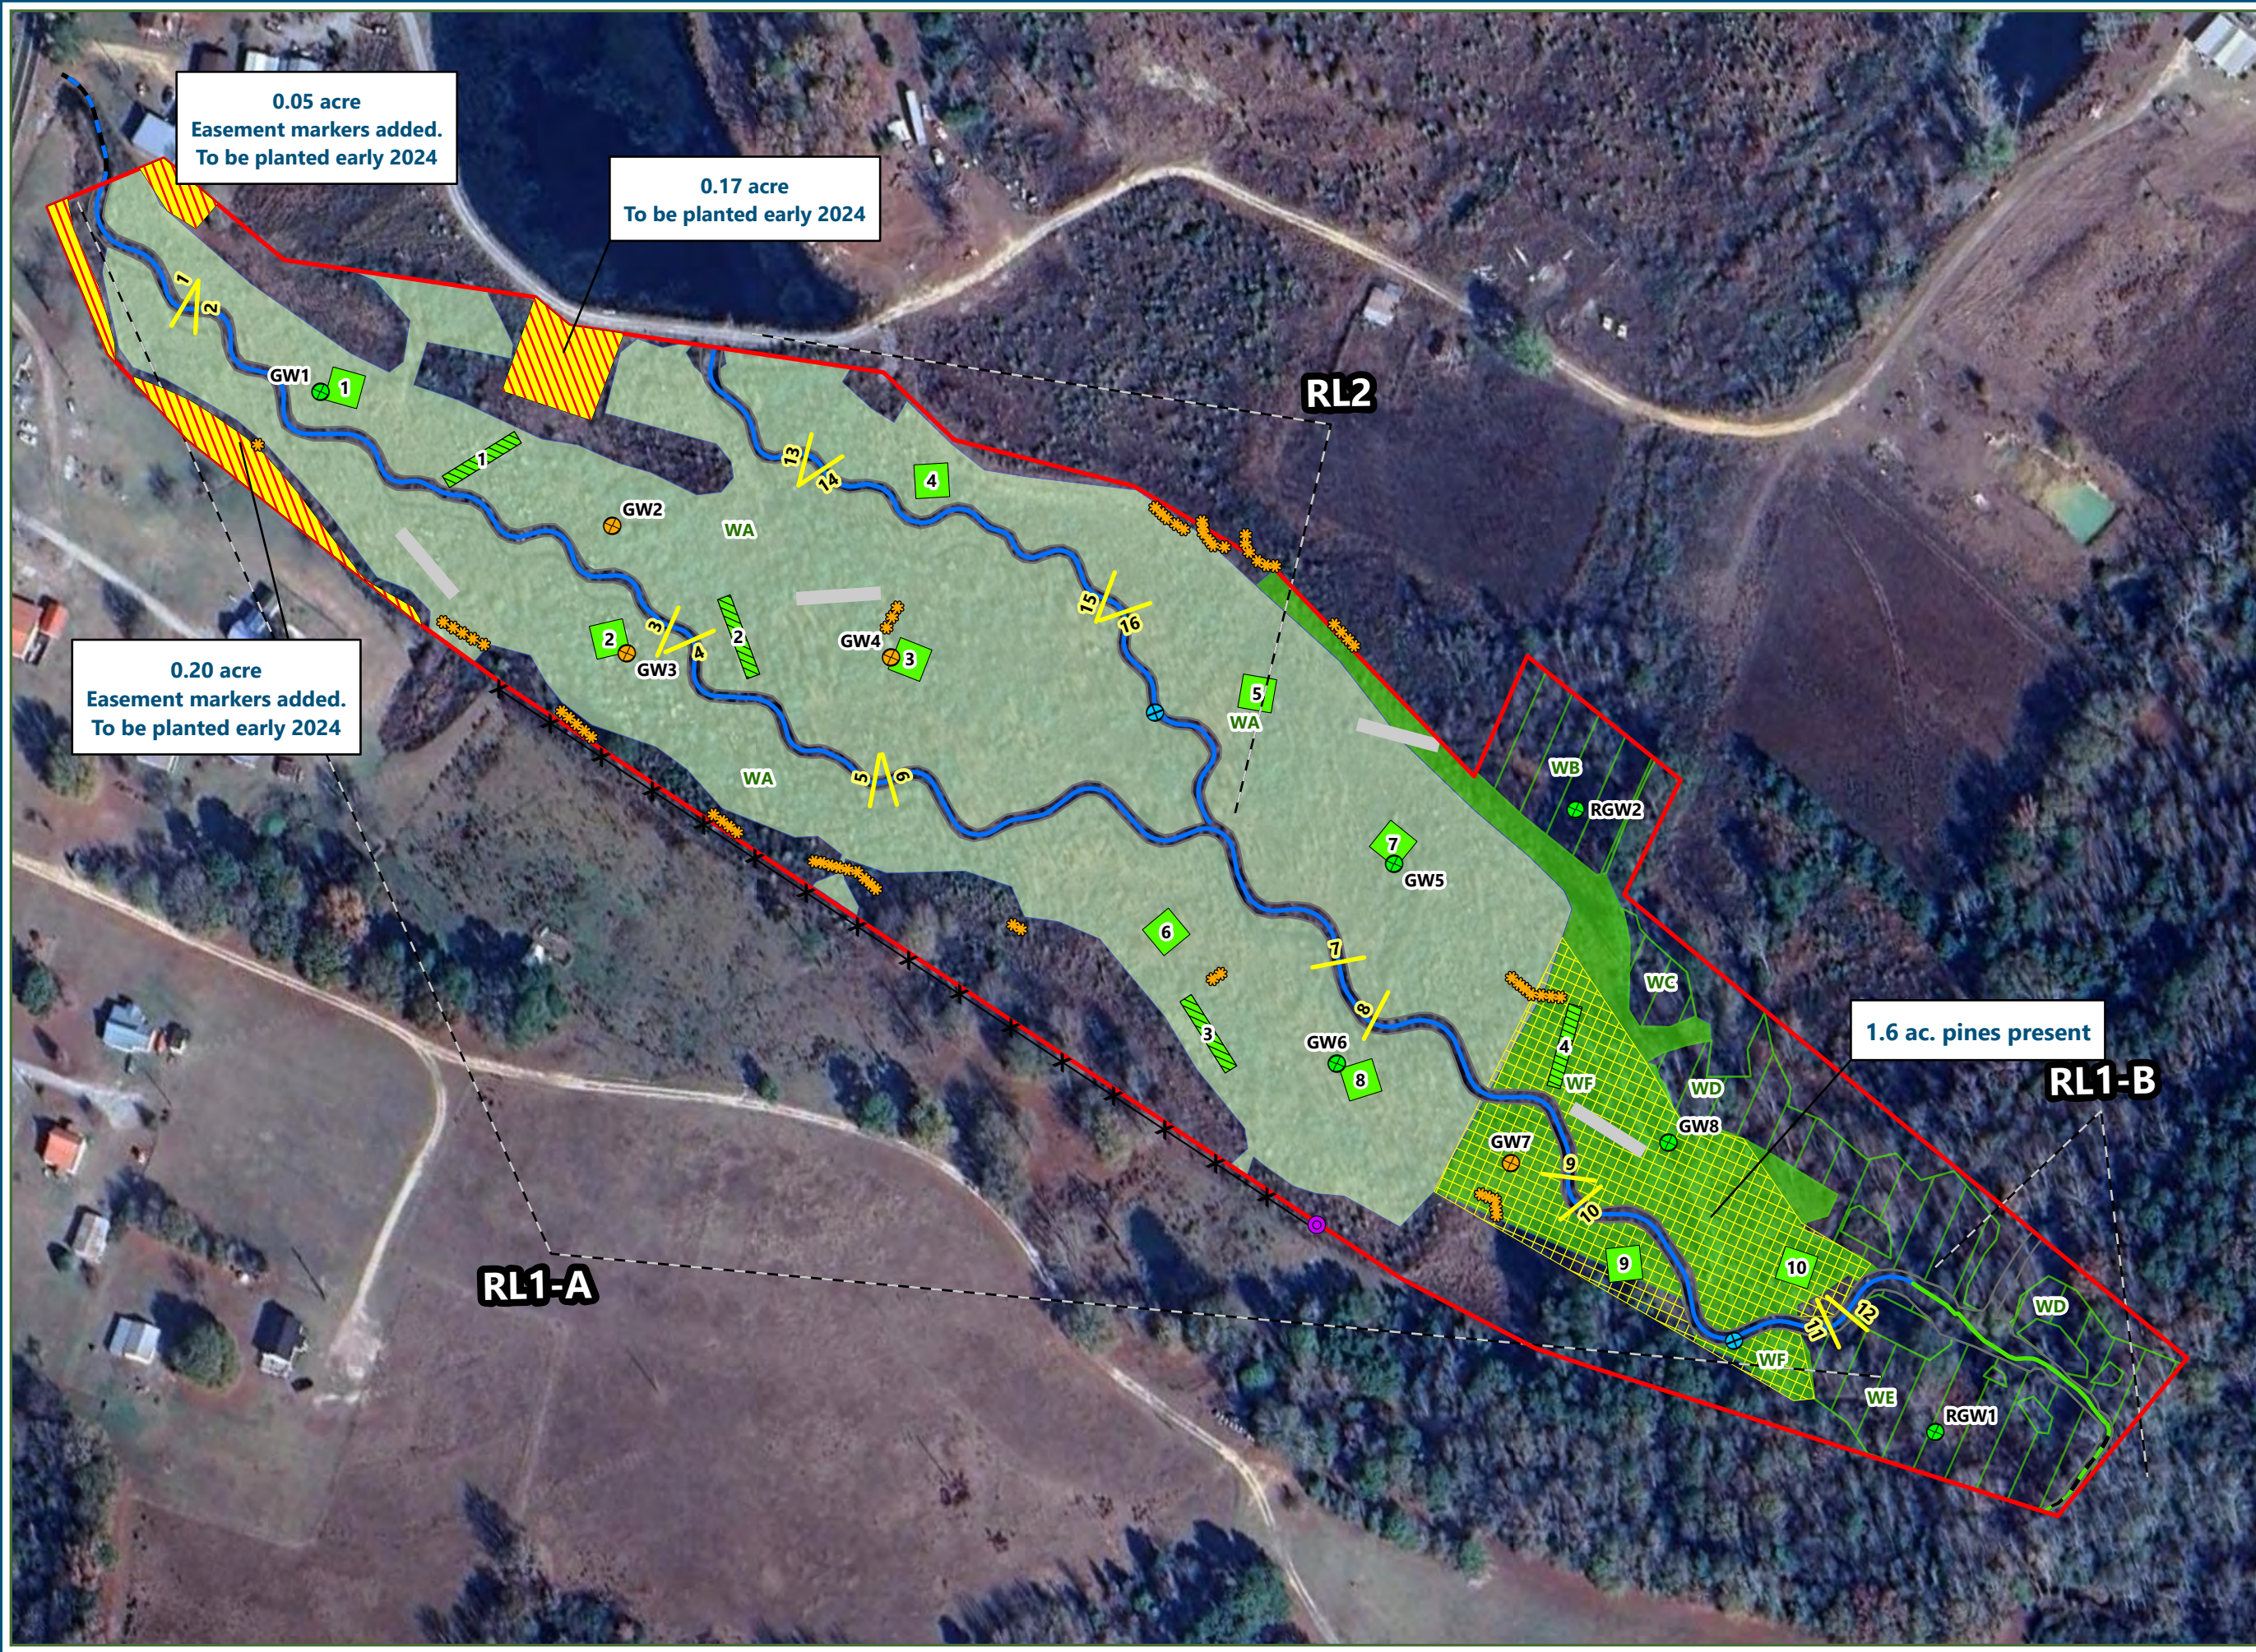
**Figure 2**  
Current Conditions Plan View

Also, RES has included another encroachment area polygon that was noted and identified by both RES and DMS during the site visit in February 2024. It is depicted in Figure 2 CCPV, and Sections 1.7.1, 1.7.5, and Table 6 have been revised accordingly, including updated bare area and encroachment area calculations.

The CCPV has been revised accordingly to depict areas of encroachment with different symbology.

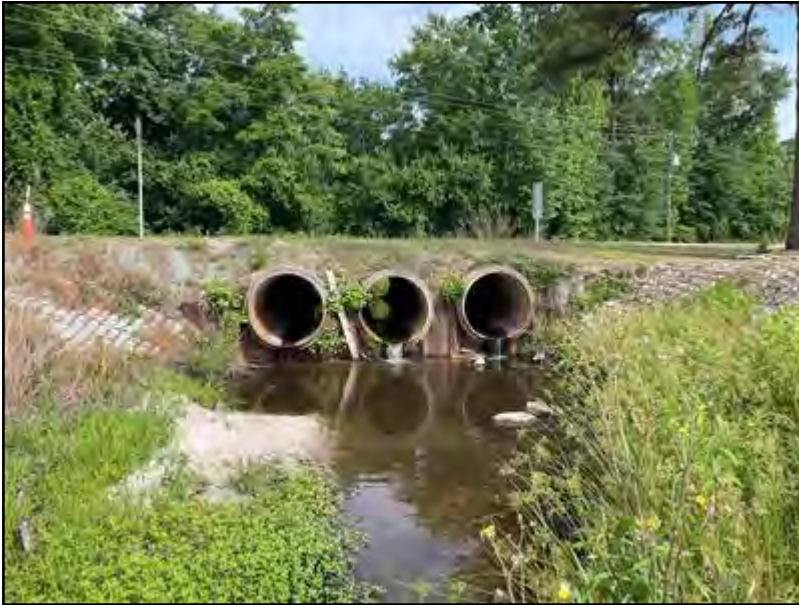
Plunge pool and boulder toe protection below NC-96 culvert on  
RL1-A (05/18/2023)

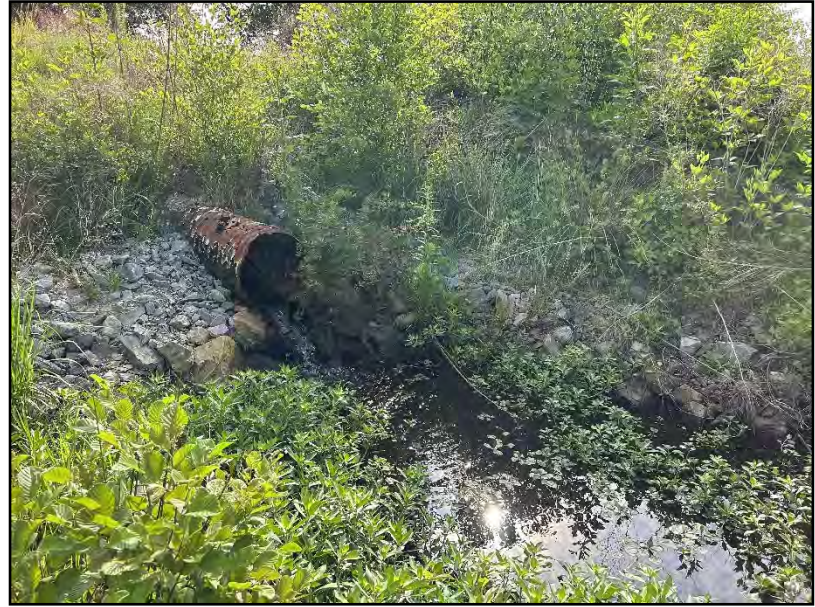
Plunge Pool at the top of RL2 (05/18/2023)

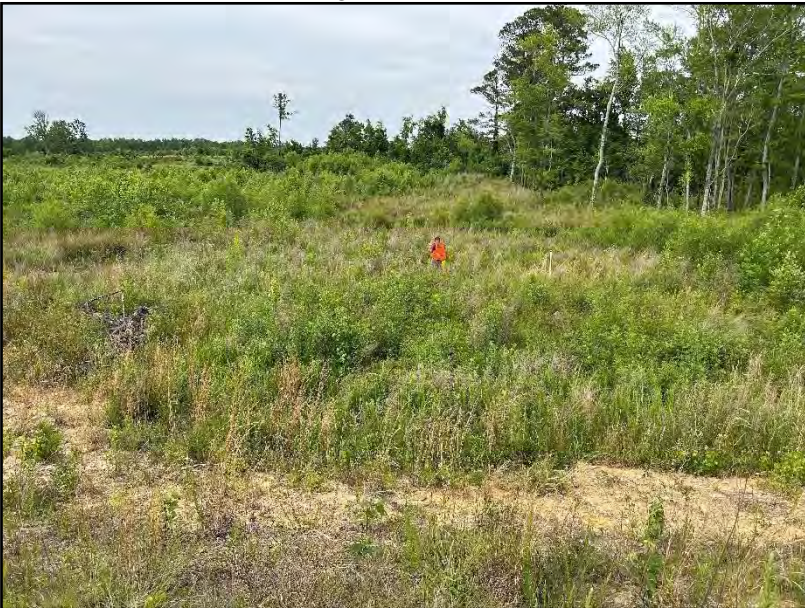
Dam Footprint (5/18/2023)

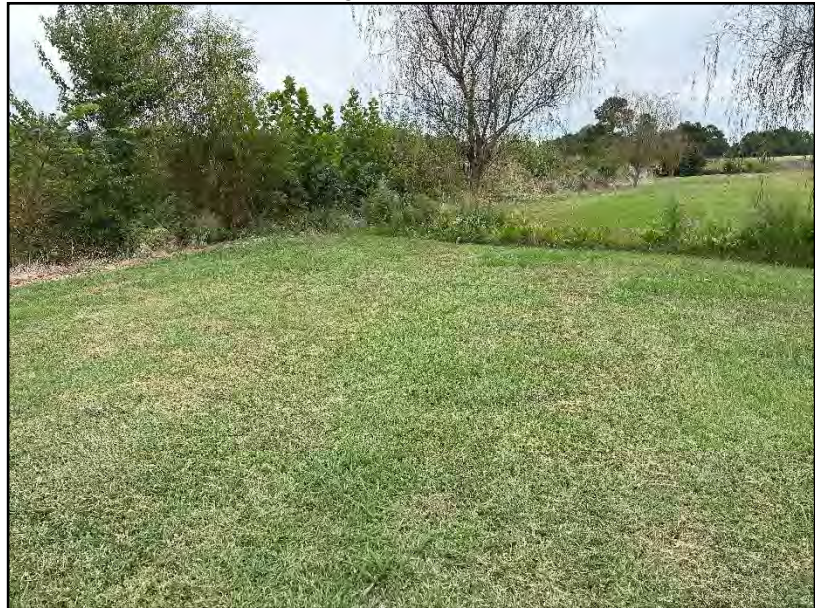
1. In the MY4 draft report, please detail, and/or any correspondence with landowner on a resolution to avoid mowing/ encroachments in the future. We also recommend speaking to adjacent property owner.

Encroachment Mowing – Southern Boundary (10/11/2023)

Noted. Subsequent communication with the landowner and adjacent property owners will be included in the MY4 draft report.

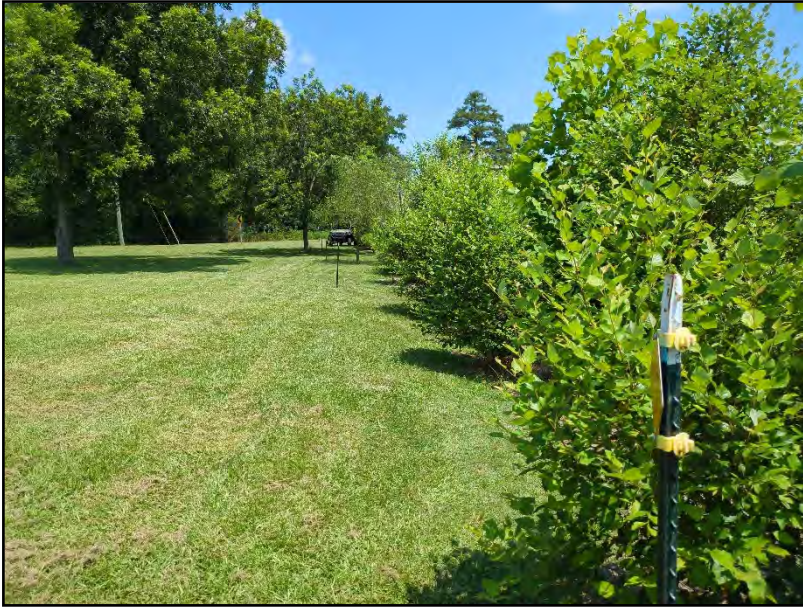
Markers added to Southern Encroachment (7/27/2023)

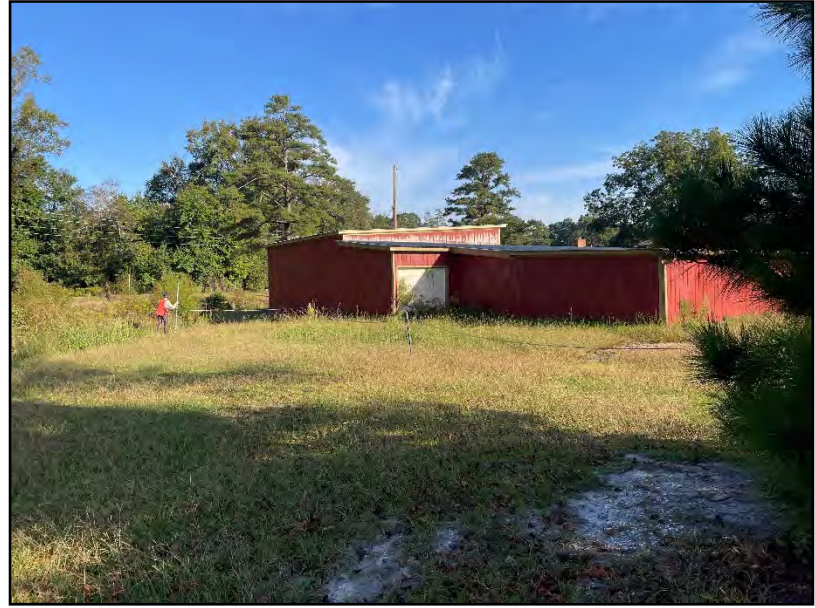
Markers added to Northern Encroachment (7/27/2023)
