**McCain Site  
Stream Restoration Monitoring Report  
EEP Project # 443  
Monitoring Year – 01  
2009**

**December 2009**

## **Design and Monitoring Firm**

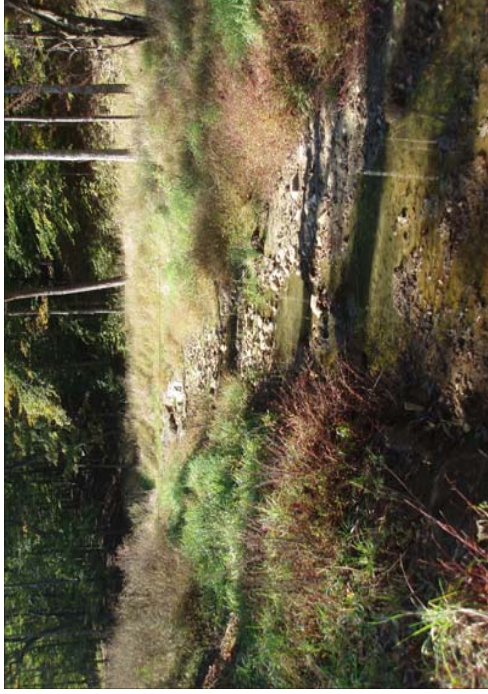
<b>River Basin:</b>	Yadkin
<b>Watershed:</b>	McCain, MY-01
<b>XS ID</b>	XS - 1, Riffle, Reach 1
<b>Drainage Area (sq mi):</b>	0.88
<b>Date:</b>	10/20/2009
<b>Field Crew:</b>	B. Roberts, A. French

SUMMARY DATA	
<b>Bankfull Elevation:</b>	544.3
<b>Bankfull Cross-Sectional Area:</b>	20.8
<b>Bankfull Width:</b>	17.2
<b>Flood Prone Area Elevation:</b>	545.9
<b>Flood Prone Width:</b>	37.0
<b>Max Depth at Bankfull:</b>	1.6
<b>Mean Depth at Bankfull:</b>	1.2
<b>W / D Ratio:</b>	14.2
<b>Entrenchment Ratio:</b>	2.2
<b>Bank Height Ratio:</b>	1.0

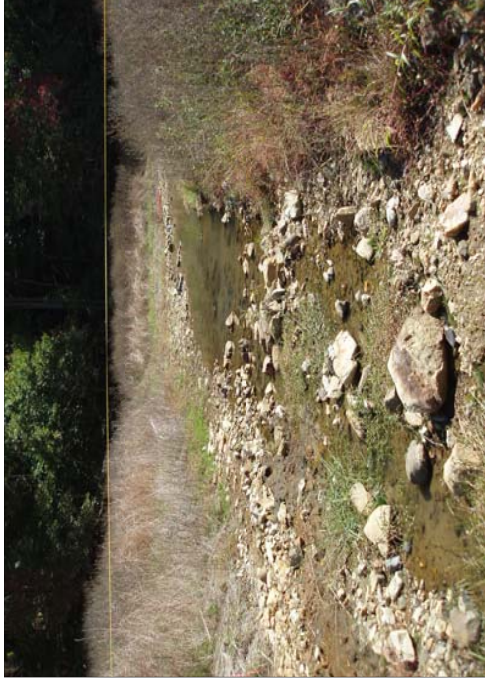
<b>River Basin:</b>	Yadkin
<b>Watershed:</b>	McCain, MY-01
<b>XS ID</b>	XS - 2, Riffle, Reach 2
<b>Drainage Area (sq mi):</b>	0.88
<b>Date:</b>	10/20/2009
<b>Field Crew:</b>	B. Roberts, A. French

SUMMARY DATA	
Bankfull Elevation:	540.9
Bankfull Cross-Sectional Area:	42.7
Bankfull Width:	25.2
Flood Prone Area Elevation:	543.4
Flood Prone Width:	>75
Max Depth at Bankfull:	2.5
Mean Depth at Bankfull:	1.7
W / D Ratio:	14.9
Entrenchment Ratio:	>3.0
Bank Height Ratio:	1.0

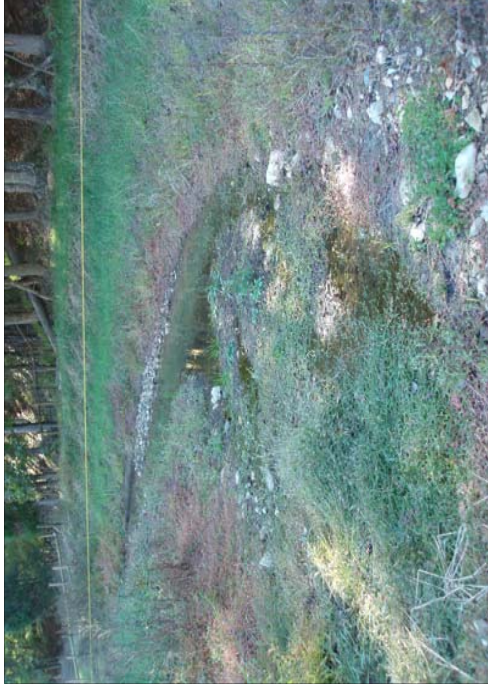
<b>River Basin:</b>	Yadkin
<b>Watershed:</b>	McCain, MY-01
<b>XS ID</b>	XS - 3, Pool, Reach 3
<b>Drainage Area (sq mi):</b>	0.88
<b>Date:</b>	10/20/2009
<b>Field Crew:</b>	B. Roberts, A. French

SUMMARY DATA	
<b>Bankfull Elevation:</b>	535.5
<b>Bankfull Cross-Sectional Area:</b>	34.1
<b>Bankfull Width:</b>	23.0
<b>Flood Prone Area Elevation:</b>	-
<b>Flood Prone Width:</b>	-
<b>Max Depth at Bankfull:</b>	2.2
<b>Mean Depth at Bankfull:</b>	1.5
<b>W / D Ratio:</b>	-
<b>Entrenchment Ratio:</b>	-
<b>Bank Height Ratio:</b>	-

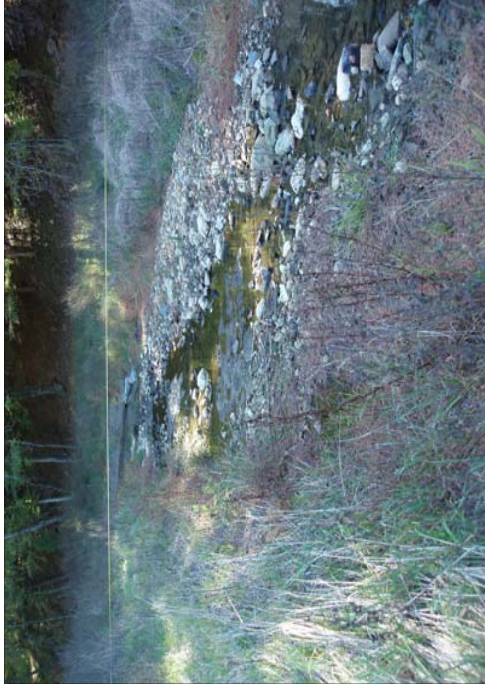
<b>River Basin:</b>	Yadkin
<b>Watershed:</b>	McCain, MY-01
<b>XS ID</b>	XS - 4, Riffle, Reach 3
<b>Drainage Area (sq mi):</b>	0.88
<b>Date:</b>	10/20/2009
<b>Field Crew:</b>	B. Roberts, A. French

SUMMARY DATA		
<b>Bankfull Elevation:</b>		534.4
<b>Bankfull Cross-Sectional Area:</b>		29.7
<b>Bankfull Width:</b>		23.4
<b>Flood Prone Area Elevation:</b>		536.4
<b>Flood Prone Width:</b>		52.0
<b>Max Depth at Bankfull:</b>		2.0
<b>Mean Depth at Bankfull:</b>		1.3
<b>W / D Ratio:</b>		18.4
<b>Entrenchment Ratio:</b>		2.2
<b>Bank Height Ratio:</b>		1.0

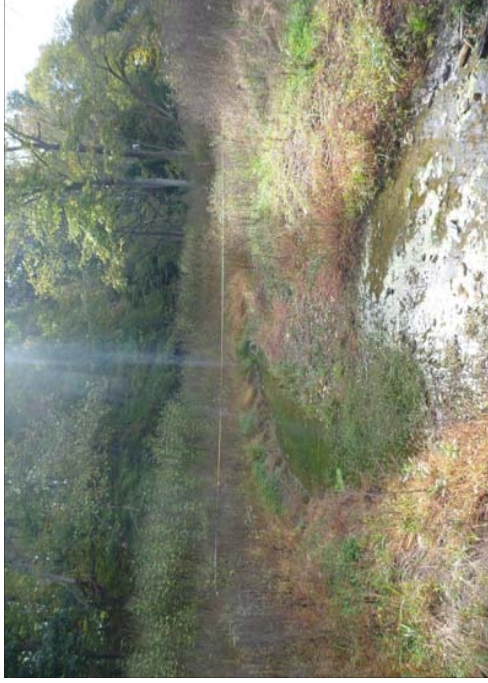
<b>River Basin:</b>	Yadkin
<b>Watershed:</b>	McCain, MY-01
<b>XS ID</b>	XS - 5, Pool, Reach 4
<b>Drainage Area (sq mi):</b>	0.88
<b>Date:</b>	10/22/2009
<b>Field Crew:</b>	B. Roberts, A. French

SUMMARY DATA		
Bankfull Elevation:		531.2
Bankfull Cross-Sectional Area:		17.8
Bankfull Width:		14.3
Flood Prone Area Elevation:		-
Flood Prone Width:		-
Max Depth at Bankfull:		2.5
Mean Depth at Bankfull:		1.2
W / D Ratio:		-
Entrenchment Ratio:		-
Bank Height Ratio:		-

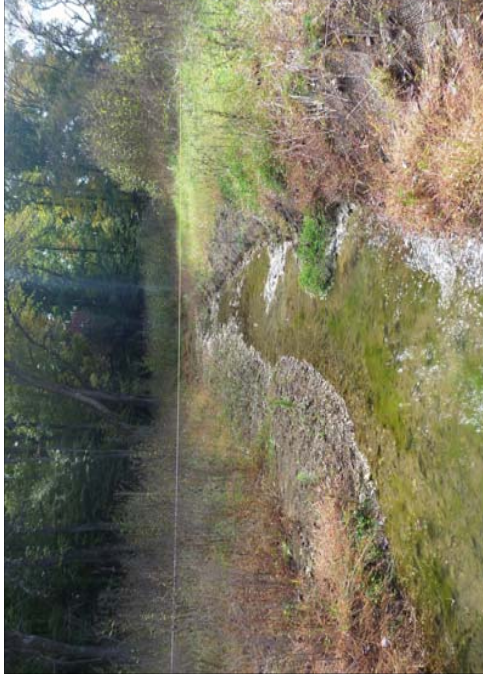
<b>River Basin:</b>	Yadkin
<b>Watershed:</b>	McCain, MY-01
<b>XS ID</b>	XS - 6, Riffle, Reach 4
<b>Drainage Area (sq mi):</b>	0.88
<b>Date:</b>	10/22/2009
<b>Field Crew:</b>	B. Roberts, A. French

SUMMARY DATA	
<b>Bankfull Elevation:</b>	531.0
<b>Bankfull Cross-Sectional Area:</b>	25.2
<b>Bankfull Width:</b>	18.4
<b>Flood Prone Area Elevation:</b>	533.0
<b>Flood Prone Width:</b>	50.5
<b>Max Depth at Bankfull:</b>	2.0
<b>Mean Depth at Bankfull:</b>	1.4
<b>W / D Ratio:</b>	13.4
<b>Entrenchment Ratio:</b>	2.7
<b>Bank Height Ratio:</b>	1.0
