**McCain Stream Restoration Project
Randolph County, North Carolina
EEP Project #443**

MY-02 Monitoring Report - Final

Data Collected: October 18, 2010

**MY-02 Monitoring Report - Final
Prepared By:**

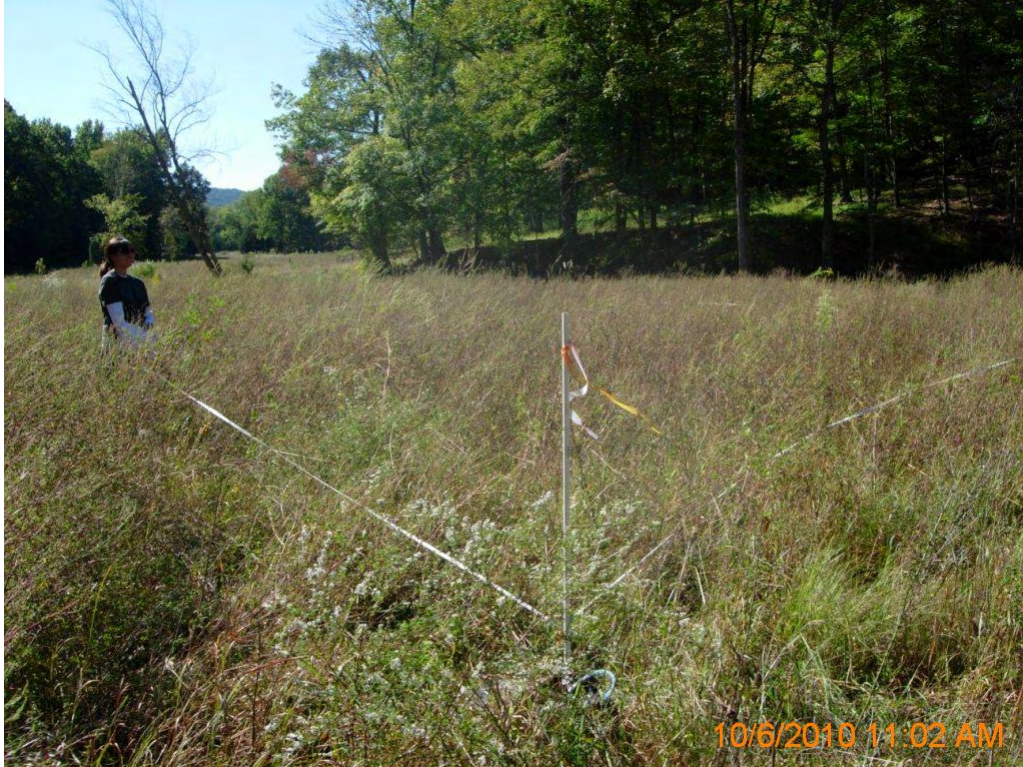
Photo 7. Vegetation Plot 1

Seven vegetation monitoring plots (1-7) were monitored for MY-02. Of these seven plots, plots 1 and 6 are not meeting vegetation success criteria, resulting in 72% of the plots meeting the vegetation success criteria. The success criterion for planted woody species is 320 stems/acre after MY-03. A mortality rate of ten percent will be allowed after MY-04 (288 stems/acre), with another ten percent allowed after MY-05 (260 stems/acre). Currently the vegetation criteria are being met with 456 planted stems/acre. Bare banks, and areas of low stem densities, and invasive exotics are the only notable vegetation problem areas for MY-02. Invasive exotics within the conservation easement include tall fescue (*Schedonurus arundinaceus*), Japanese stiltgrass (*Microstegium vimineum*), and Chinese privet (*Ligustrum sinense*). Although these species have been given different ranks of severity, the functionality of the project is not expected to be impaired significantly. It is likely that all of these species were present in and adjacent to the conservation easement previous to construction. The fescue appears to be inhibiting some growth of planted stems and there is very few successional woody stems were observed in the fescue dominated areas. For additional information relating to vegetation, see Appendix C.

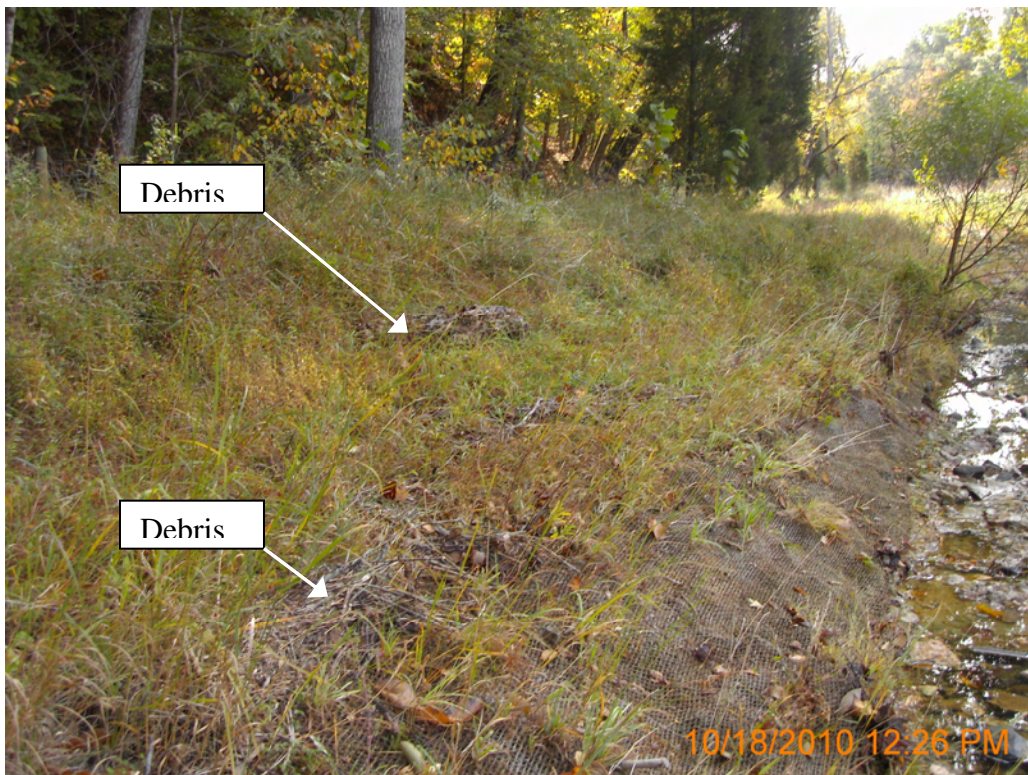
A stream crest gauge was installed on the site on November 1, 2010. The data for the rainfall event was collected from NWS Cooperative Observer Station Asheboro 2 W (310286) located in Asheboro, NC. The daily observed precipitation on September 30, 2010 shows rainfall of 3.81 inches over a 24 hour period which is greater than the bankfull storm event for the project location. Photo 14 shows the wrack line on the bank providing evidence of the bankfull event on the project site.

Photo 14. Wrack line
