**McCain Stream Restoration Project  
Randolph County, North Carolina  
EEP Project #443**

**MY-03 Monitoring Report**

**McCain Stream Restoration  
EEP Project #443  
Sophia, North Carolina  
Randolph County**

**MY-03 Monitoring Report  
Prepared By:**

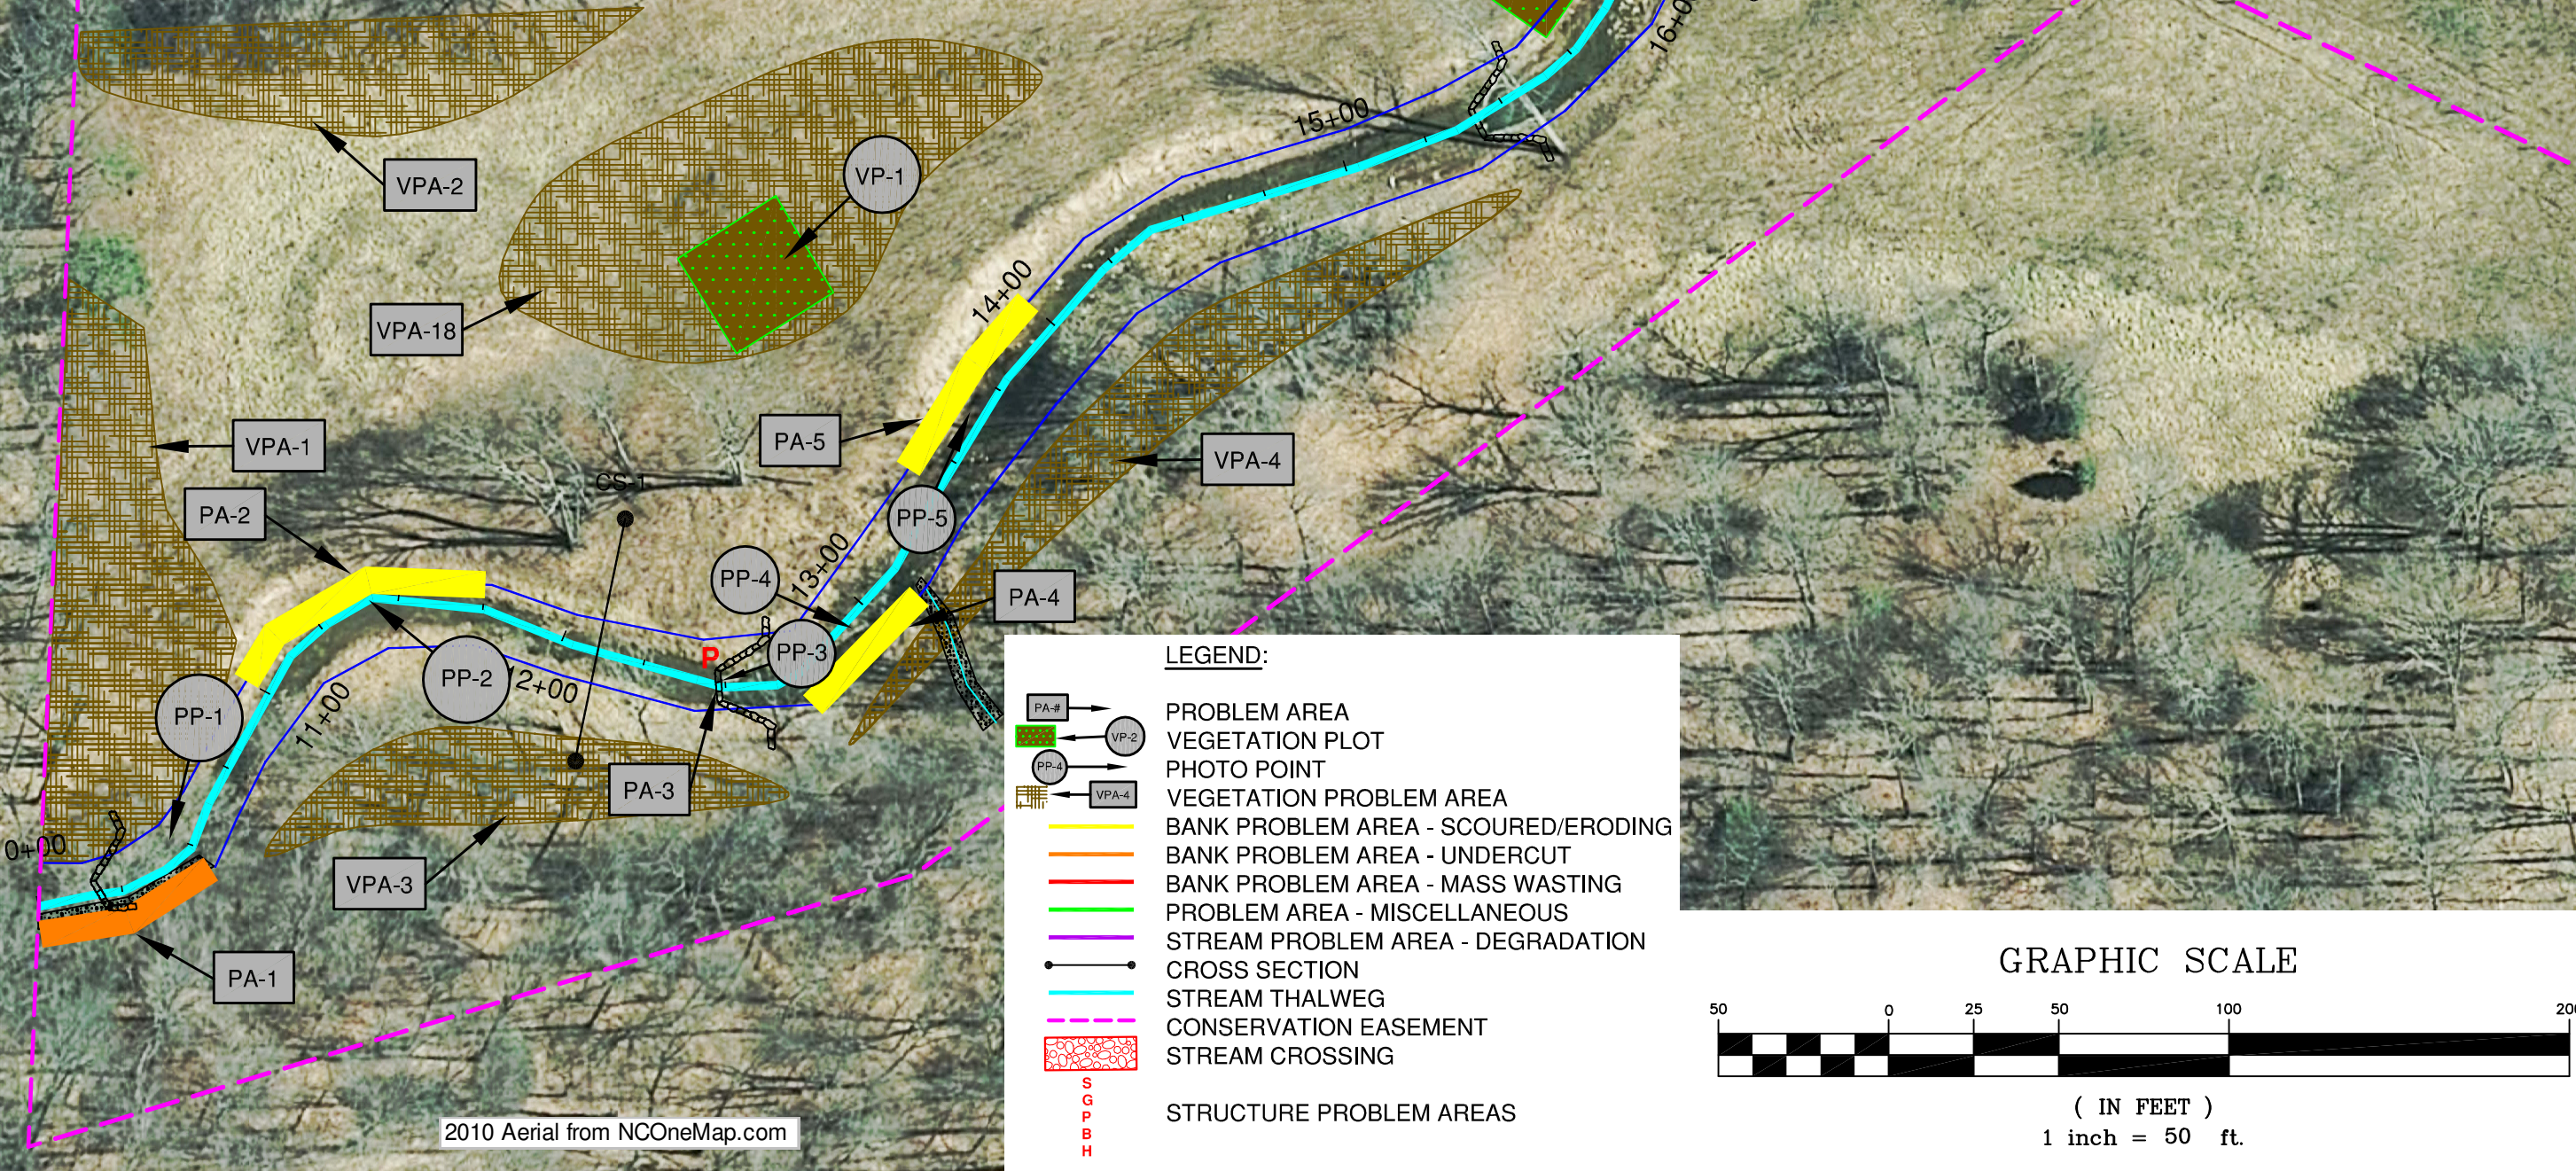
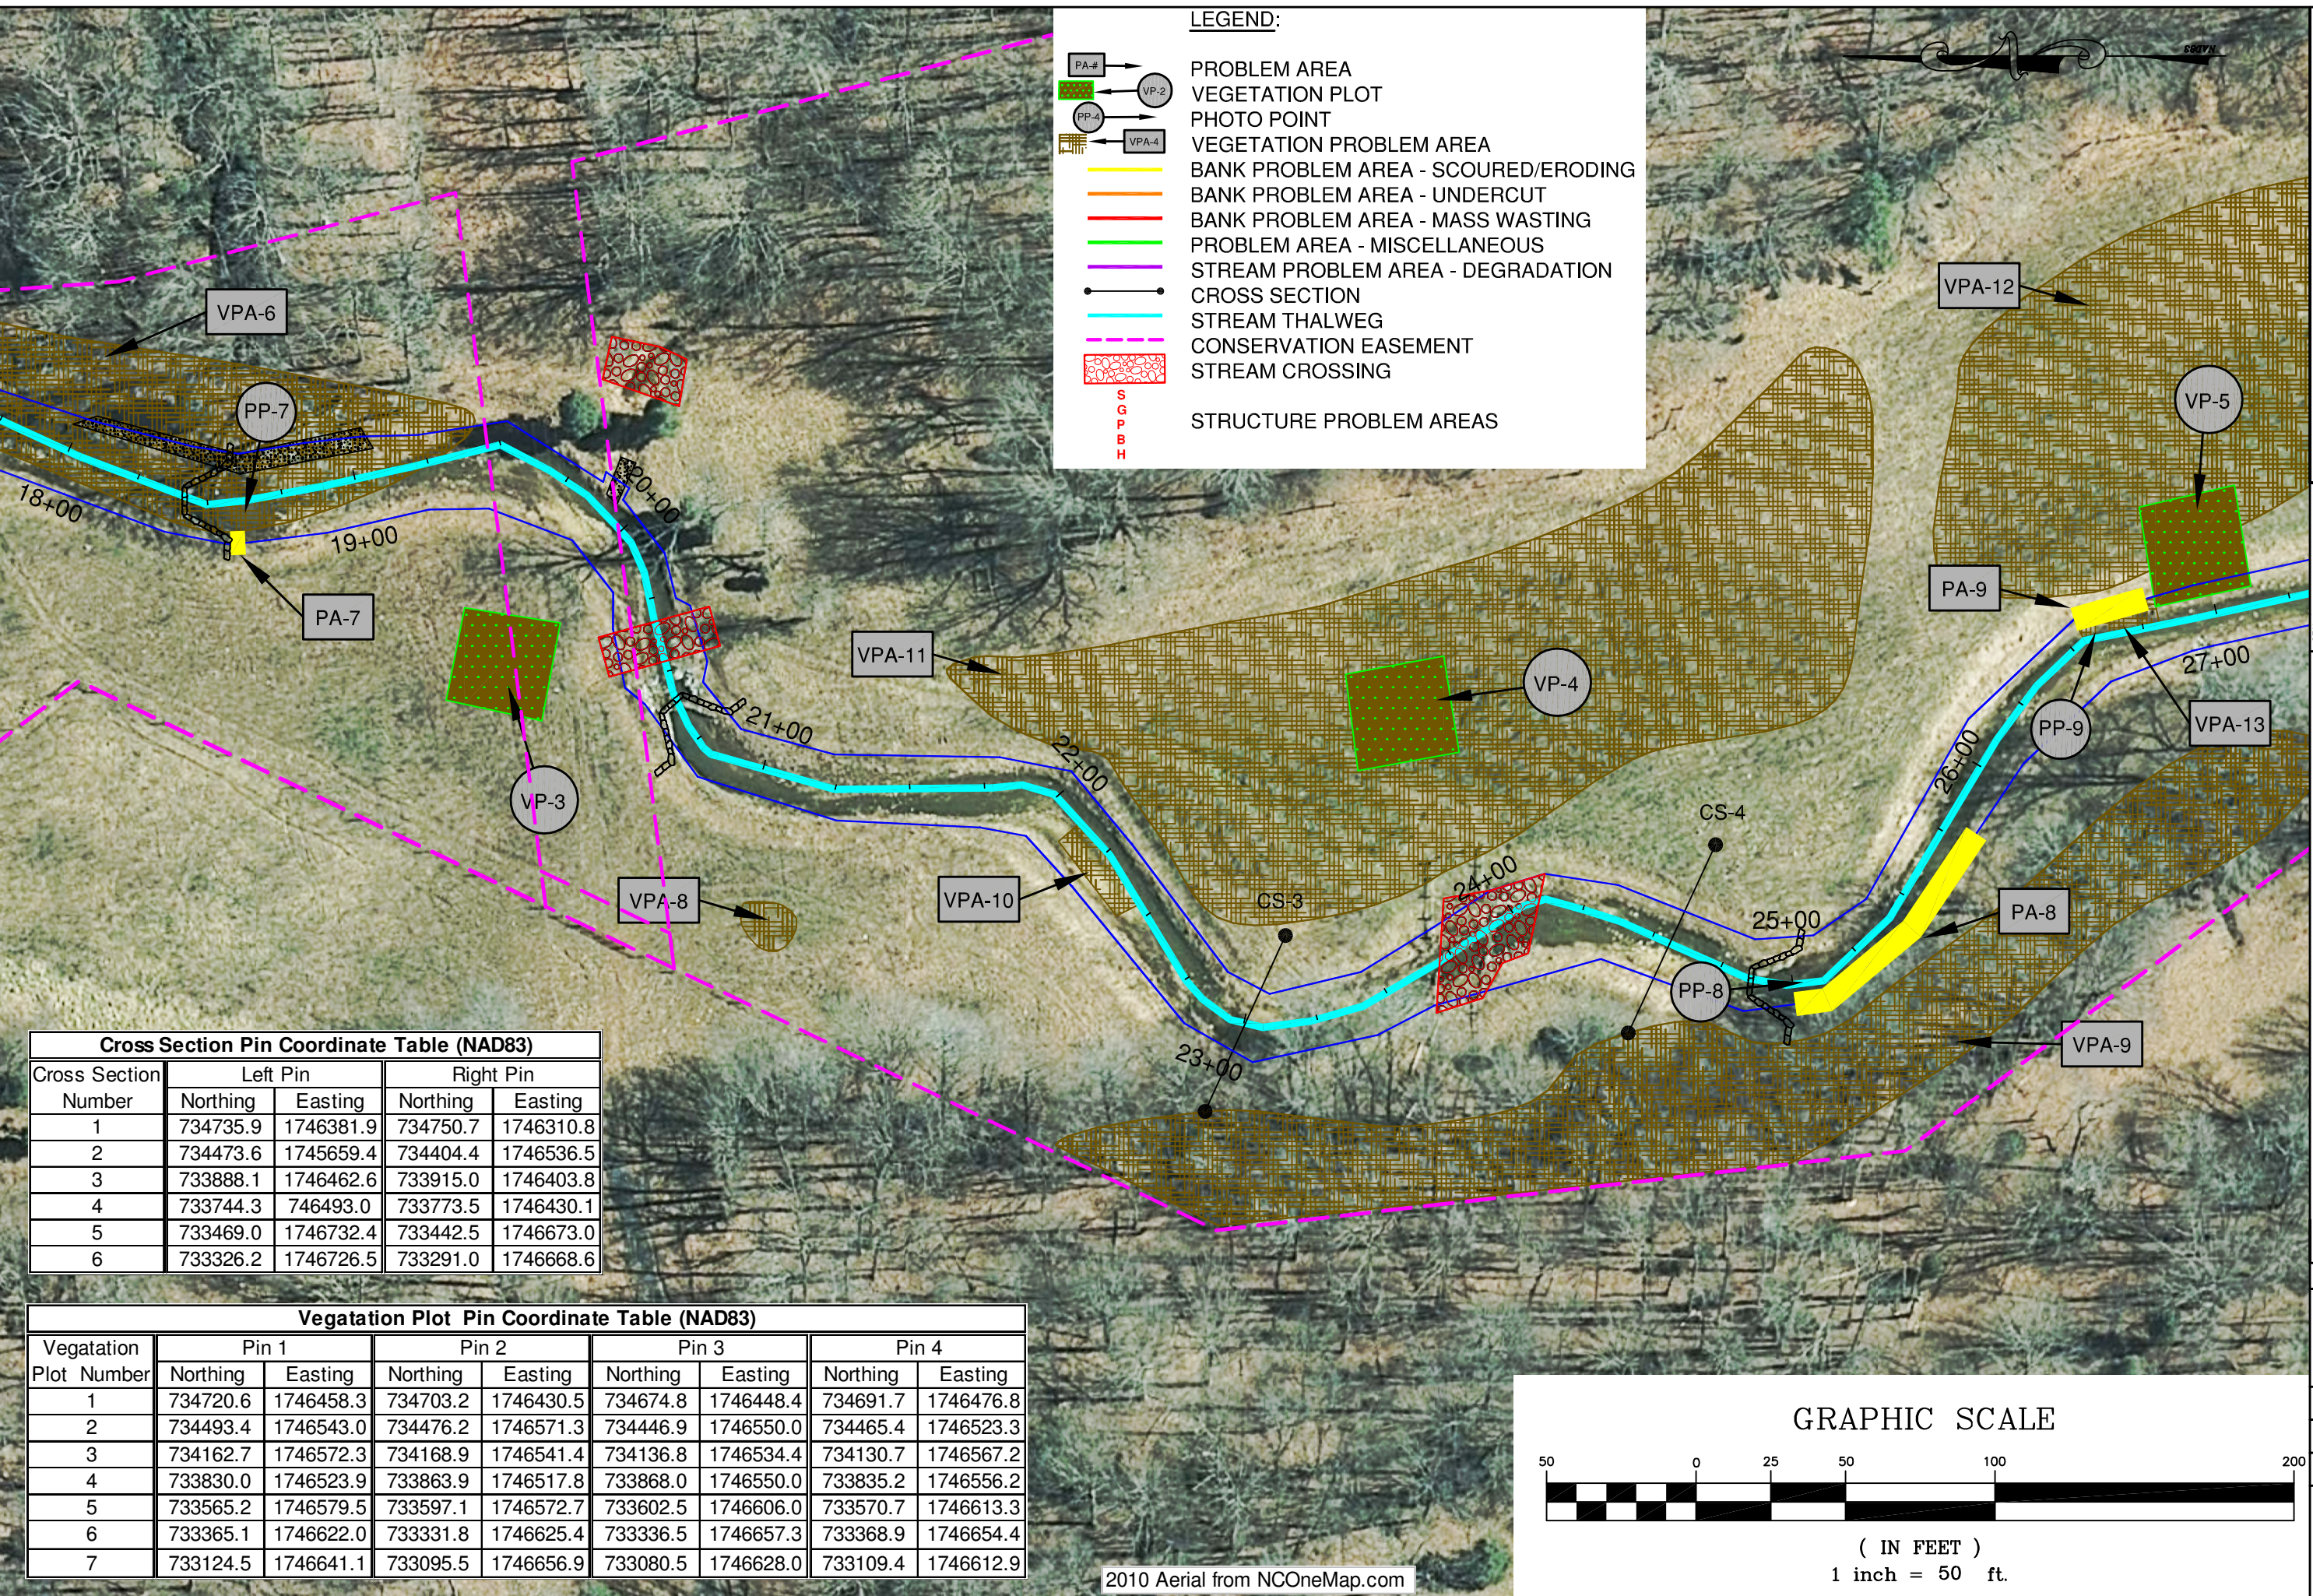
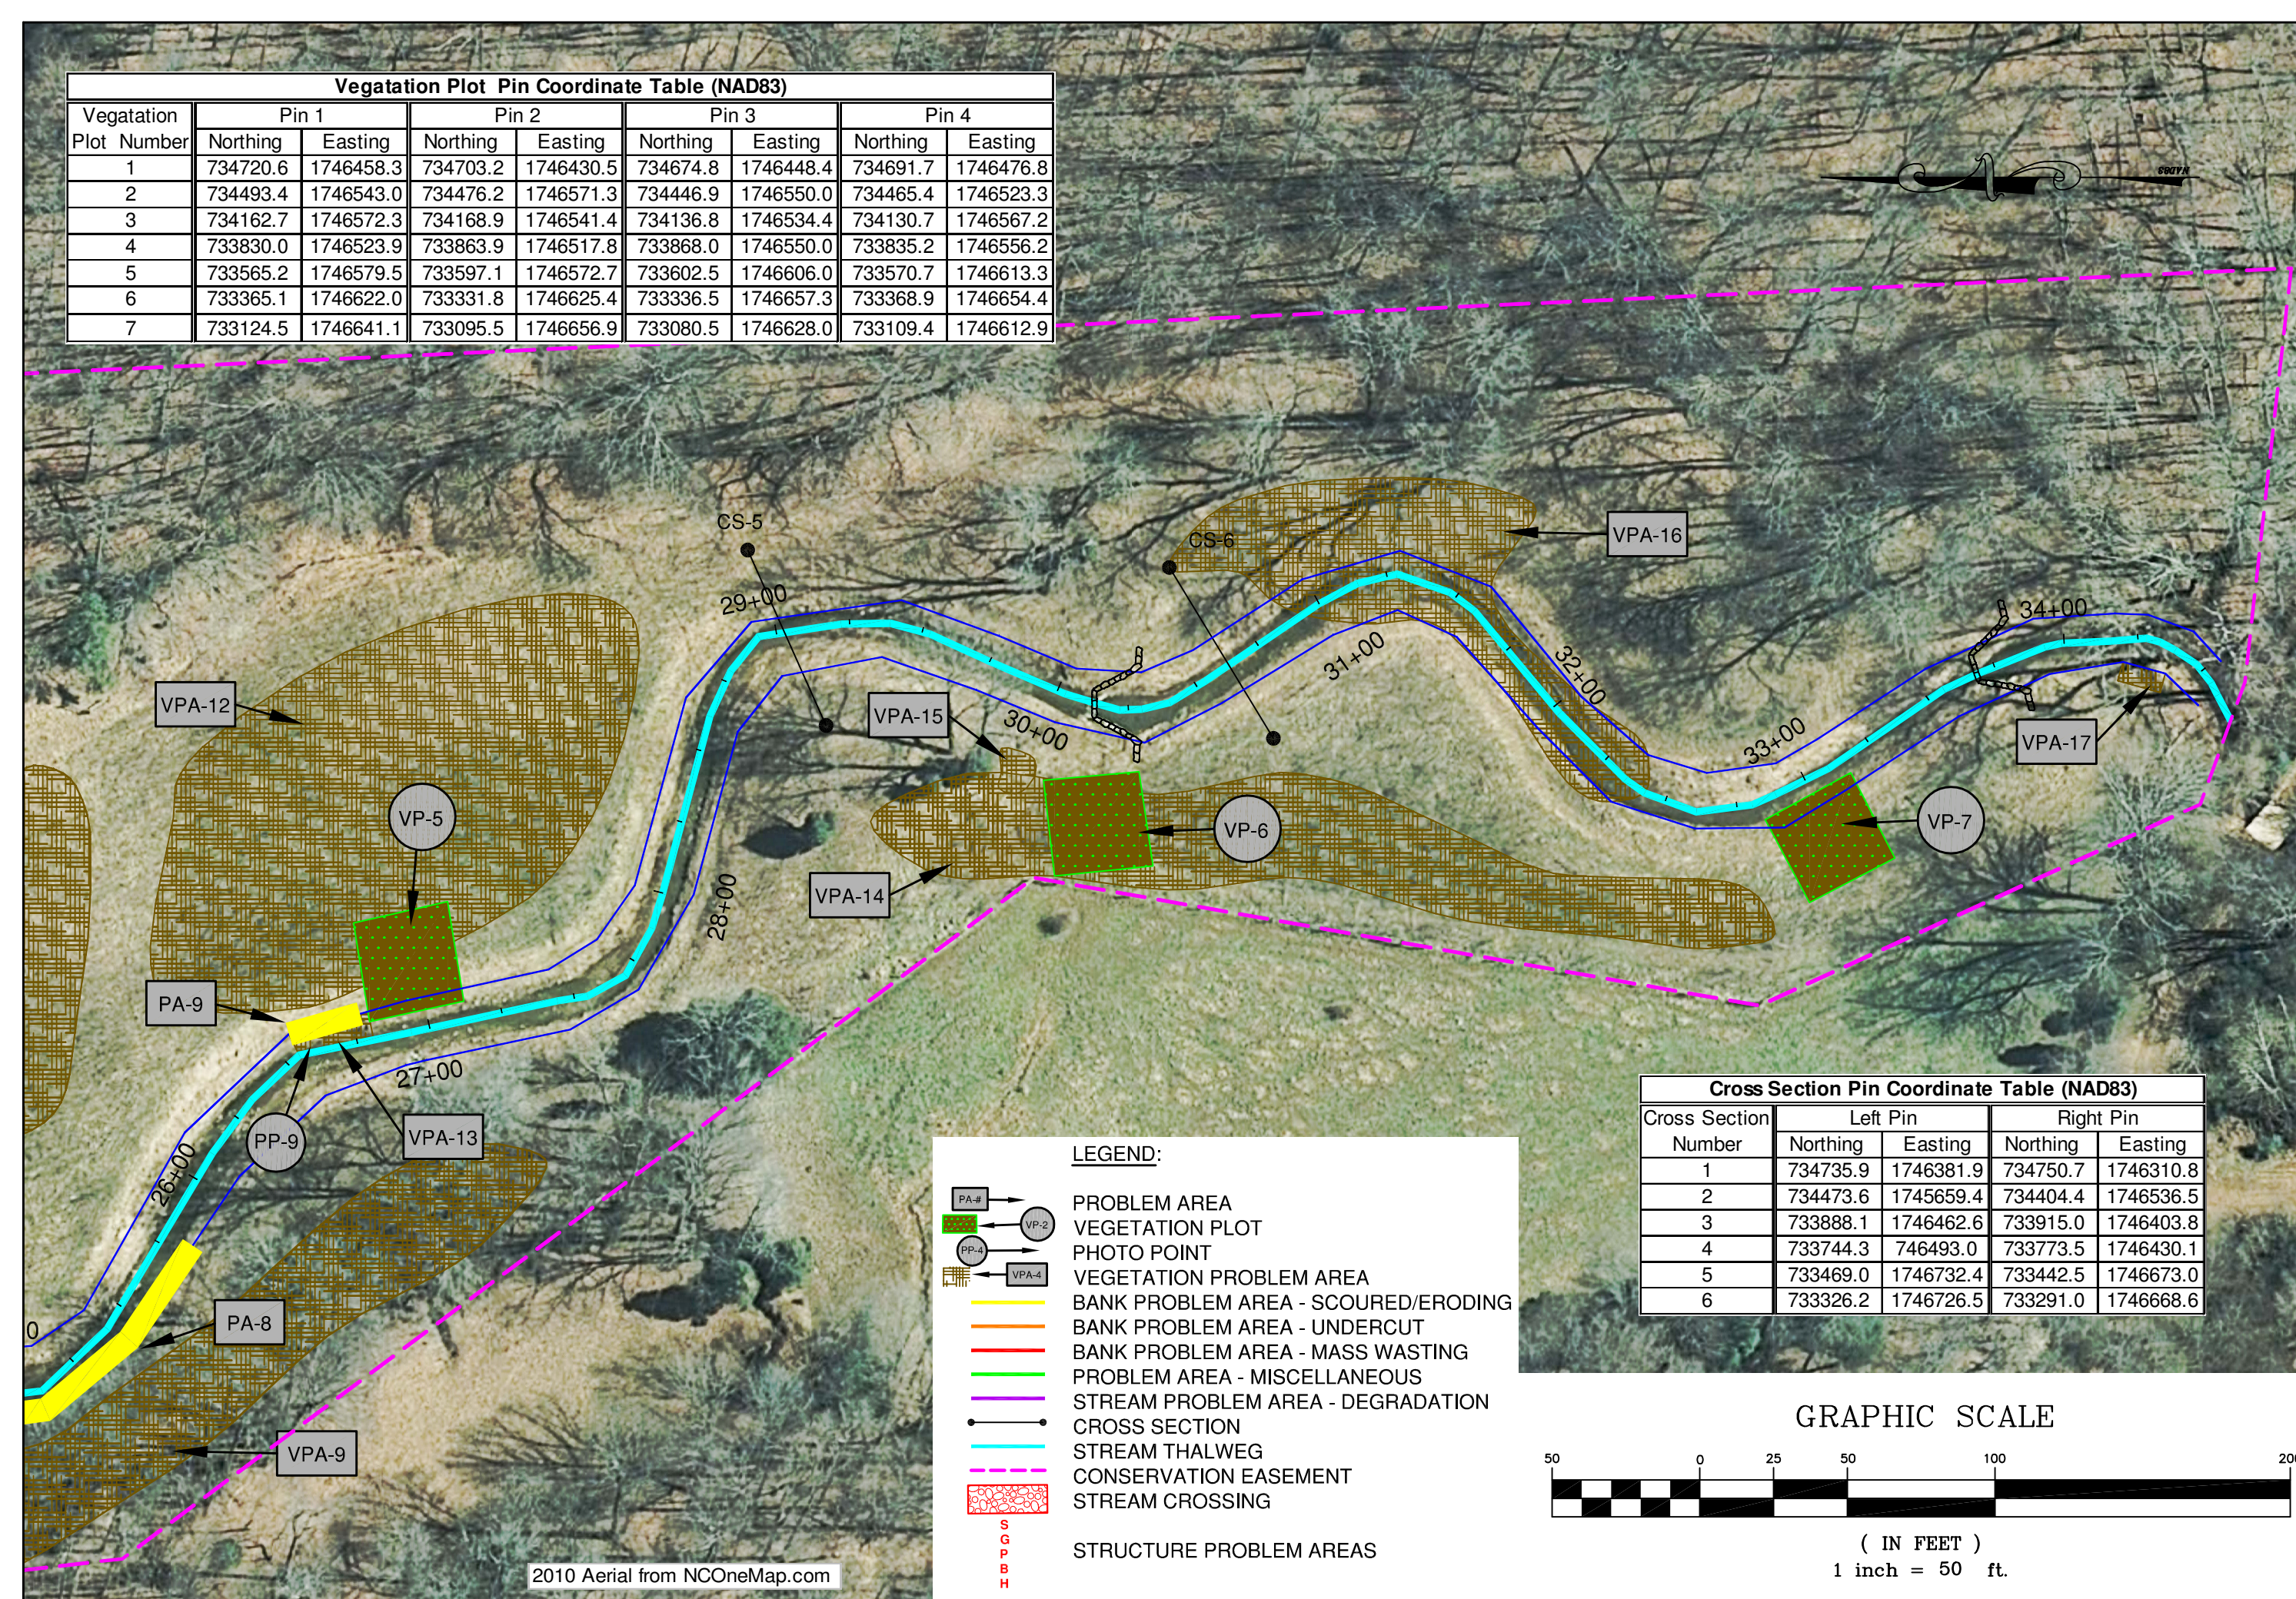
**FIGURE 2 OVERALL**

Reach 1 is a short stream segment consisting of 286 linear feet in the upper most portion of the project. In this reach 100% of riffles and pools are stable and functioning as designed. The riffle pebble count in this reach exhibits slight coarsening. The visual assessment for Reach 1 reflected bank stability at 91%. The total bank erosion length of 50 feet is a relatively small length of the total project distance but resulted in a high percentage value due to the short reach length. The bank erosion on the left bank at station 10+25 was marked as an erosional feature however significant erosion has not occurred this year as compared to its condition in previous monitoring years. The stream right bank, due to tie in constraints at the beginning of the project, is an extension of the steep valley slope. The toe of the slope is stable however the bank supports woody vegetation at bankfull elevations perched on the slope with undercut roots. The bank is not expected to fully stabilize due to lack of vegetation and the steep grade of the adjacent slope, however continued mass wasting is not anticipated. Only two structures are located in Reach 1. The structure functionality rate was 50% for MY-03 due to signs of piping that were observed at the rock cross vane located at station 12+49 during the site visit conducted in March 2011. Piping was not observed during the August 2011 data collection due to a lack of flowing water. The piping was occurring between the sill rock and vane arm and was viewed as minor as it was not causing scouring or compromising the structure function. The structure will be re-evaluated during the site visit in the spring of 2012.

Reach 2 is 2250 linear feet and comprises the majority of the stream length. In Reach 2, 94% of riffles and 89% of pools are functioning properly. Thalweg centering appears to be an issue on approximately 24% of the upstream side of pools (Runs) and 6% of the downstream side of pools (Glides). This is primarily due to aggradation, which appears in about 1% of the overall reach length. The lack of centering is not causing bank erosion. The structures in Reach 2 are showing a functionality of 100% throughout the reach and exhibit no signs of piping or integrity issues. The banks of Reach 2 appear to be stable with no signs of new erosion.

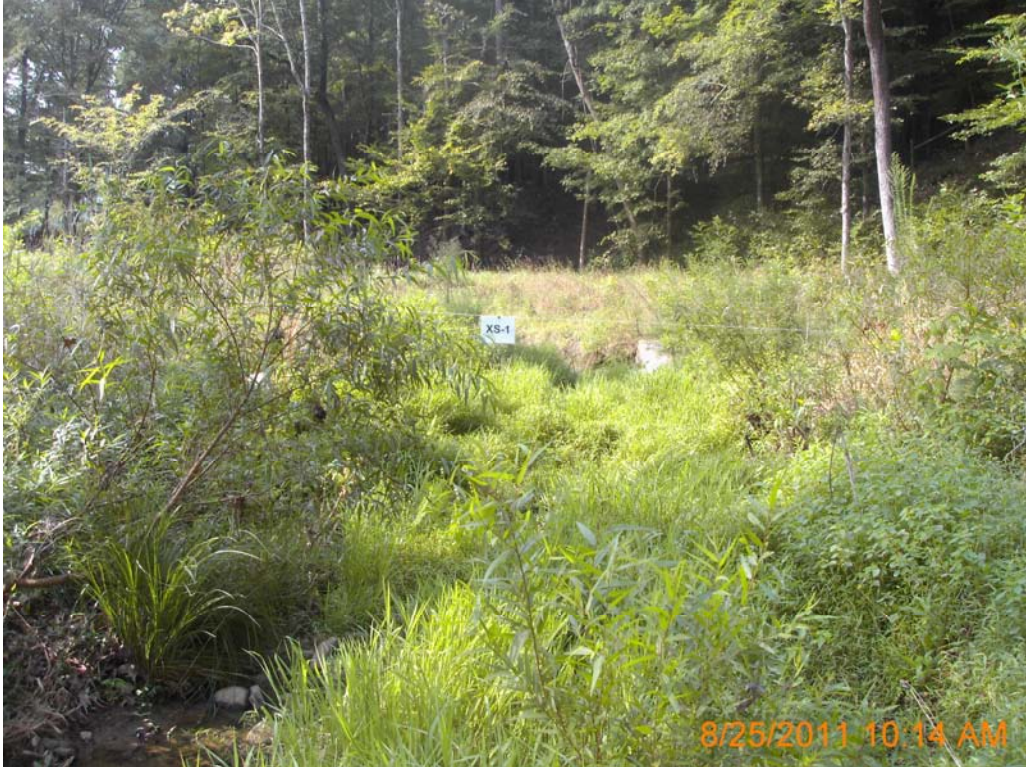
Photo 1. Looking downstream at XS-1

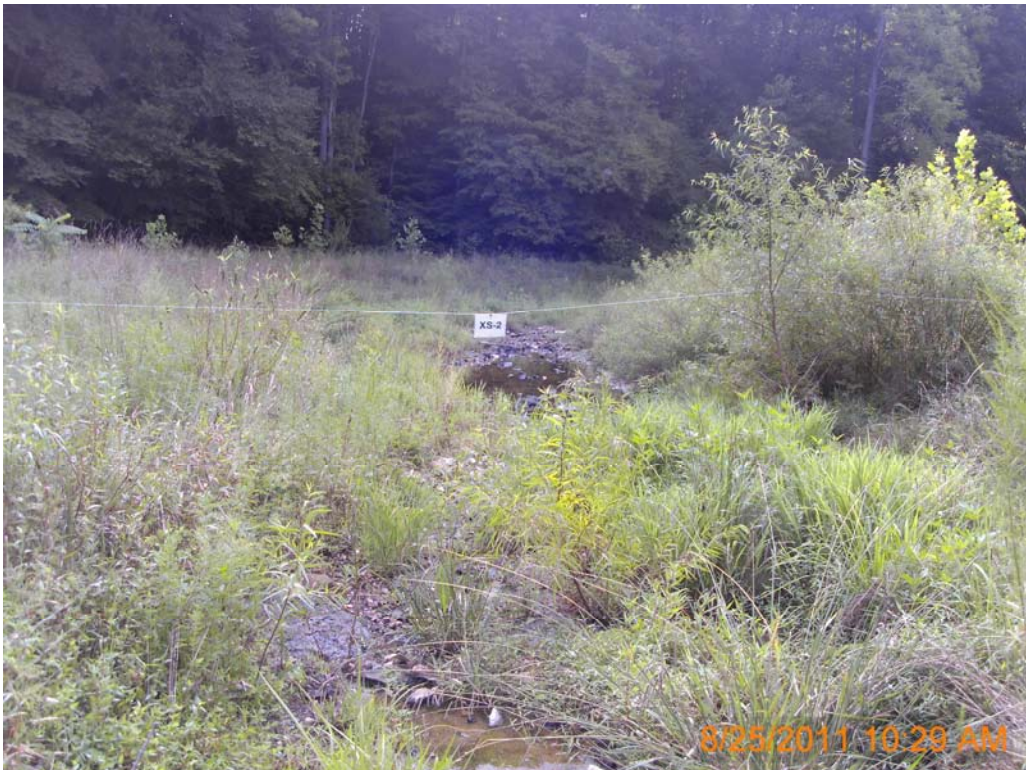
Photo 2. Looking downstream at XS-2

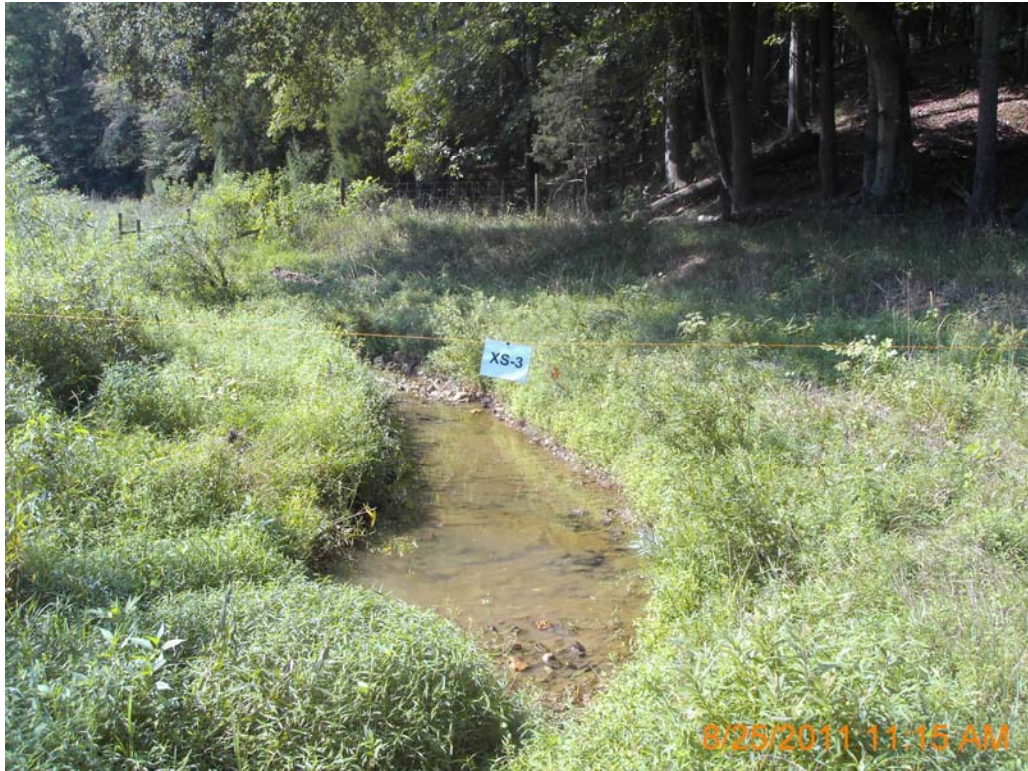
Photo 3. Looking downstream at XS-3

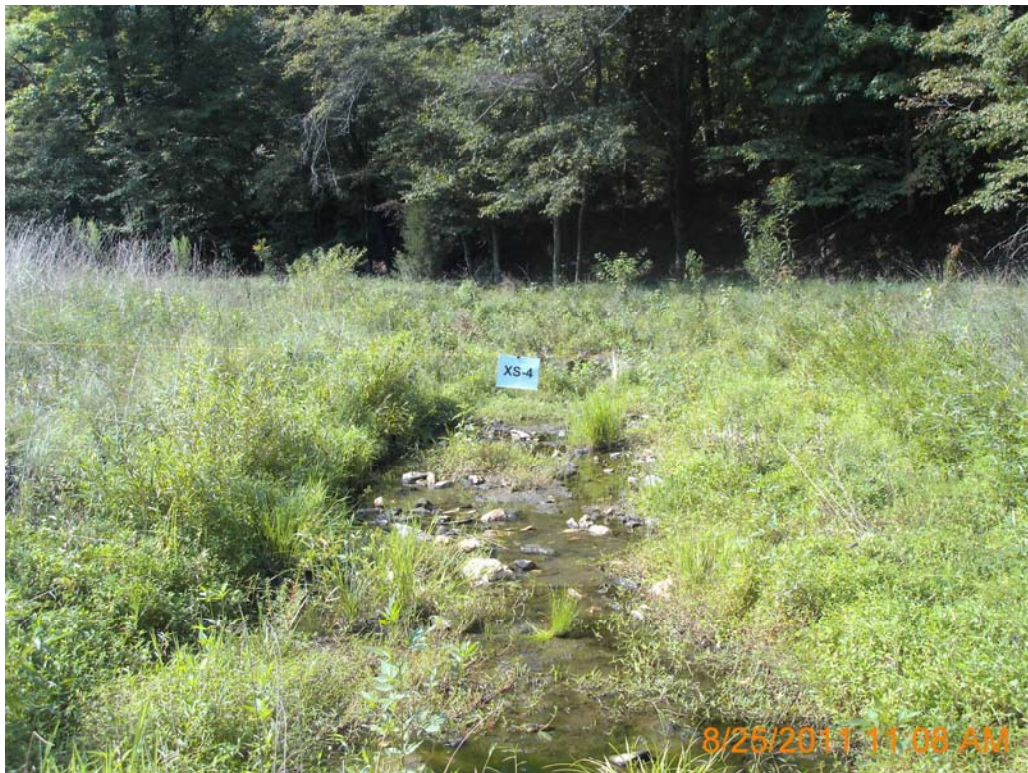
Photo 4. Looking downstream at XS-4

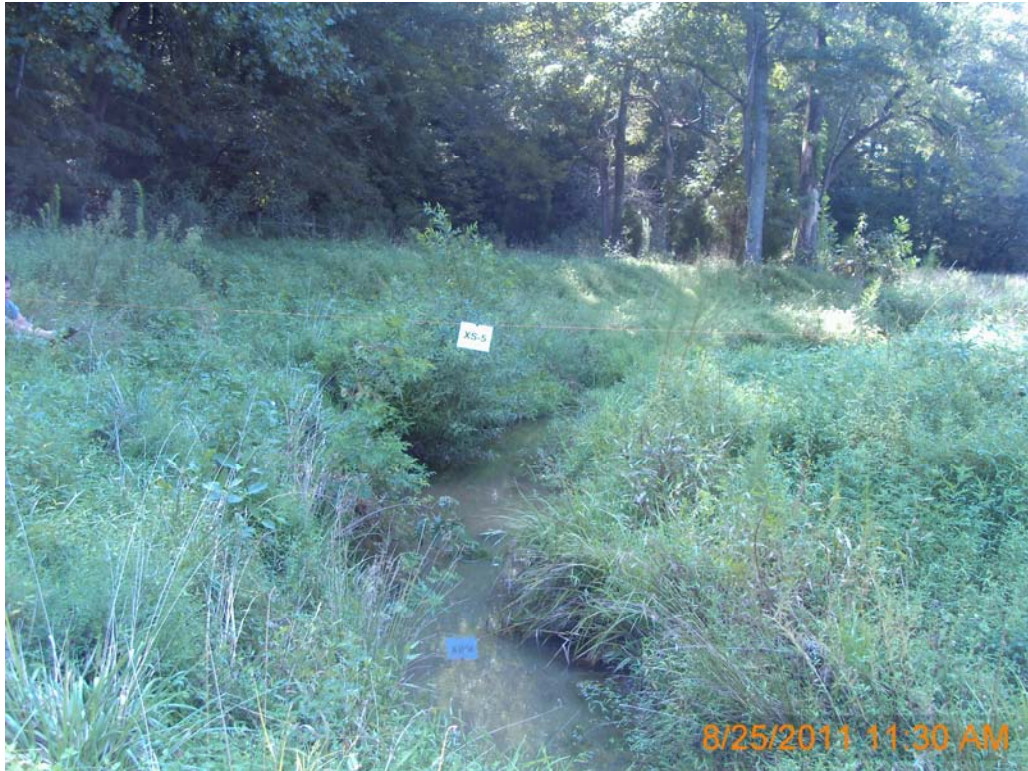
Photo 5. Looking downstream at XS-5

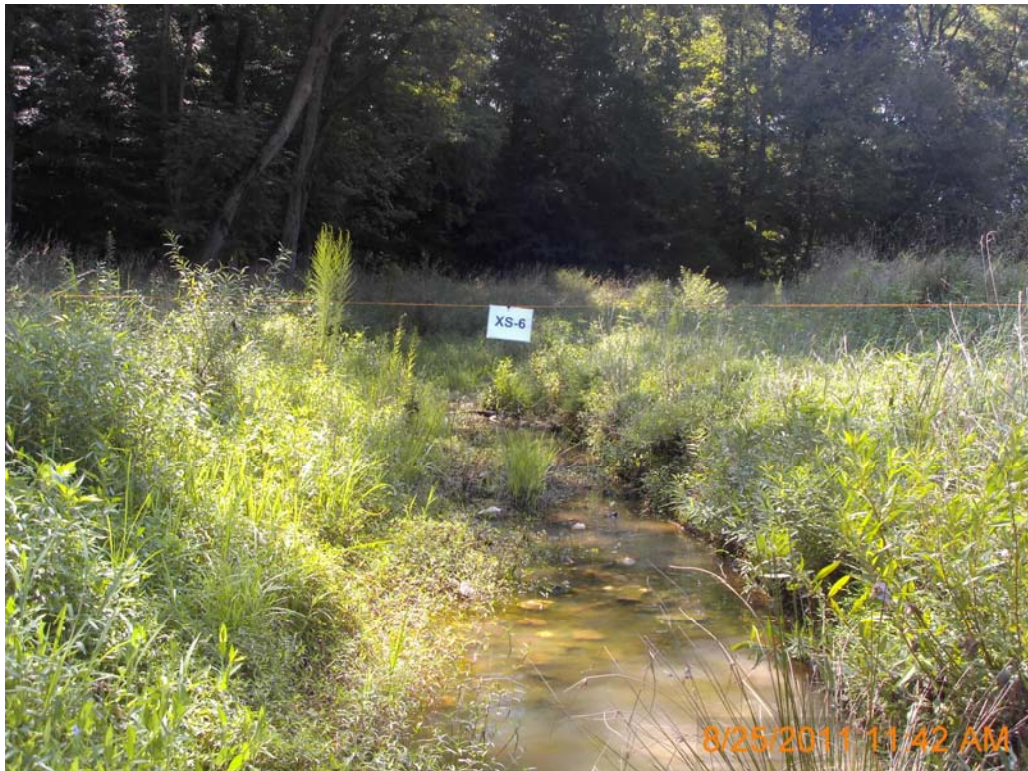
Photo 6. Looking downstream at XS-6

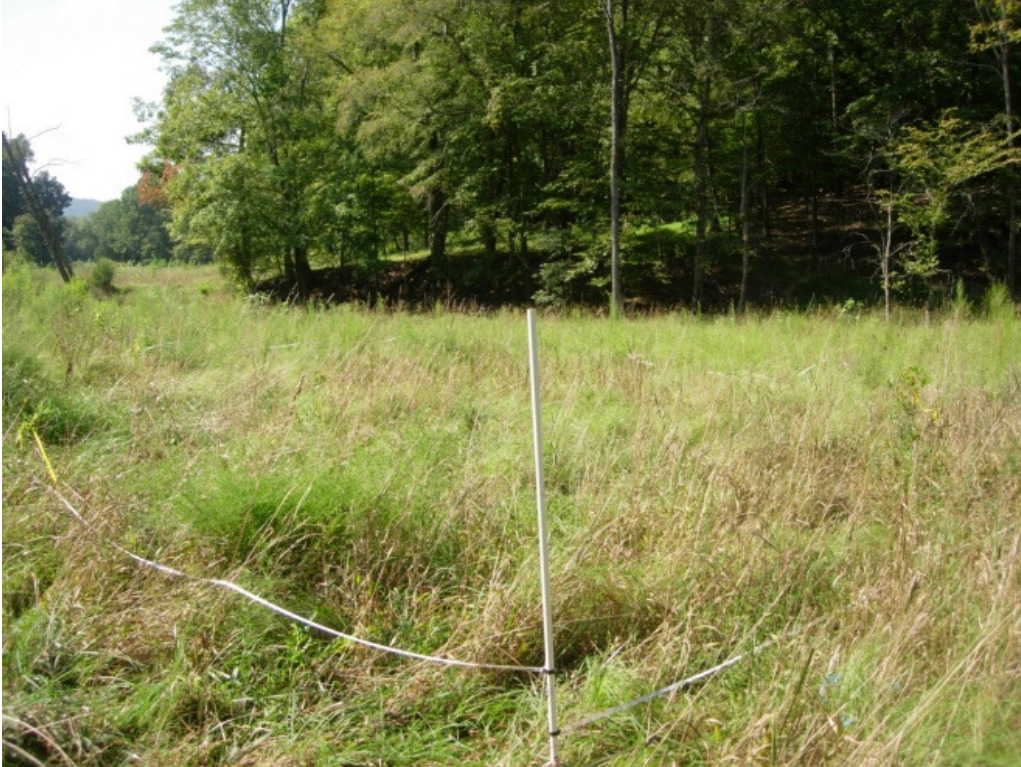
Seven vegetation monitoring plots (1-7) were monitored for MY-03. Of these seven plots, plots 1, 2, 5, 6, and 7 are not meeting vegetation success criteria. The vegetation success criteria have been met by 28% of the plots in monitoring year MY-03. The success criterion for planted woody species is 320 stems/acre after MY-03. A mortality rate of ten percent will be allowed after MY-04 (288 stems/acre), with another ten percent allowed after MY-05 (260 stems/acre). Currently the site contains 289 planted stems/acre, excluding livestock, which is below the success criteria for MY-03. Total stem counts including natural stems and livestock resulted in 722 stems/acre. Bare banks, areas of low stem densities, and invasive exotics are the only notable vegetation problem areas for MY-03. Invasive exotics within the conservation easement include tall fescue (*Schedonurus arundinaceus*), Japanese stiltgrass (*Microstegium vimineum*), multiflora rose (*Rosa multiflora*), Chinese lespedeza (*Lespedeza cuneata*), and Chinese privet (*Ligustrum sinense*). Although these species have been given different ranks of severity, the functionality of the project is not expected to be impaired significantly. It is likely that all of these species were present in and adjacent to the conservation easement previous to construction. The tall fescue and Japanese stiltgrass appears to be inhibiting some growth of planted stems in some areas, and there is very few successional woody stems were observed in the fescue dominated areas. For additional information relating to vegetation, see Appendix C. Approximately 4 acres have been identified for supplemental planting in the future but has not been scheduled by the time of this report.

Photo 7. Vegetation Plot 1 (September 8, 2011)

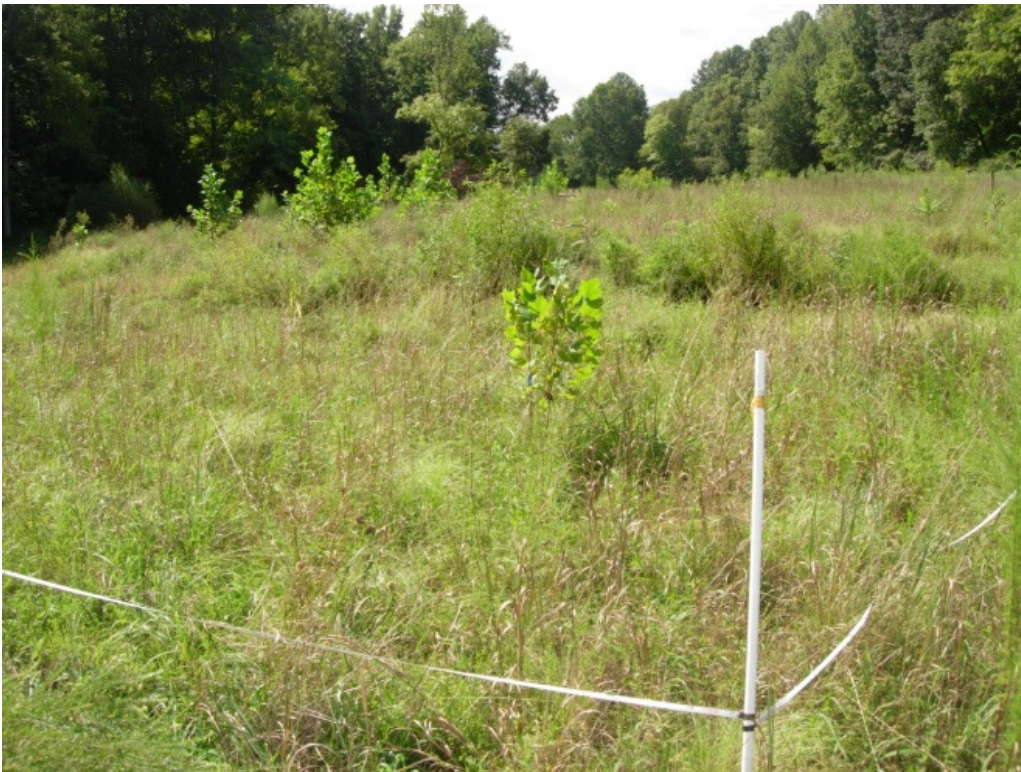
Photo 8. Vegetation Plot 2 (September 8, 2011)

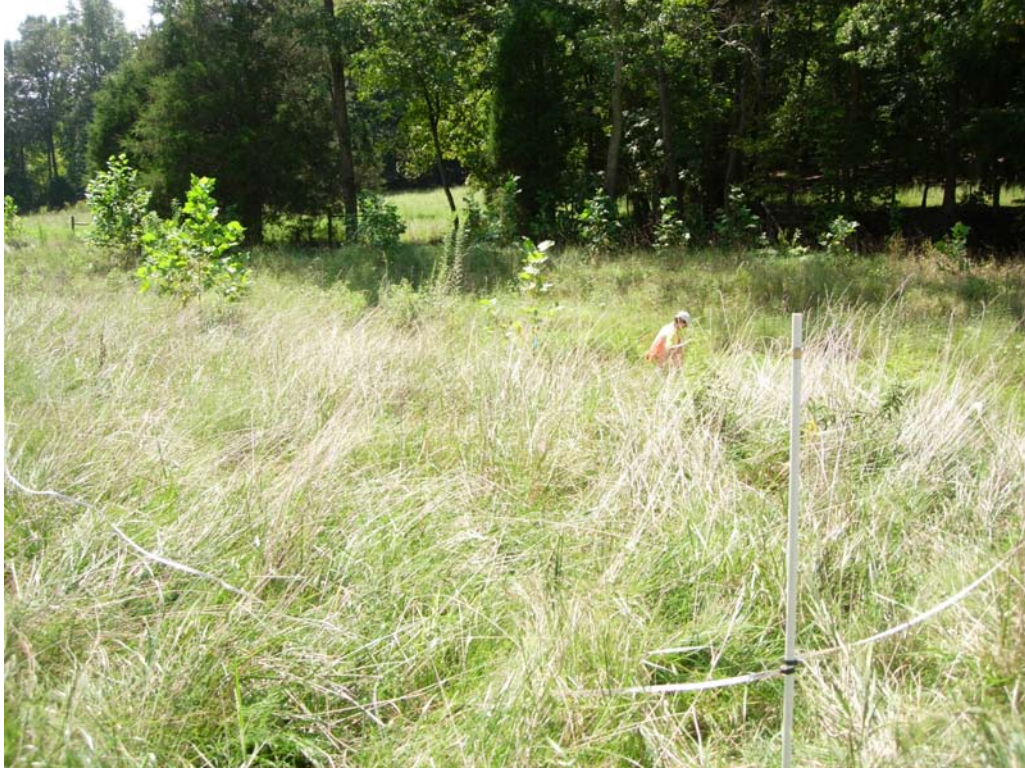
Photo 11. Vegetation Plot 5 (September 8, 2011)

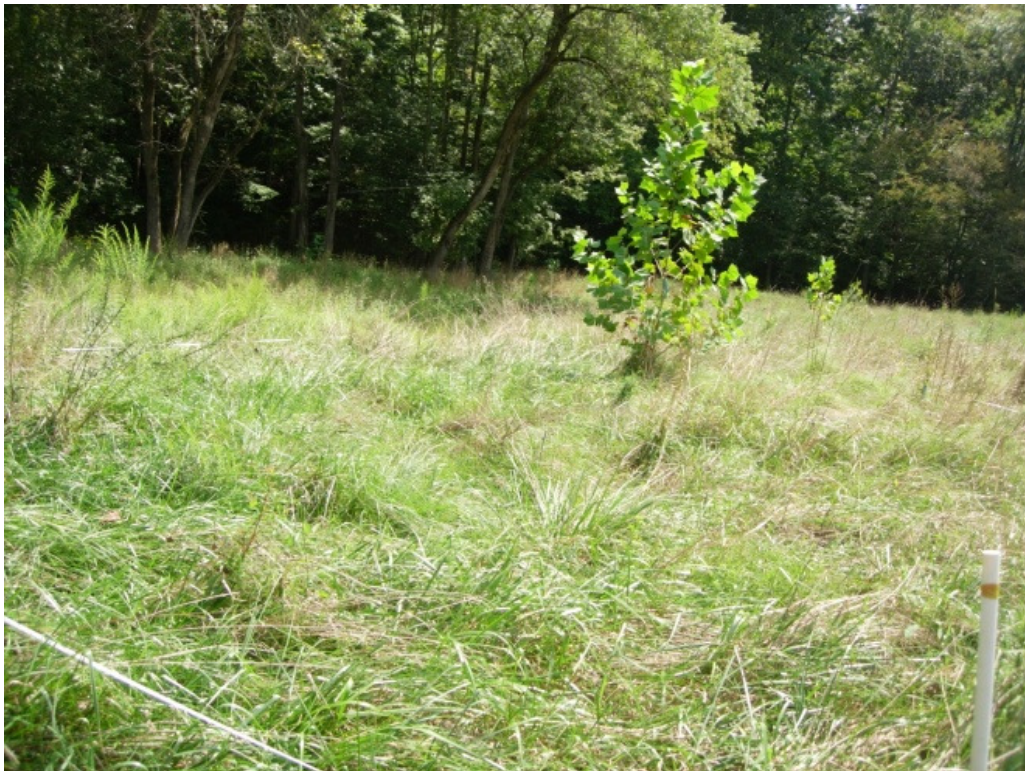
Photo 12. Vegetation Plot 6 (September 8, 2011)

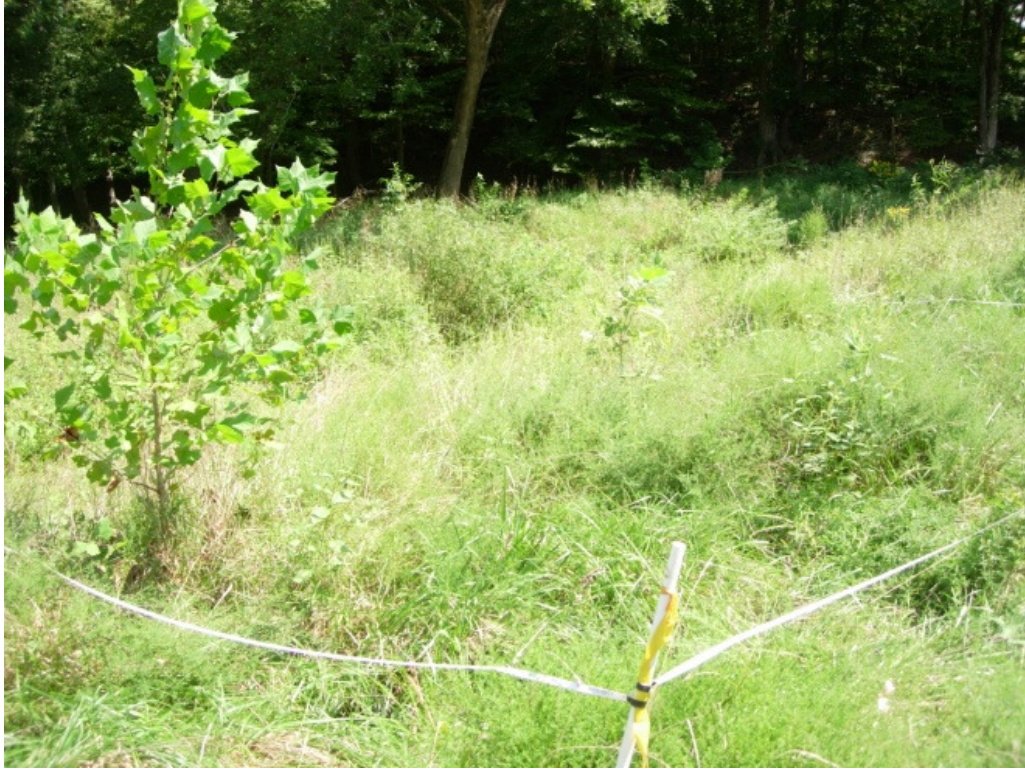
Photo 13. Vegetation Plot 7 (September 8, 2011)
