FINAL
ANNUAL MONITORING REPORT
YEAR 4 (2012)
McCain Stream Restoration Site
RANDOLPH COUNTY, NORTH CAROLINA
(EEP Project No. 443, Contract No. 004807)
Construction Completed March 2009

December 2012

Prepared by:
Axiom Environmental, Inc.
218 Snow Avenue
Raleigh, North Carolina 27603

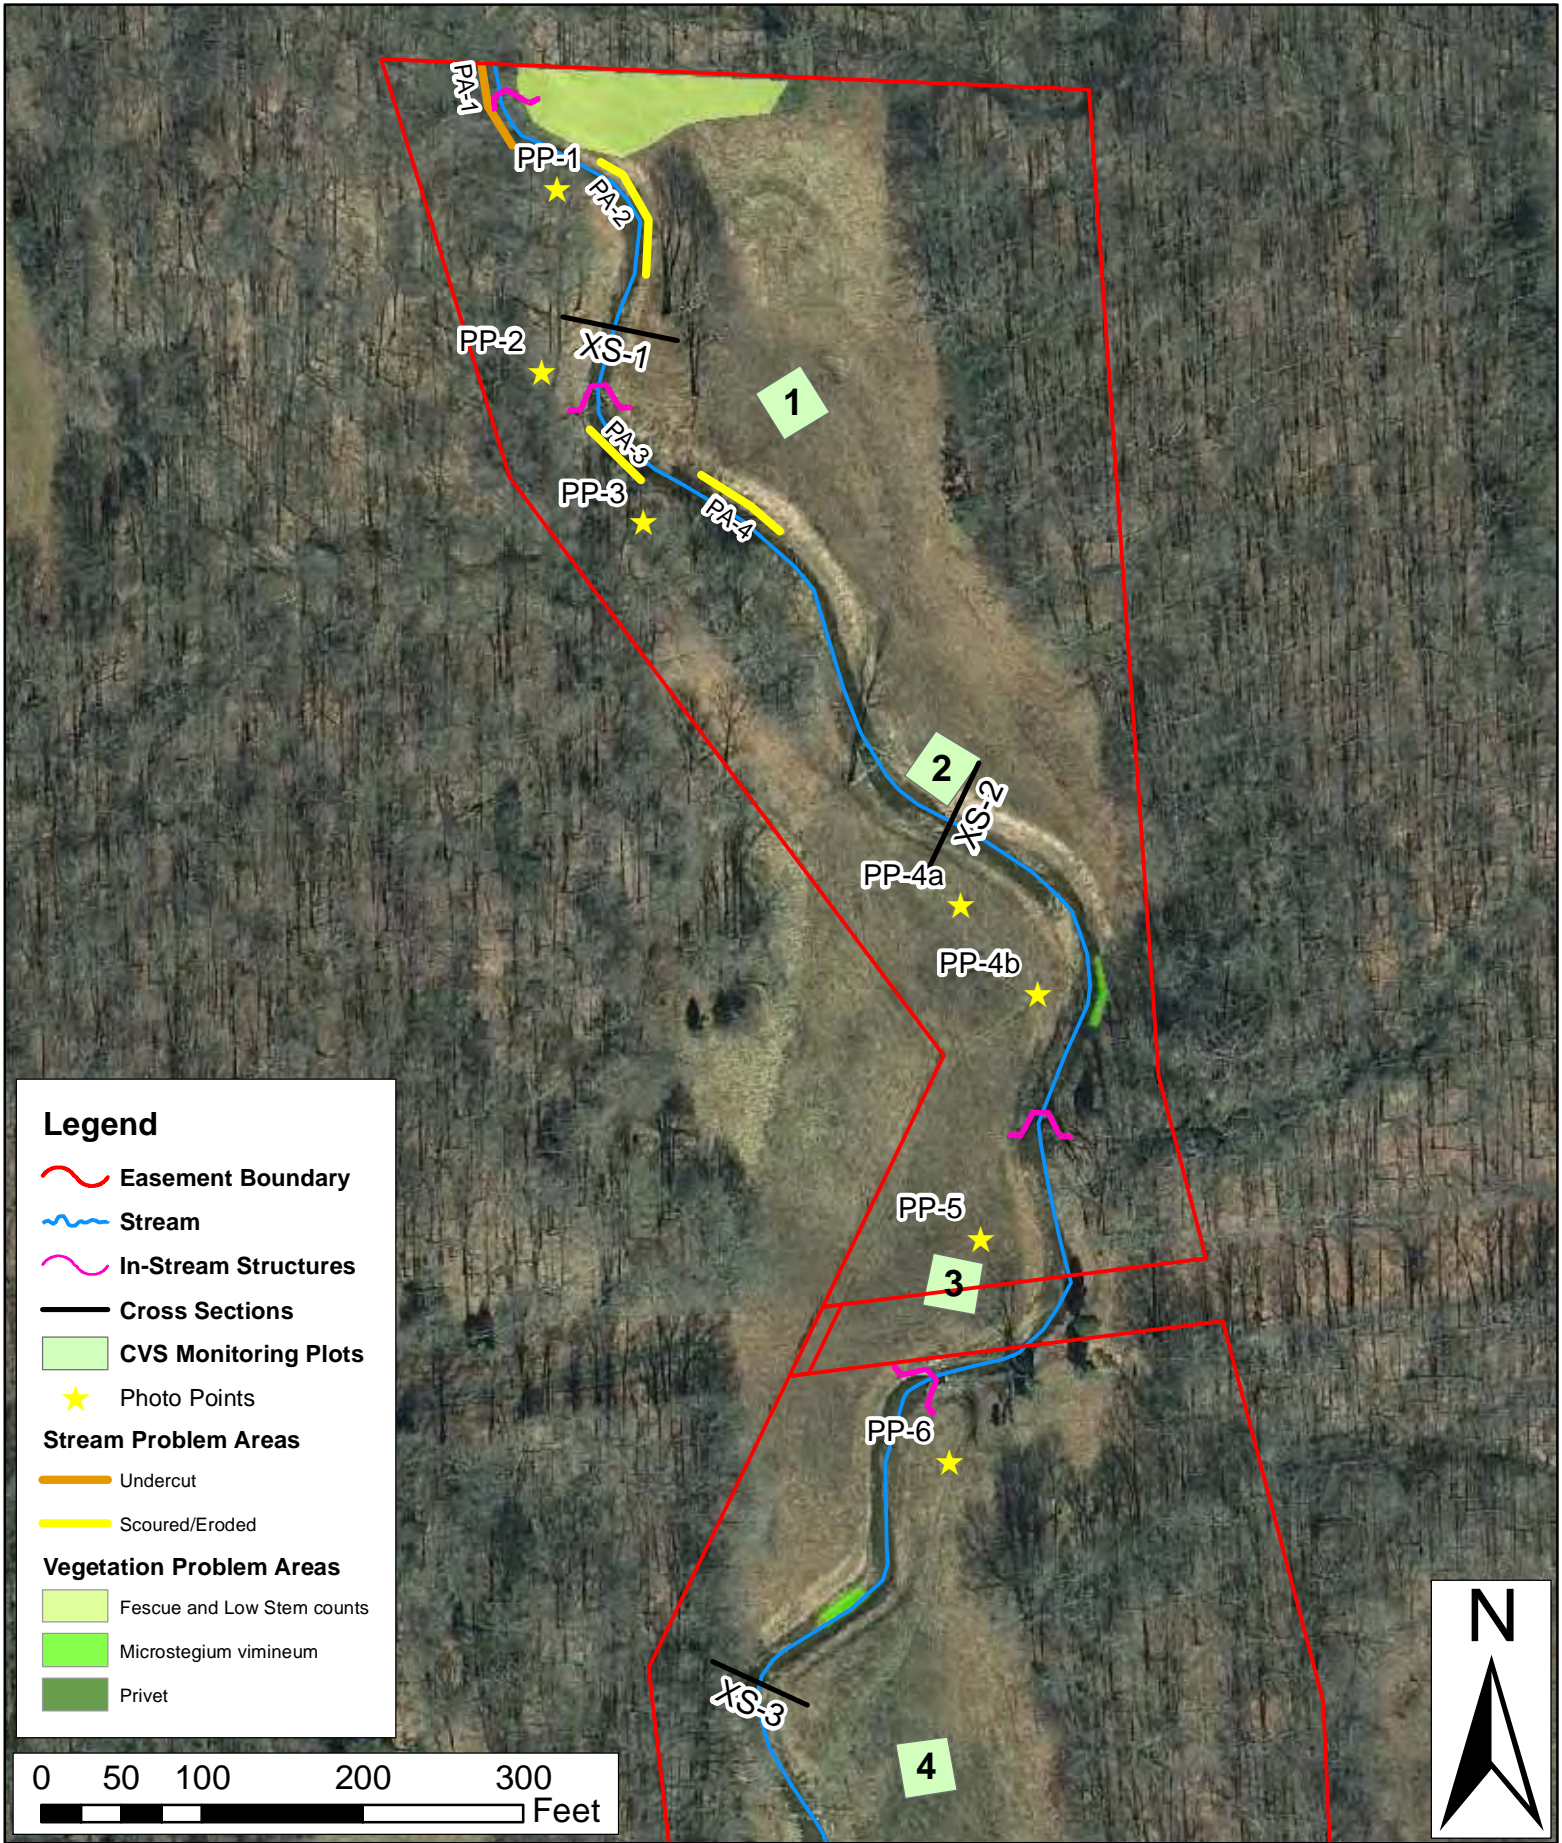
FIGURE
2A

Stream problem areas include areas of minor bank erosion/scour in the upstream 300 linear feet of the Site (Reach 1). Stream problem areas do not appear to be worsening and no immediate maintenance actions are recommended at this time. Many areas considered problems during previous monitoring years have recovered and vegetation has established; therefore, these areas are no longer considered problems. Stream problem areas are depicted on Figures 2A-2B (Appendix B) and include the following.

Map Label*	Station	Notes
PA-1	10+00	Undercut banks at easement boundary
PA-2	11+25	Minor erosion and undercut bank on outer/left bank; vegetation is establishing
PA-3	12+90	Some erosion on outer/right bank; vegetation is establishing
PA-4	13+50	Minor scouring in riffle; vegetation is establishing
PA-5	25+00	Erosion on outer/right bank
PA-6	26+50	Minor erosion on outer/left bank; vegetation is establishing

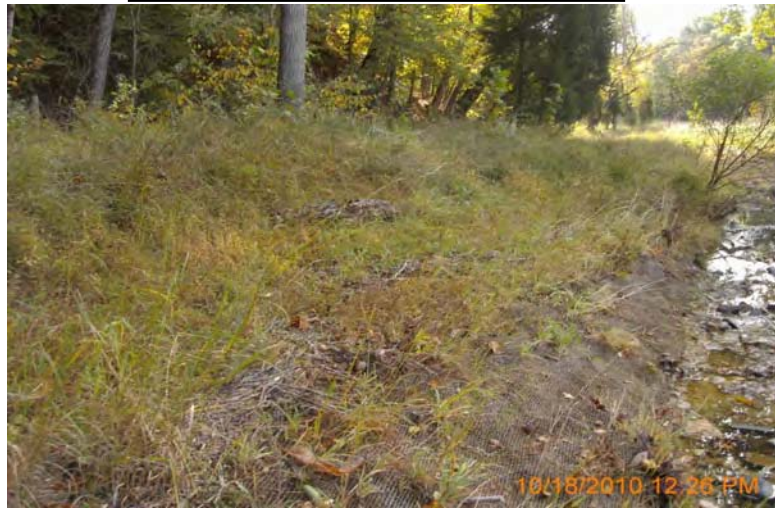
Photo 14. Evidence of overbank including wrack on top of banks.
