**FINAL
ANNUAL MONITORING REPORT
YEAR 5 (2013)
McCain Stream Restoration Site
Randolph County, North Carolina
(EEP Project No. 443, Contract No. 004807)
Construction Completed March 2009**

October 2013

Prepared by:
Axiom Environmental, Inc.
218 Snow Avenue
Raleigh, North Carolina 27603

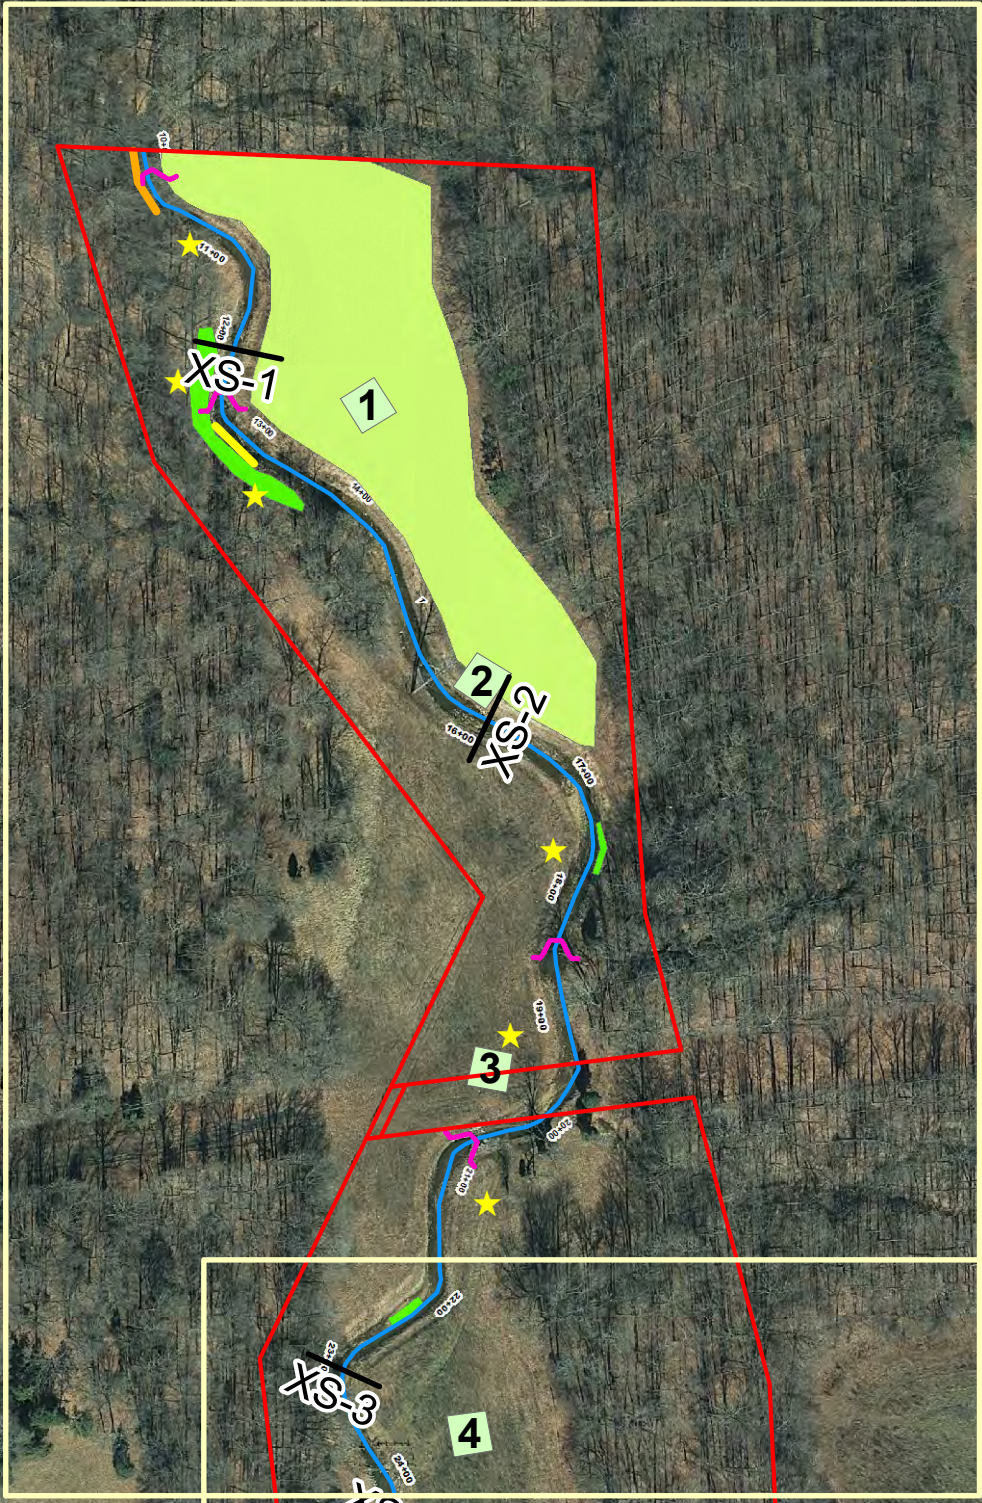
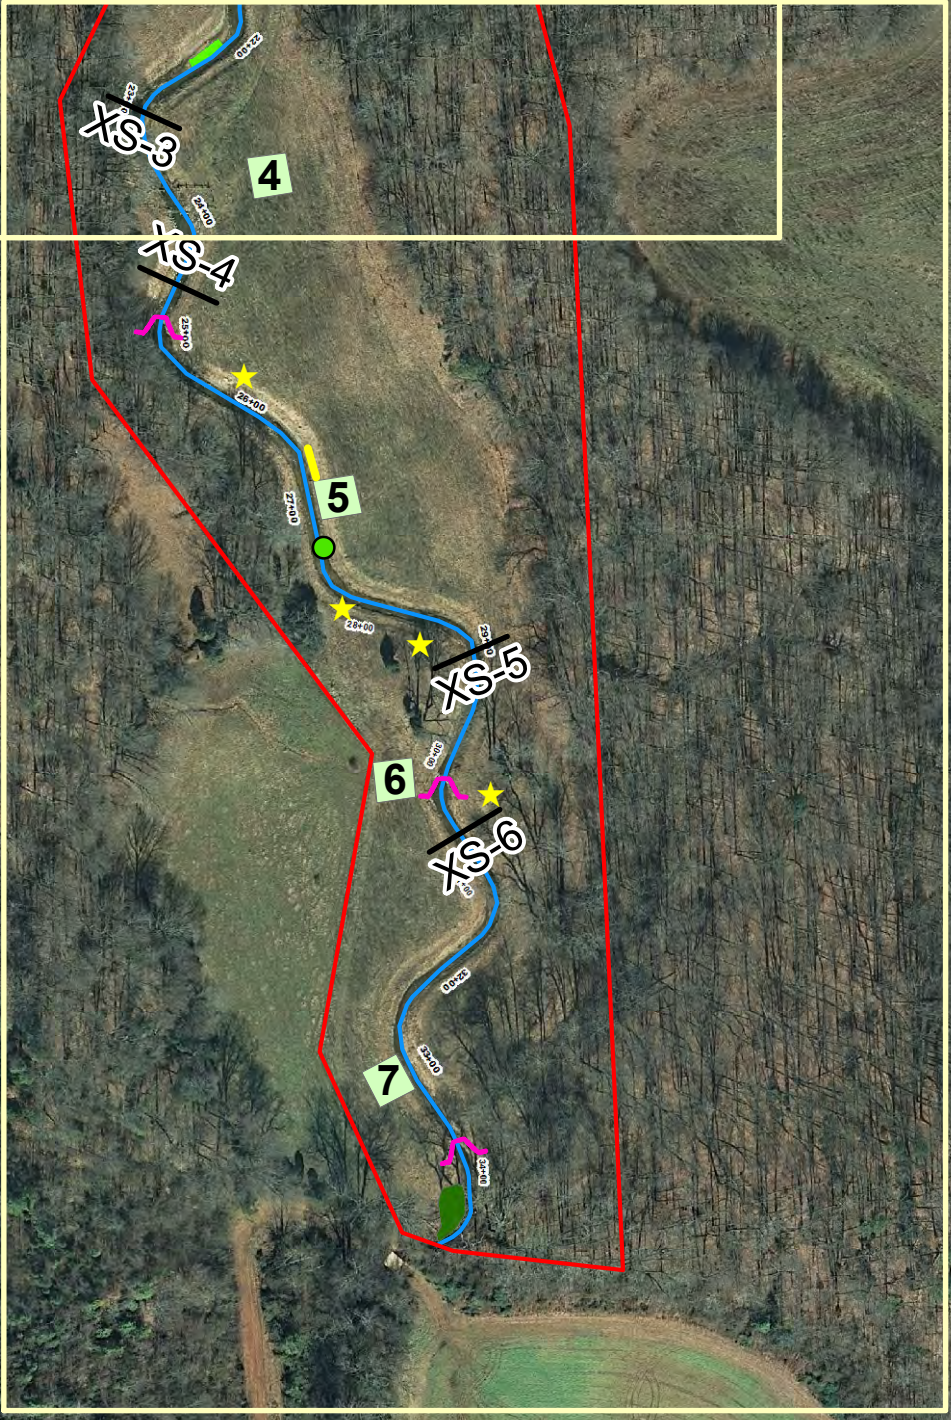
Stream areas of concern include areas of minor bank erosion/scour in the upstream 300 linear feet of the Site (Reach 1). Stream areas of concern do not appear to be worsening and no immediate maintenance actions are recommended at this time. Many areas considered areas of concern during previous monitoring years have recovered and vegetation has established. Current stream areas of concern are depicted on Figures 2A-2B (Appendix B) and include the following.

Map Label*	Station	Notes
SAC-1	10+00	Area of poor vegetation along eroded, undercut, outer bend at beginning of restoration reach
SAC-3	12+90	Eroded outer bend lacking deep-rooted vegetation with some scour in pool
SAC-6	26+50	Minor erosion and poor vegetation development
